Cut away view of CLIC travelling wave RF cavity

# Impact of linear coupling correction on LHC Beam2 bunch shape measured with the synchrotron radiation monitor

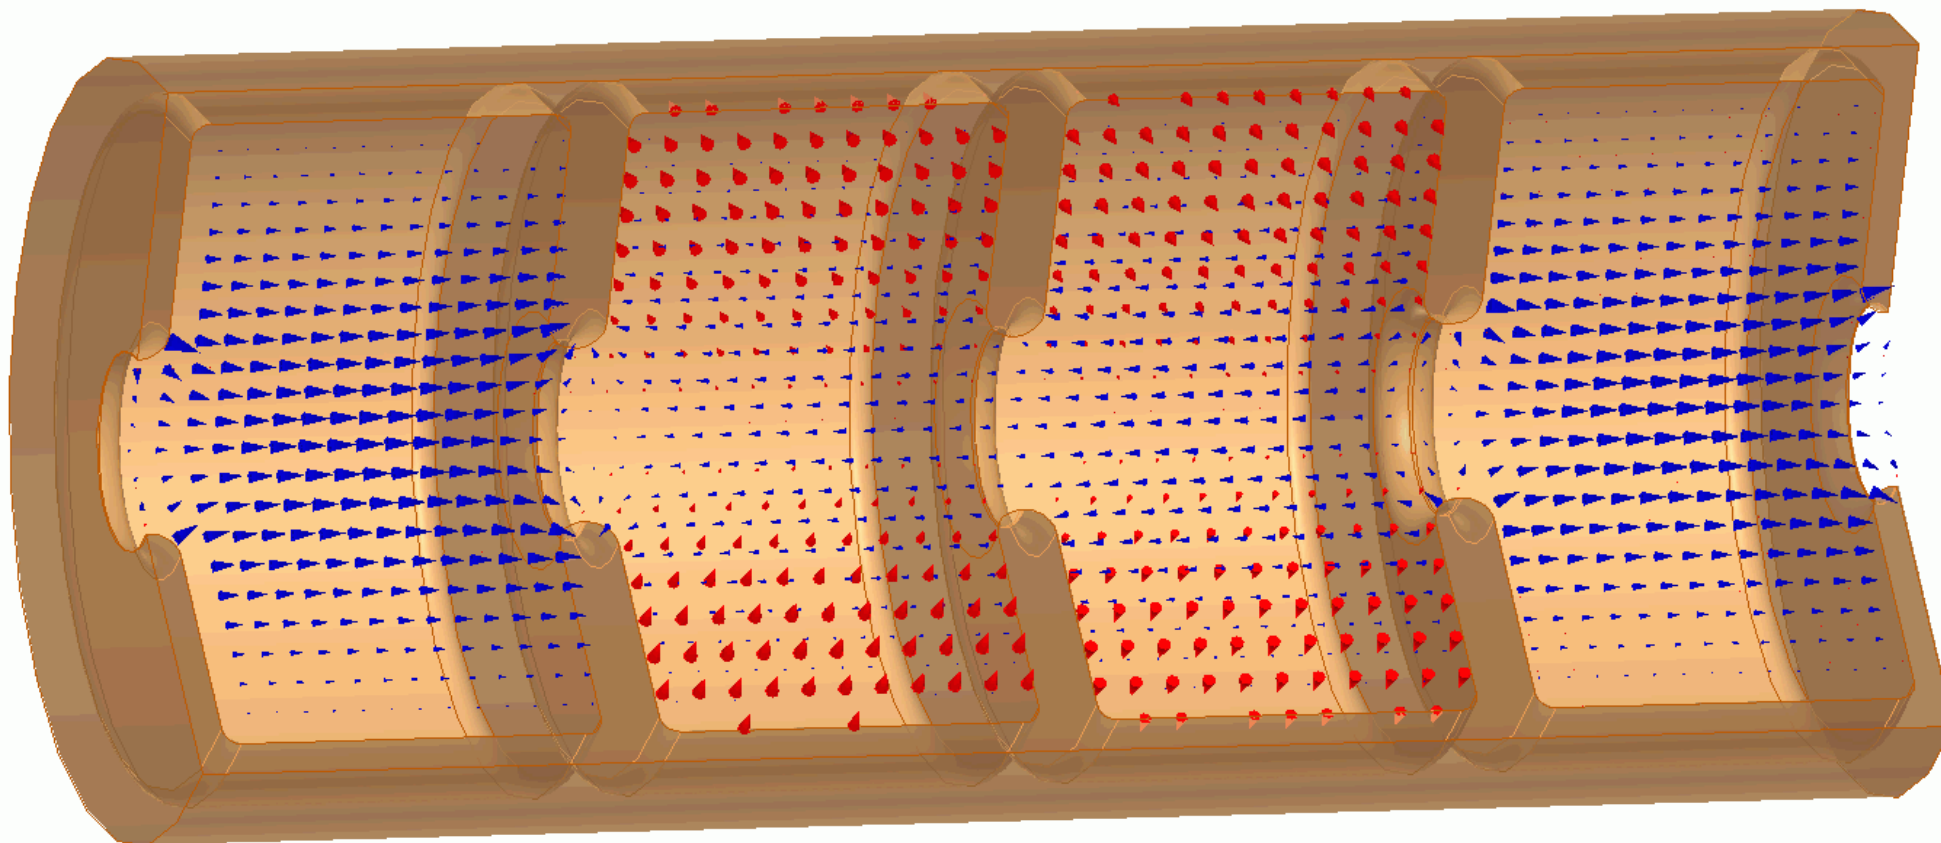
Beam accelerated from right to left

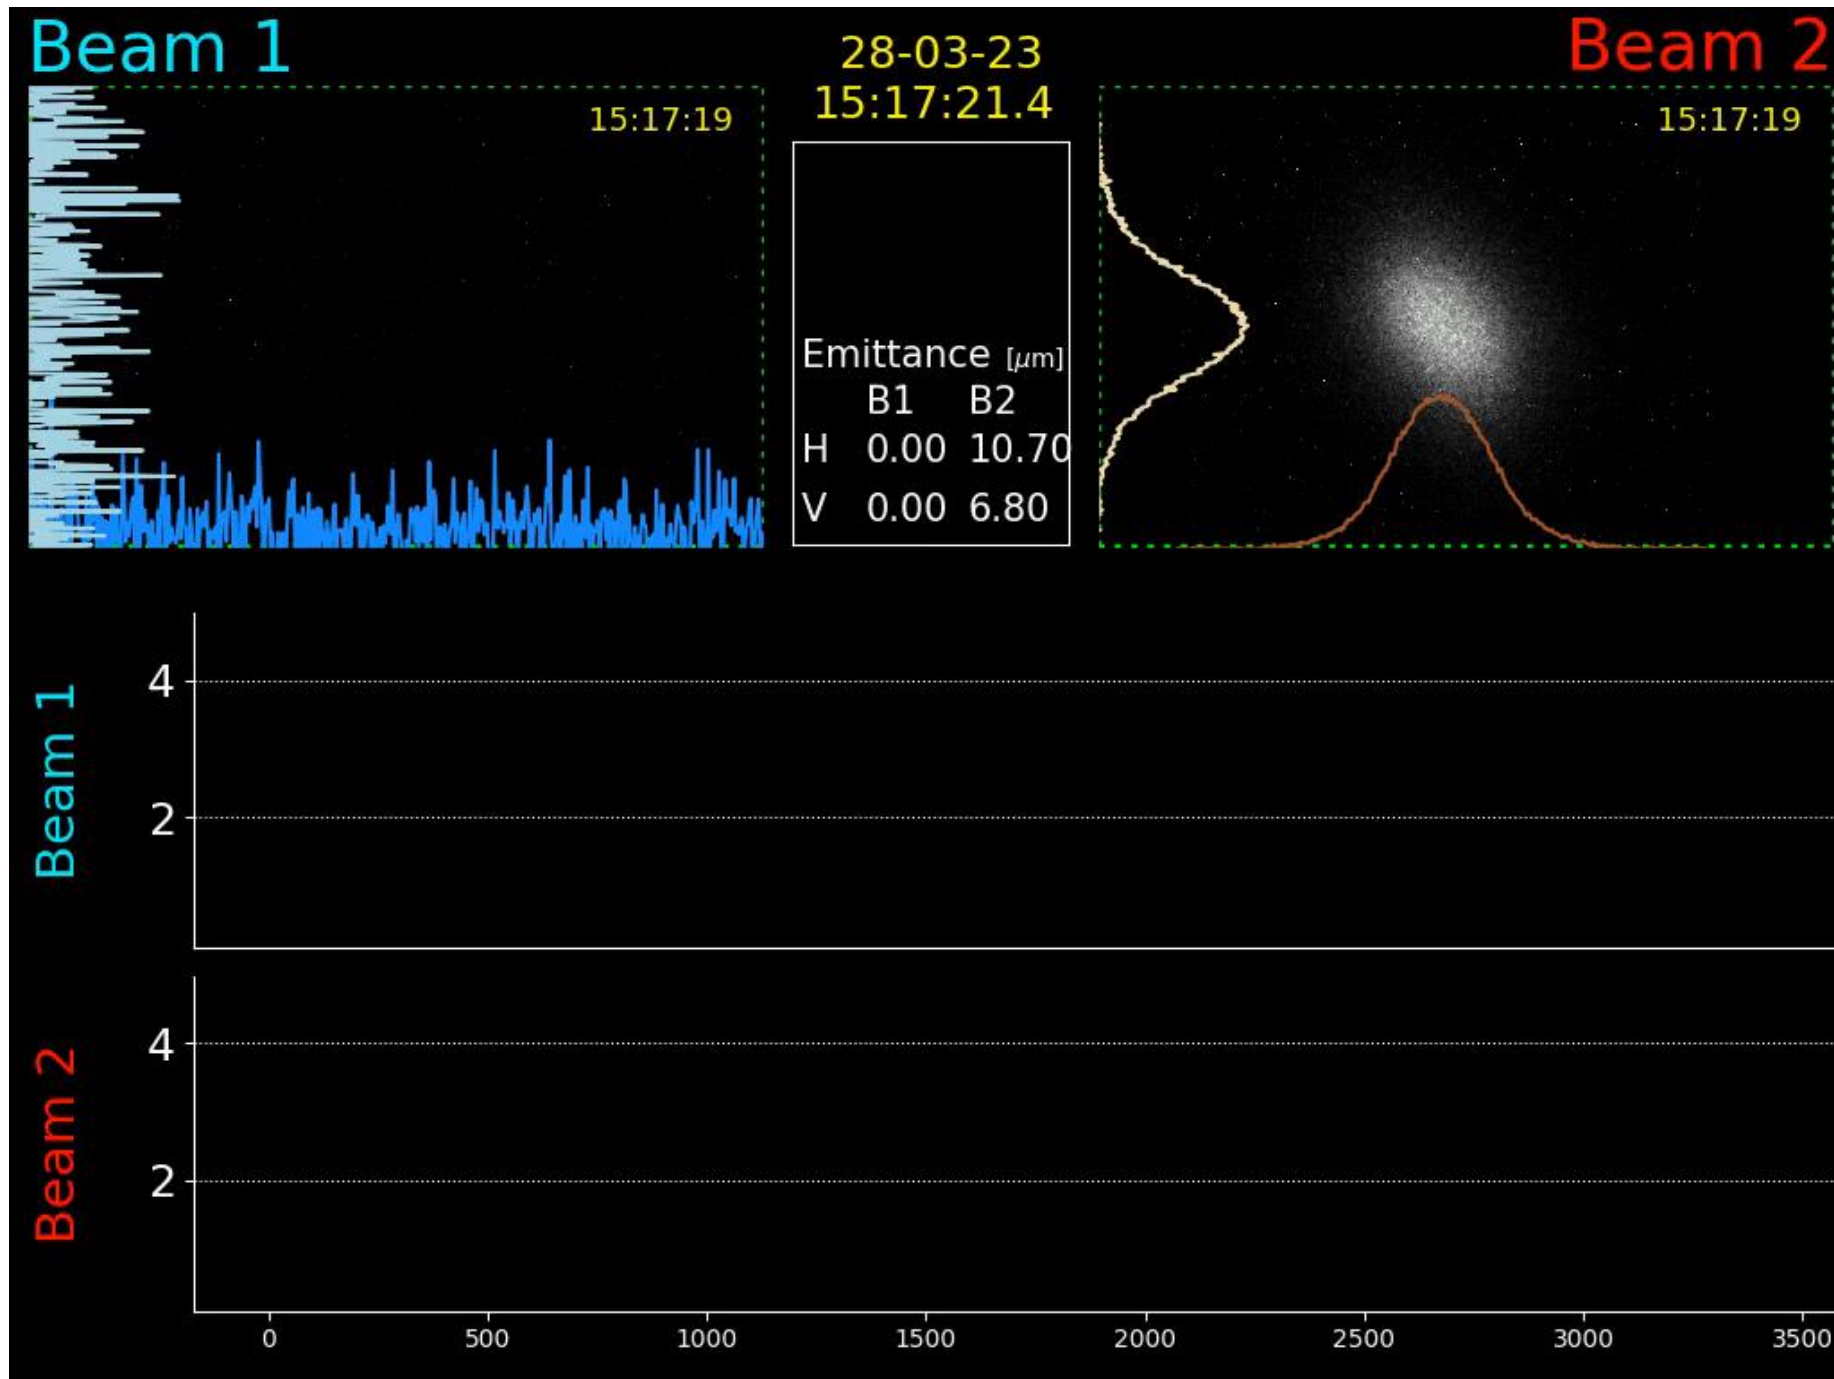
- Linear coupling was changed between 15:17:45 and 15:18:05
