# PHENIX Silicon Pixel Detector Construction, Operation, and the first Results

Atsushi Taketani

**<u>RIKEN</u>** Nishina center

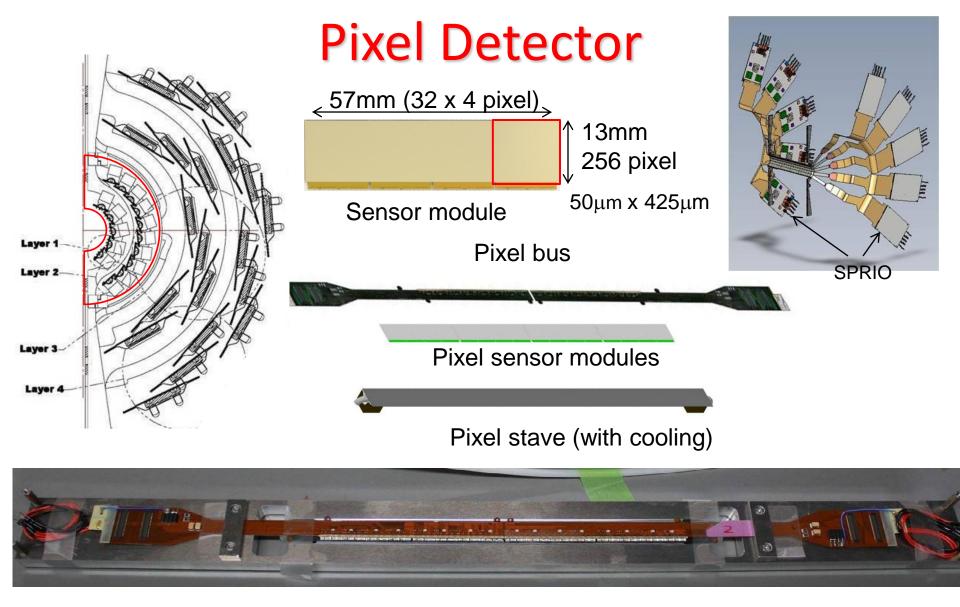
Pixel : inner 2 layers and Stripixel: outer 2 layers

Pixel detector = inner 2 layers of VTX 1<sup>st</sup> layer: 10 full pixel ladders = 20 half ladders = 40 sensor modules 2<sup>nd</sup> layer: 20 full pixel ladders = 40 half ladders = 80 sensor modules

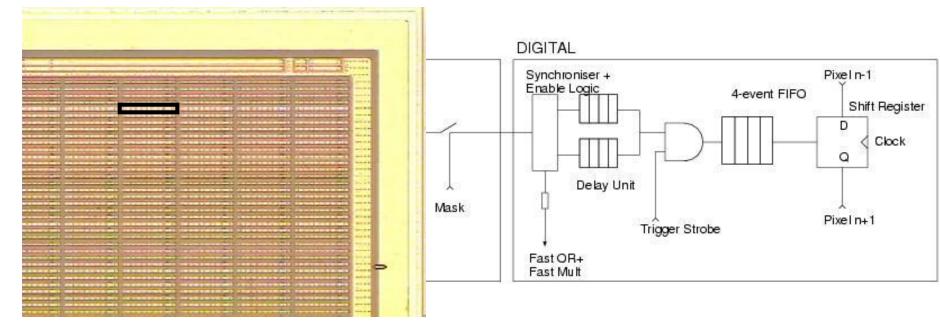
## PIXEL (Sensor and Readout, bump bonded)

Pixel size( $\Phi \times z$ ) 50 µm x 425 µm Sensor Thickness 200µm  $\Delta r \Phi = 1.28$ cm,  $\Delta z = 1.36$  cm (Active area) 256 x 32 = 8192 channel / sensor 4 chip / sensor 4 sensor / stave

Total 4M Pixel

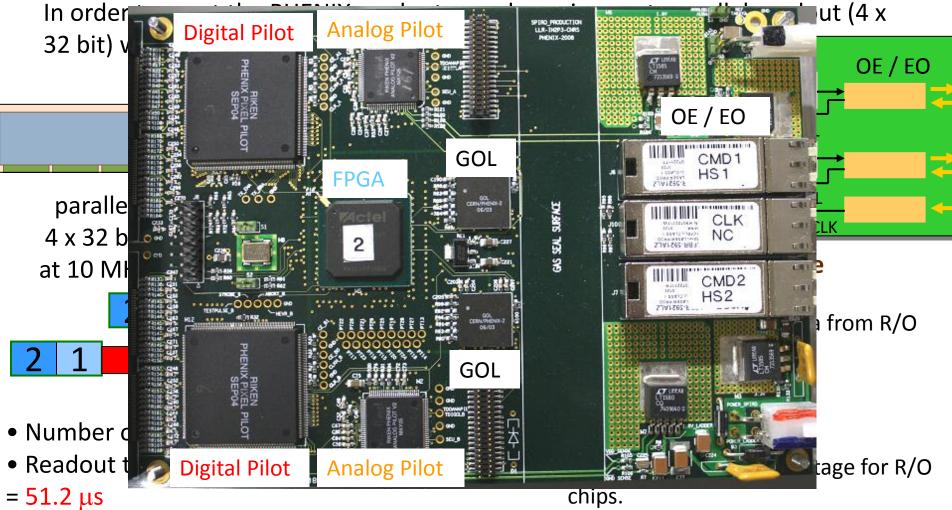
#### **Readout scheme**

- Monitoring supply, bias voltage and temperature on the detector.
- GOL : Transmit data with 1.6 Gbps

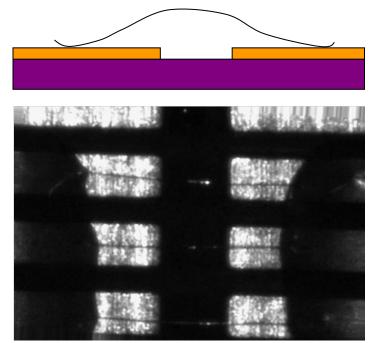
Side view of bonding wire

- •Wire has intermittent current due to readout synchronized the level 1 trigger.
- •Wire vibrates in magnetic field and may break

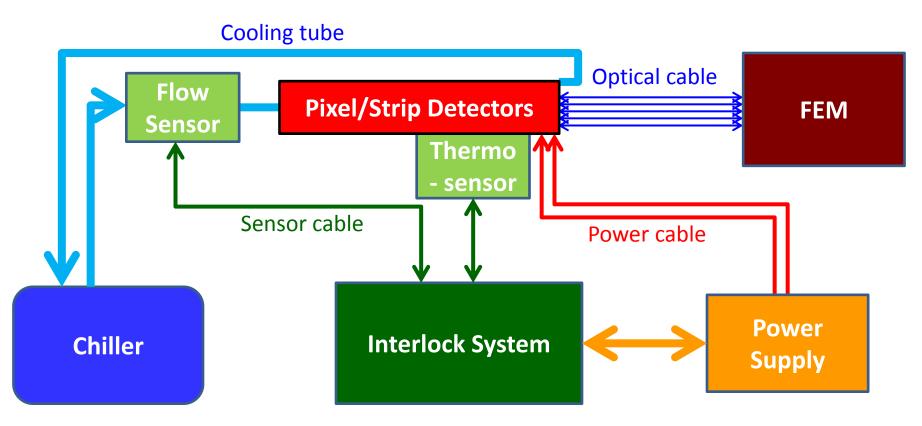
### VTX System

- To remove power dissipation 1560W/VTX, need to cool down pixel/strip detectors.
- To avoid detector destruction by heating, need safety interlock system
  - Interlock trips off power supply by temperature and flow of coolant.

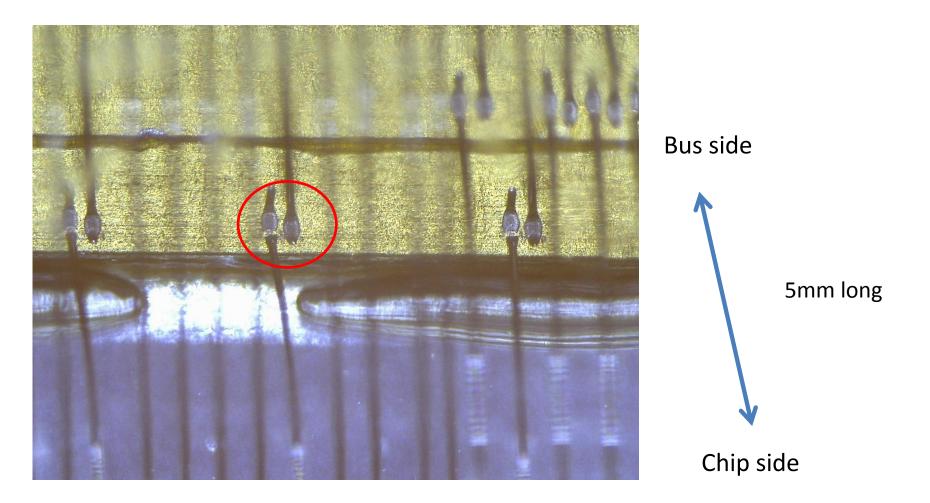
Large temperature excursion due to the cooling interlock broke wires.

- Wire breaks at neck. -> not problem on wire bonding, problems on extra tensions
- 5-10deg -> -5deg for a few minibus, by turning off power ~  $1W/cm^2$ , but running cooling system
- Expansion coefficient Encapusulant ~ 300ppm/deg (Sylgard 184 and 186) Other material (Myler, Si, Al, Cu Carbon) 20~30ppm/deg 20

- Fix interlock system, minimize unnecessary LV off.
- Operate 15-20deg, to decrease thermal shock.
  No additional broken wire.
- Repair work
  - 1. Remove encapsulant
  - 2. Clean up bonding pad
  - 3. Re-wire bonding
  - 4. encapsulation
- Encapsulant
  - Available encapsulation material 300ppm/deg
  - Use soft material to minimize extra tension.
    - Penetration 65 (JIS K2207)
- Survive Heat shock test ( 0<->40deg 1min 50 times)

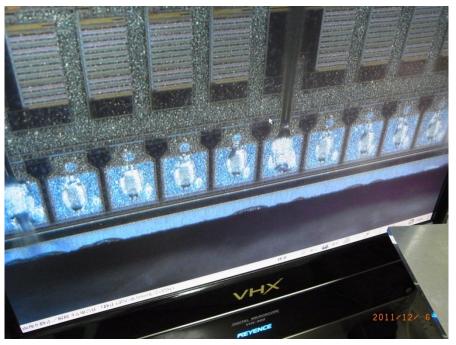
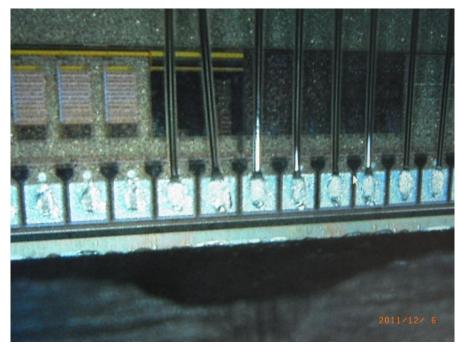
## Reapir

- 1. Removing encapulant
- 2. Clean up pad
- But fear to damage pad
- Decide wire on bond mark.

- After re-wire bonding, pull tests were performed.
- Always neck breaks with 6-8g tension.

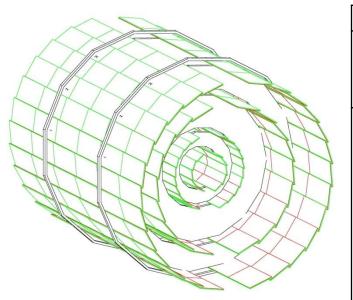
_	 	- BEAM
S.		Pixel
		Strip

Layer	radius	Detector	Occupancy in Au+Au collision	
Layer 1	2.5 cm	Pixel	0.53 % 0.16%	
Layer 2	5.0 cm	Pixel		
Layer 3	10.0 cm	Strip	4.5 % (x-strip)	4.7 % (u-strip)
Layer 4	14.0 cm	Strip	2.5 % (x-strip)	2.7 % (u-strip)
