Power coupler activities at IHEP

T.M. Huang
(RF group, IHEP)

2 **Power coupler for HEPS 166MHz SCC**

Power coupler for HEPS 166MHz SCC

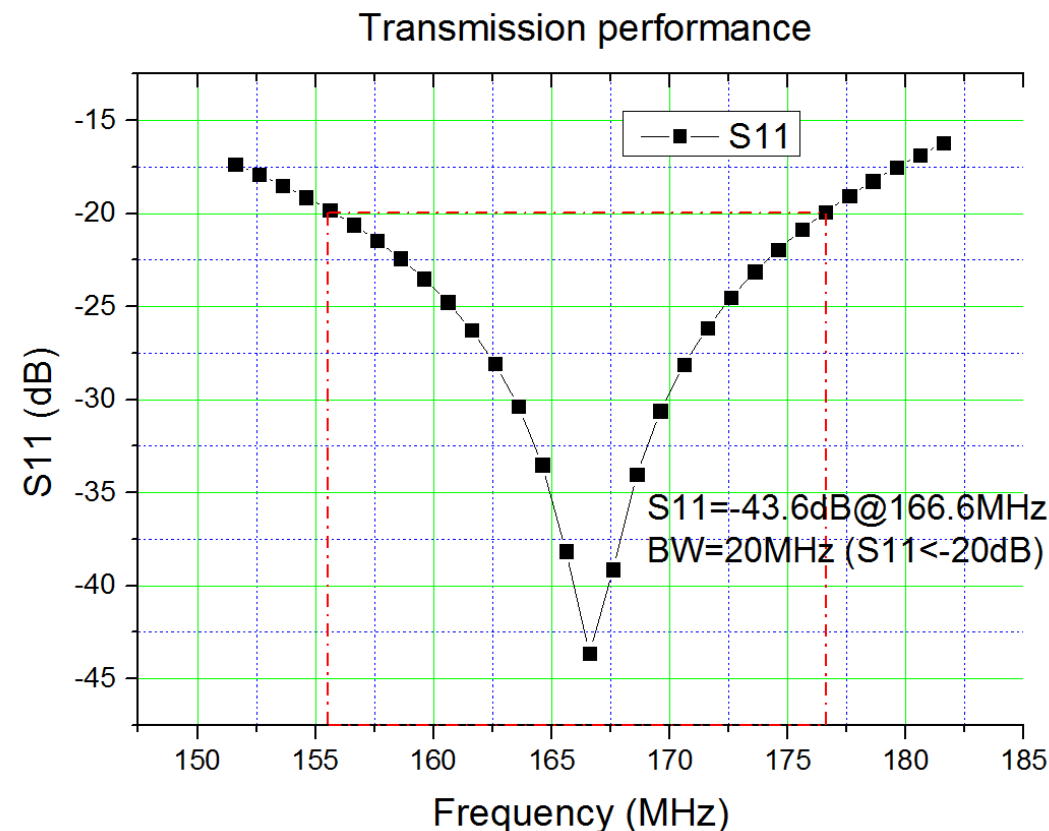
Calculated S11 vs frequency curve

$E_{max}=6.7E5$ V/m at 300kW (TW)
 Located at the inner choke tip

TW: travelling wave

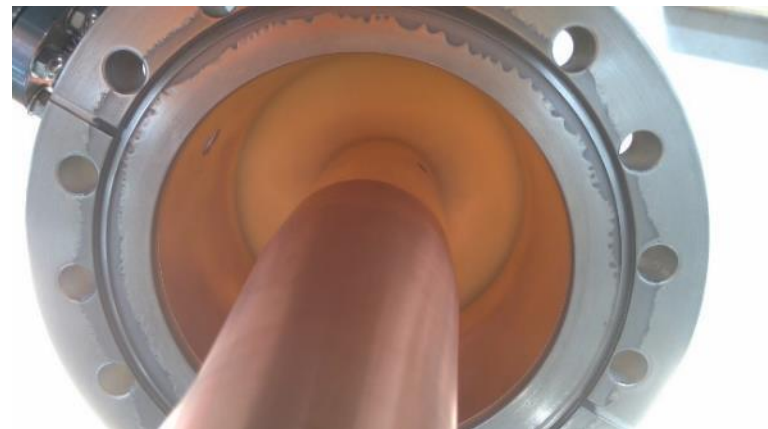
1#: Window cracked due to FE (Spoke021 SCC for CADs)

- FE induced e- bombardment might damage the TiN coating
- Arc may result in copper sputtering and the increasing of the surface resistivity.

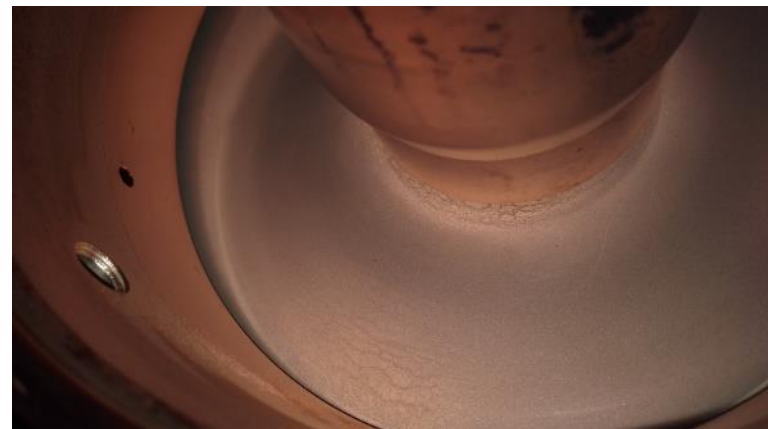
2#: Window cracked due to disabled ARC interlock (BEPCII 500MHz SCC)

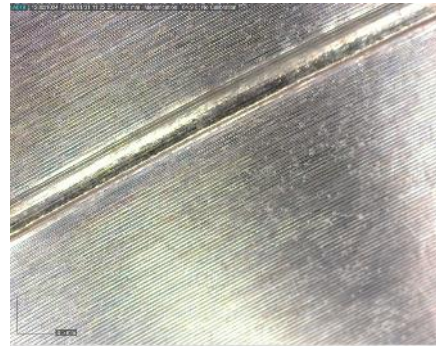
Gasket indentation: OC side

Wider gasket indentation: window side → sealing knife of the window flange too soft

Sealing knife getting soft

- **Confused:** same fabrication technic and never happened before; **Material problem?**
- **Final solution:** change to flat sealing using Al gasket
