RFD SPS TUNER SM18 tests CD1 + CD2

K. Artoos, A. Edwards, D. Glenat, N. Stapley, K. Turaj, N. Valverde

18.06.2024

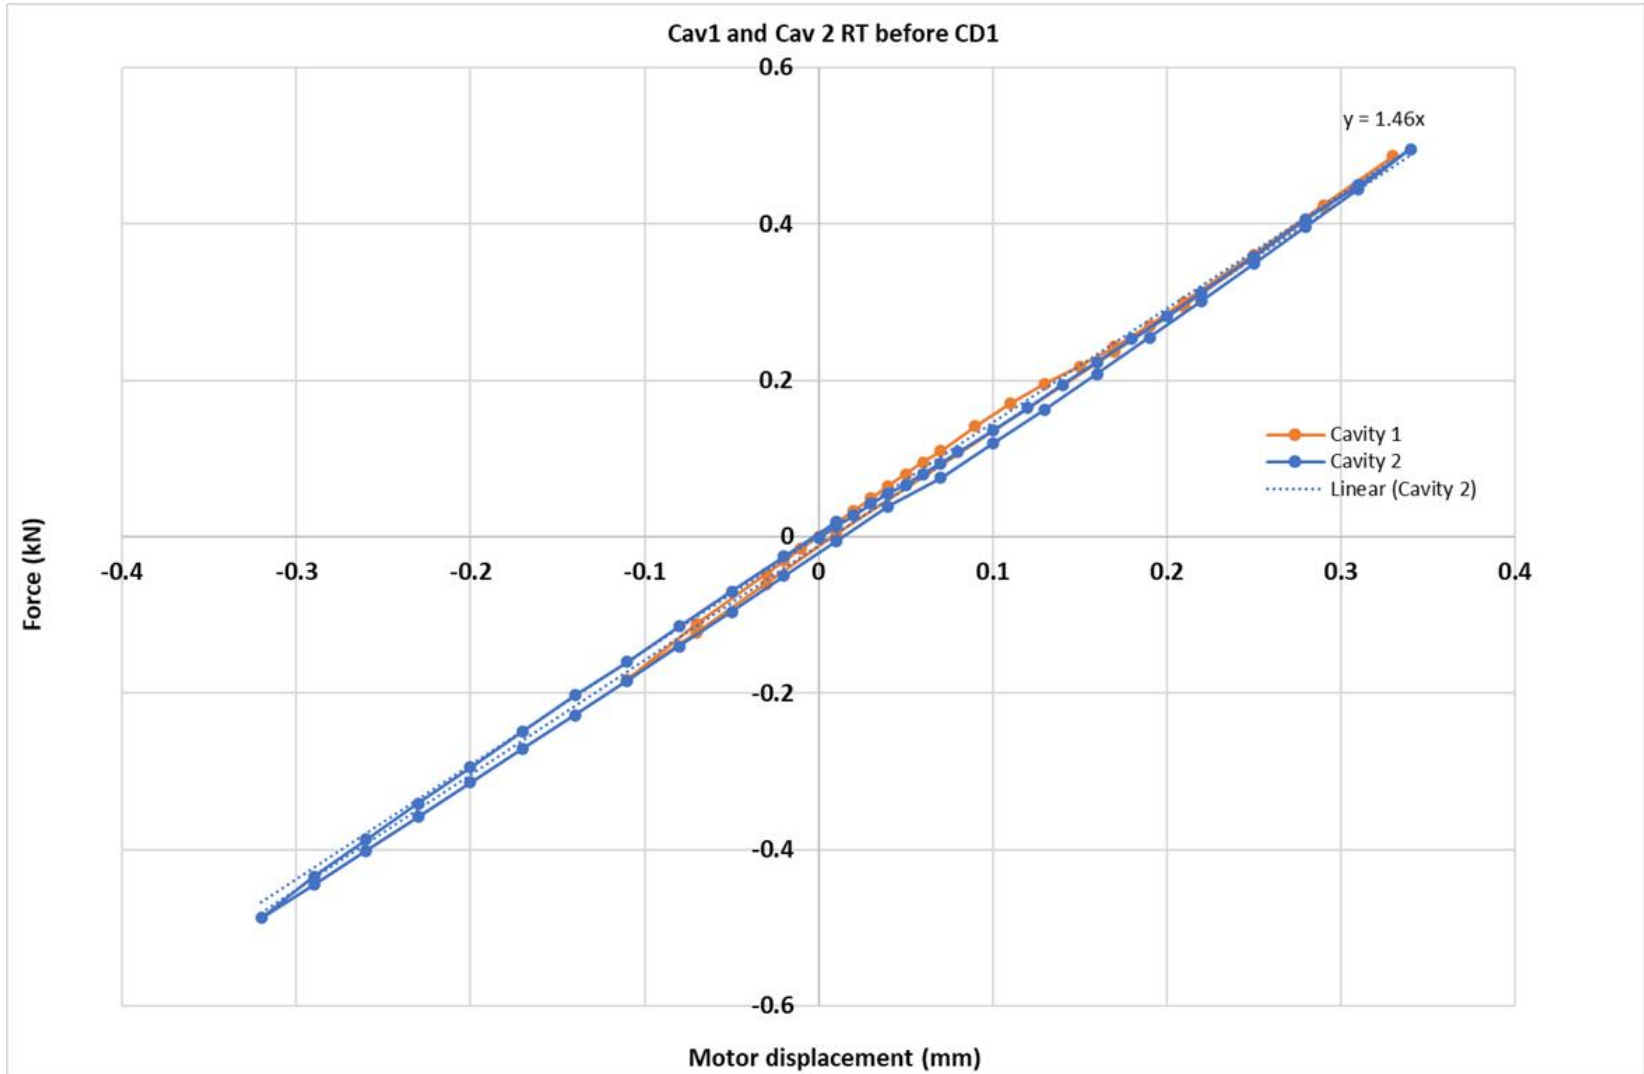
RT cycle before CD 1, OVC open

*Cycle on Cav1 shortened due to x-rays in evening

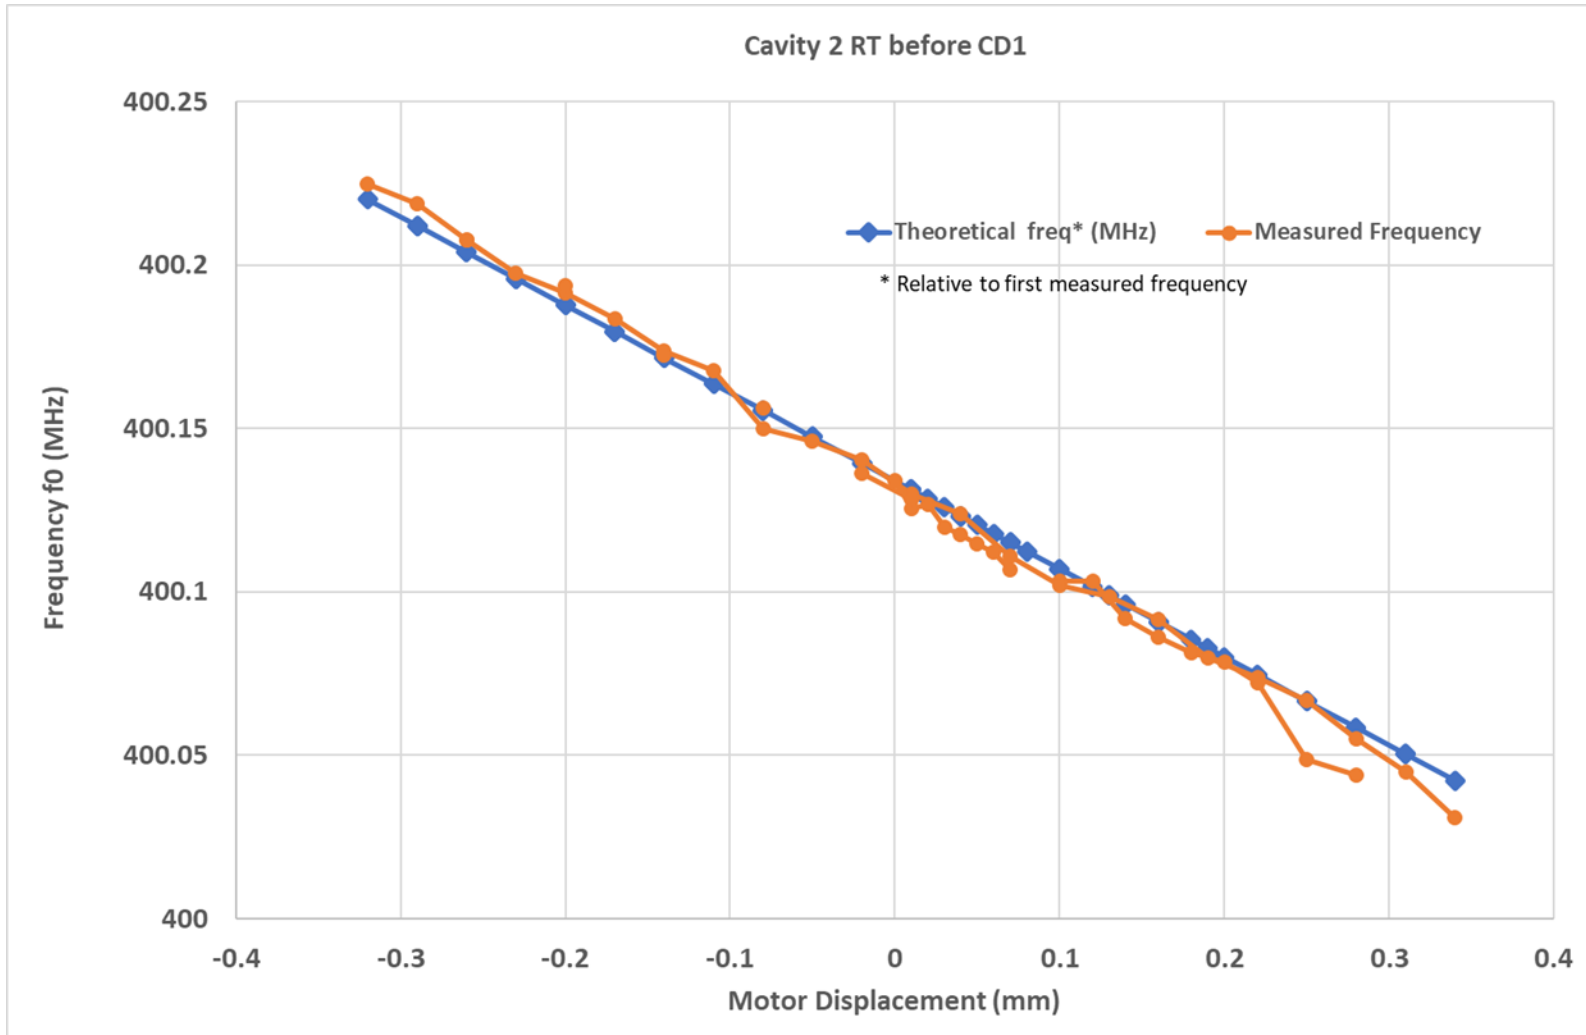
RT before CD 1, OVC open

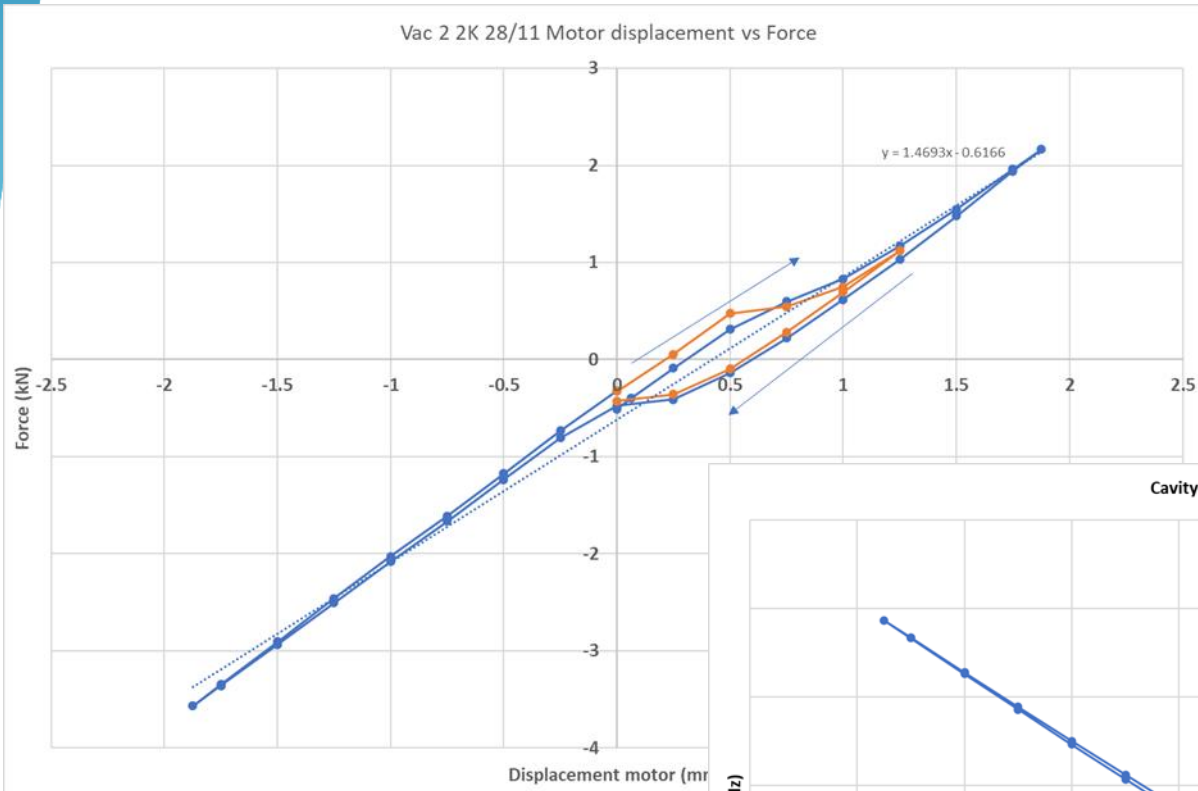
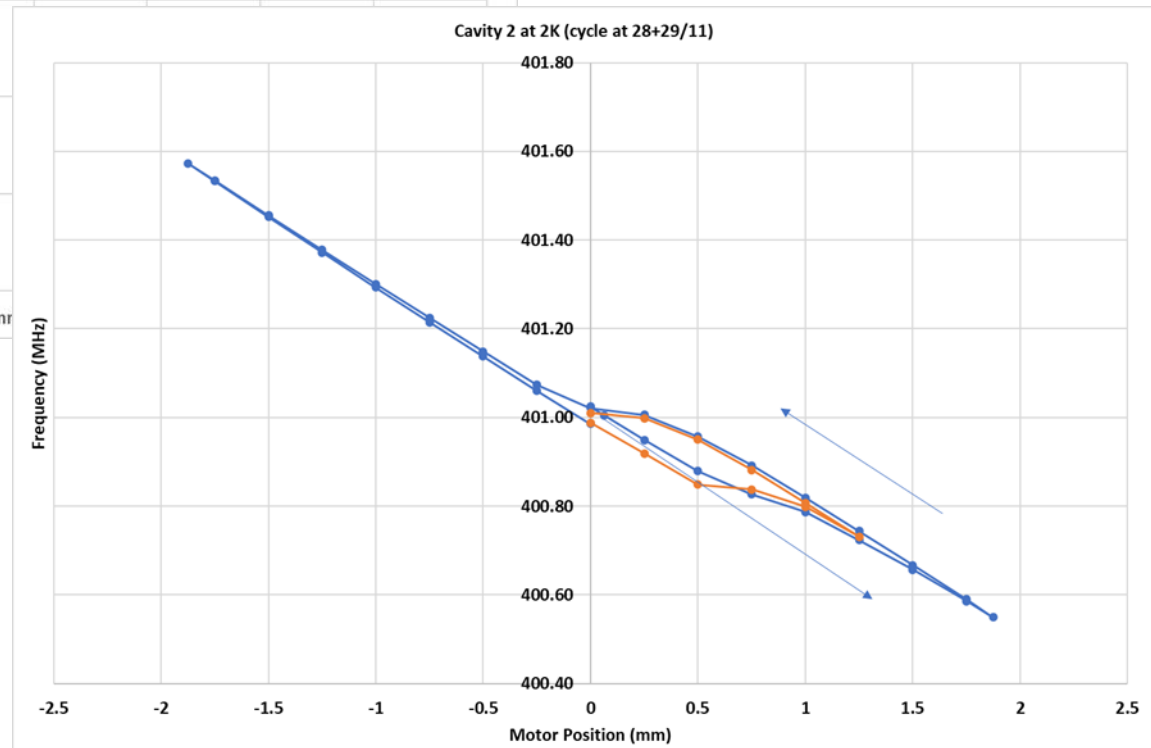
Cool Down 1 to 2 K

- No tuner force measurements during cool down
- Non-linearity measured on cavity 2 and cavity 1 (backlash with a twist)

- Reason for the backlash: play in actuator clamp reproduced on actuator test bench, part out of tolerance

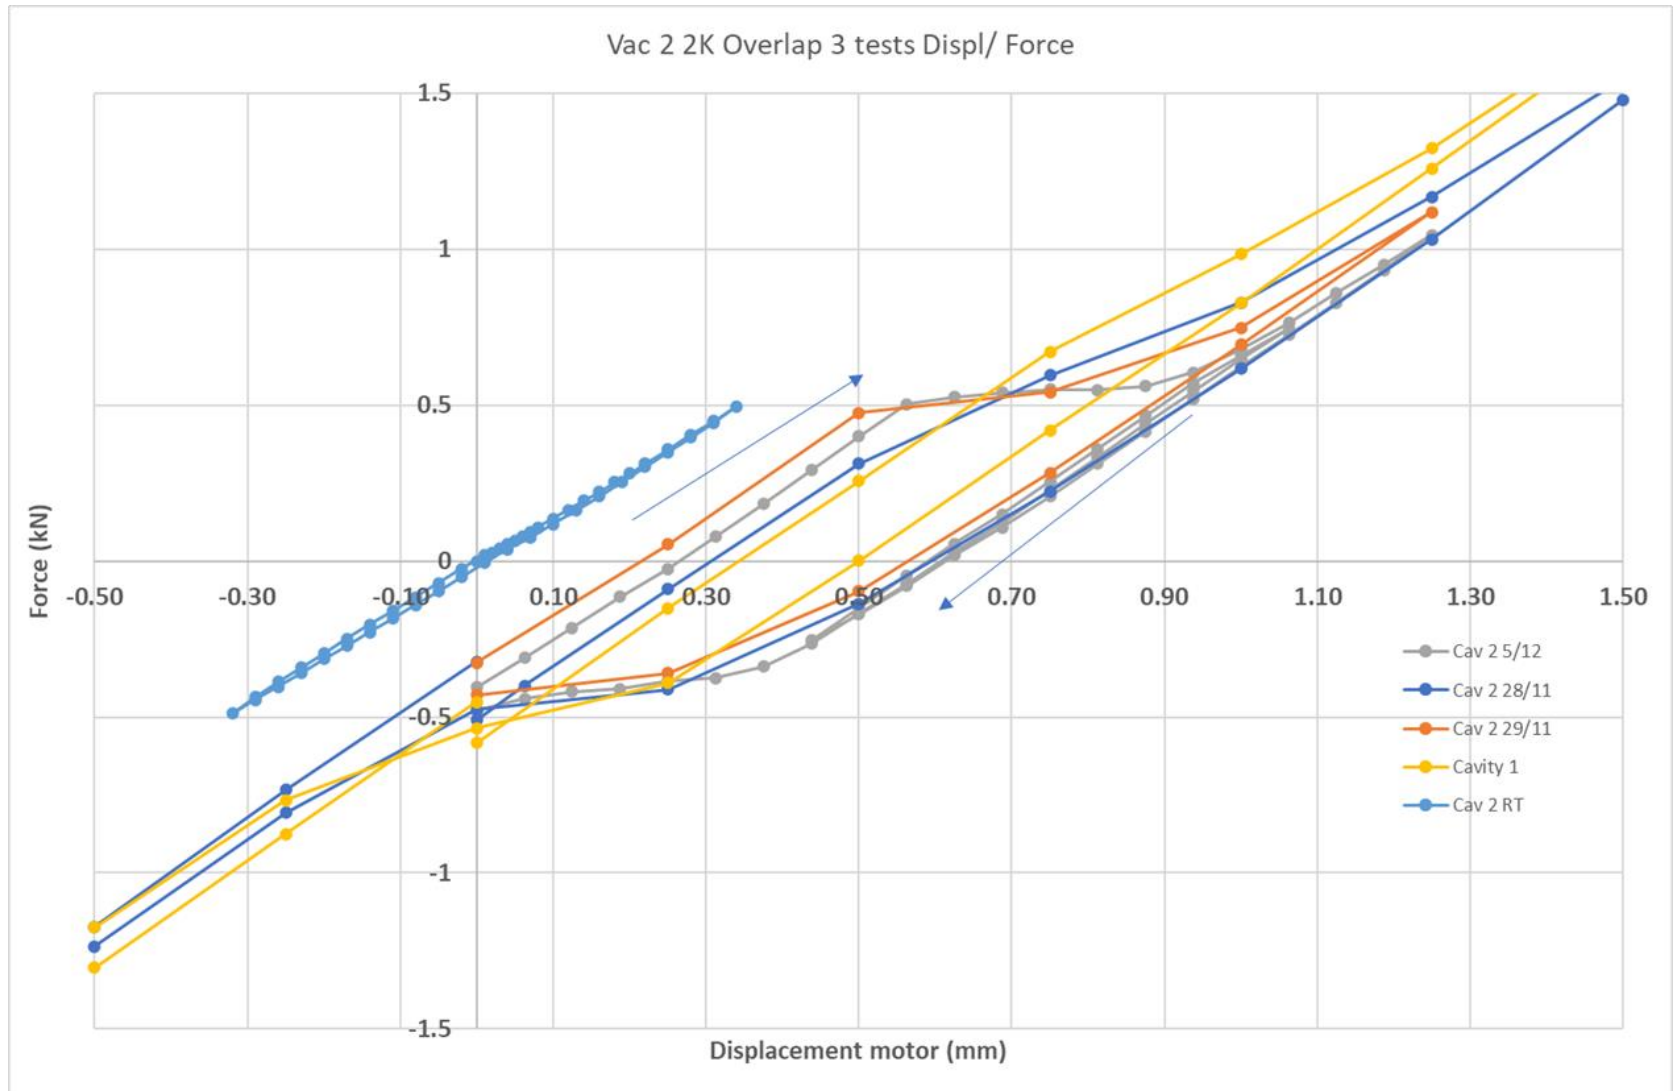
Cav 1 + 2, CD1 several cycles

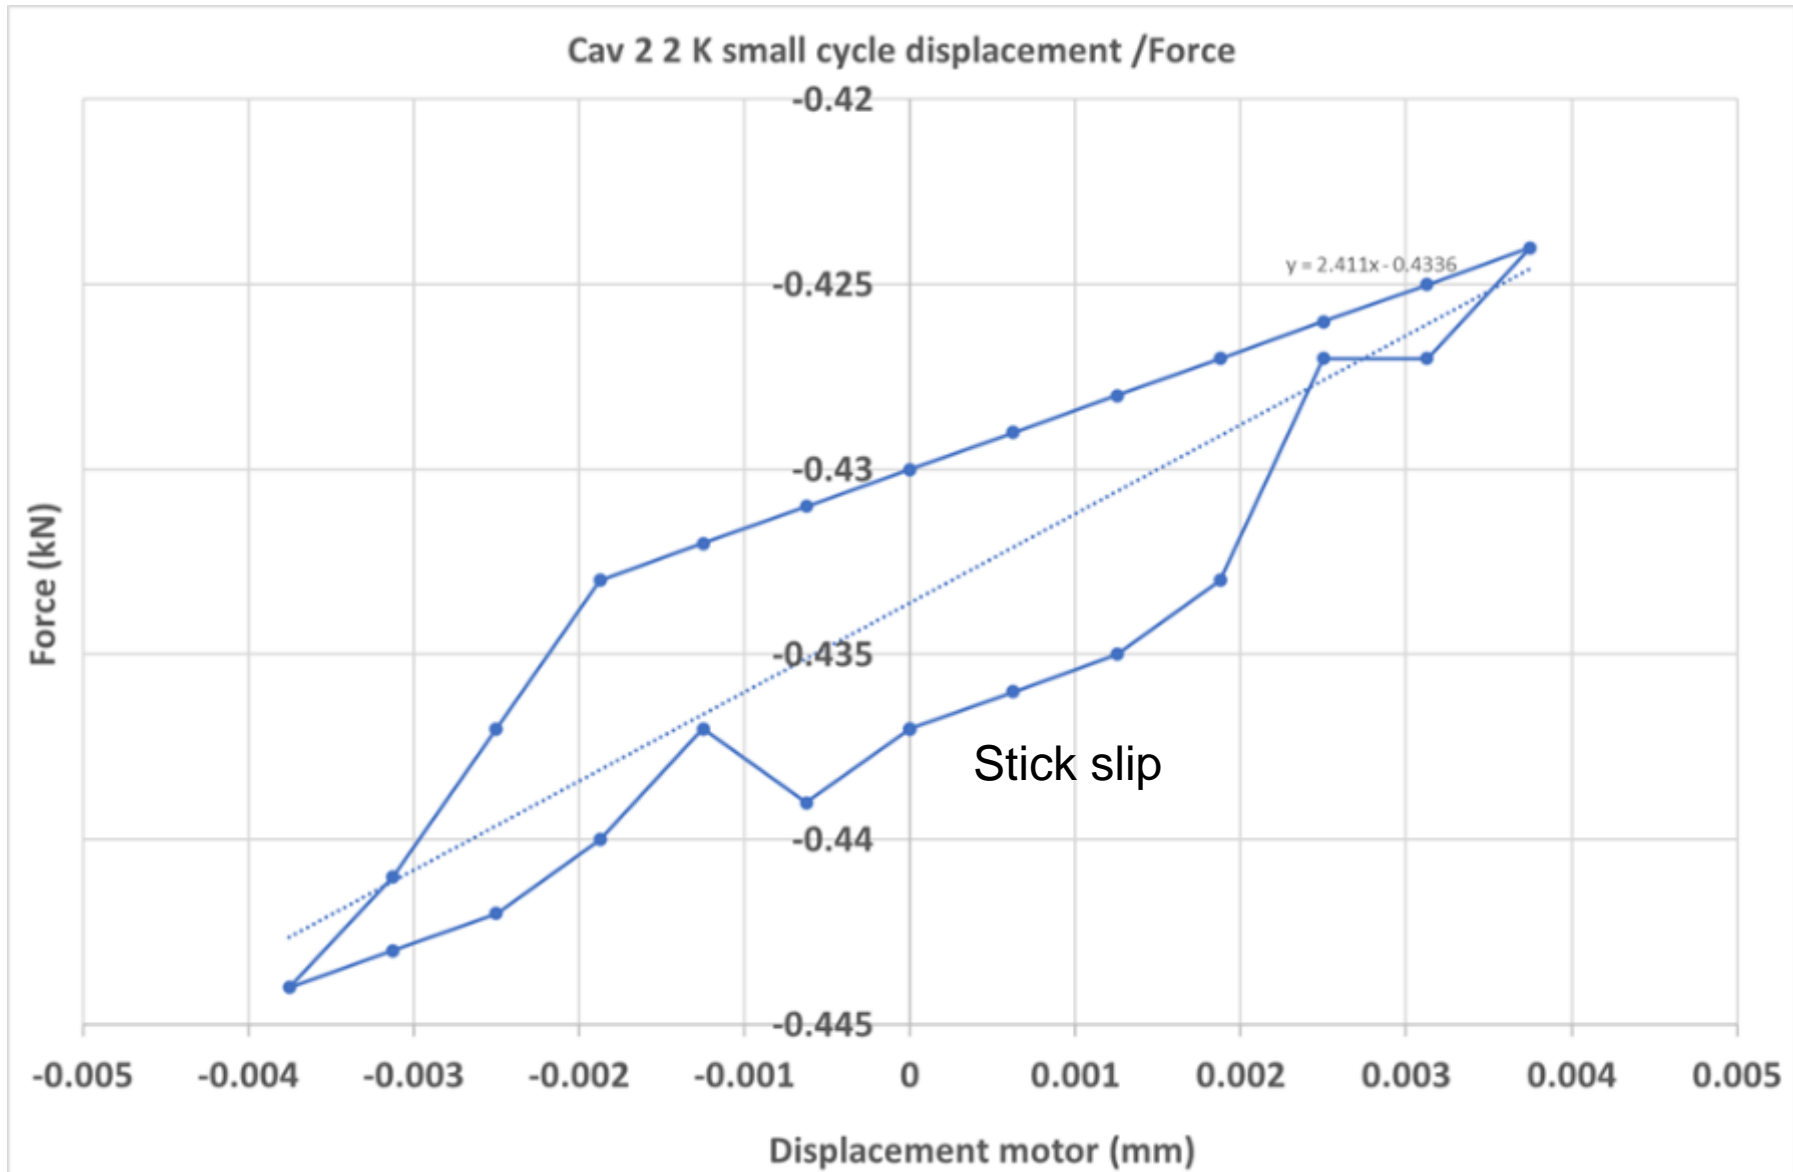
Small precision cycle CD1

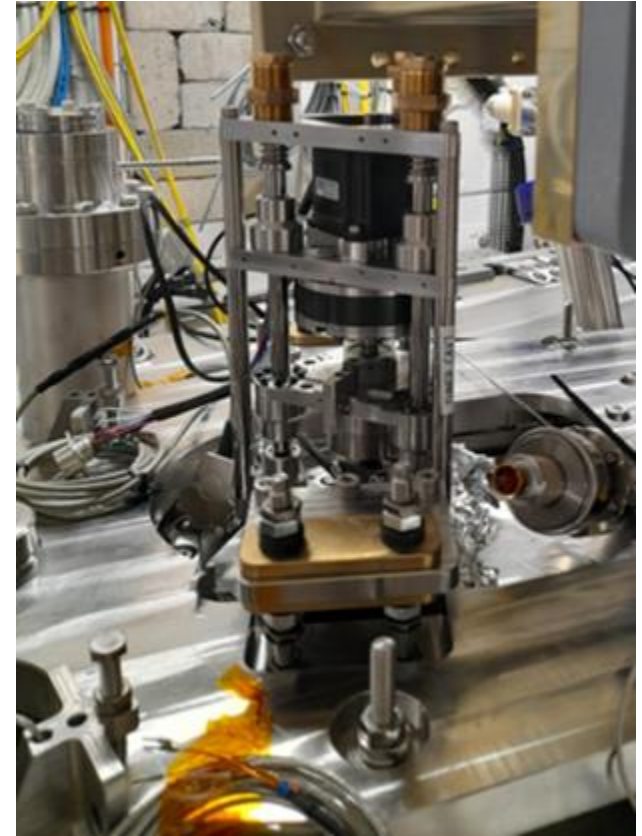
CD1 Other observations tuner

- Tuner laterally blocked on sliding pads support
- During assembly tuner, bearings very hard to align, some “hard points” in guidance
- No ice nor condensation observed during CD1 run on tuner feed through
