TECHNICAL GALLERIES
CONSOLIDATION

Technical Galleries Consolidation Program

Project Safety Challenges

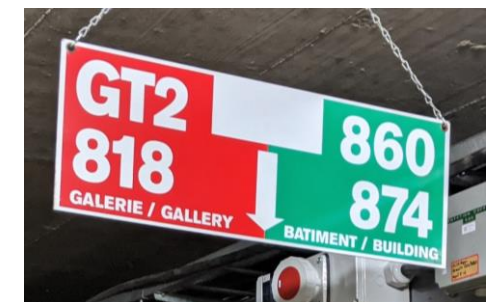
Location plates currently present in technical galleries

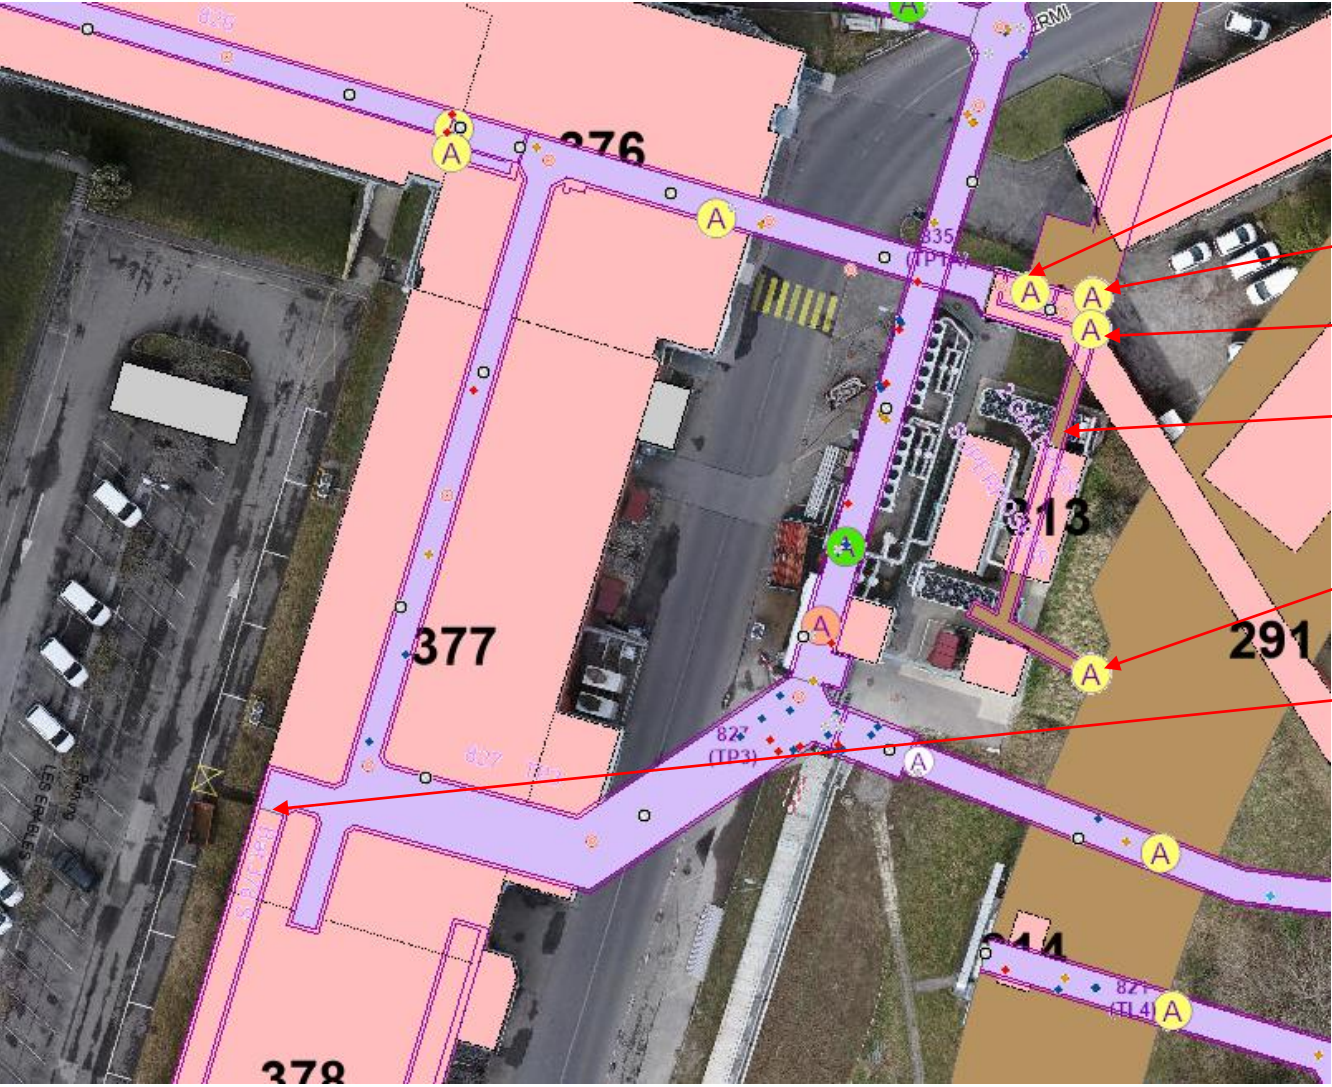
Gallery 827: access points and limits

Access point to be locked from outside, openable from inside (electronic key)

Fire partition to be installed, emergency exit both directions

Old doors to be removed

To be separated from 839 and marked as gallery in GIS

Doors to be equipped with alarm system (to register entrance to ISR storage in case of emergency escape from the gallery)

Limit of the gallery, fire partition to be installed

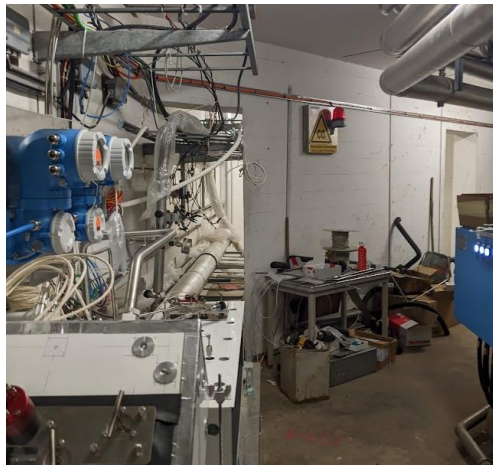
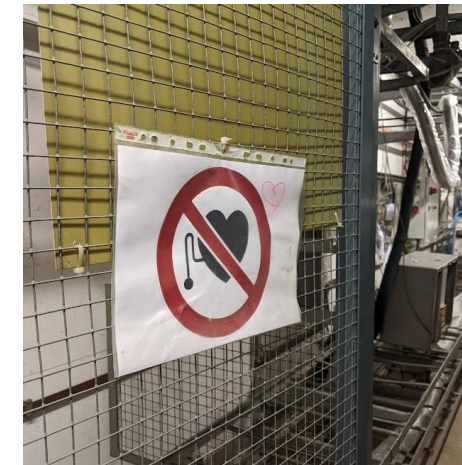
Electromagnetic hazard?

- **No hazard present in gallery 180 – confirmed by Herve Prin, Magnet Production Responsible**
- **Obsolete warning signs were removed**

CO² - Risk Assessment - B180 Galleries under Baby demo

- **Result: no additional action needed – the existing safety measures were recognized as sufficient**
- **EDMS [3072490](#)**

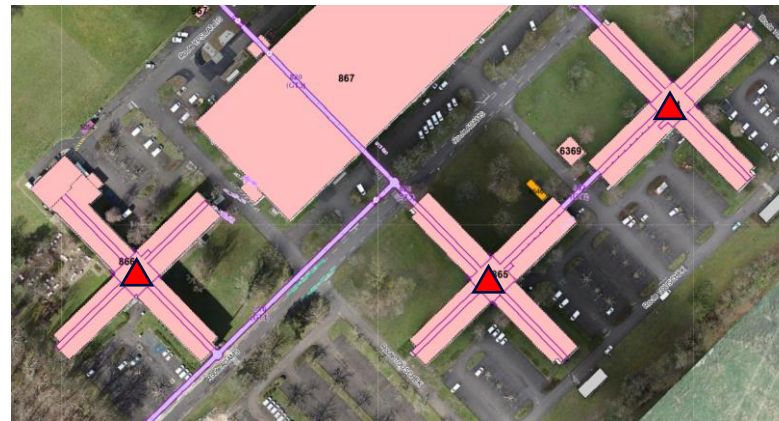
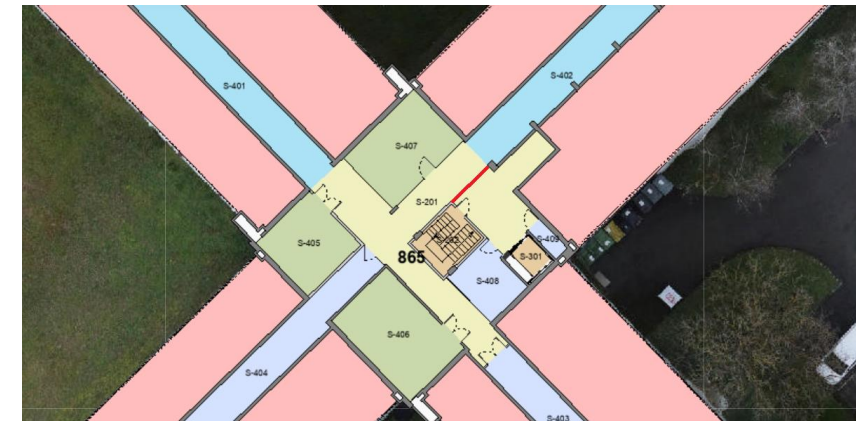
ECR: EDMS [3017204](#)

Fire safety and access control in galleries under buildings 864, 865, 866

- **Goal: improving fire safety and access control to technical galleries below buildings 864, 865, 866**
- **Meetings among TG-CONS Team, EN-AA , EN-HE, HSE-OHS**
 - Buildings 864, 865, 866: new fire doors to be installed between building staircase and basement (864, 866 equipped with access control, marked with red triangles)
 - Building 865 additionally: access control gate to be installed (marked with red line)

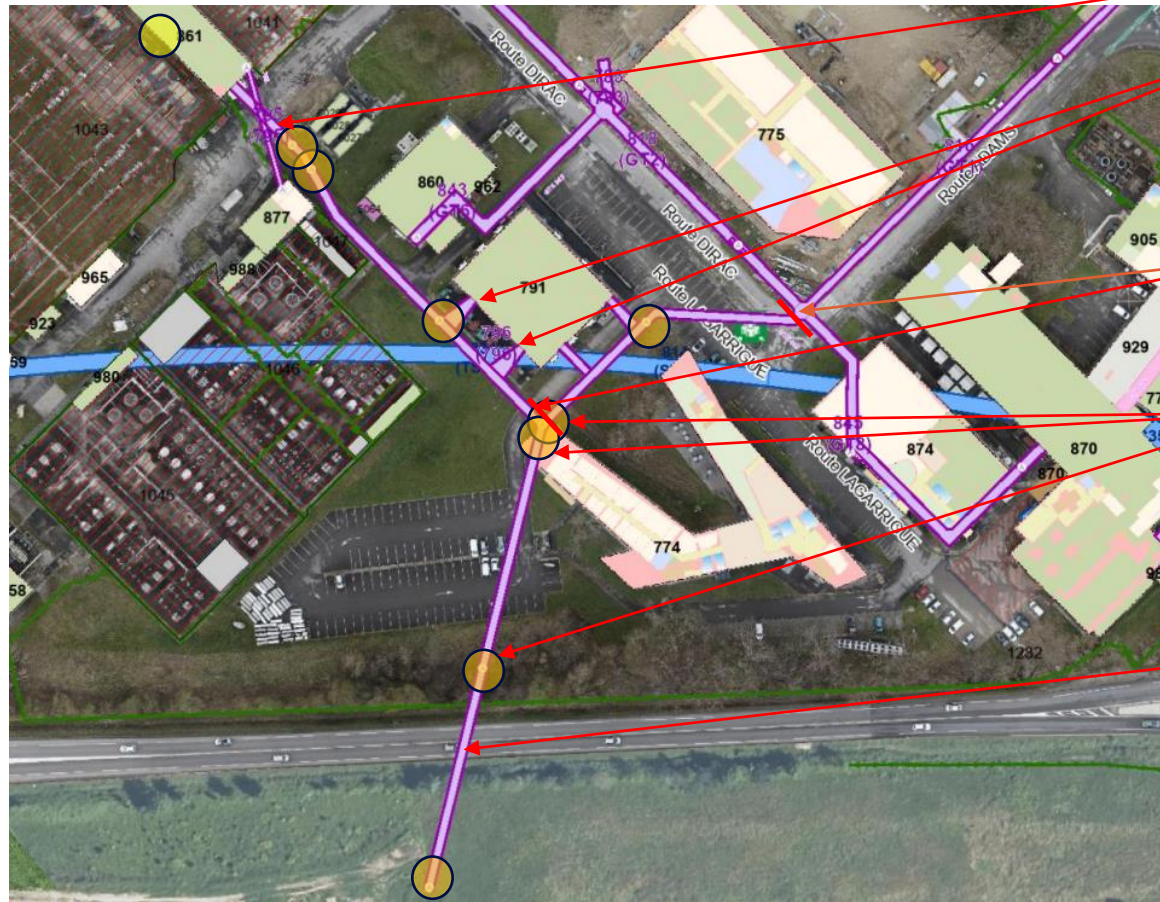
Gallery 796: access points and fire safety - ongoing

New fire partition to be installed and access to be controlled

Openings between gallery 796 and basement of b.791 (BE91) to be closed

Passage blocked because of cable trays

Consolidate access points

Unblock drain pipes

ECR: [EDMS 3017542](#) (In Work)

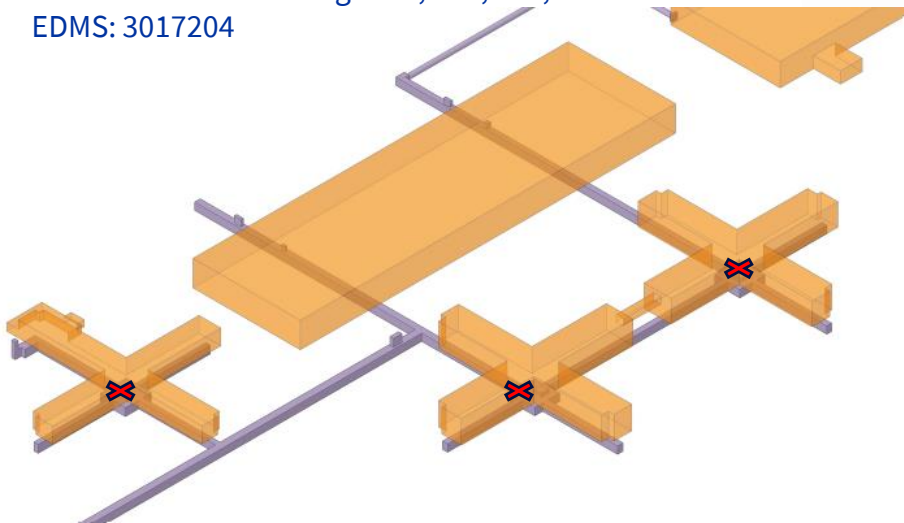
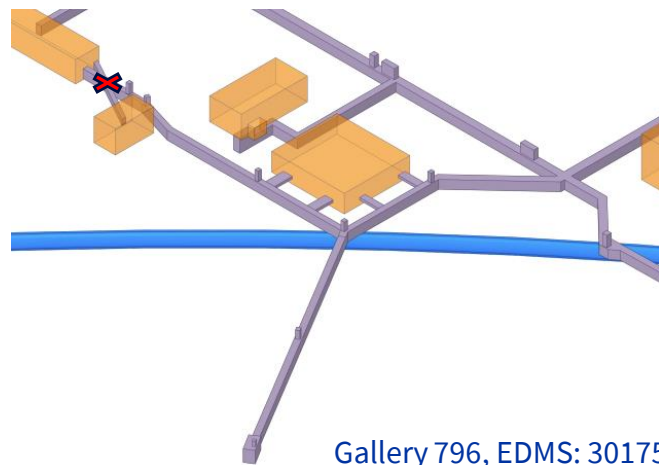
Galleries under buildings 864, 865, 866,
EDMS: 3017204

Fire partitions study - ongoing

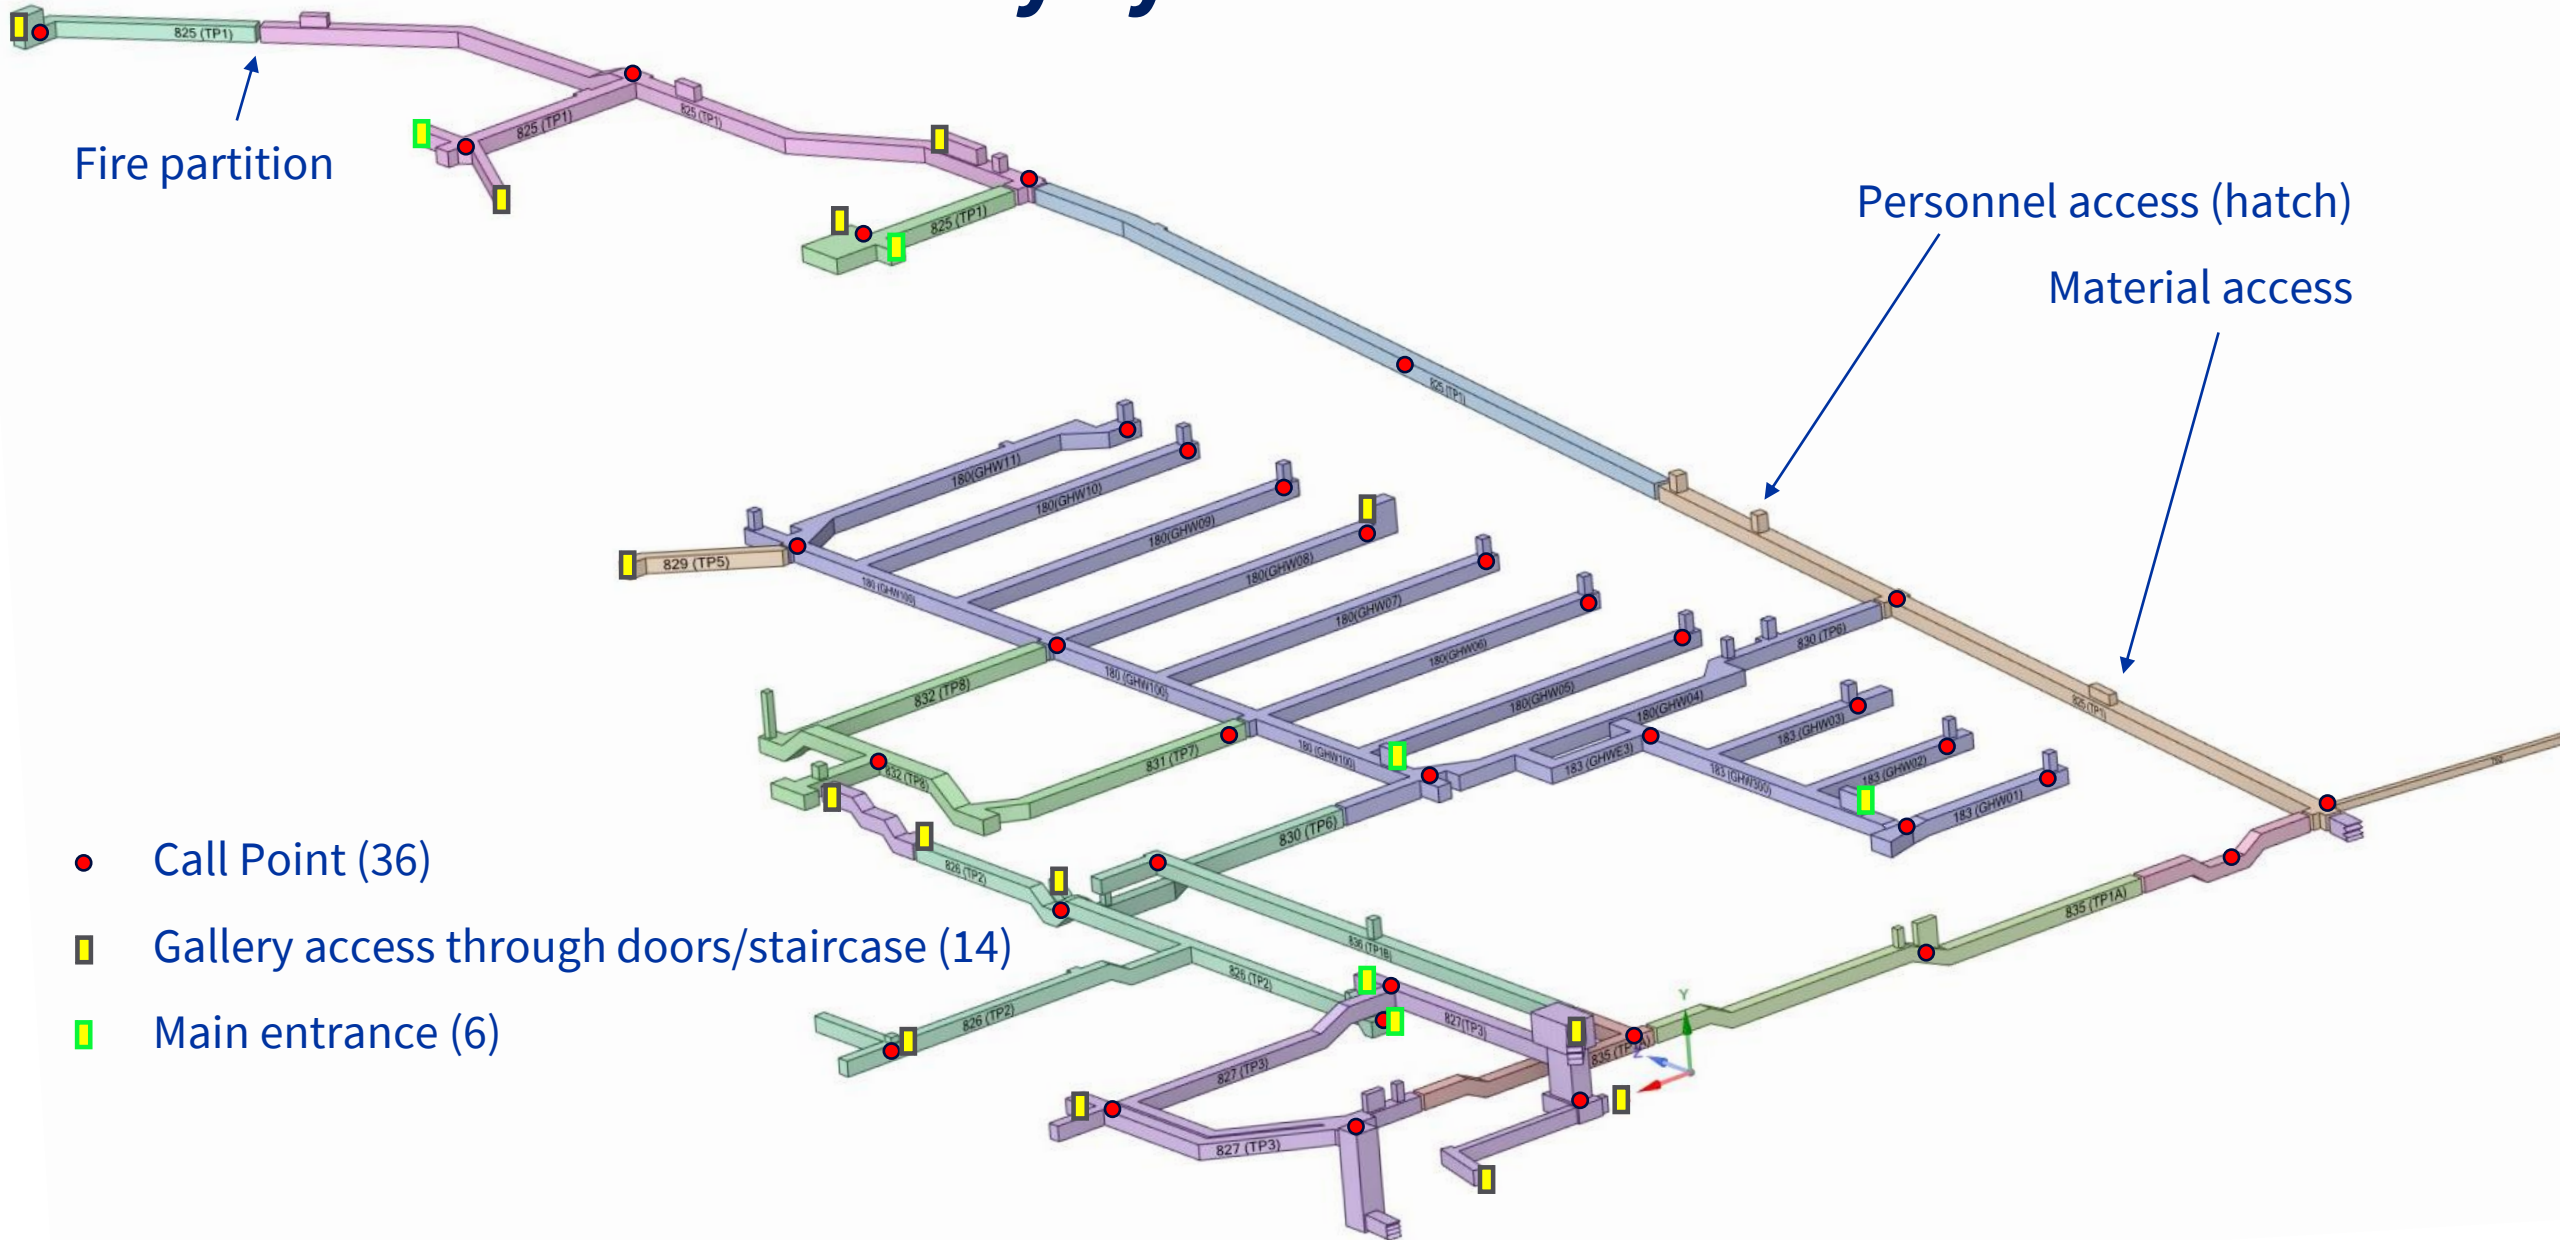
Meyrin West Area, EDMS: 2794867

12 new fire partitions/doors to be installed:

- 8 in Meyrin
- 4 in Preveessin

Safety systems combined - future state

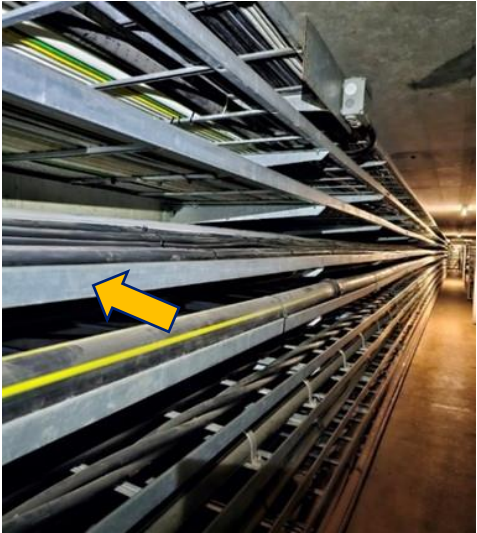
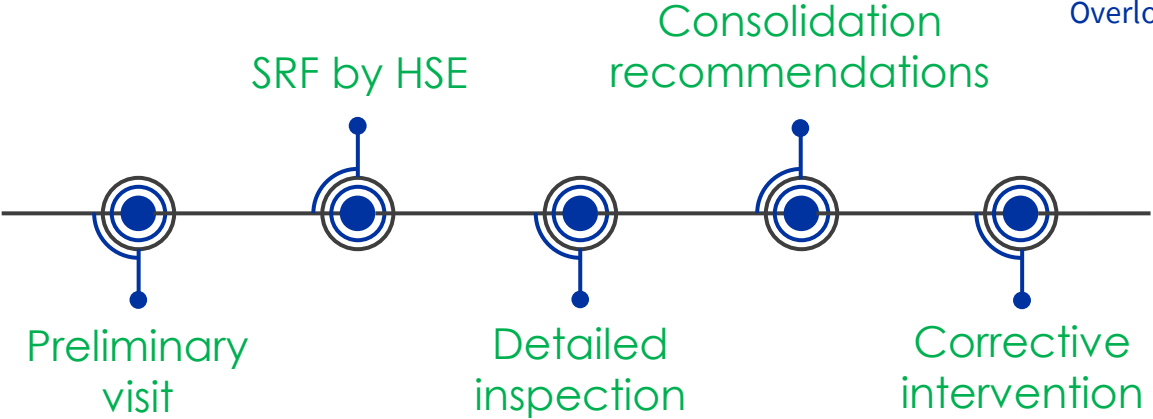
Overloaded cable tray, EDMS: 2900780

Cable tray supports found in bad condition in gallery 818
(issue might be also present in other galleries).

Intervention done in YETS 23/24 ✓

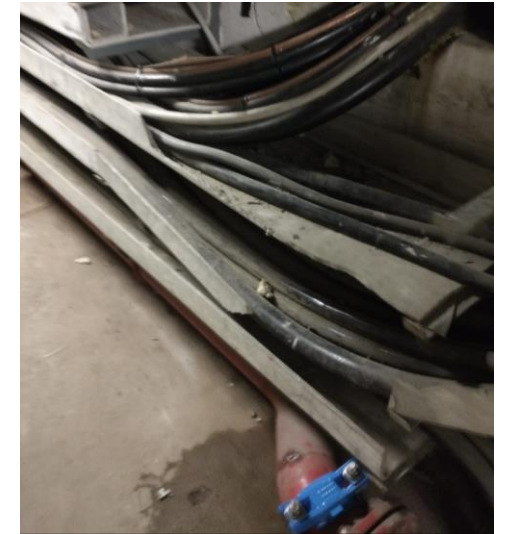
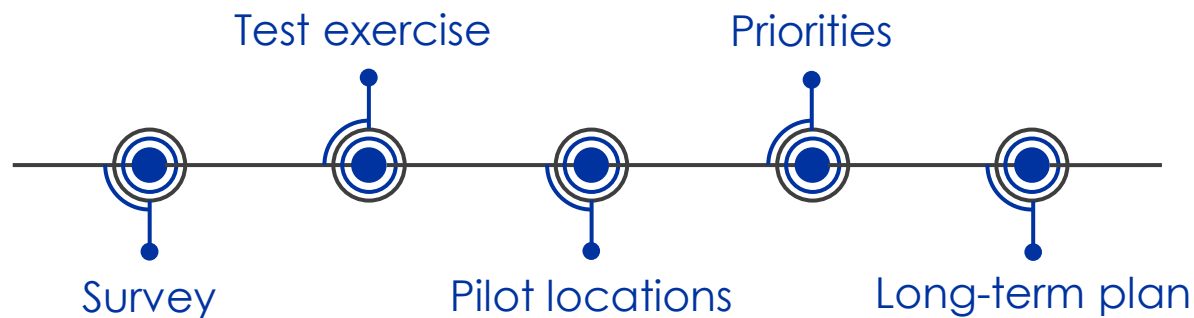
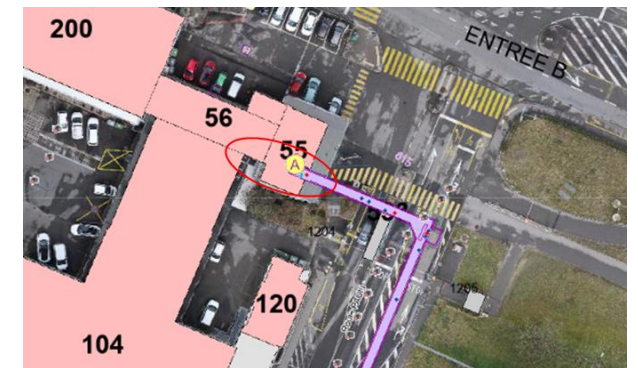
Broken asbestos tray, EDMS: 2871752

- **Recurring and omnipresent issue**
- **Special focus on the Swiss part of Meyrin**
- **2 main hazards: asbestos, live cables – dual competencies needed**

- **Pilot location chosen: gallery 815, under b.55**
- **Contractor: TIA Suisse**
- **Pilot intervention: postponed to YETS 24/25**
