# Technical Galleries Consolidation Program

## EN-EL Status Report

S. FASEL, G. GEORGIEV, EN-EL

30/05/2024

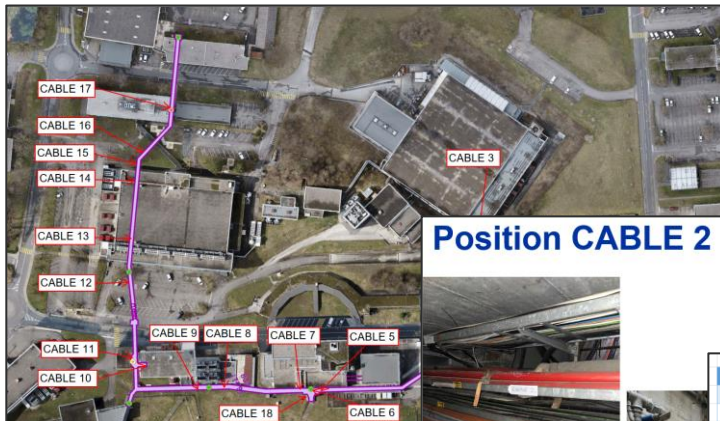
Position CABLE 2

- Adding length for each cable (if possible)
- Adding mechanical repair works

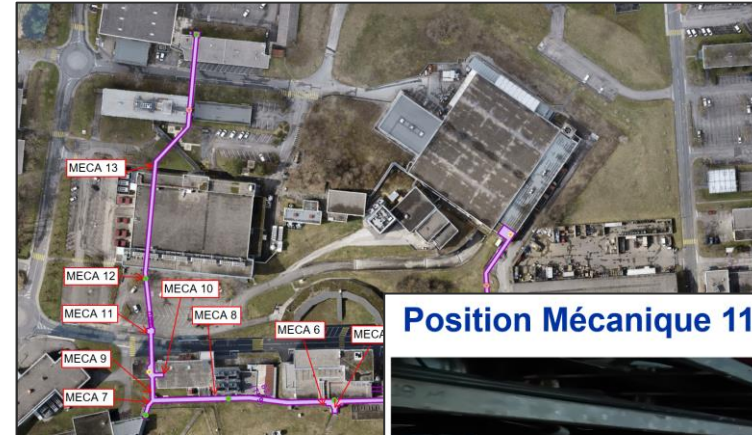
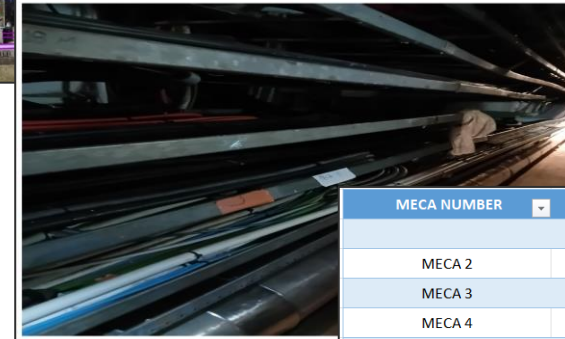
Position Mécanique 11

Redresser l'échelle à câble

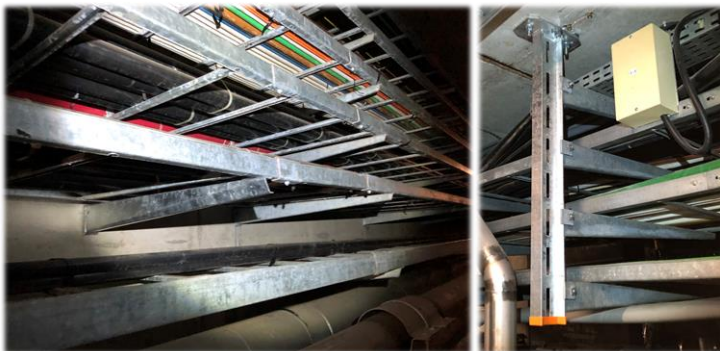
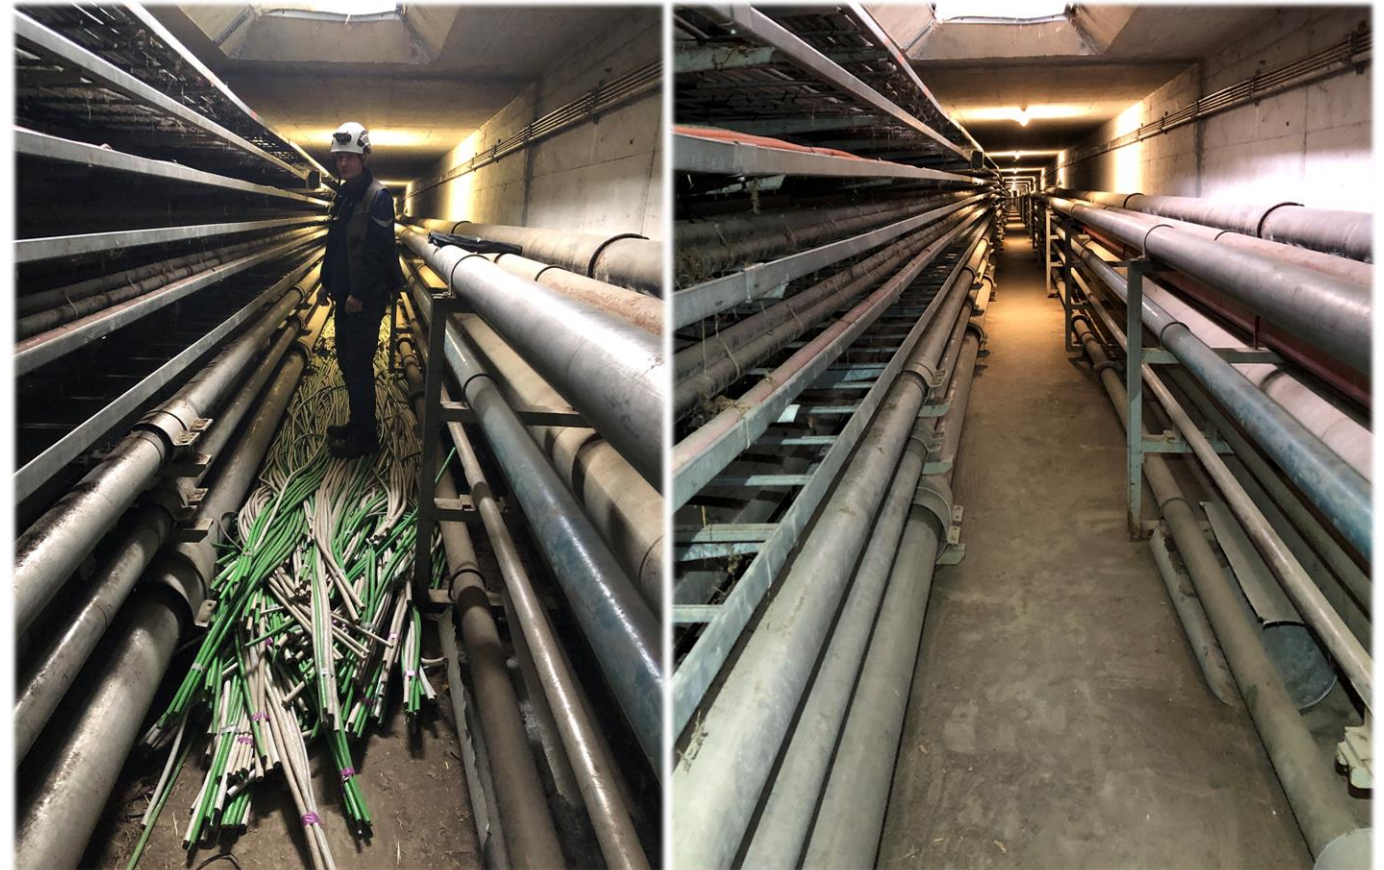
## YETS23-24

- **GT80 decabling + cable tray repairs**
  - Removed 29km of cable, 28m<sup>3</sup> (8x 4m<sup>3</sup> skips)
- **GT2 cable tray consolidations**
  - Installed 35 new supports, 1 IPN replaced
- **Financial volume used: 82 kCHF**

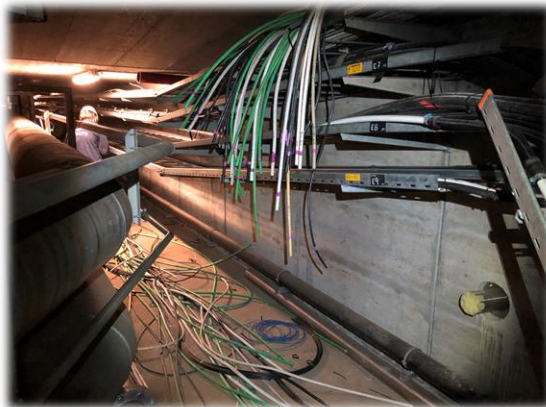
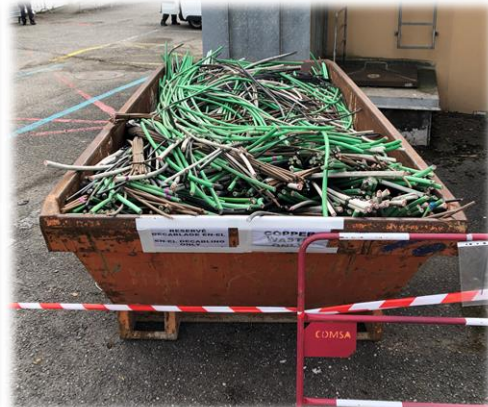
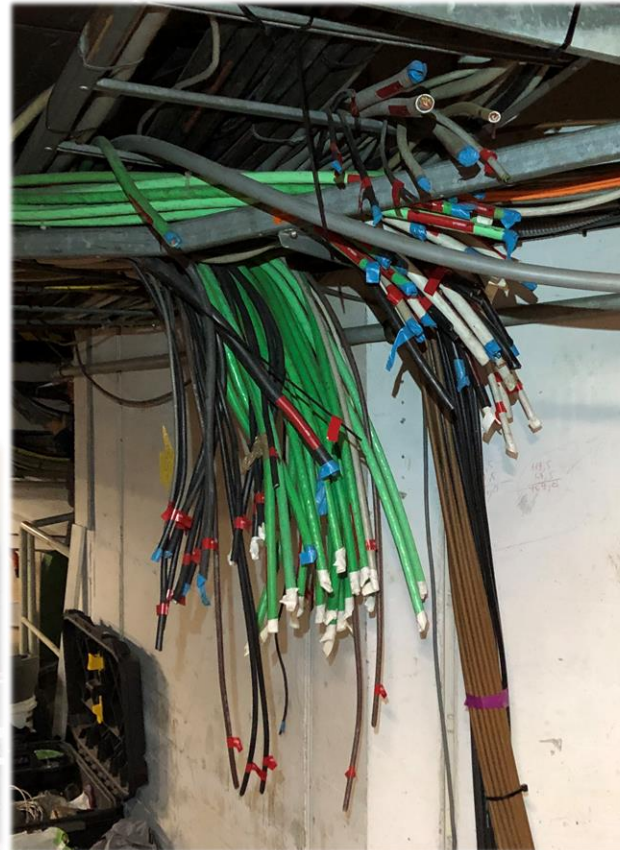
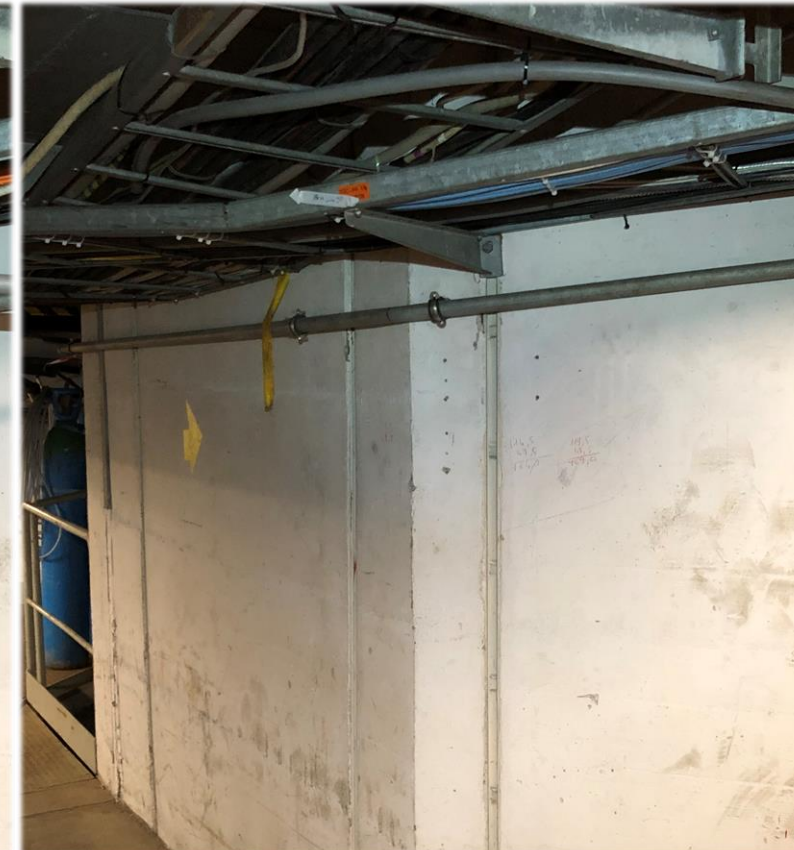
## RUN3-2024

- **Meyrin decabling + cable tray repairs**
  - Area of intervention: 825-835-836-827-826
  - Removed 111km of cable, 92m<sup>3</sup>
  - 6x 10m<sup>3</sup> & 11x 4m<sup>3</sup> skips
- **Financial volume used: 230 kCHF**

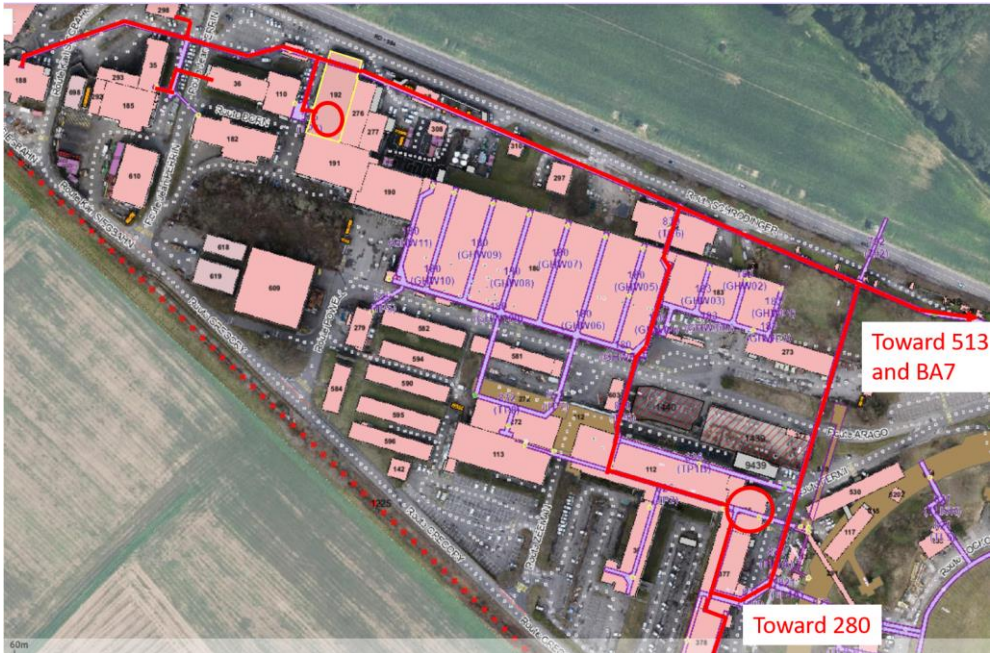
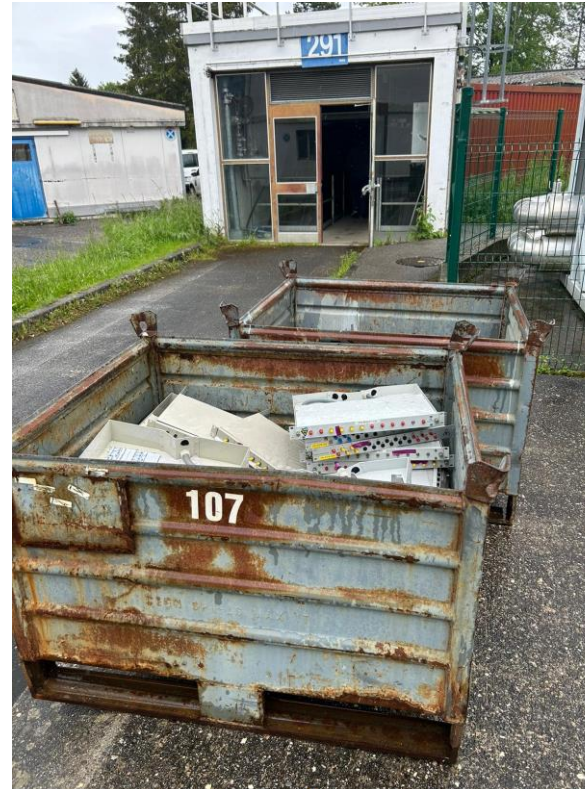
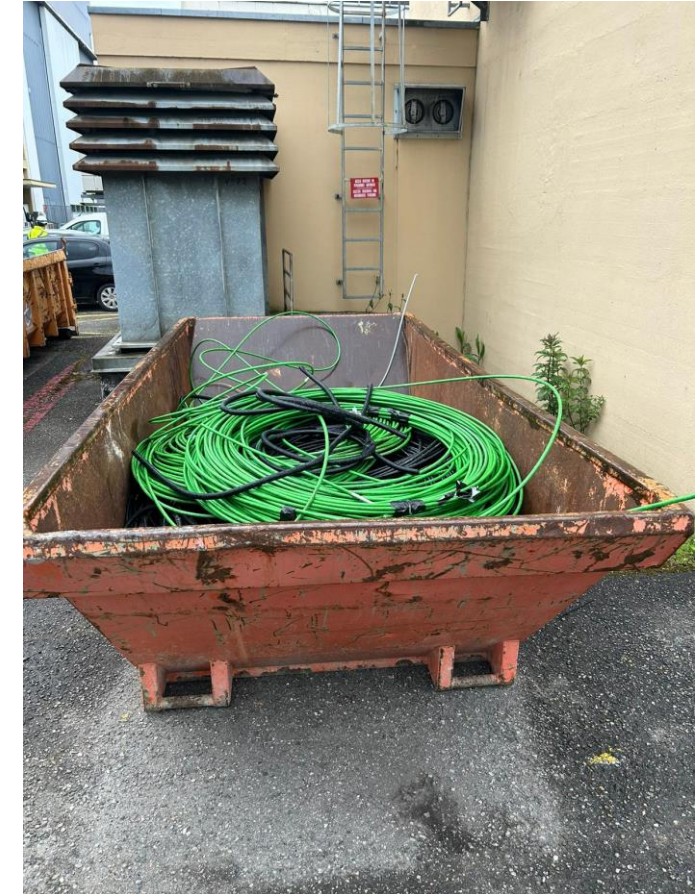
# Optic Fibre removal Meyrin

- 11.3 km of conventional optical fibre cable removed
- Removal of 75 terminal box
- Total waste volume 11m<sup>3</sup>
- Total budget of 30 kCHF
