SMAUG 2 – HRMT Users Day

Anthony Harrison, Jose A. F. Somoza

SMAUG 2 concept

SMAUG 2 design

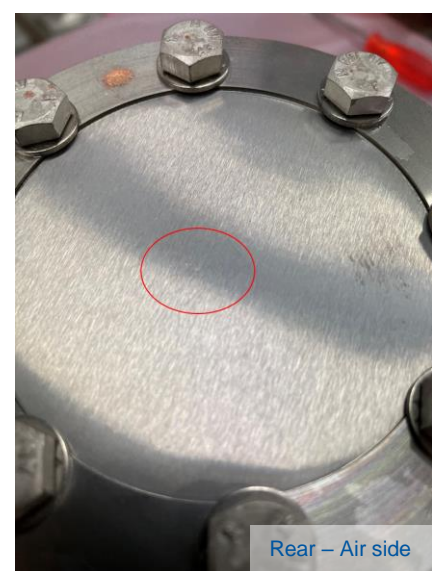
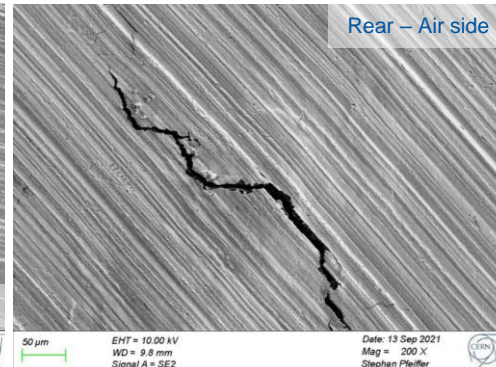
Beryllium PF-60 with niobium coating (0.254mm)

Fracture propagates from air side to vacuum side.

Crack develops in the direction of the rolled structure.

Temporary solution to displace vacuum window by 1.5 m upstream to reduce beam brightness

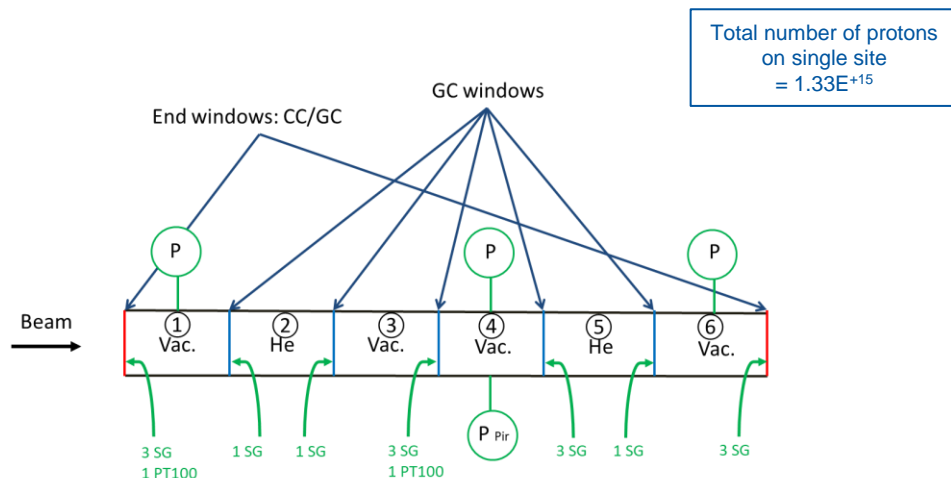
HRMT #26 - Glassy Carbon study

- Development of material for vacuum structures – including beam windows
- Maximum beam shot intensity = $3.7e^{+13}$ p (for 5x shots), optics from sigma 2mm to sigma 0.25mm.
- Maximum energy deposition density of $4.1\text{kJ}/\text{mm}^3$

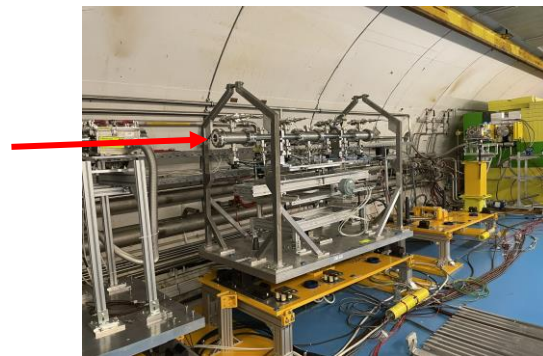
- 8 windows – 4 vacuum chambers and 3 HELIOX chambers.
 - HELIOX tracer gas - He 80%, O2 20%. Monitoring with leak detector.
- 6 test spots – horizontal motion table.
- PLC automated valve control.
- All windows individually tested before final assembly.
- Fiducialisation at surface (BA7) before plug and play in TNC.

Si₃N₄ window with 6 individual sites (spots), membrane glued to S/steel plate

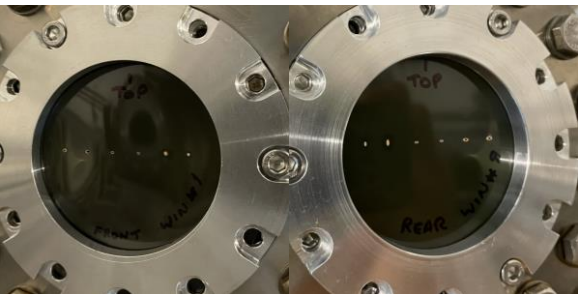
Gauged film shows focused beam upstream and divergence downstream

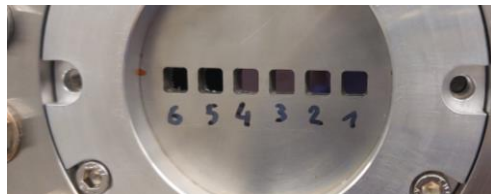
Window #1 Si_3N_4 – spots 5 & 6 broken

- Maximum energy deposition density of 9.46 kJ/mm^3
- 1st shot at higher intensity broke window
- Deposition of Gafchromic on spots #3 & #4

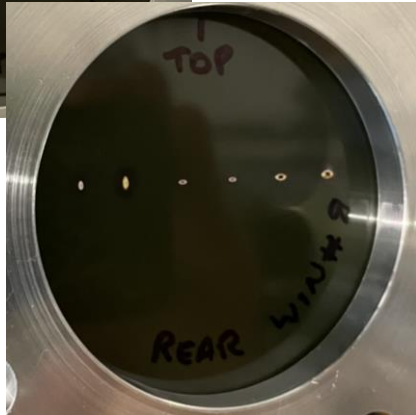
All 6 Pulse sites clearly visible and represent beam intensities

Round beam trace upstream, indicating more focused beam. Elliptical beam trace downstream – focal point of experiment was towards the front of the experiment

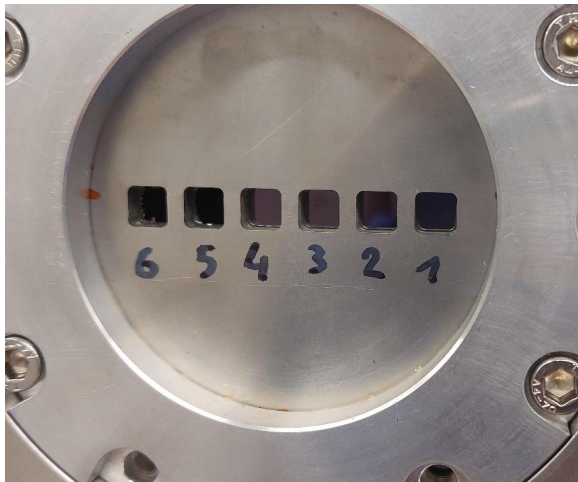
Window #1 Si_3N_4 #2

Vacuum failed

Pulses #1 & #2 – No visible impact marks

Pulses #3 & #4 – Impact mark can be seen

Pulse #5 – Failed after 1st Pulse

Pulse #6 – Failed (probably 1st Pulse but unable to verify)

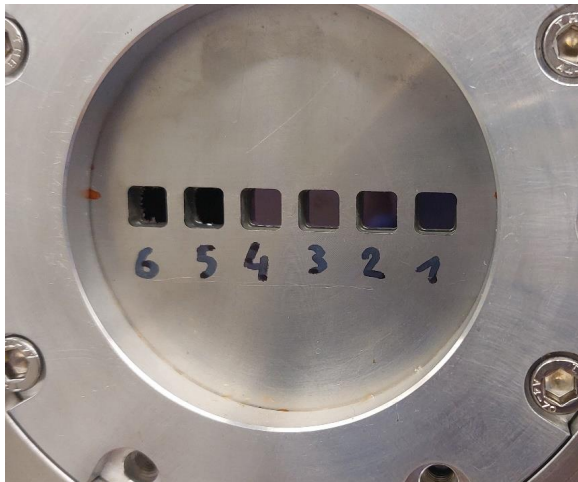
Window #1 Si_3N_4 #2

Vacuum failed

Pulses #1 & #2 – No visible impact marks

Pulses #3 & #4 – Impact mark can be seen

Pulse #5 – Failed after 1st Pulse

Pulse #6 – Failed (probably 1st Pulse but unable to verify)

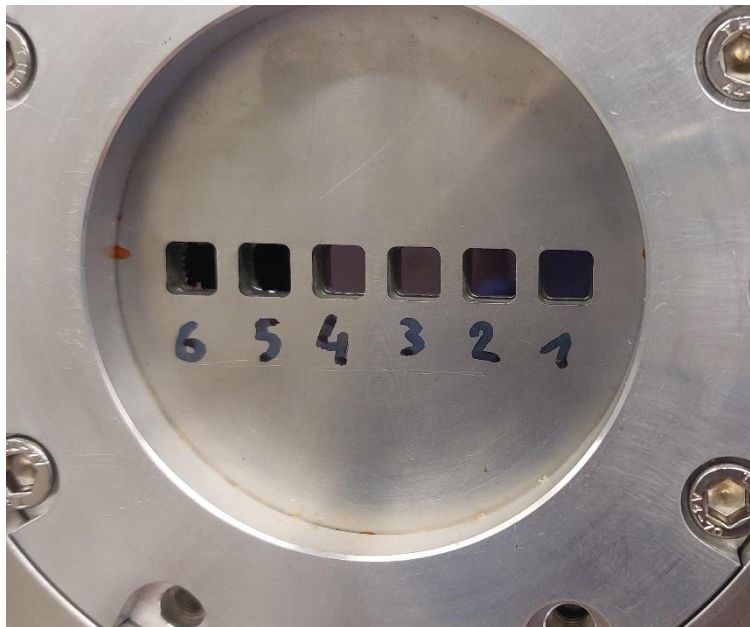
Window #7 Si_3N_4 #3

Window leak tight

Pulse #1, #2, #3, #4, #5 & #6 - No visible impact marks

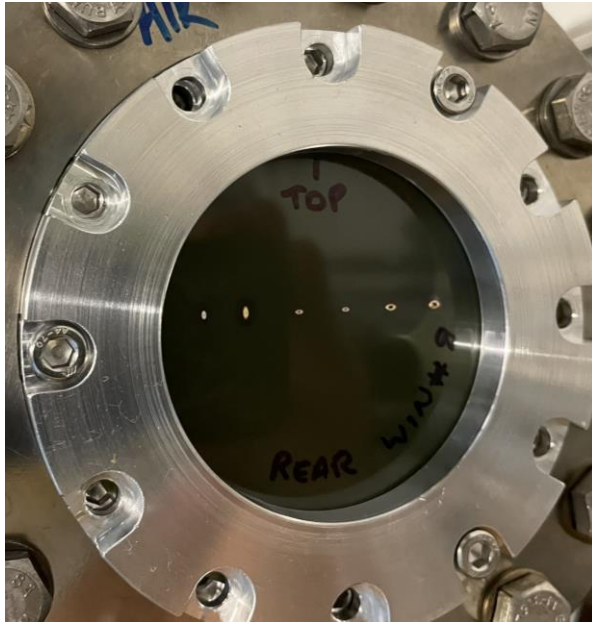
Downstream Gafchromic

All 6 Pulse sites clearly visible and represent beam intensities

Elliptical beam trace in horizontal plane, indicating more defocused beam
