Vacuum chambers : TAXN, TAXS

Jaime Perez Espinos, Marco Morrone

10th October 2024

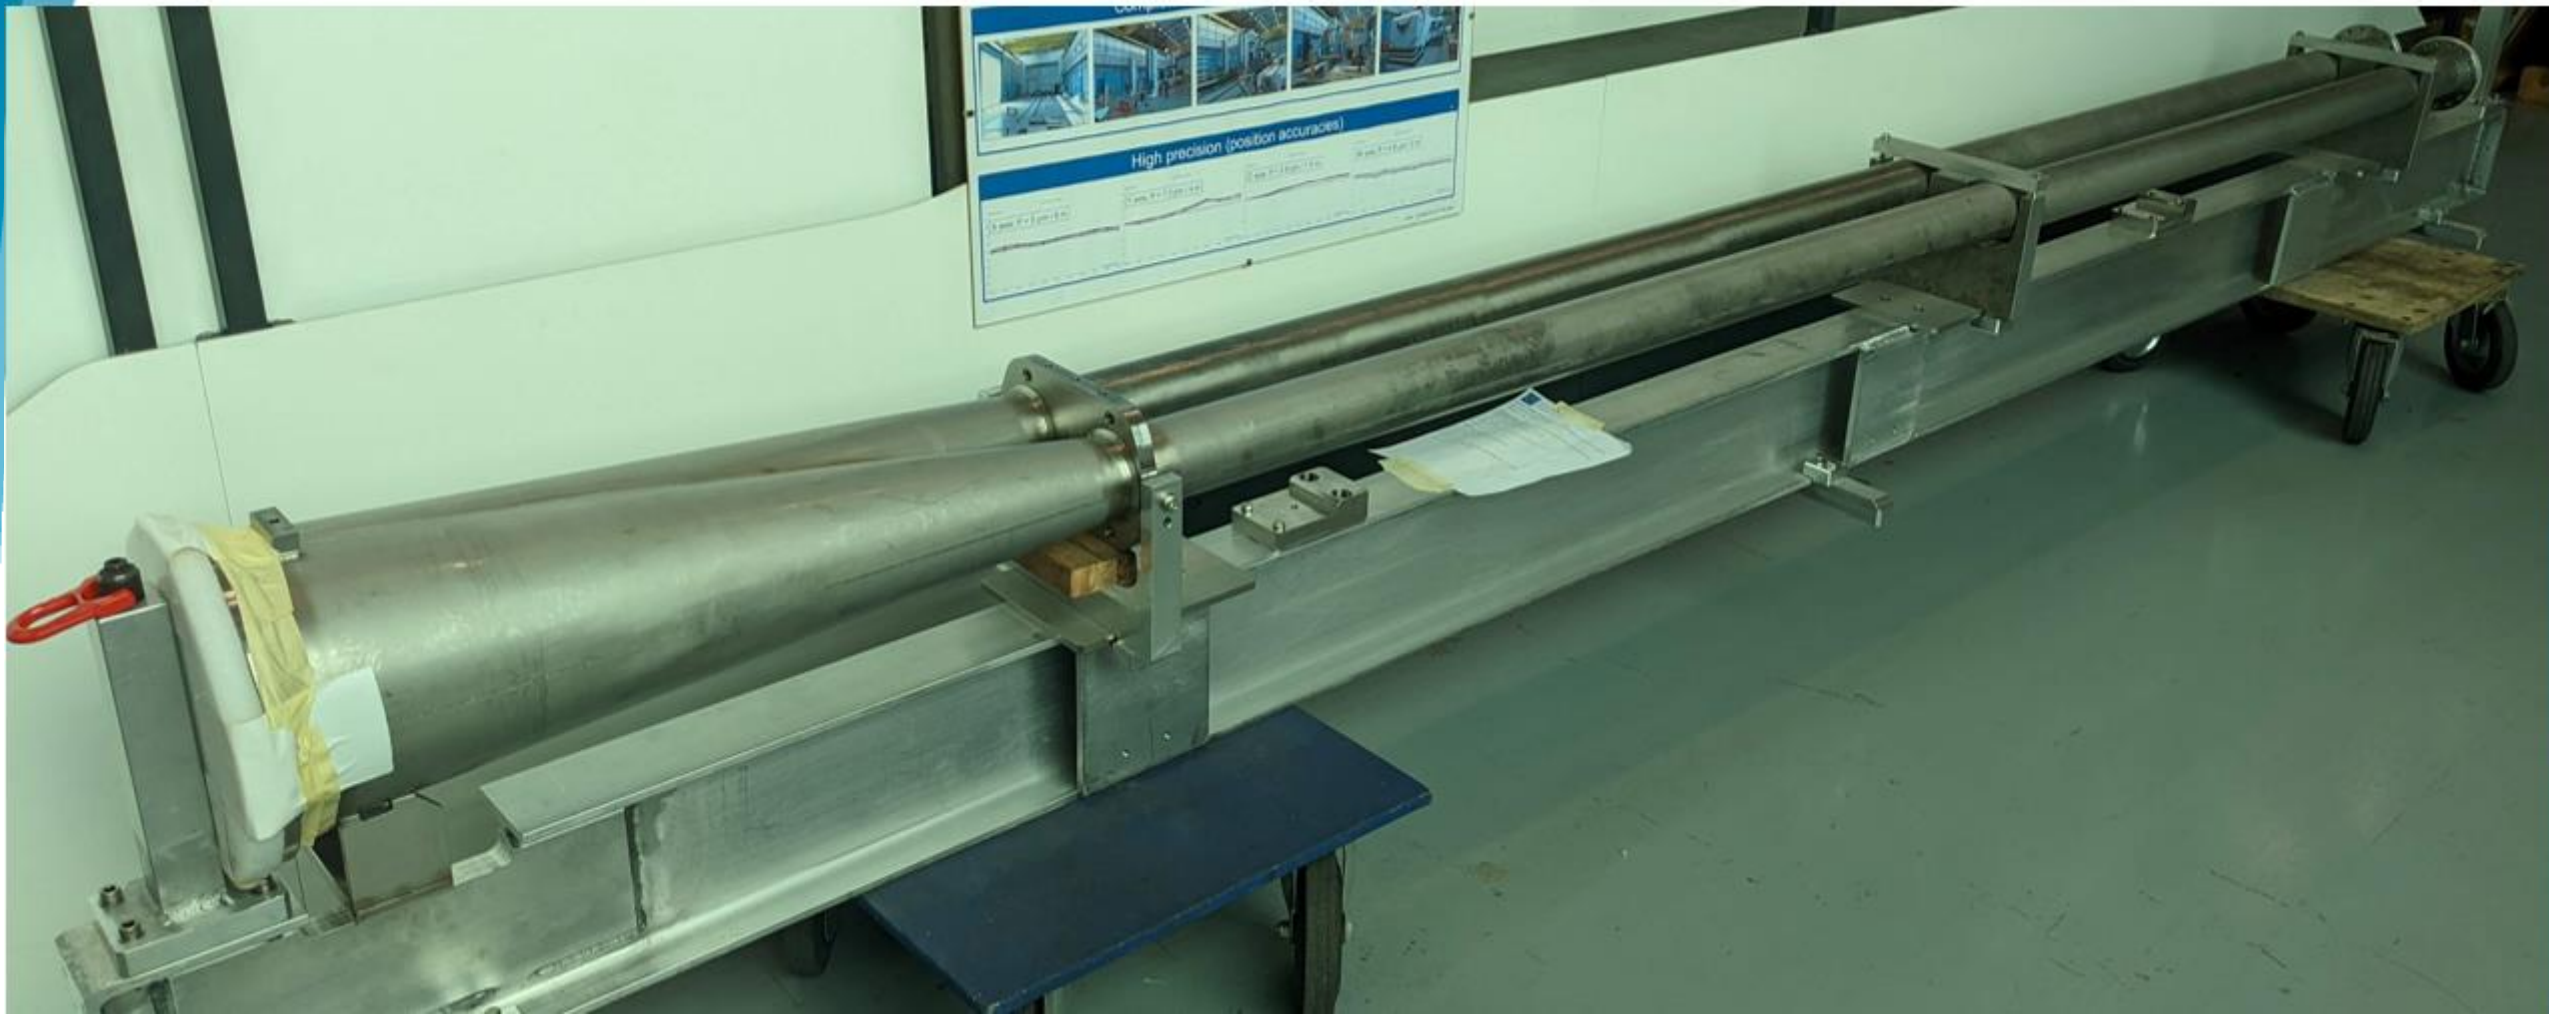
Status of TAXN chambers

1st chamber manufactured (spare): 2 NCs under discussion

- After vacuum firing some black stains appeared. With the intent to remove these stains some wiping tissues were used.
- Some fibers got stuck on the surface of chamber. They were unnoticed and got metalized during the NEG coating.
- SEM-EDS analyses proved that the fiber surface was NEG but that the core was indeed organic.

Many NEGGED fibers observed after the chamber was coated:
The SEM-EDS was used to analyze the surface (NEG composition) and the core (Carbon).

- 1) NEG stripping **(DONE)**
- 2) Vacuum firing @ 650 °C for 24 h to burn the fibers
- 3) Microscope analysis
- 4) Cleaning (with reinforced ultra-sound)
- 5) Microscope analysis
- 6) Re-NEG

HOLD POINT: continuation of action plan is linked to resolution of metrology NC and potential repair, under study by Main Workshop

- 1st TAX-N chamber (spare chamber) is manufactured but two NCs are reported: unwanted NEG fibers (minor) and metrology anomaly (major).
 - Although the NEG was coated with good adhesion, some NEG fibers were found stuck to the internal surface of the chamber. These might detach during operation involving potential serious UFO-like problems. VSC is confident that **this problem can be solved**.

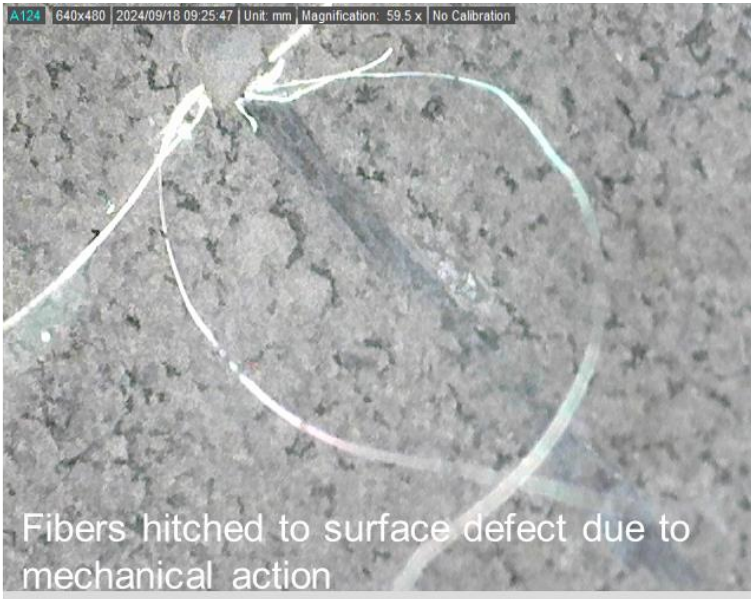
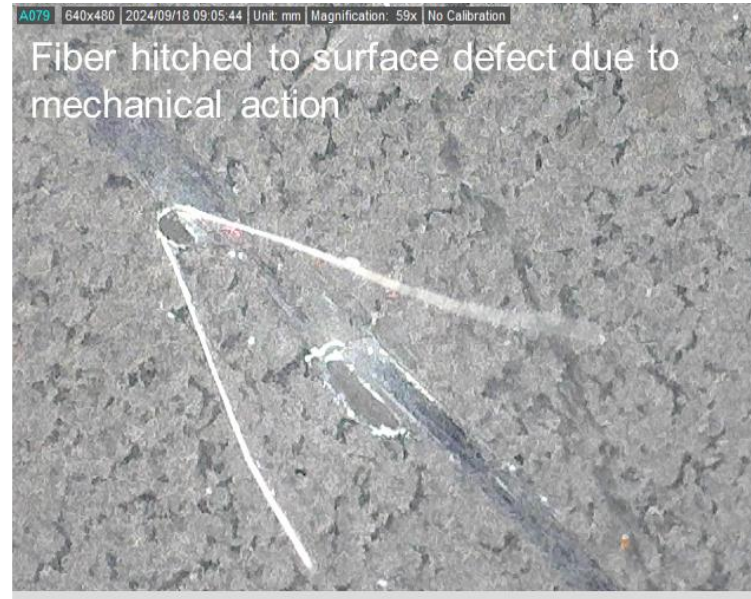
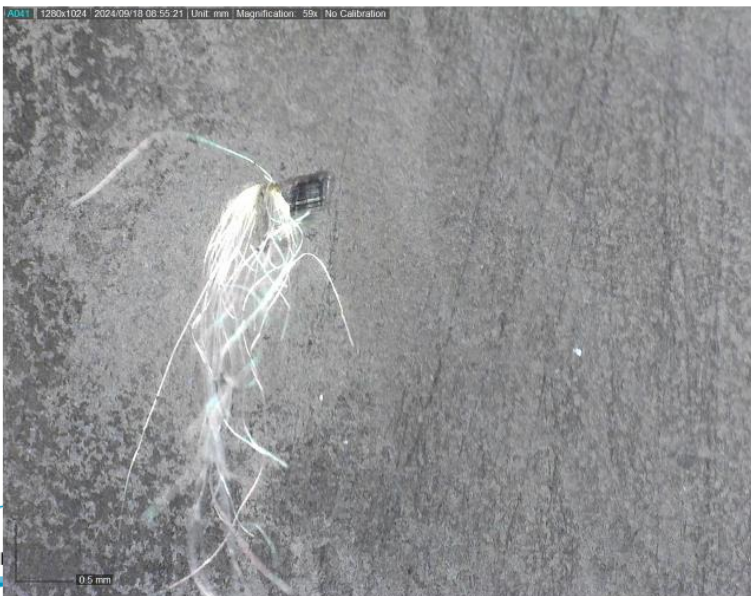
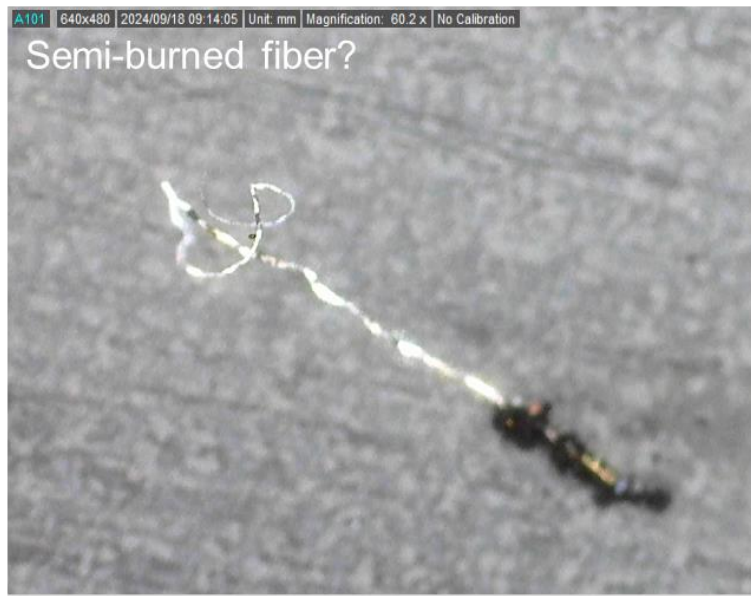
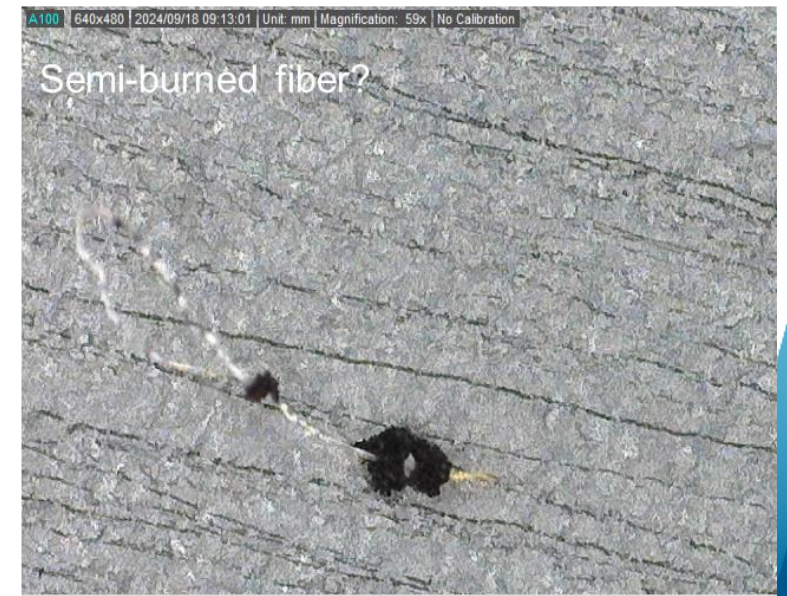
Inspection after stripping the NEG coating

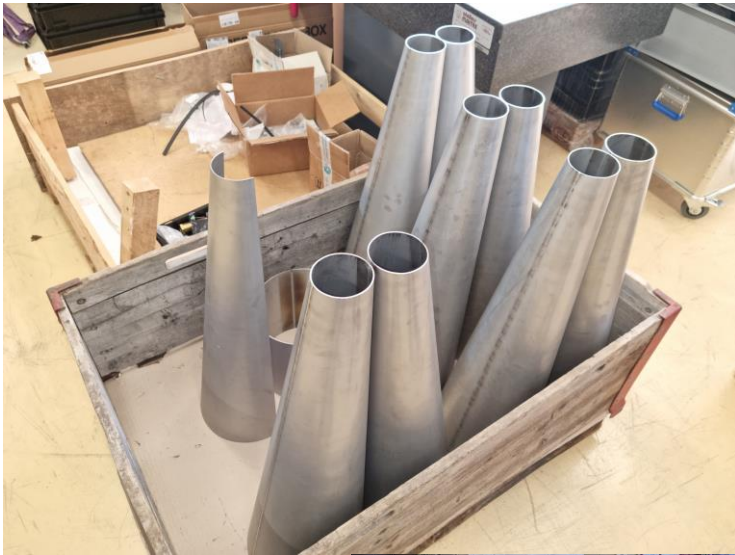
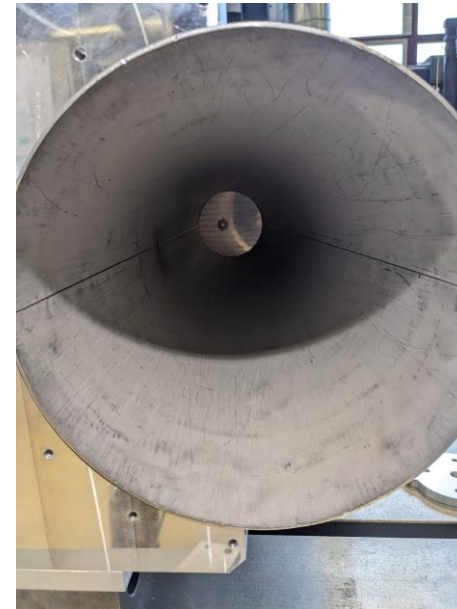
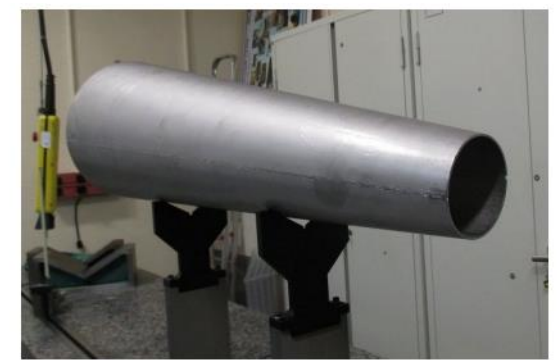
- Half-cones (8x) formed and welded
 - Shape calibrated, wire cut, and intermediate metrology checked
 - Vacuum acceptance test for conical part of the first chamber ok!

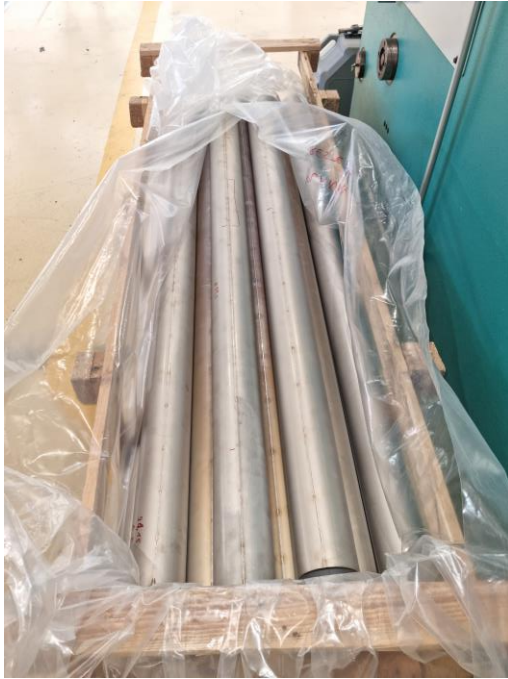
- Half tubes (20x) formed and welded (linear weld)
 - Shape calibrated, wire cut for prototype chamber.

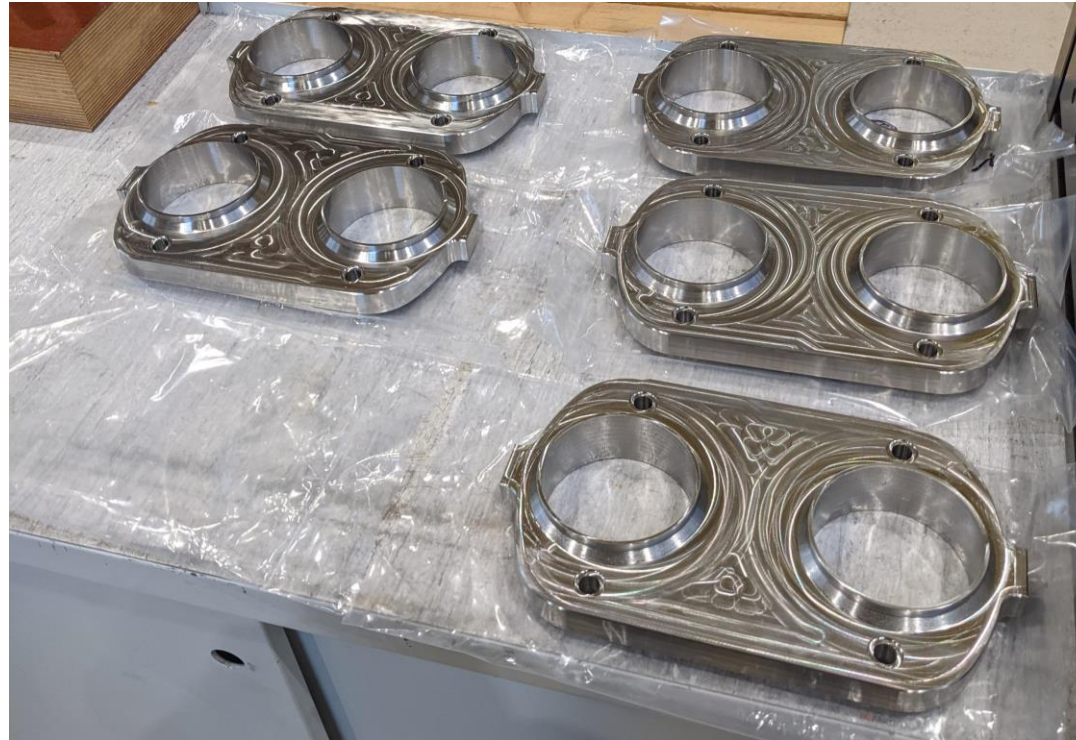
- Other components
 - Flanges & recombination reference plate machined.
 - Transporting/storage beam + special beam for NEG coating ready.

All the subcomponents for the 5 chambers have been manufactured
