RFD-SPS Cryomodule Repair Overview and Highlights

Simon Barrière, Joanna Świążek – CERN
on behalf of the HL-WP4 team

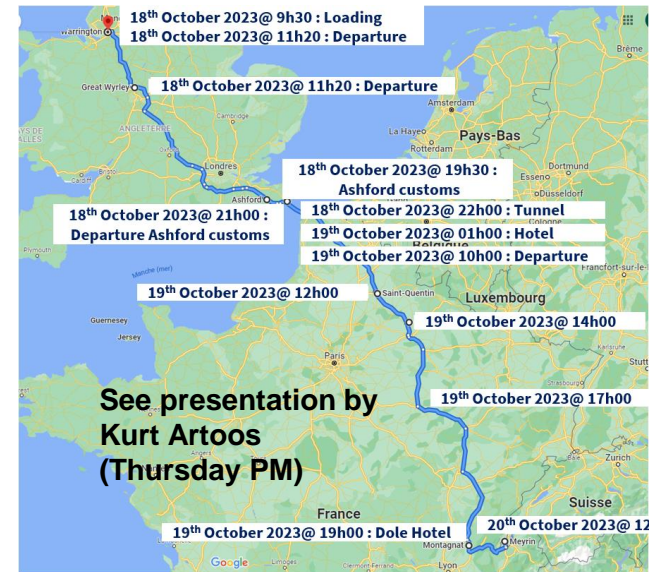
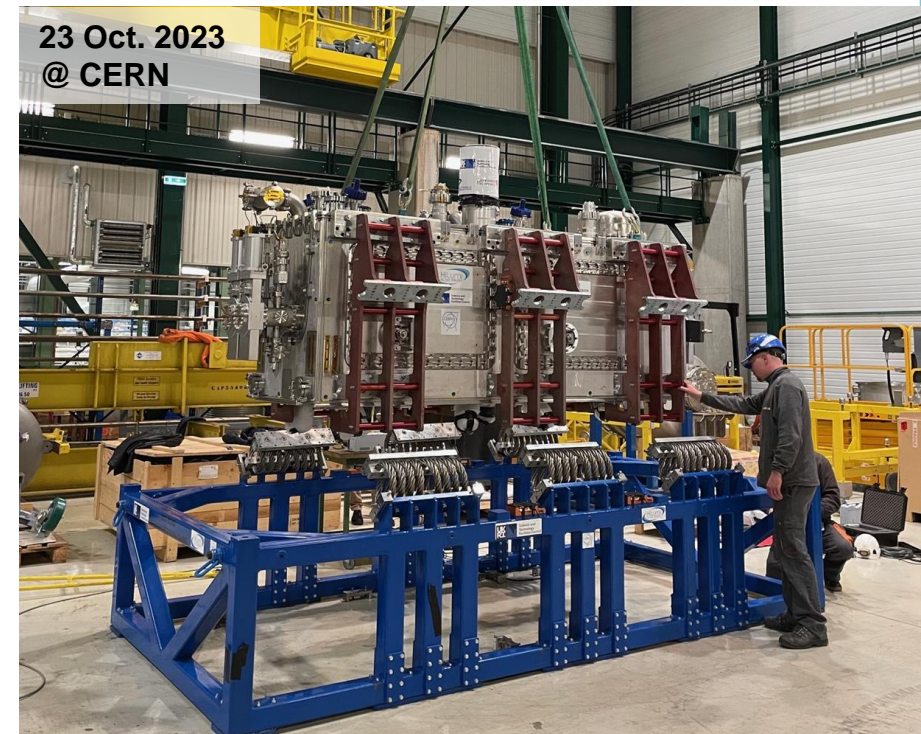
- First RFD version crab cavities cryomodule (prototype for SPS tests)
- Assembled in UK-STFC Daresbury Laboratory
- Transport to CERN in Oct. 2023

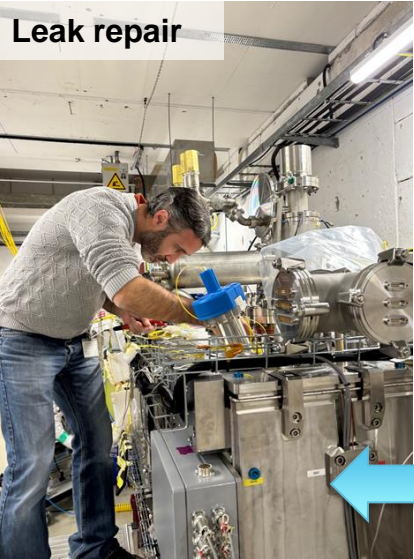
Leak repair

✓ Leak closed, allowing cold test of C2 (see presentations this morning)

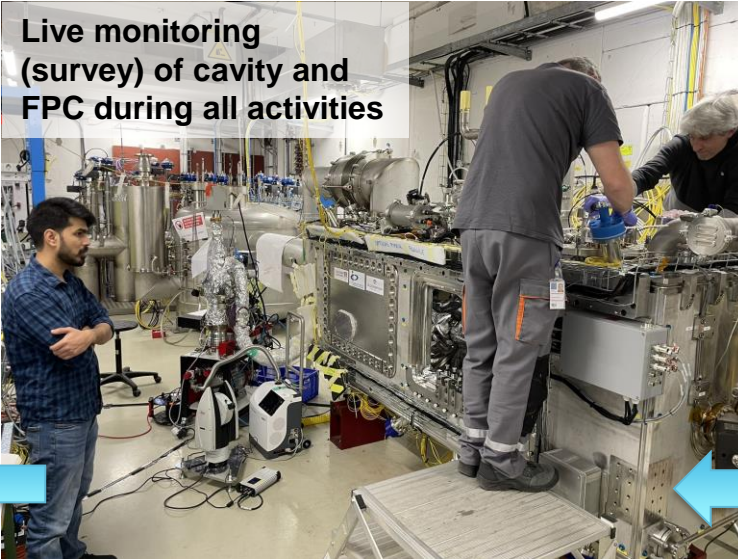
Live monitoring (survey) of cavity and FPC during all activities

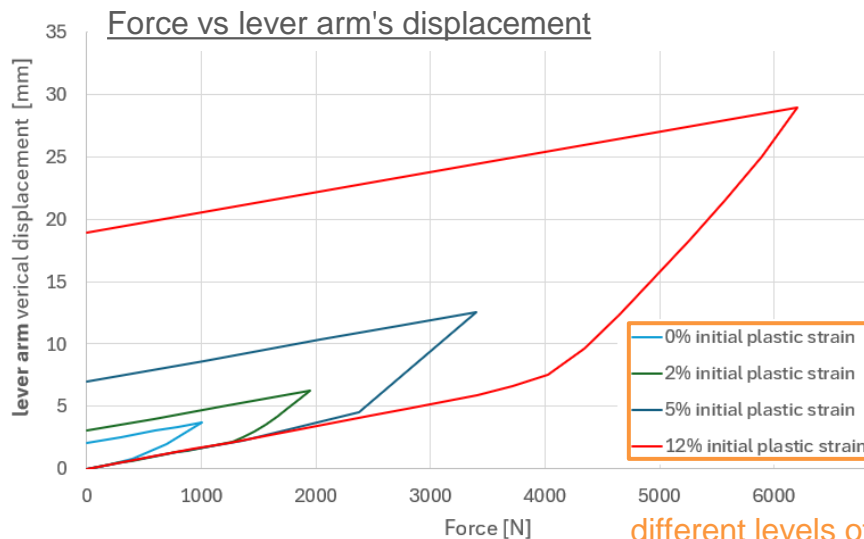
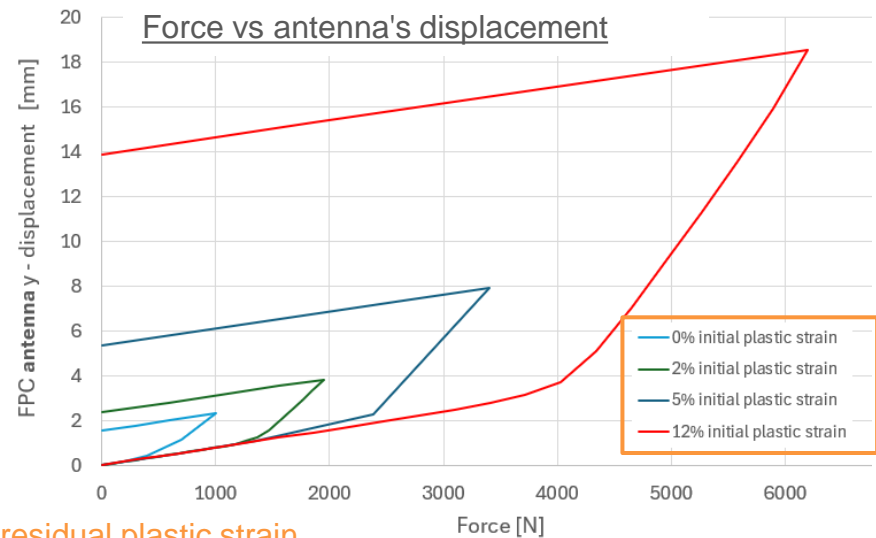
- Force/displacement plots for different initial hardening scenario.

different levels of residual plastic strain
in FPC copper body

- **Measuring** force and lever arm's displacement
- **Superposing** measurement curves on the simulation curves
- **Comparing** sims and measurements to indicate the initial hardening of FPC copper body
- **Choosing** a curve for estimation of the antenna's displacement

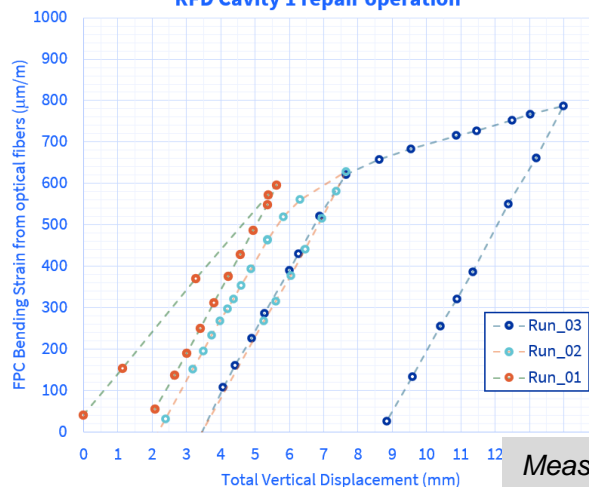
RFD Cavity 1 repair operation

- limiting component is FPC tube: 0.2% of plastic strain in the FPC tube if applying 6.2 kN force
- careful monitoring of the FPC tube strain

Type: Equivalent (von-Mises) Stress
Unit: MPa
Time: 3
02/02/2024 09:14

319.57 Max
284.07
248.57
213.07
177.57
142.07
106.56
71.063
35.561
0.059686 Min

Type: Equivalent Plastic Strain
Unit: mm/mm
Time: 3
02/02/2024 09:15

0.0024931 Max
0.0022161
0.0019991
0.001662
0.001385
0.001108
0.00083102
0.00054401
0.00027701
0 Min

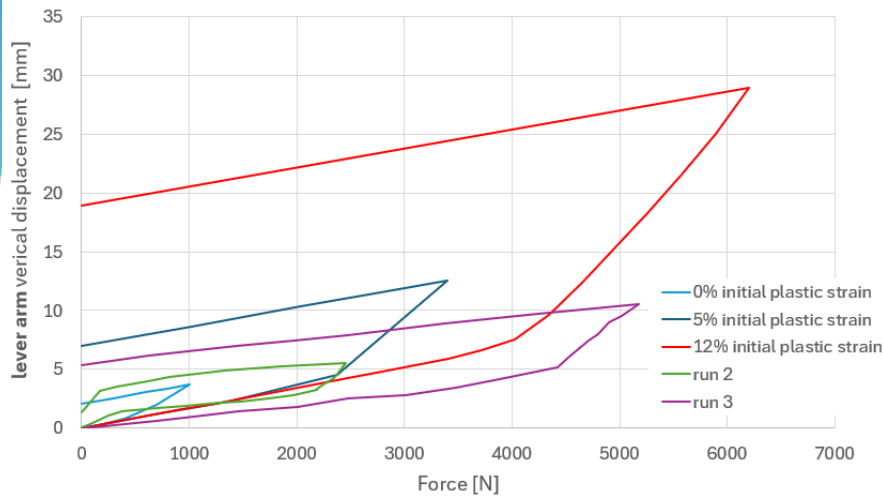
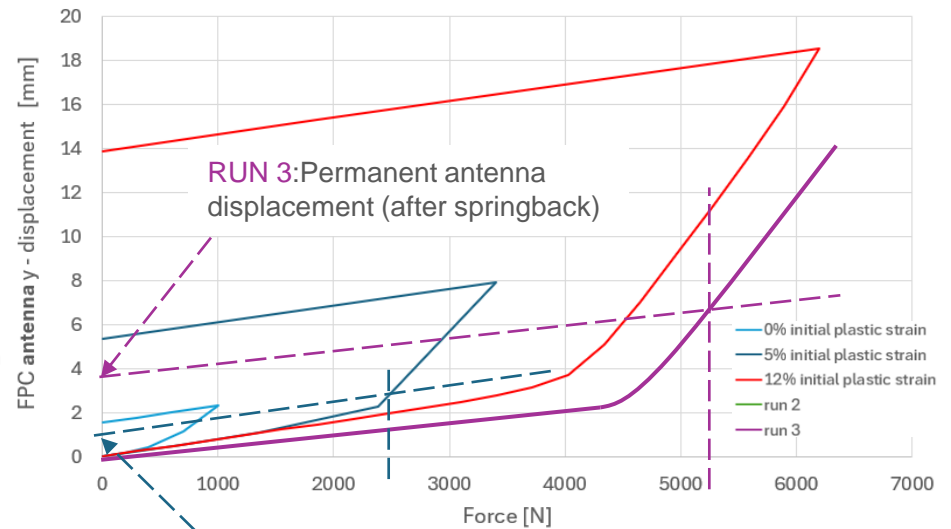
Simulations & Measurement

Force vs lever arm's displacement

Force vs antenna's displacement

Run 1: apply a force to test structure response, closing gaps in contacts, tool put in place

- Applied force: 1 kN

Run 2: apply a force to test structure response, springback slope, hardening level

- Applied force: 2.5 kN
- Following "5% initial plastic strain" curve
- **Springback slope confirmed**
- Estimated displacement of the FPC hook: 1mm

Run 3: apply a displacement corresponding to the straightening objective set

- Applied displacement: 10.5 mm
- Measured force: 5.2 kN
- ~15% plastic strain, strain hardening after run 2
- Estimated displacement of the FPC hook: 3.6 mm
- Approaching admissible stress limit for the FPC tube

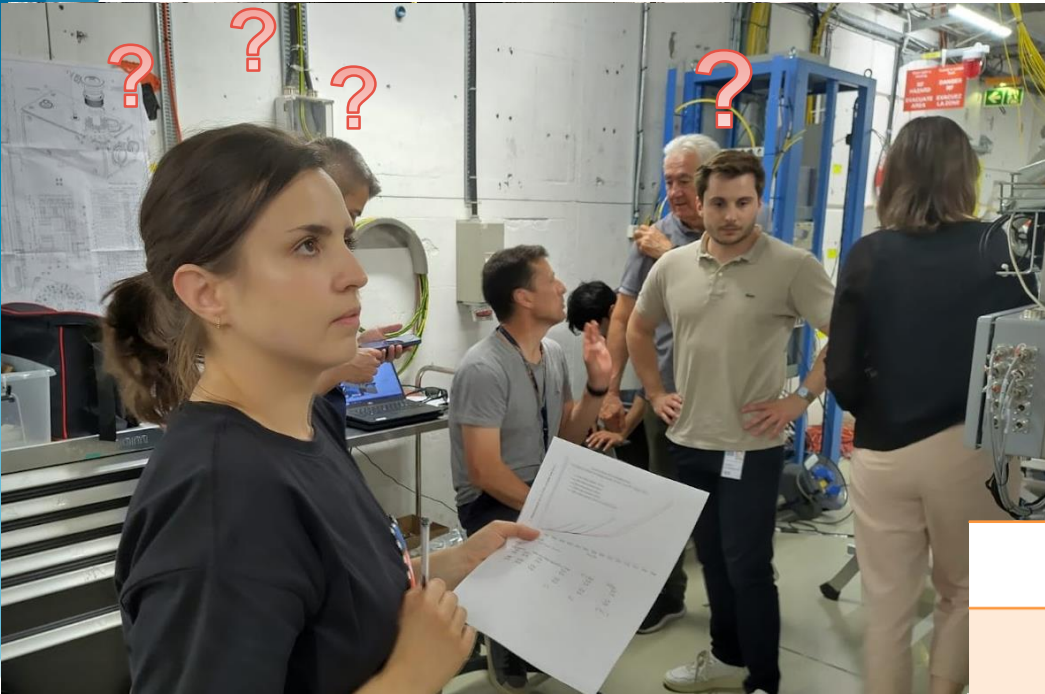
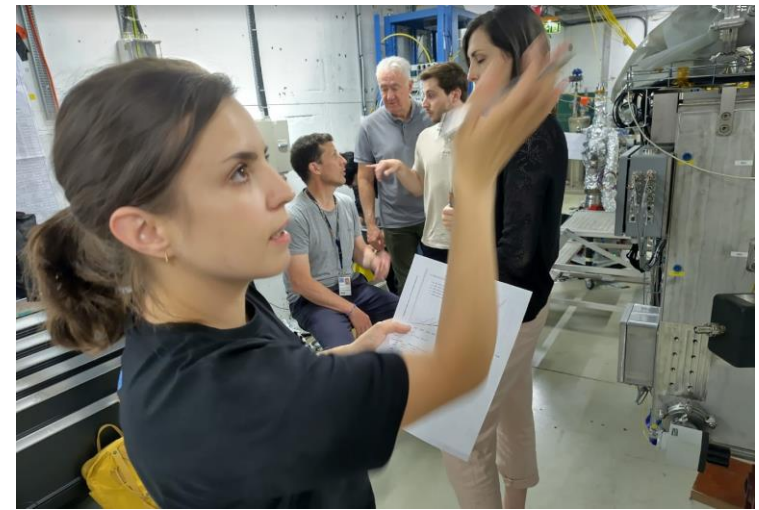
Results

ANTENNA'S DISPLACEMENT

SIMULATION	MEASUREMENT
1 st run	1 mm	0.9 mm
2 nd run	1 mm	1.1 mm
3 rd run	3.6 mm	4.1 mm
TOTAL	5.6 mm	6.1 mm

Very good coherence between simulation prediction and final measurements!

- Antenna's tip was permanently moved by 6.1 mm
- FPC copper body was plastically deformed

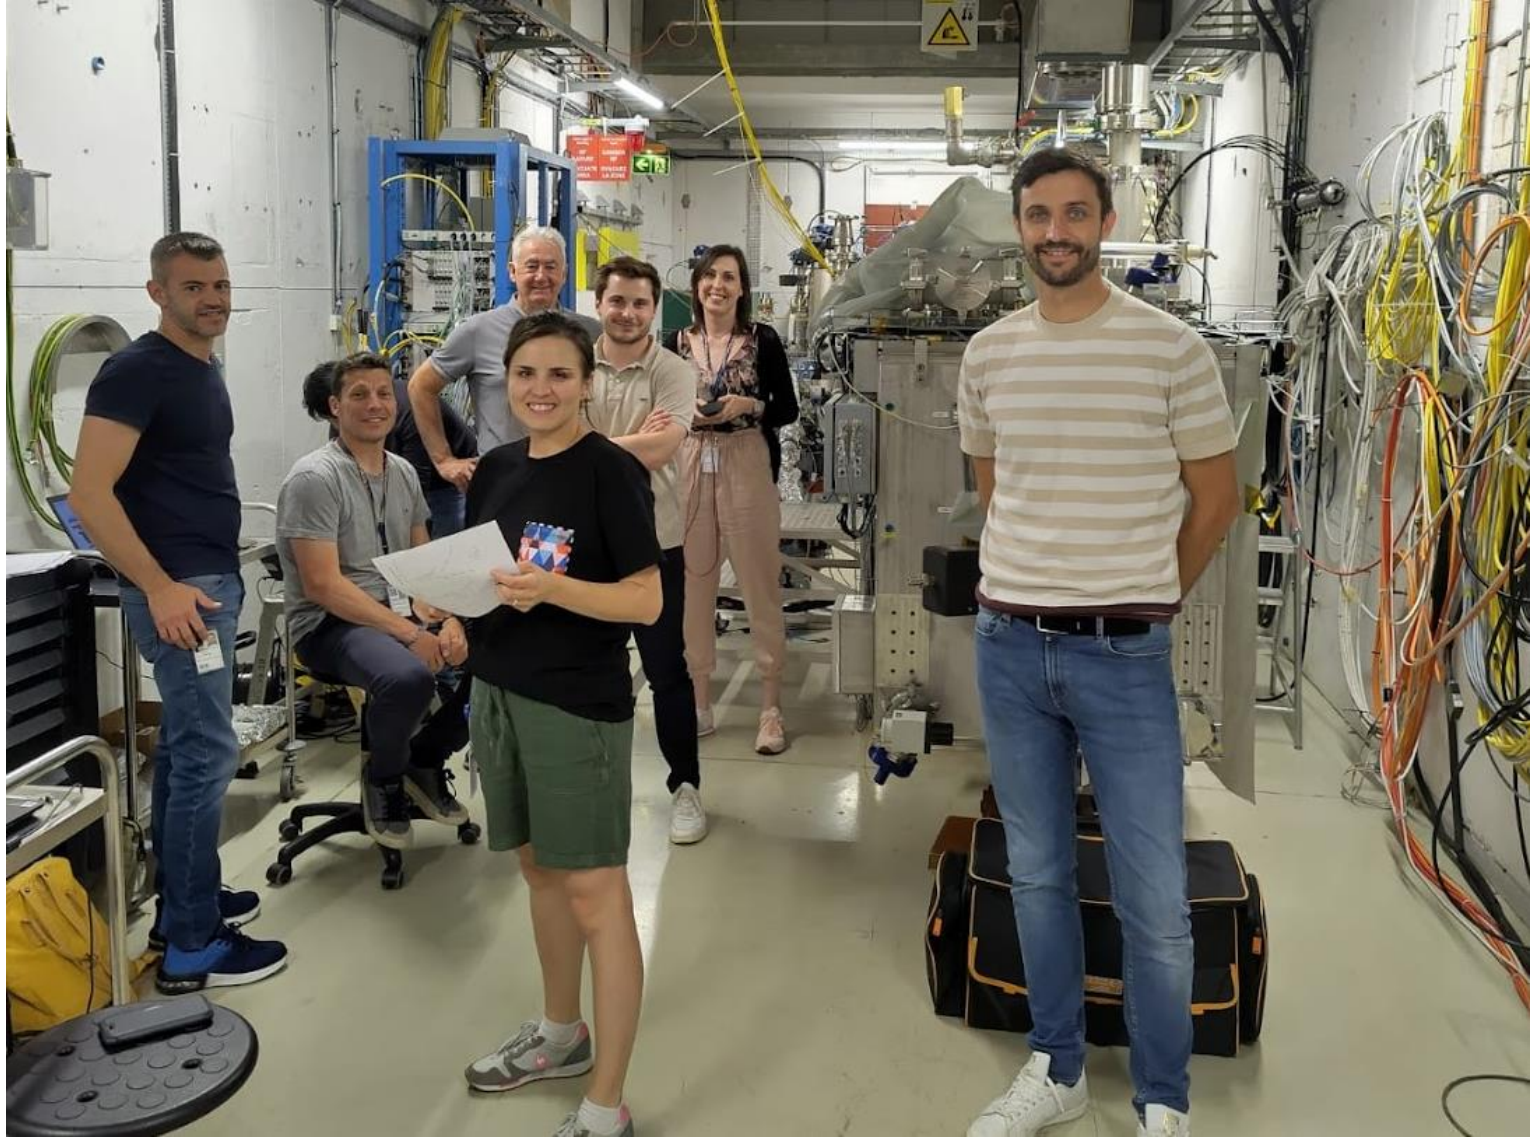
Results

Laser tracker measurement and FSI Validation
Praneeth Sarvade
Vivien Rude
Teddy Capelli

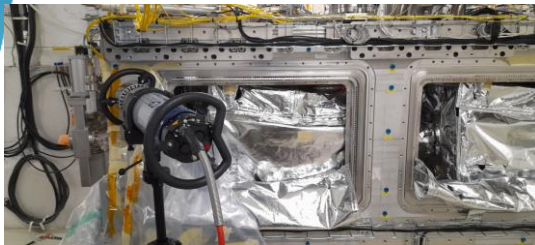
Set up preview - courtesy A.Porret

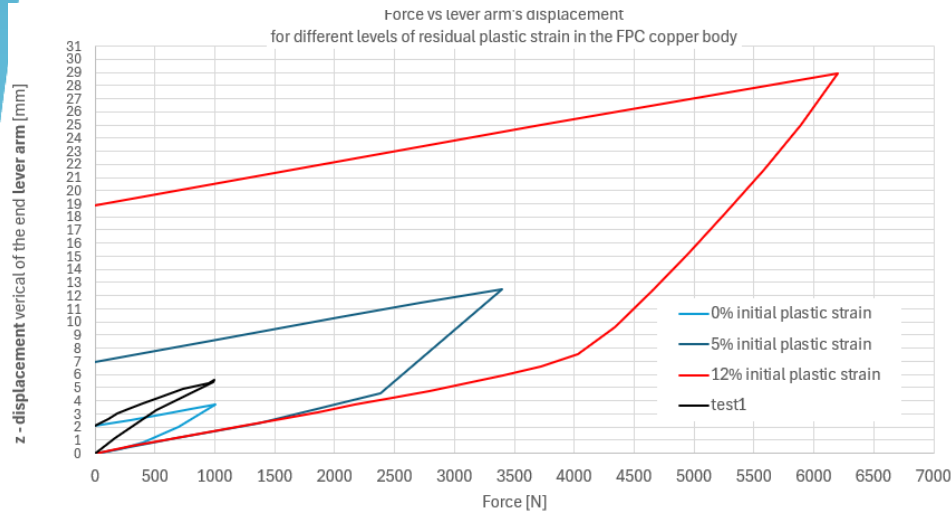
Run 1: Simulations & Measurement

Antenna's displacement obtained through simulations

Run 1: apply a small force to test tooling and structure response

- Applied force: 1kN
tooling adjustments, contact sliding, actual deformations difficult to estimate
- Estimated displacement of the FPC hook: ~1mm
- **Contact removed**

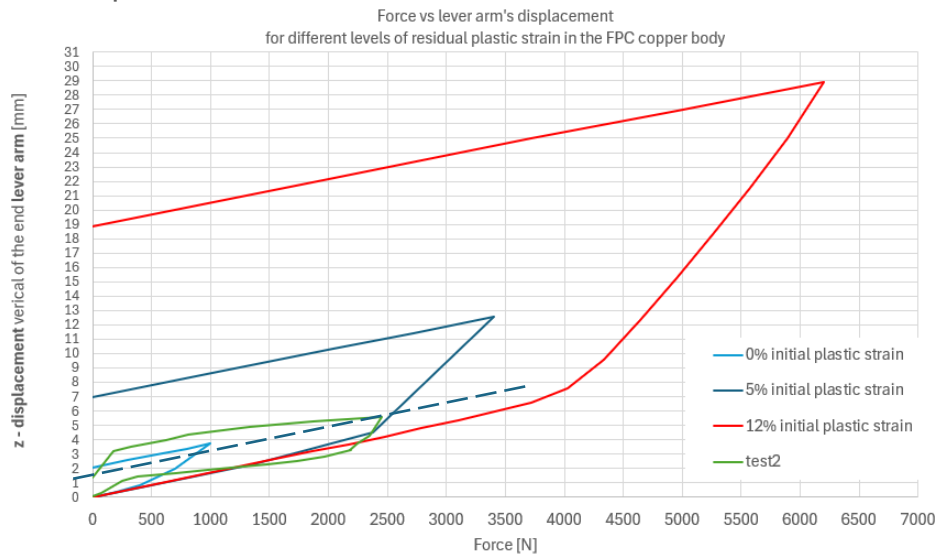
Run 2: Simulations & Measurement

Antenna's displacement obtained through simulations

Run 2: apply a force to test structure response, springback slope, hardening level

- Applied force: 2.5 kN
- Measured displacement:
Following dark blue curve – 5% plastic strain
- Estimated displacement of the FPC hook: 1mm
- Springback slope confirmed
