# Preliminary Results of Ion Implantation to Improve the Insulation of Non-arcing Metal Vacuum Gap in Vacuum Interrupter

**Yongjia Luo, Shenli Jia, Yuwen Zeng,  
Saikang Shen, Xiaolong Huang, Jiayi Song**

College of Electrical Engineering, Sichuan University, Chengdu, China

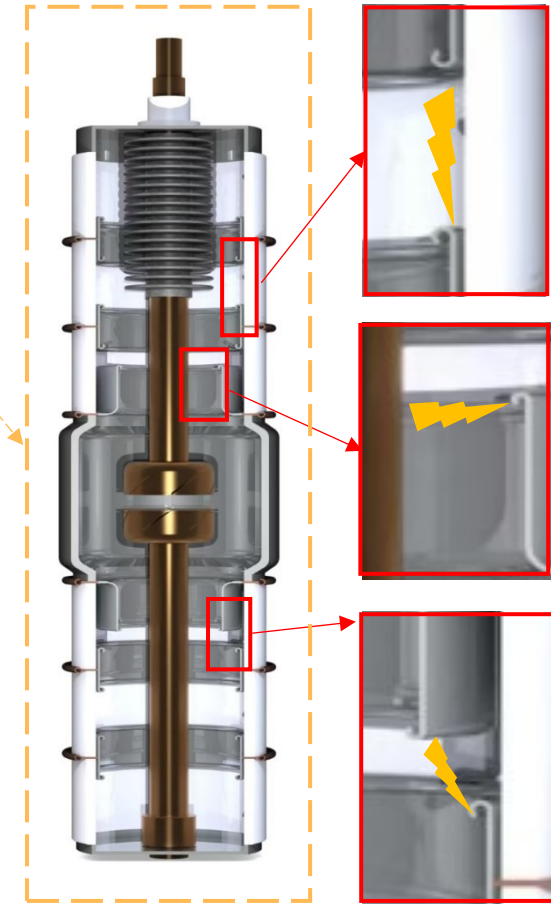
Vacuum interrupter

- The vacuum interrupter is the core of the vacuum circuit breaker, which undertakes most of the insulation properties of the circuit breaker.
- High-voltage, high-capacity vacuum interrupters adopt a multi-stage suspended shield structure.
- Breakdown can occur in unintended metal gaps, such as **between shields** or **between shields and conductive rods**.
- It is essential to enhance the withstand voltage performance of these gaps.

Undesired  
breakdown locations

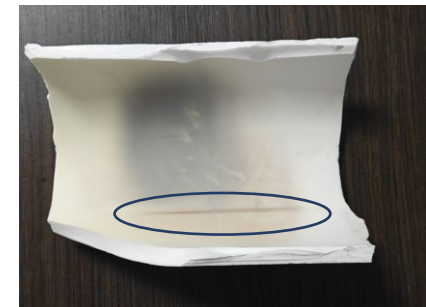
Breakdown traces after shields conditioning

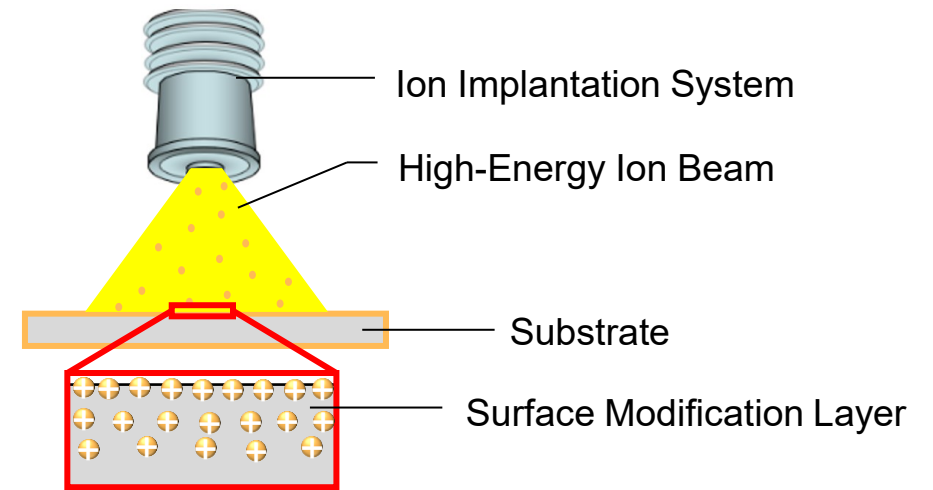
- Ion implantation technology involves bombarding and embedding high-speed ions into the substrate surface, creating a surface layer with unique physical, chemical, and mechanical properties.
- Proper ion implantation can enhance **the wear resistance, oxidation resistance, corrosion resistance**, fatigue resistance and high-temperature performance of metallic materials.
- Can ion implantation of **high-melting-point/ high hardness** metals on non-arcing surfaces enhance gap withstand voltage?

Ion implantation schematic

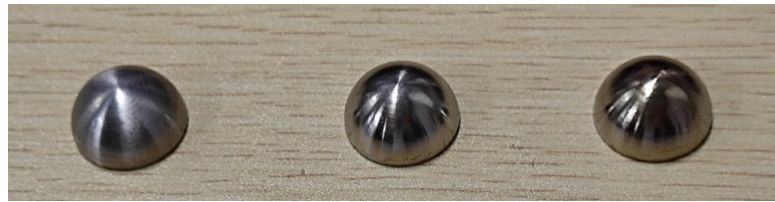
SUS

SUS+Ta

SUS+Mo

- Implantation Substrate: **Stainless Steel**
- consistent surface treatment
- Select appropriate parameters to ensure a better treatment effect on the electrode surface

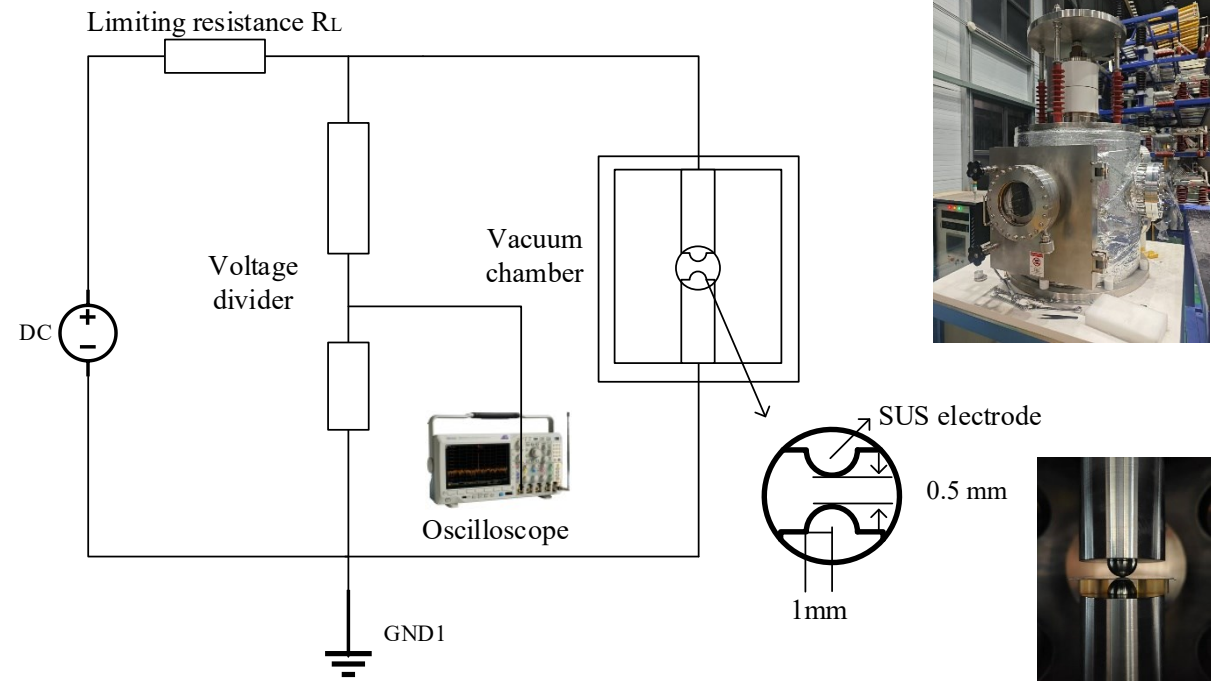
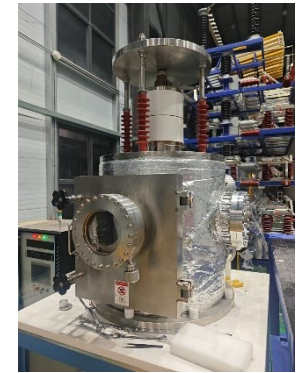
Schematic diagram of the experimental setup

- Discharges occurred in demountable vacuum chamber
- A ball-ball electrode were installed with a 0.5mm gap
- The DC source provides 0-100kV high voltage with a rise rate of 1kV/s

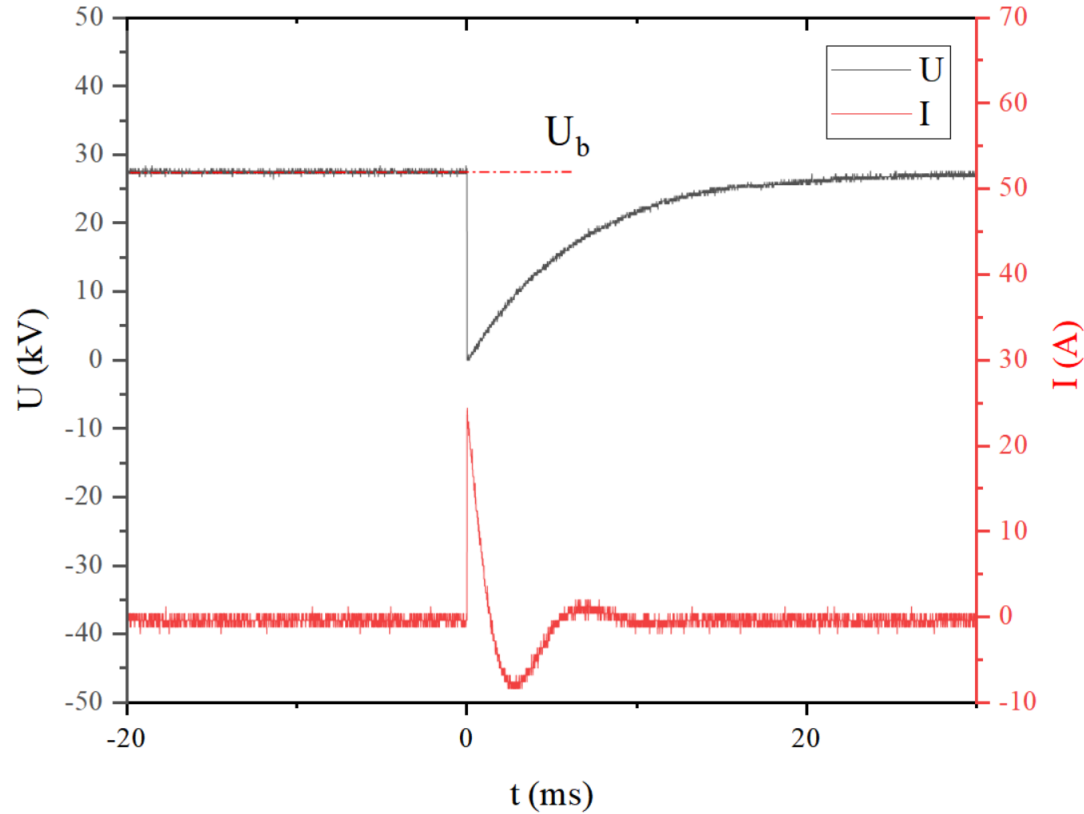
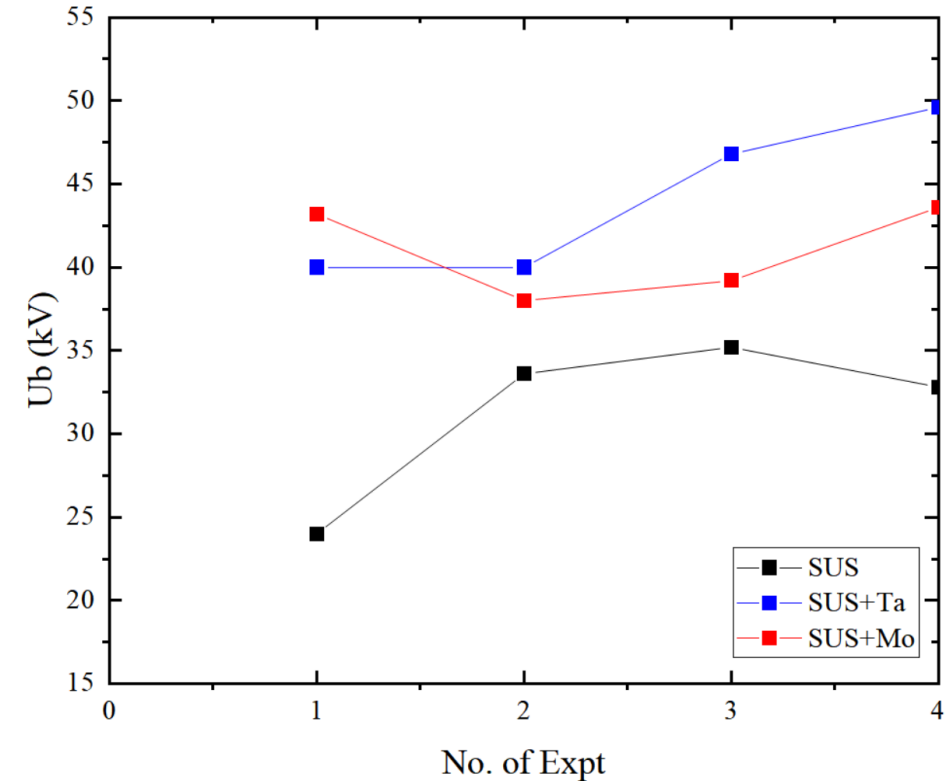
- Ion implantation effectively enhances the initial breakdown voltage
- The breakdown voltage and current is obtained by recording the waveform with an oscilloscope

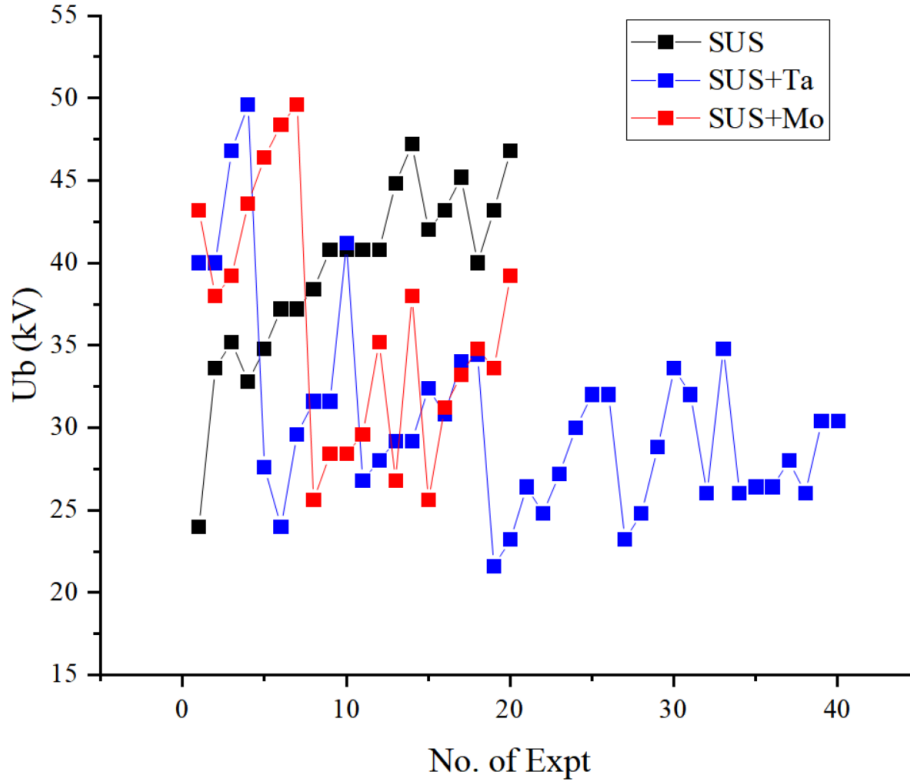
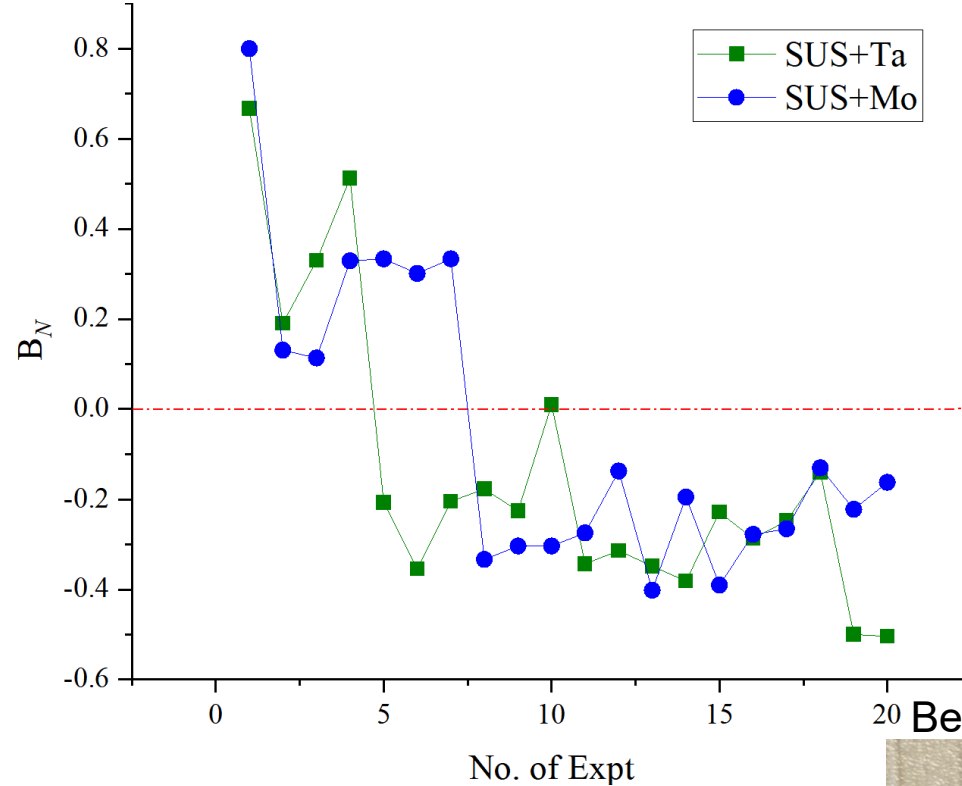
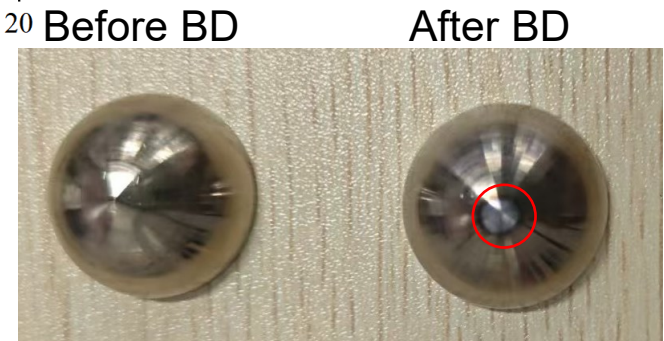
Parameter  $B_N$  reflects the significance of the increase in breakdown voltage

- The non-ion-implanted sample showed obvious conditioning effect.
- After a brief voltage rise, the breakdown voltage drops rapidly. The cause is presumed to be the destruction of the ion implantation layer.

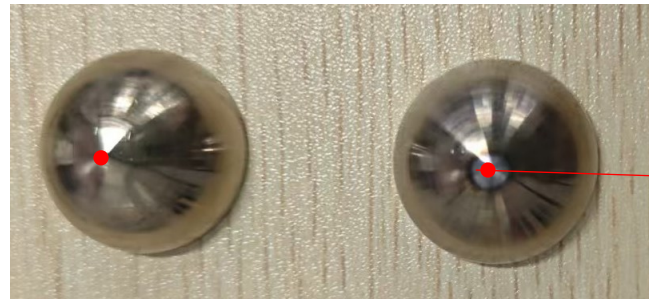
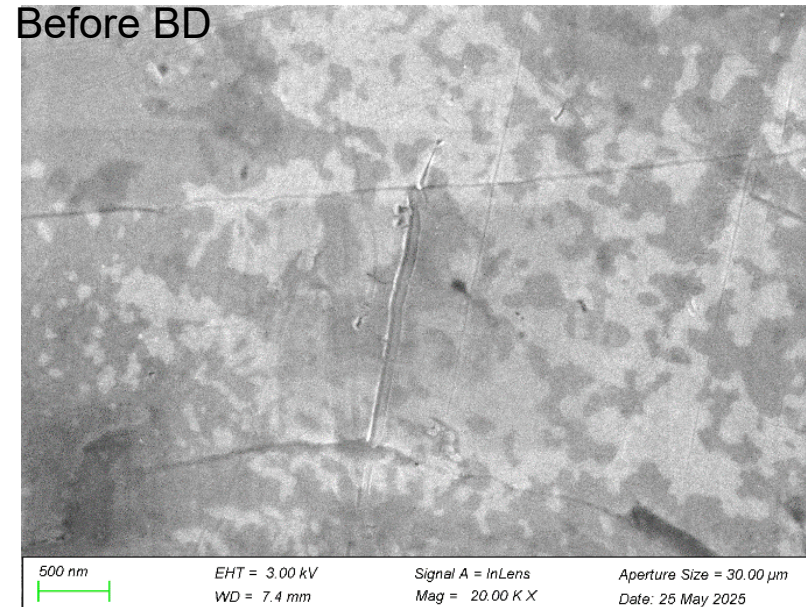
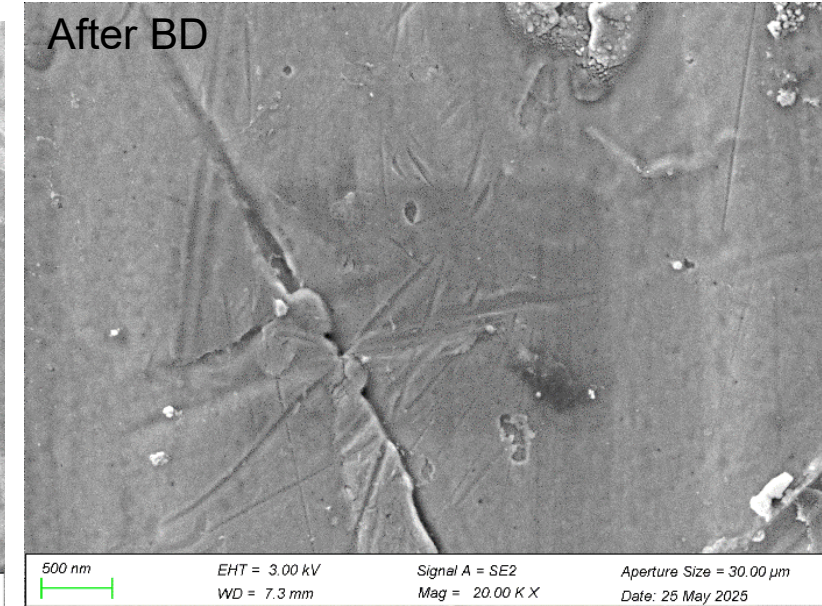
Scanning Electron Microscope(SEM) test

- Before breakdown, Uniform and fine nanostructures appears on the surface of the ion-implanted sample
- After breakdown, the surface becomes uniform due to arc ablation and loses its regional characteristics

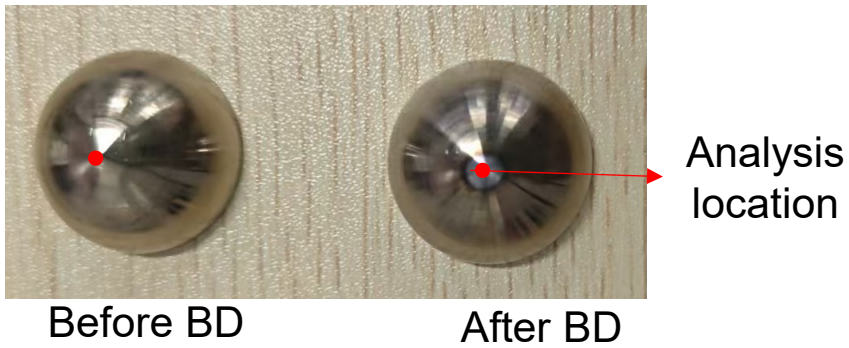
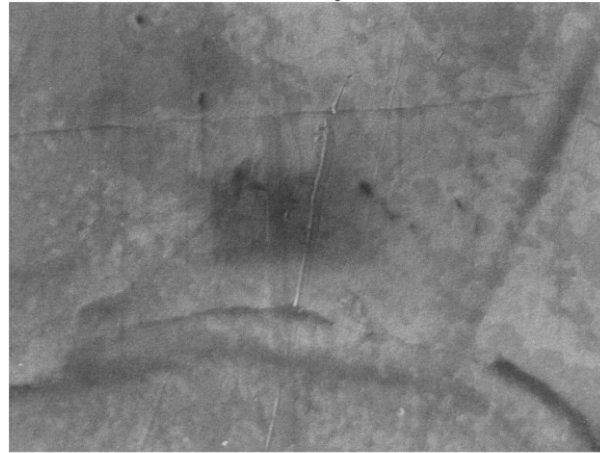
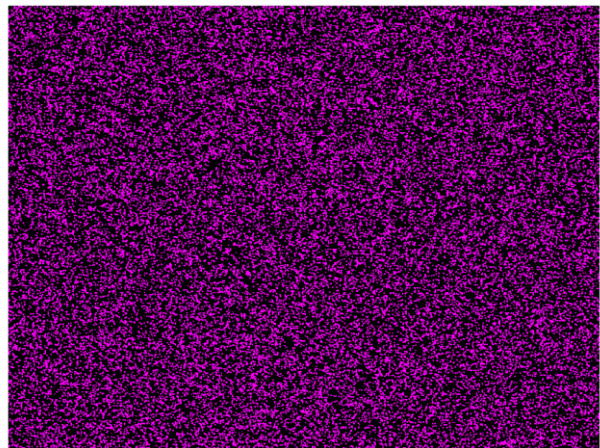
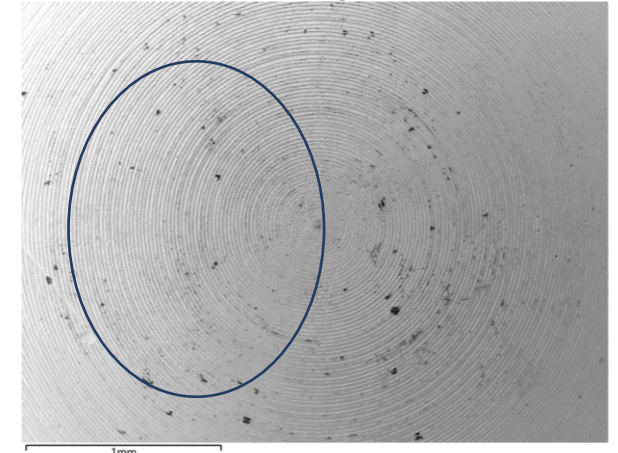
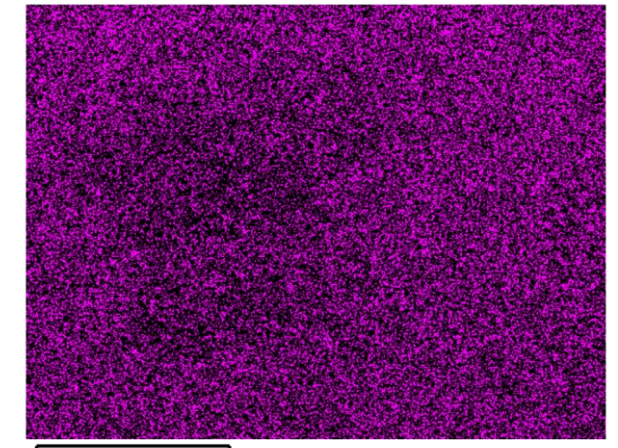
## Energy Dispersive Spectroscopy (EDS) test

- Before breakdown, EDS can't detect elemental differences in different regions.
- After breakdown, the surface Mo elements are unevenly distributed.

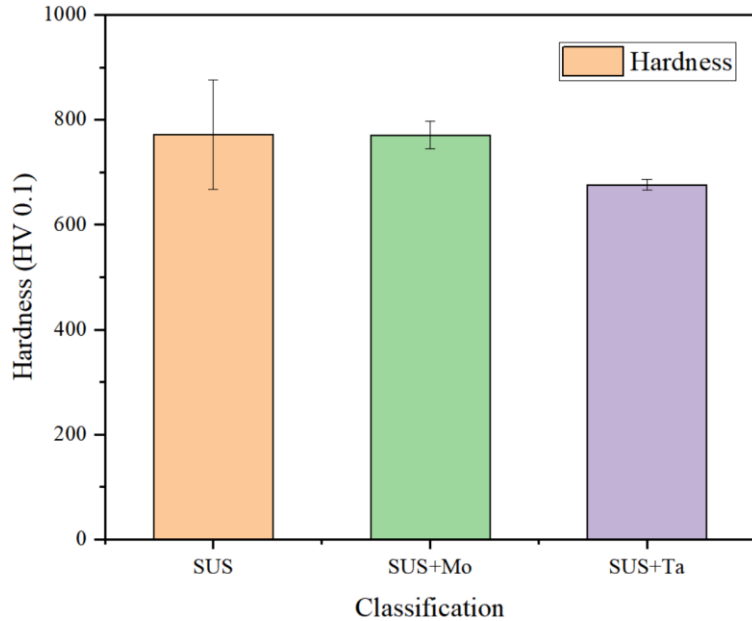
Microhardness tester      **Hardness**

- Improved hardness uniformity after ion implantation
- The roughness of the sample itself is too large, and the effect of ion implantation on the roughness of the sample itself is not obvious

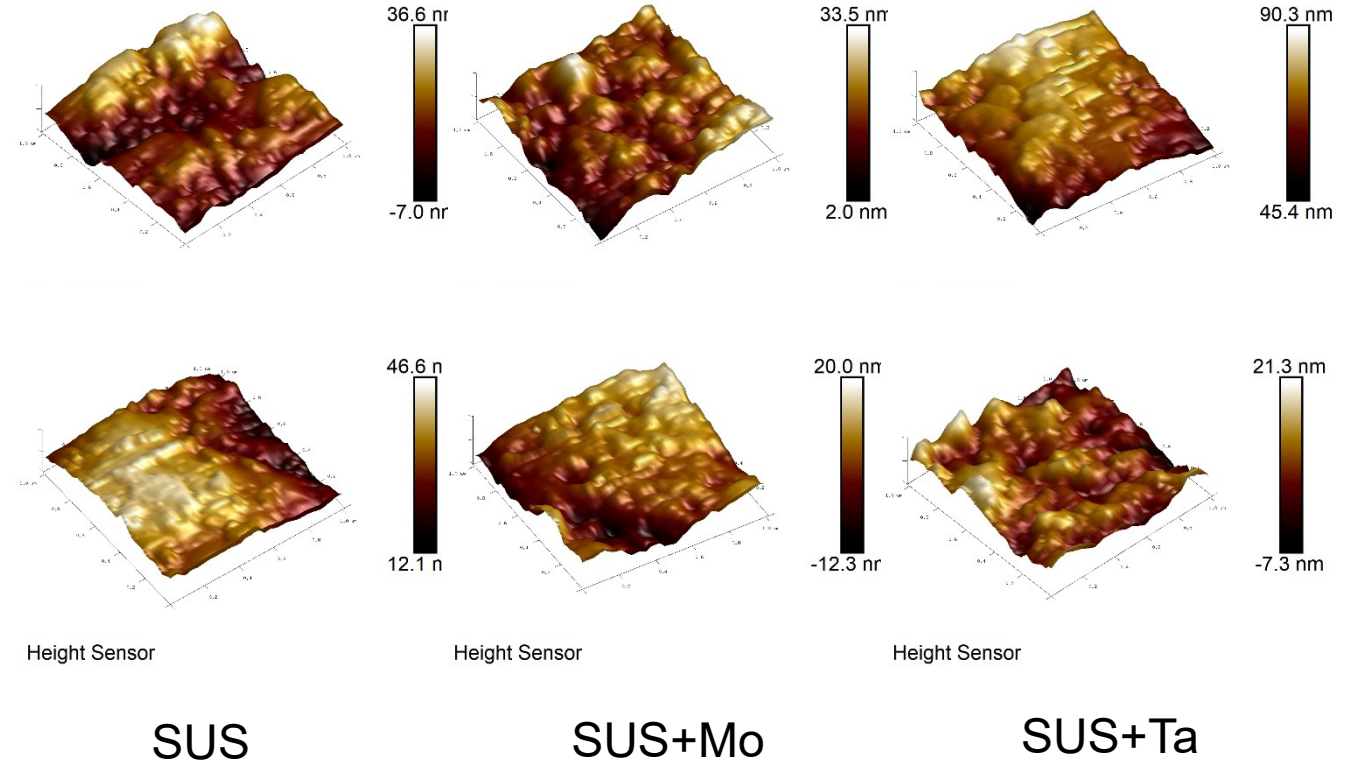
Atomic Force Microscope      **Surface roughness**

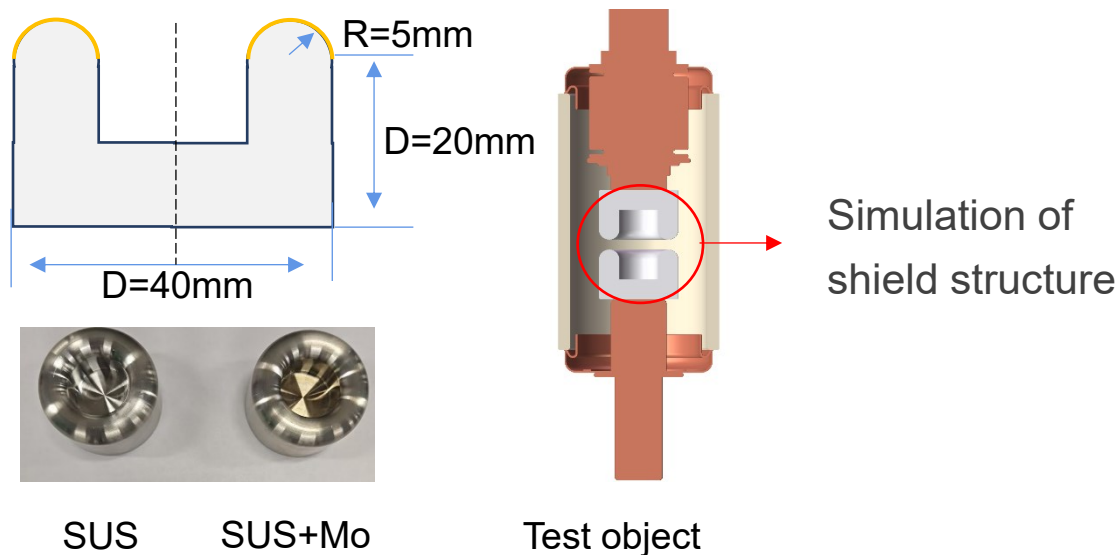
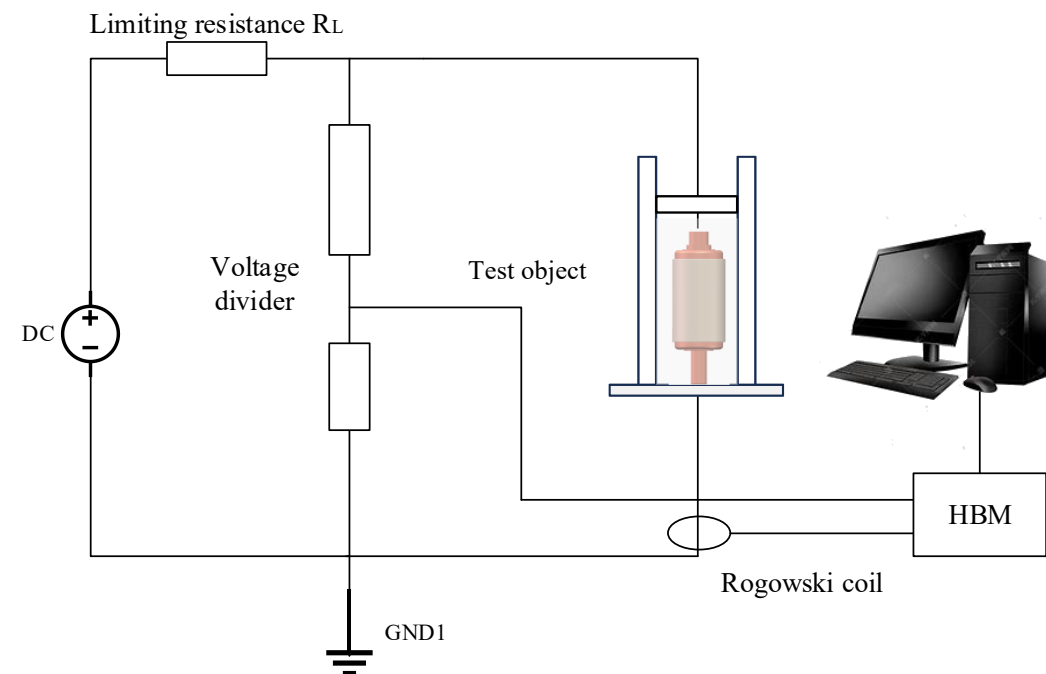
Schematic diagram of the experimental setup

- Discharges occurred in vacuum interrupters
- Assembly of ring-ring electrodes with 3mm/5mm gaps
- The DC source provides 0-500kV high voltage with a rise rate of 1kV/s

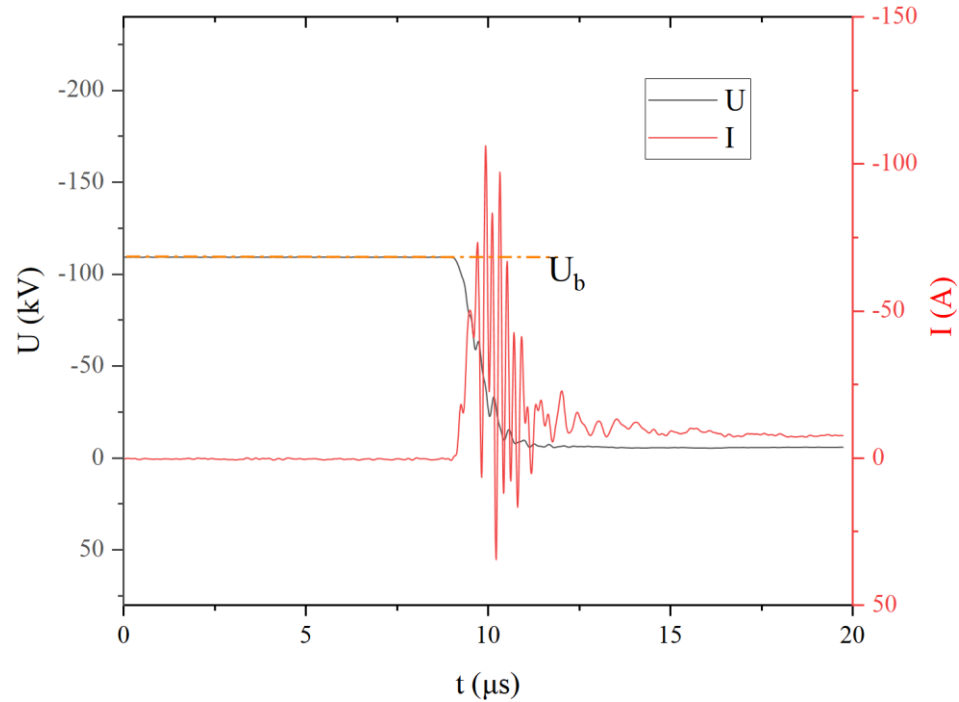
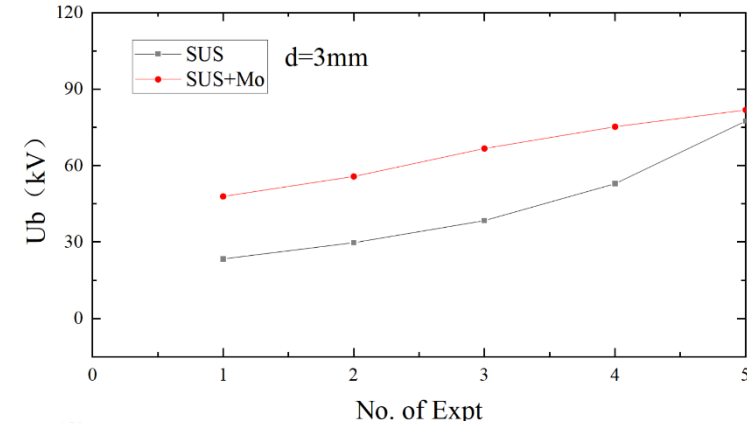
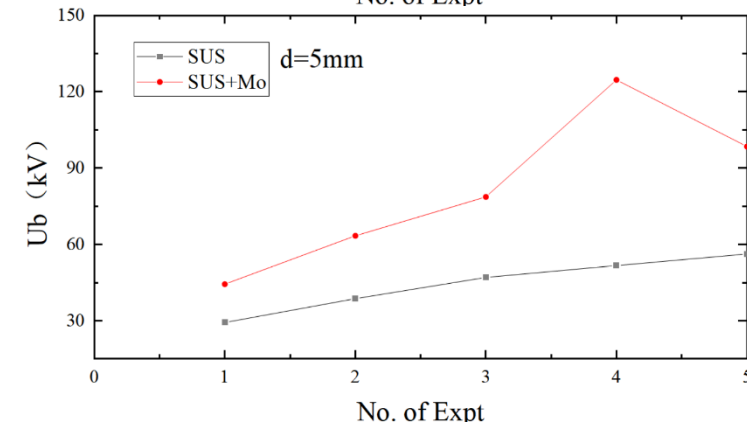
- Like small gaps, Ion implantation effectively enhances the initial breakdown voltage

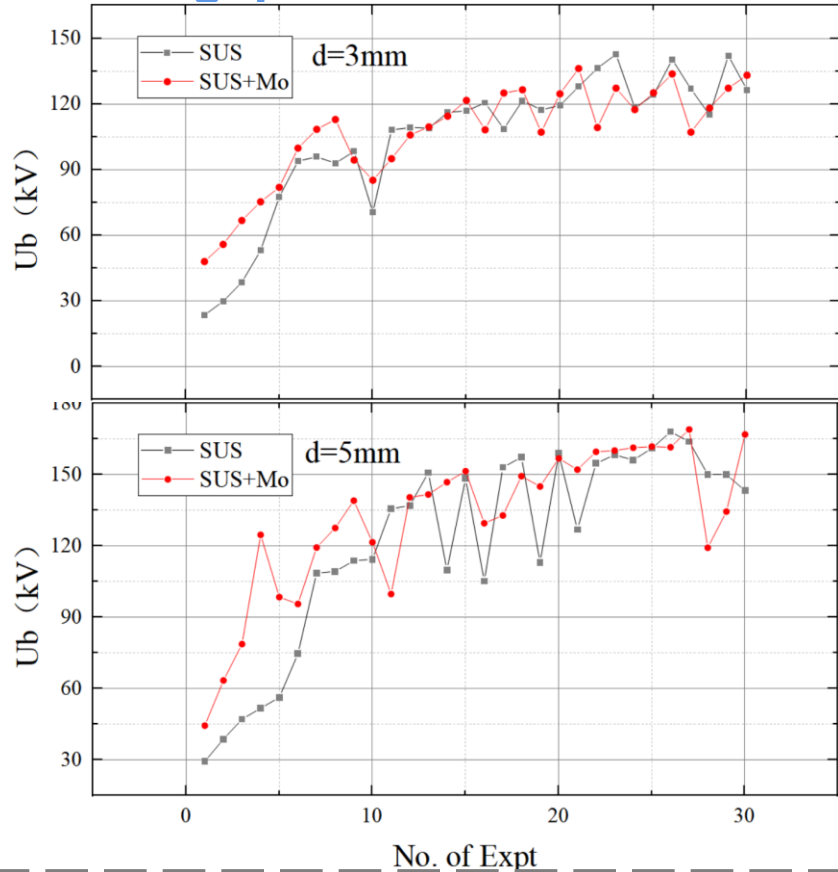
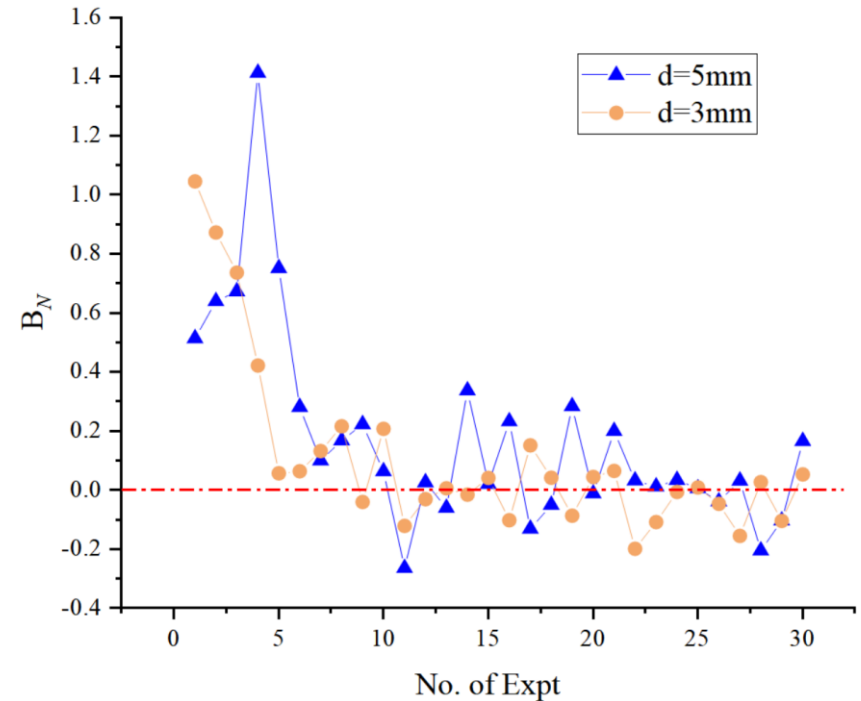
- All sample showed obvious conditioning effect.
- Unlike small gaps, the breakdown voltage does not drop after the ion implantation layer is destroyed.
- Why? **It is speculated that first ion implantation introduced other elements.**

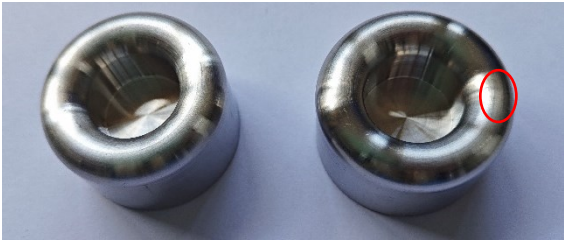
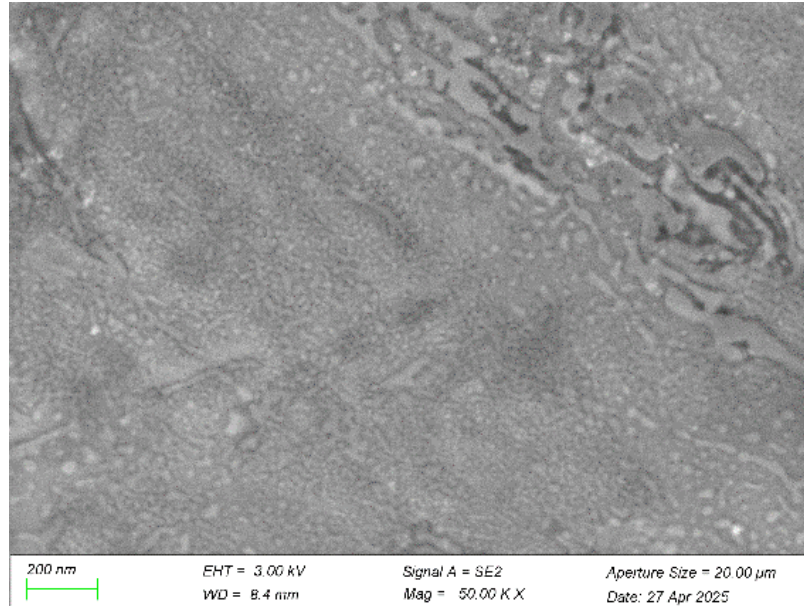
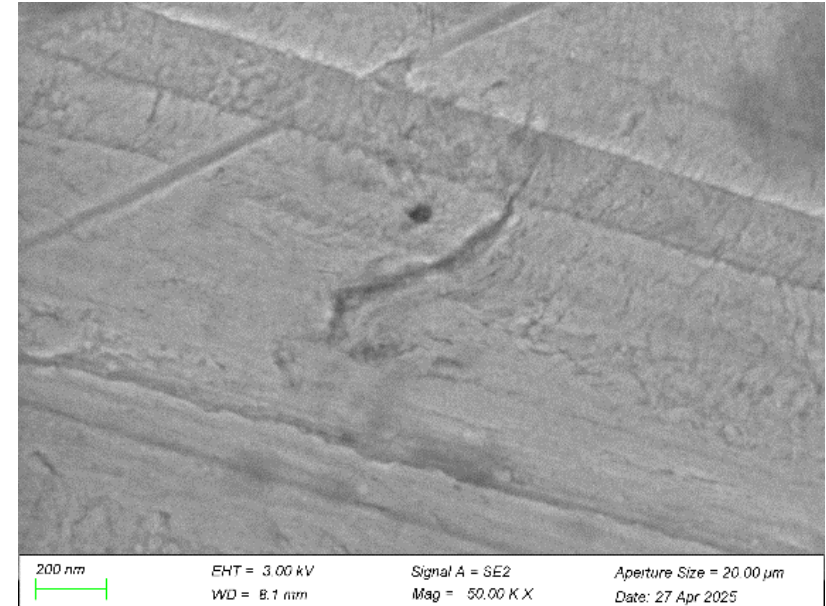
Scanning Electron Microscope(SEM) test

- Uniform and fine nanostructures appears on the surface of the ion-implanted sample

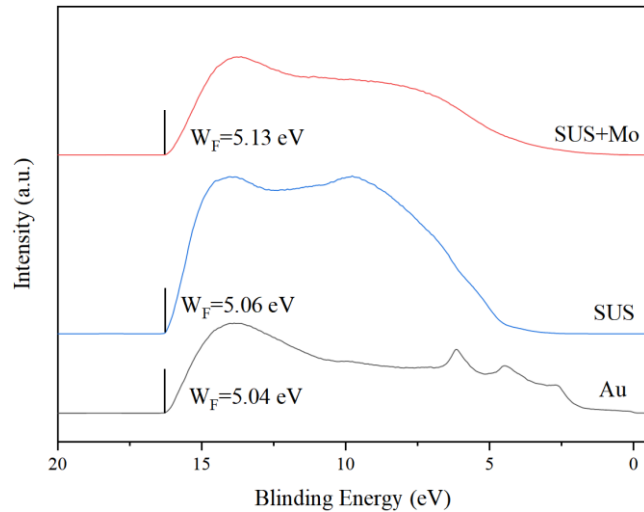
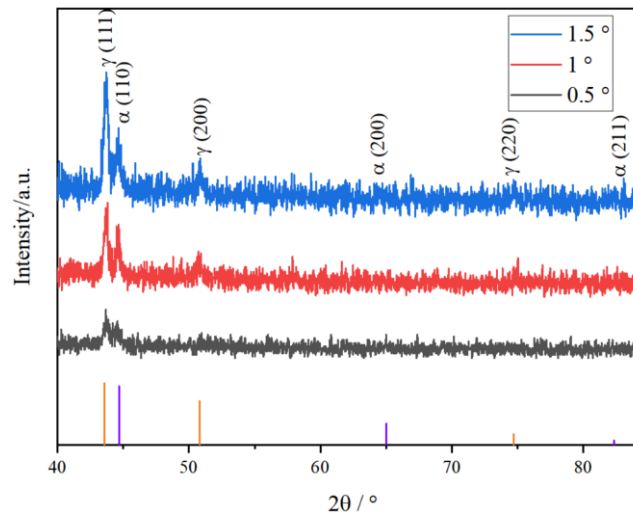
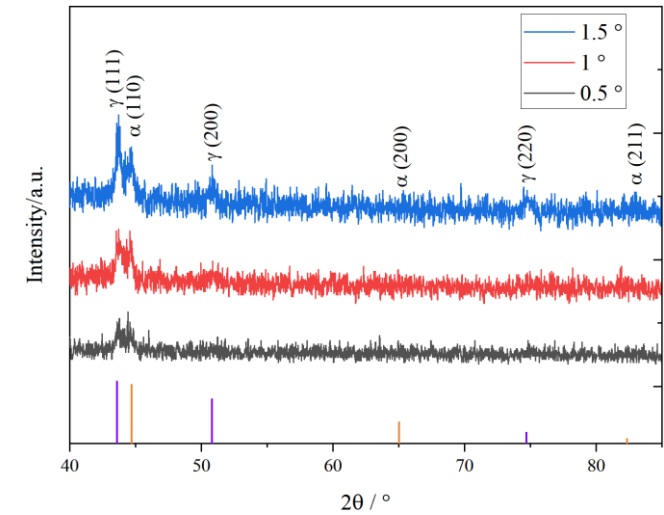
GIXRD test    Surface phase

UPS test    Work function

- Research indicates that after molybdenum ion implantation into stainless steel, molybdenum atoms extensively occupy the original chromium atomic sites on the steel surface.

- Ion implantation is typically accompanied by damage to and modification of the surface crystalline structure.
