RFD-SPS tests, Status

RF Conditioning Overview

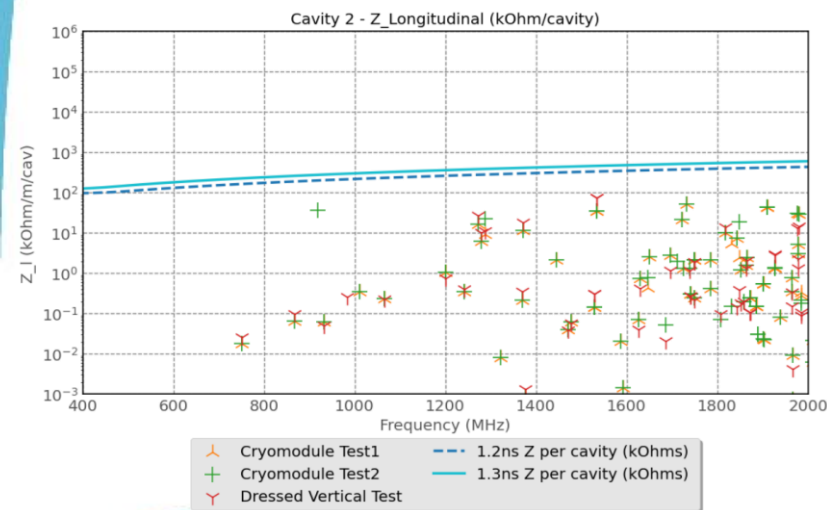
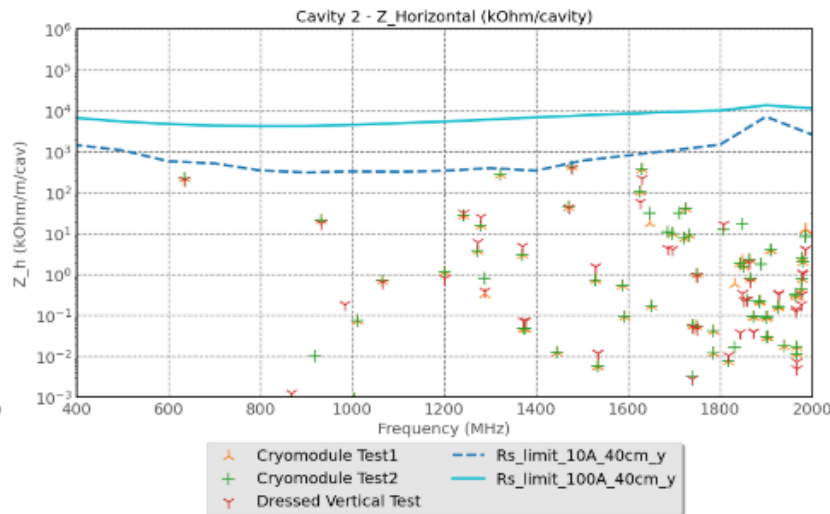
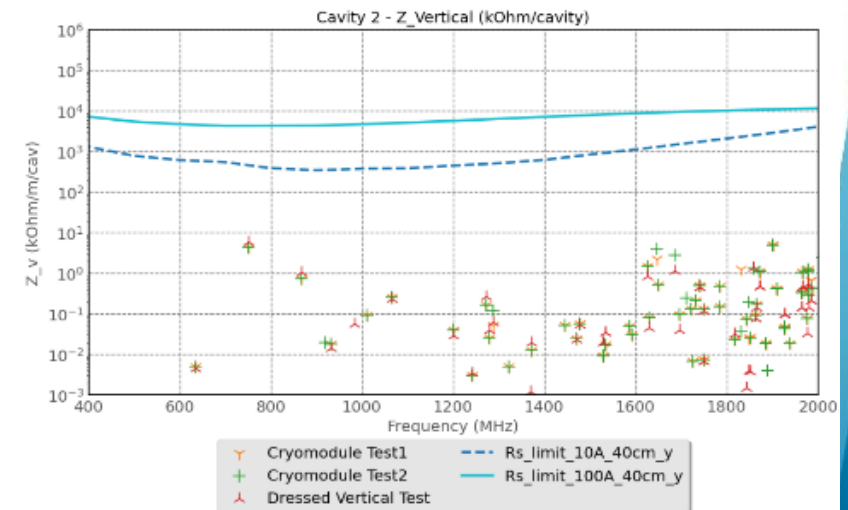
HOM Measurements

- Impedance measurements at 2K on the cryomodule are within specification
- Also consistent with the measurements done during 2021 vertical tests showing no surprises from cryostating & RF lines (25Ω)
