ASG SUPERCONDUCTORS

MBRD, VS-06 Testing Activities
31° July 2024

Focus on RNC240705A: QH breakdown VS coil during the fourth collaring attempt

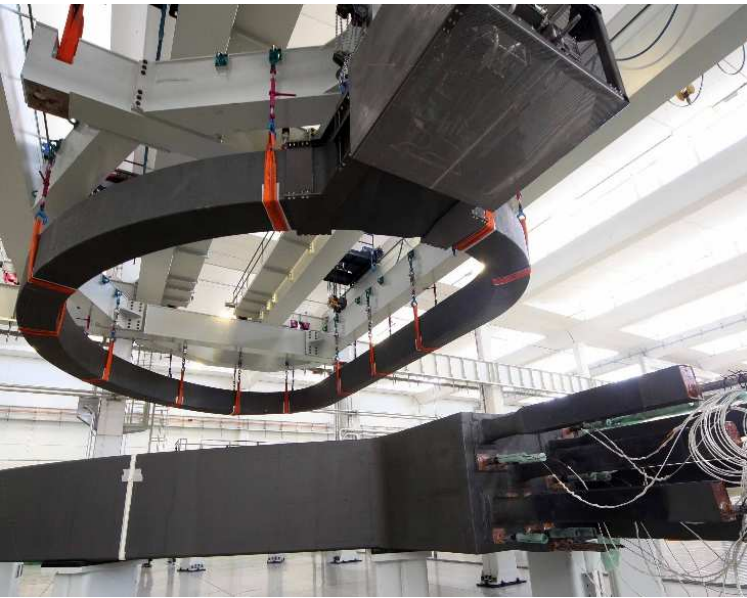
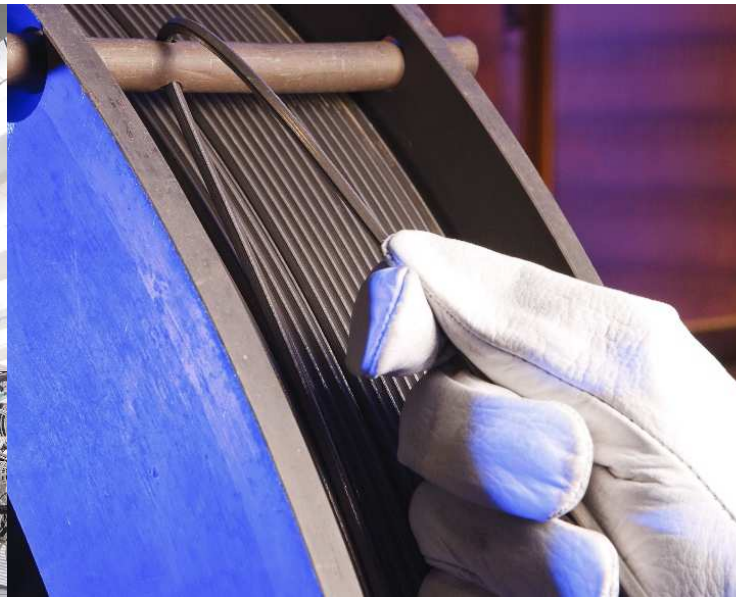
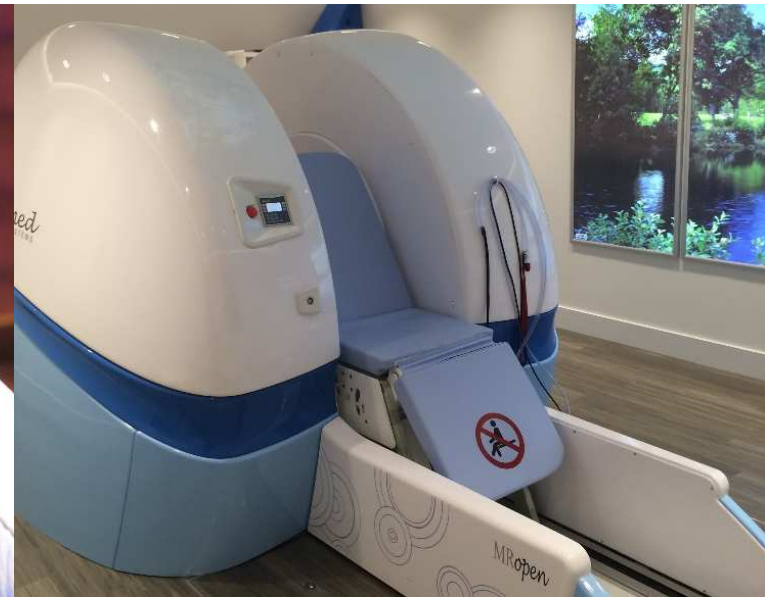
Date	Short Circuit between:	Localization from LC side end	Evidence	Cause	ASG RNC Nr.
10/04/2024	Coil AS-07 - QH dx	4000 mm	Punching/Burning	Foreign Debris	RNC240411A
12/04/2024	Coil BS-08 - Ground	500 mm	Ground Insulation damaging	PTFE Coated Sheets overlapped cut the ground insulation	RNC240422A
28/05/2024	Coil BS-08 - QH sx	4500 mm	Punching/Burning	Foreign Debris	RNC240529A
01/07/2024	Wedge - QH sx (*)	6400 mm	LF insulation breakage	See detail here below	RNC240705A

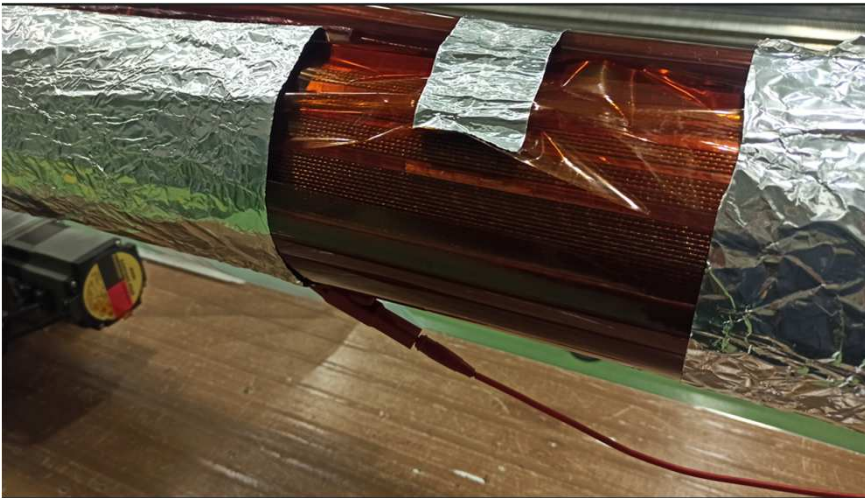
Disease:
coil BS-08 discharge VS QH left when 3,1kV
testing voltage is applied.

Preliminary investigation localized the electrical
issue on QH in correspondency of a wedge. The coil
seems stranger at the problem.

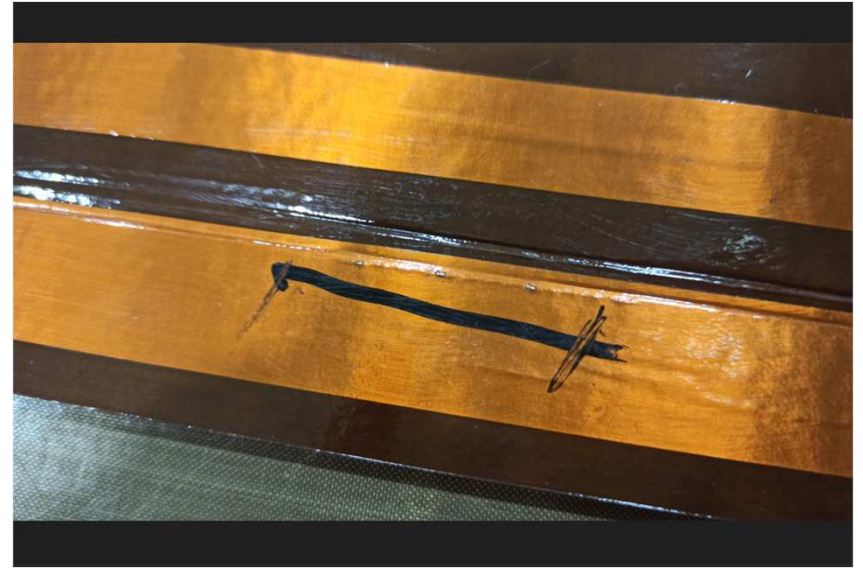
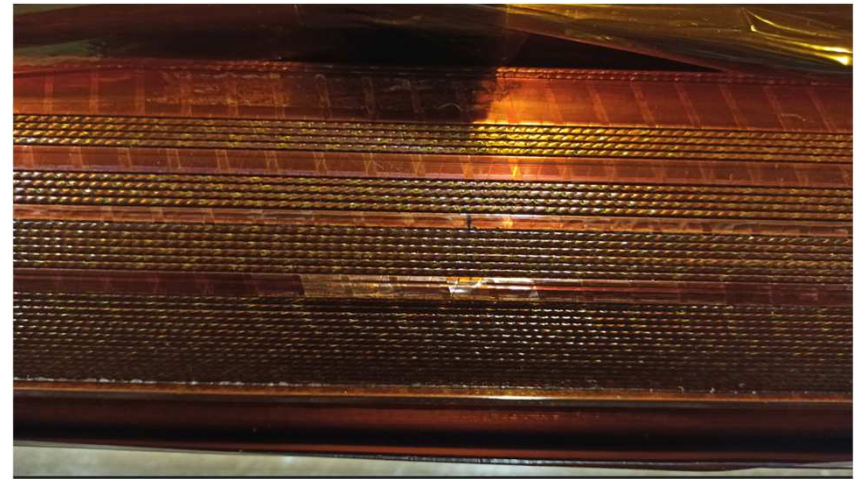
in order to understand how and if, is possible that the QH - floating from the electrical point of view - should discharge VS the QH, that is grounded, we need analyze the electrical configuration of the insulation system of D2 coils and try to deduce a electric equivalent scheme

1. The electrical model of the coil-wedge-grounded QH demonstrates that the wedge can reach a certain voltage level V_w during tests
2. V_w cannot damage the insulation if the insulation is integer
3. V_w can generate a problem if the insulation VS QH is mechanically damaged: in this case the current generated by the 5nF capacitance of wedge can lightly burn the kapton fringes around the mechanical damage.
4. the coil seems not involved in this electrical damage.

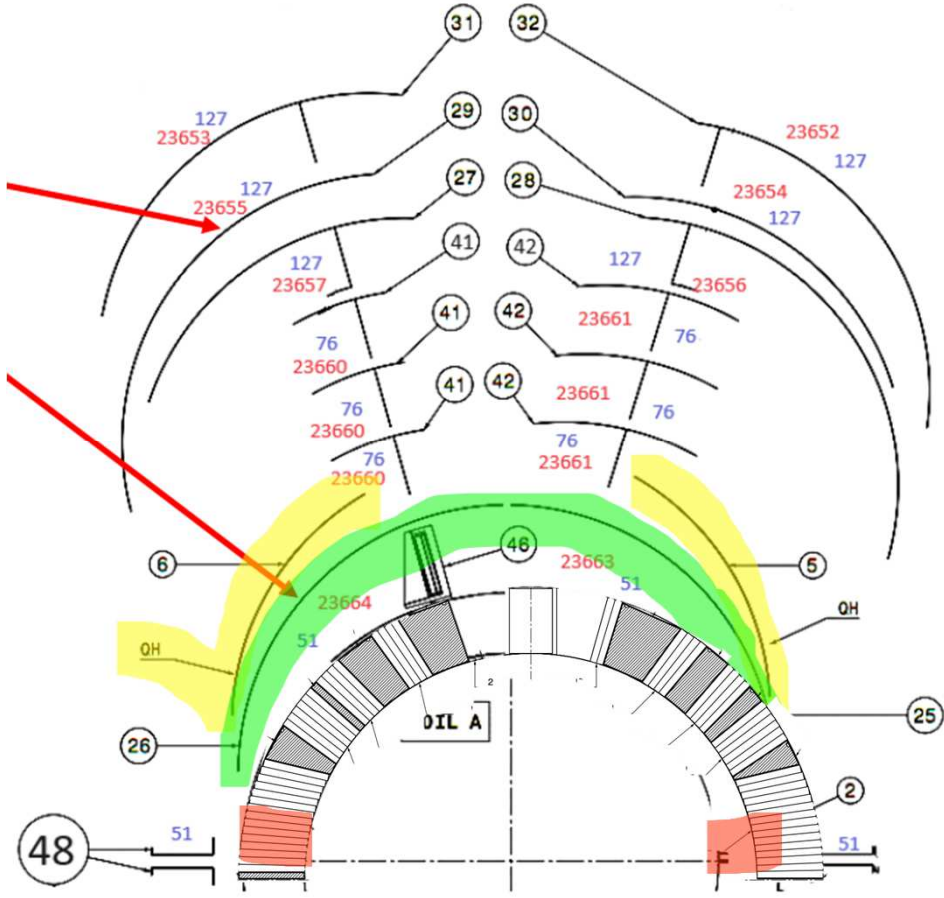
effectively, the QH offers respect the coil the capacitance of a a long capacitor having 2x 2000x15mm surface that means, modelling 0.2mm of kapton per side (kapton permeattoivity=3.5 about) a capacitance of about 5.5nF. The measured capacitance is 5nF that confim calculation

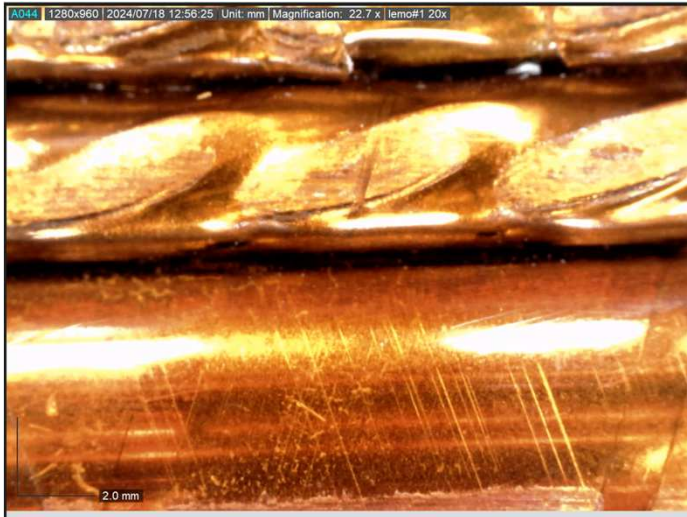
The wedge, due the capacitive partition, reaches a certain level of voltage V_w during the HV test. This capacitor is like an small ideal current generator

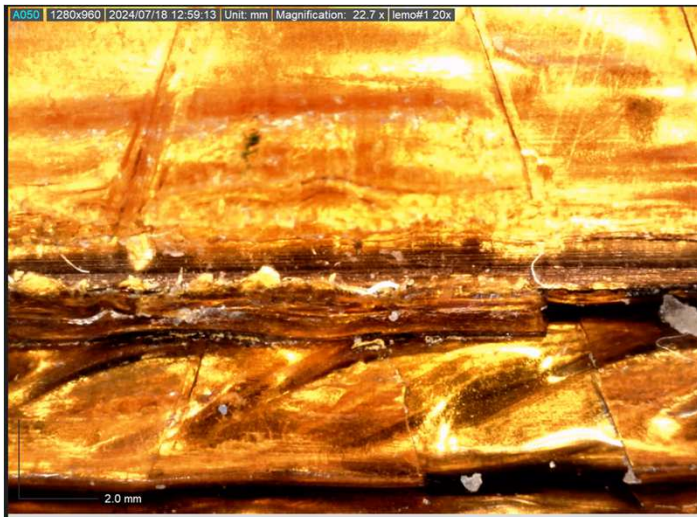
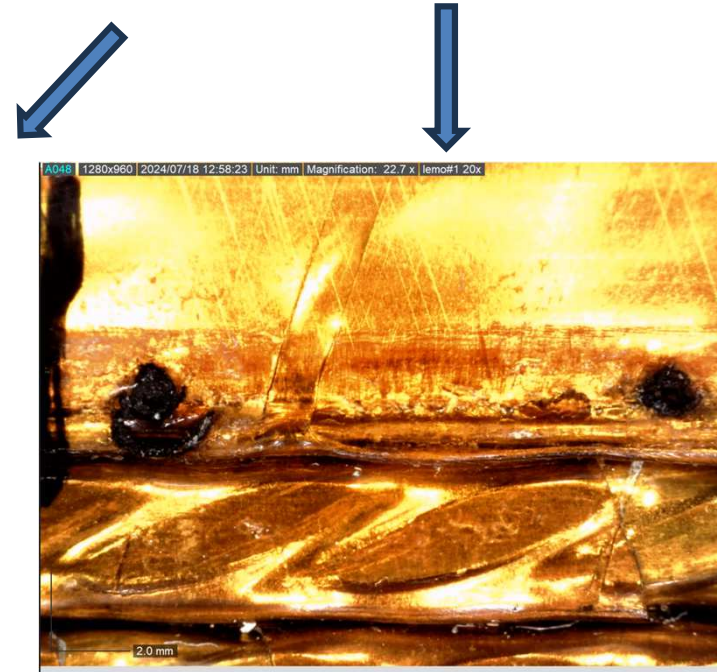
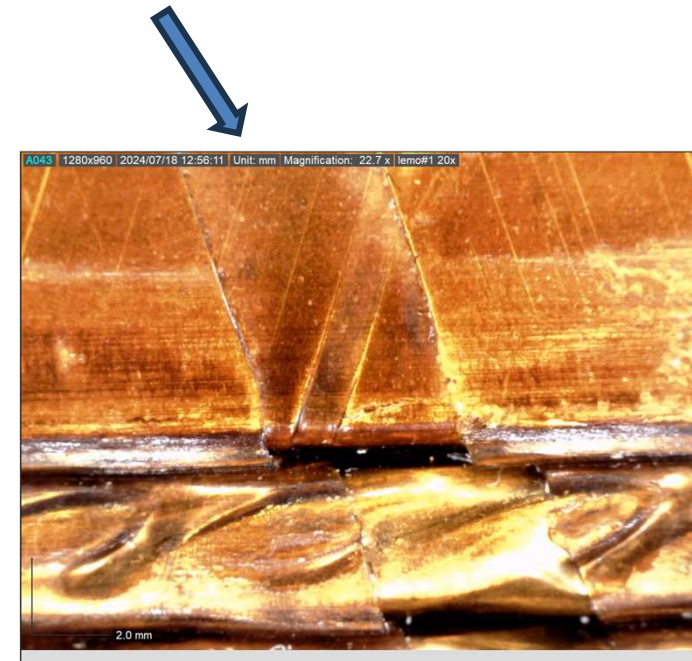
however, in the present case, close to the damaged zone, we observed a damage on the QH insulation due to a mechanical event (sliding?). The carbonaceous residuals are on the wedge.

corresponding of the wedge position there is a long-shaped cutting (on item 26 in the drawing a p.4)

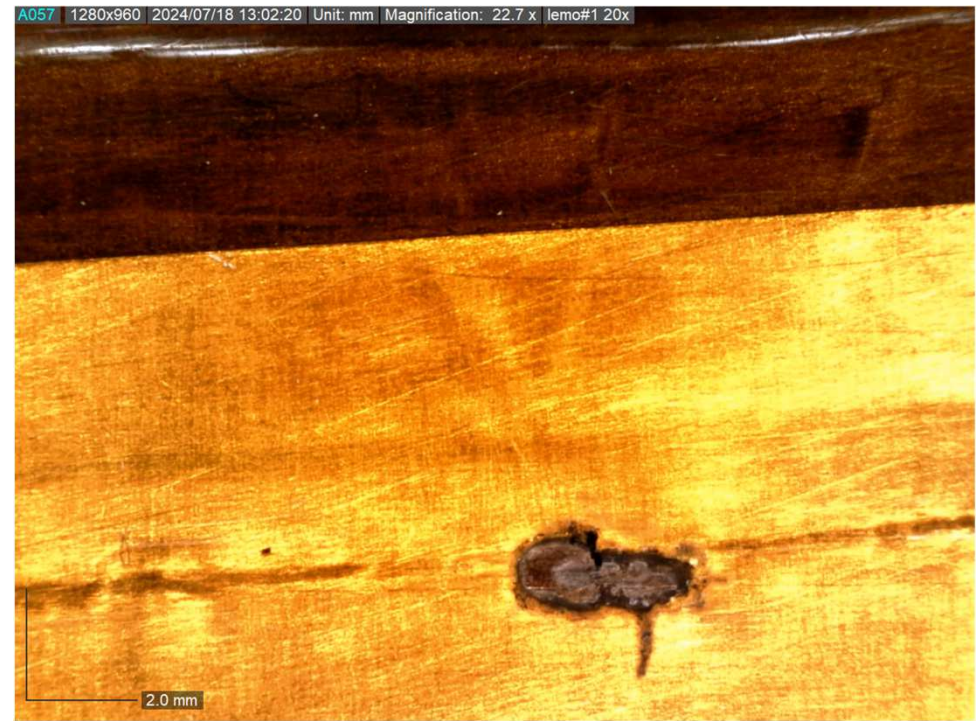
...and here below the magnification of the damage directly on the wedge surface
