Operational Experience from PETRA III

...and NEG-related Tests for PETRA IV

N. Plambeck, L. Lilje, R. Böspflug

Deutsches Elektronen-Synchrotron DESY

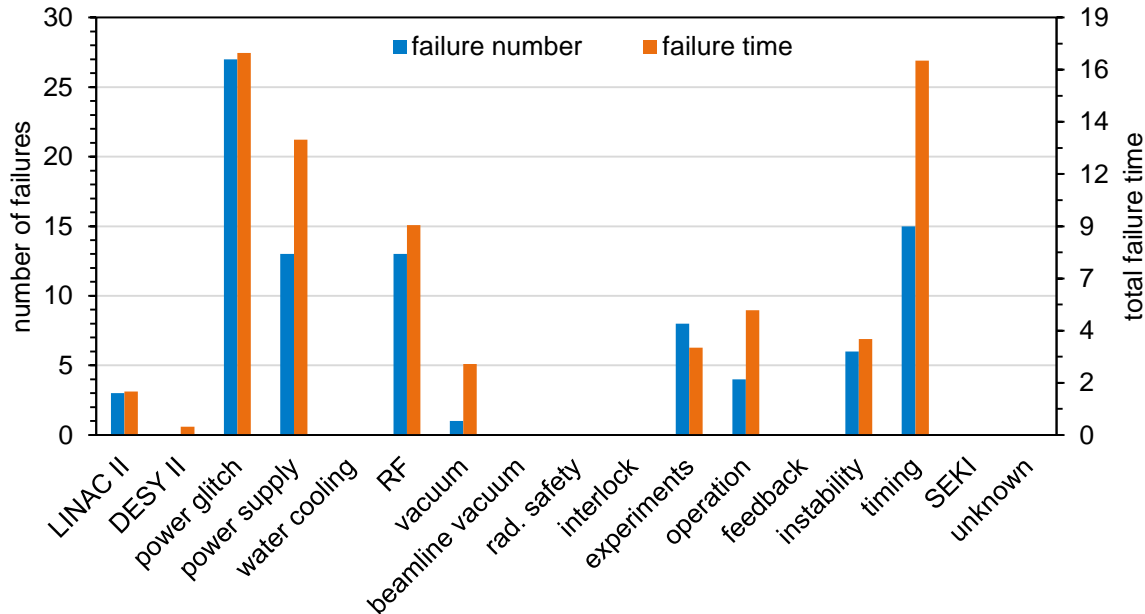
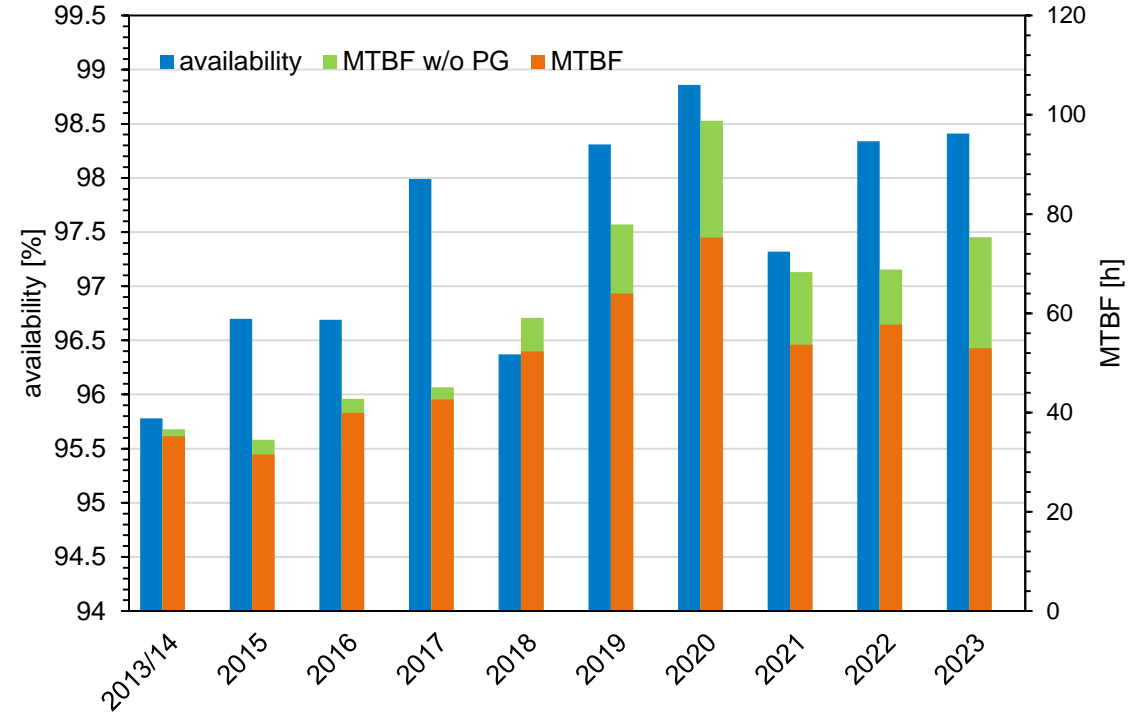
- Since 2018 power glitches have an increasing impact on the availability
 - >60 h MTBF goal is achieved if power glitches are neglected
- 10 vacuum failures during user operation since 2014
 - Few major events with >2 h downtime in 2016 and 2023

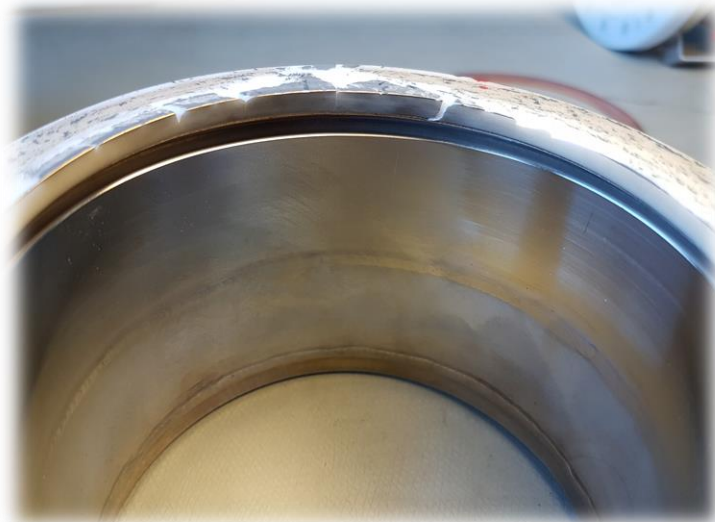
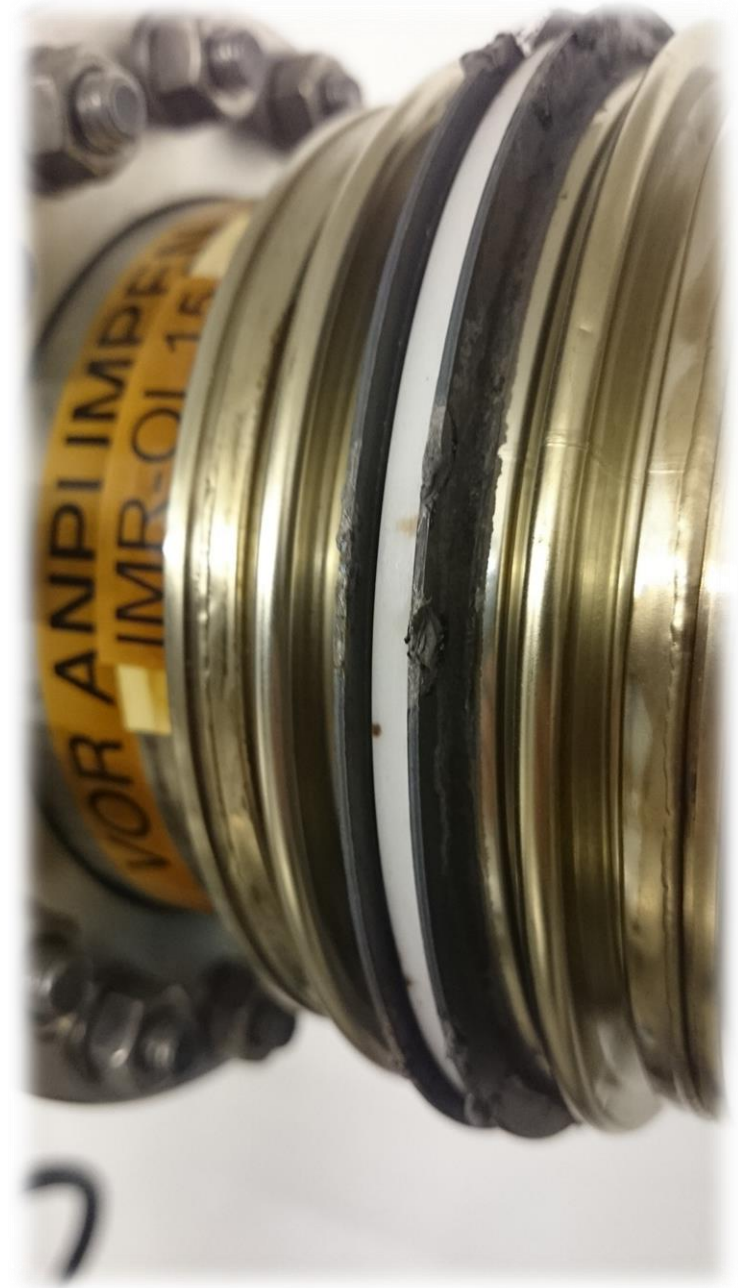
Ripped ceramic insulation at current monitor (2018 KW13)

- Brazed ceramic-metal joint at current monitor ripped apart probably because of warmup during operation
 - **Monitor was not used anymore, risk factor left in the machine!**
 - No/insufficient temperature monitoring
 - Installed close to experimental area / beamlines
 - Three adjacent sectors affected, 7 vacuum sections vented to 1000 mbar
- Replaced by simple dummy pipe
- Other unused parts were removed as well, e.g. two spare kickers

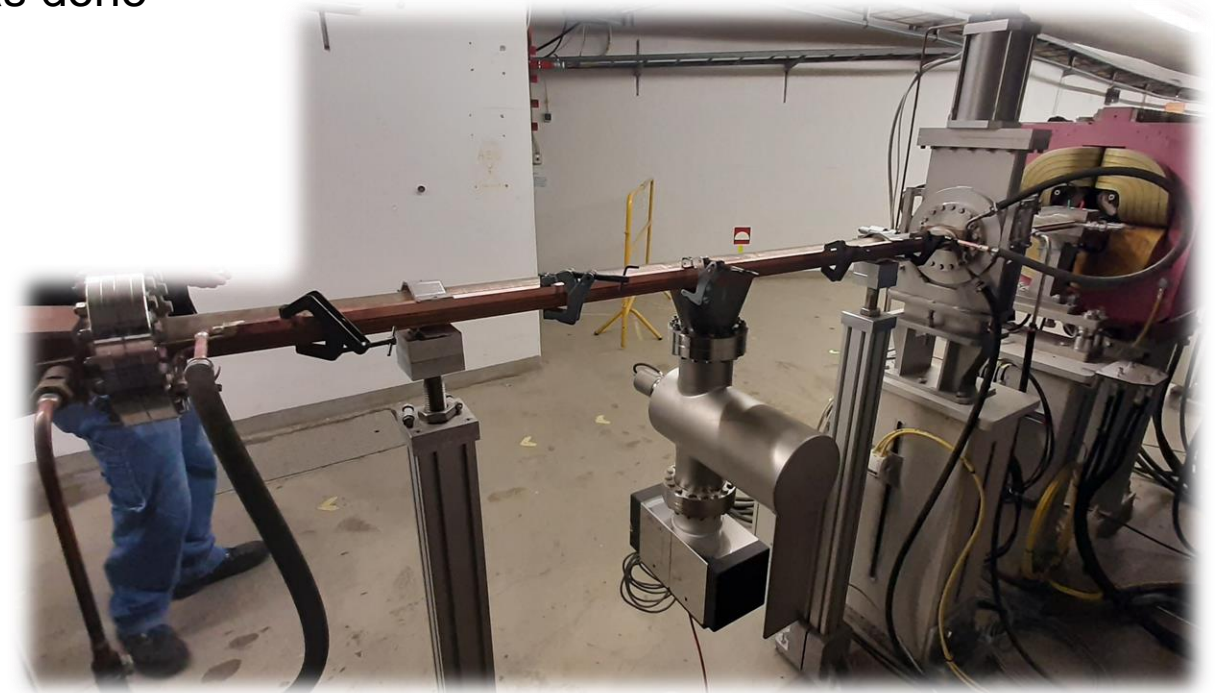
Water-leak at beam pipe cooling channel (2023 KW43)

- Water leak spontaneously occurred at cooling pipe due to erosion
 - Probably caused by too strong bending of inlet/outlet in 2009!
- ⇒ New cooling pipe clamped on the existing beam pipe
- Additional survey for wrong bending at water inlets was done
 - ⇒ No other locations found

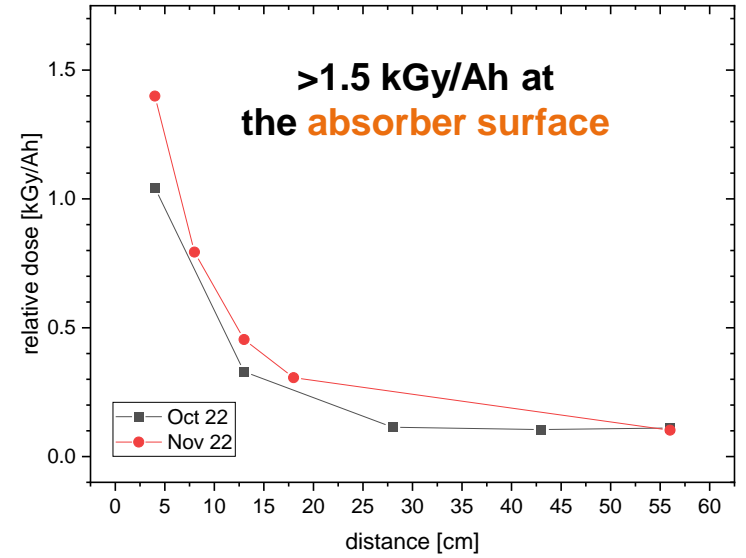
Cable defects due to synchrotron radiation

- Very high synchrotron radiation loads especially within wiggler sections
 - Estimated dose up to 2 MGy/year – e.g. on the surface of the last absorber of the damping wiggler section
- Cable insulation is falling apart, even at larger distances (ground)
 - Scattered photons are filling the tunnel during operation!
- Soldered cable joints at Pt-100 temperature sensors coming off, probably due to irradiation
 - Predominantly occurs at high radiation area
 - A dedicated cable strain relief would help!

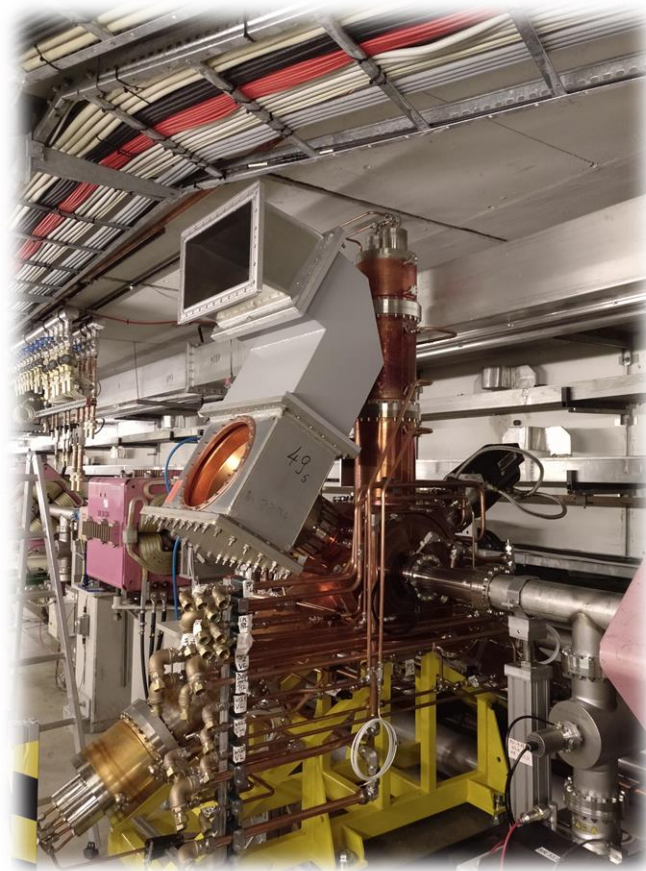
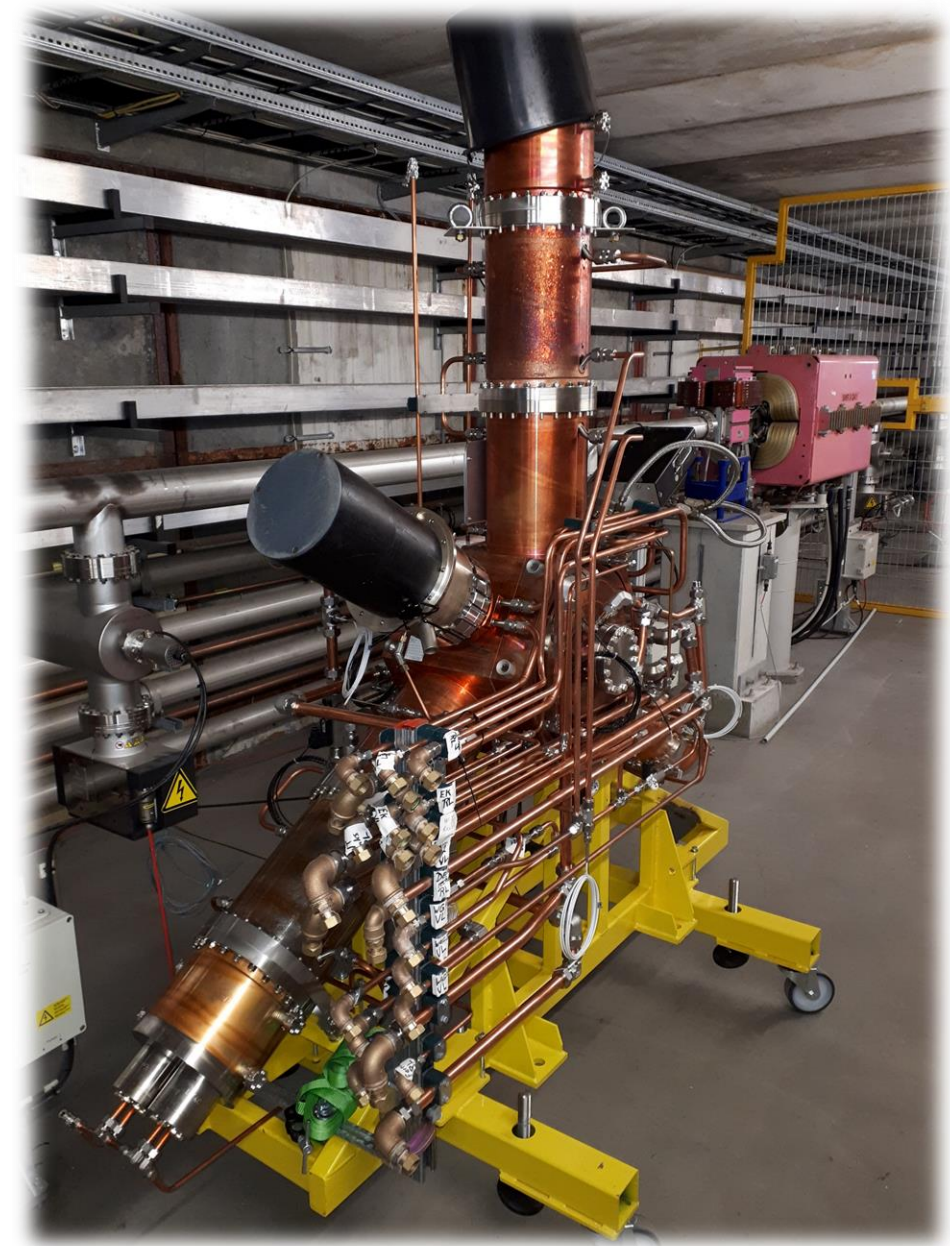
PETRA IV HOM damped cavity (2023)

- A preliminary HOM damped cavity for PETRA IV developed by MHF-e was installed within the PETRA III with help of MVS

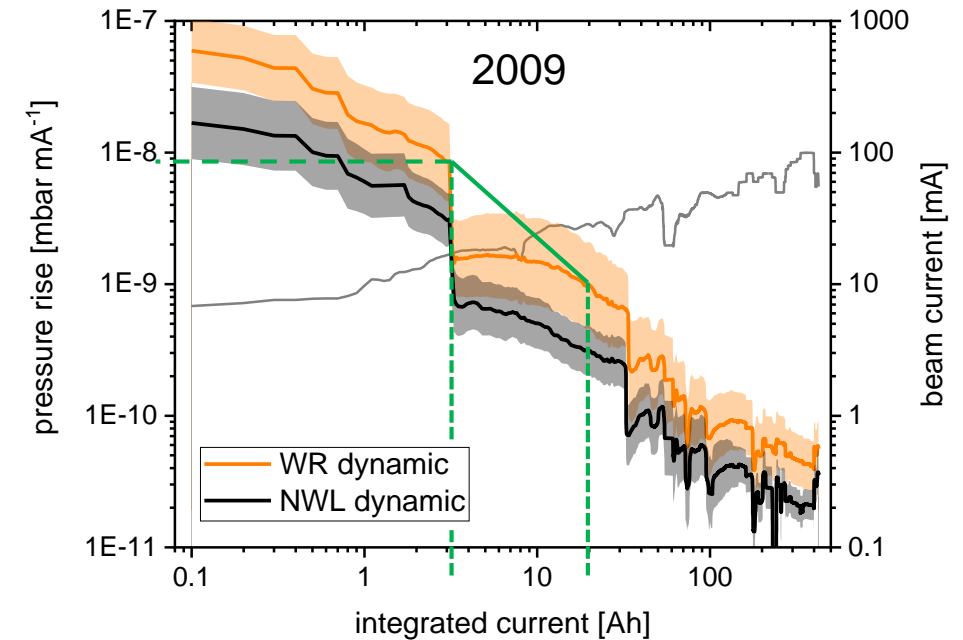
Partial NEG coating in PETRA III arcs: PSD estimates

- Similar conditioning behavior of adjacent sectors apart from offset (factor ~2.5)
- Photon-stimulated desorption (PSD) may be estimated from
 - a) time until saturation after NEG strip regeneration [1]

⇒ Significantly less PSD or additional pumping due to NEG coating

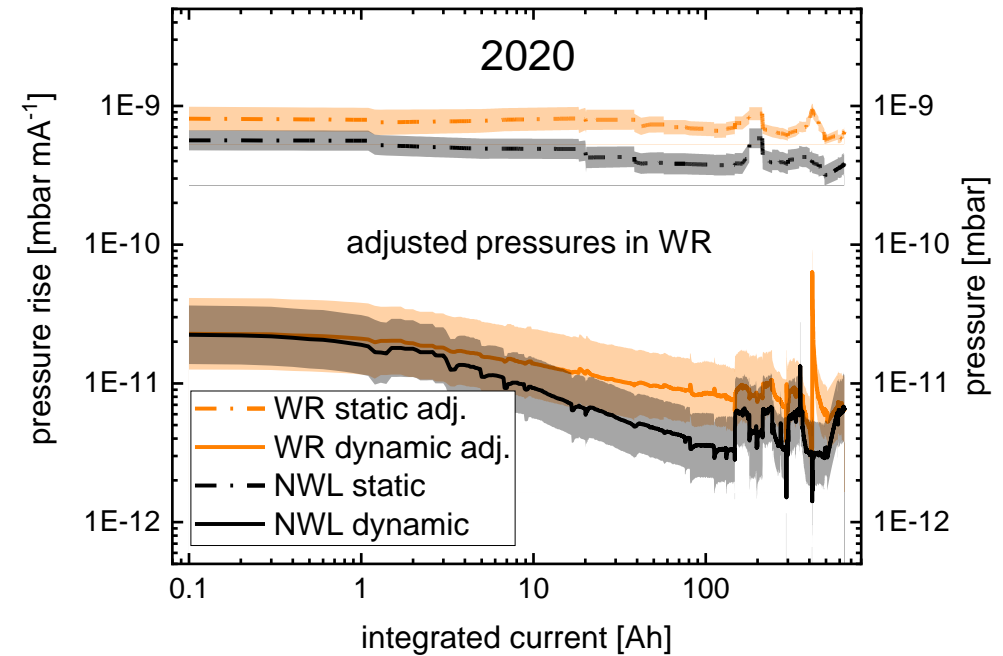
Conditioning after vent with N₂ beginning of 2020

- Adjacent sectors vented to 100 mbar for 30 min with N₂ in 2020
 - NEG strips in NWL previously activated to some degree
 - NEG coating in WR without clear indication of activation
- Very low pressures after re-commissioning
 - Physical error sources have an increasing impact (e.g. outgassing from RGA and SIP; change of bunch pattern...)
- For adjusted pressures in WR (factor 2.5) conditioning curves are initially in-line
- For the NEG coated sector $sf \ll 10^{-4}$ similar to 2019
- Significantly higher sf indicated in NWL (NEG strip)
 - $7 \times 10^{-4} < sf < 3 \times 10^{-3}$
 - $sf > 4 \times 10^{-3}$ unlikely because corresponding PSD too high

⇒ Probably NEG strips were partially regenerated under UHV conditions

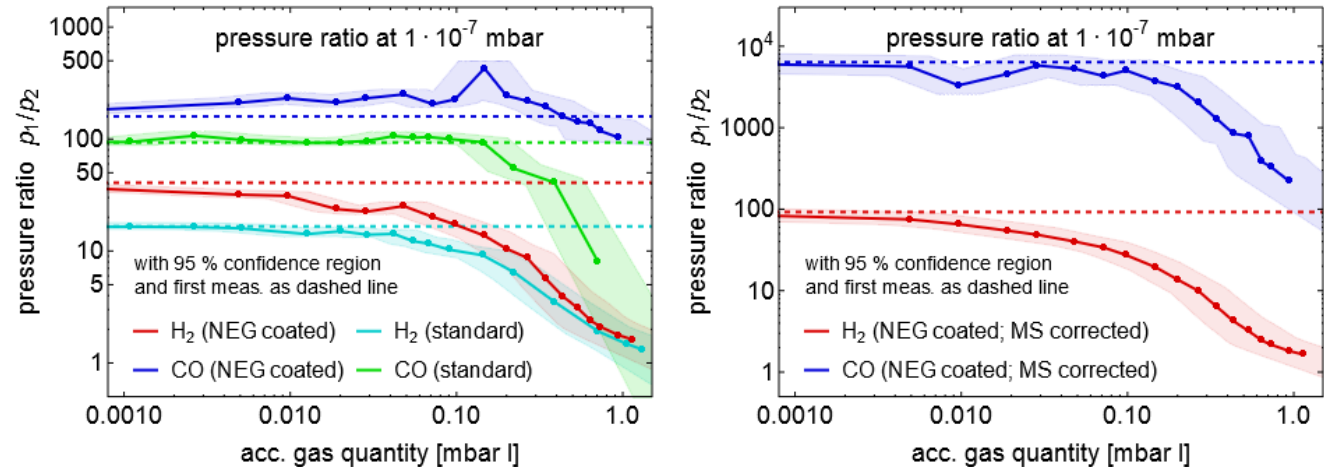
PETRA III dipole chamber

1) Test of standard dipole chamber with activated NEG-strip

change of transmission factor with increasing saturation
