CERN RTD positions on LMQXFA01

Plan view (view from above) with CERN desired layout of Q1/Q3

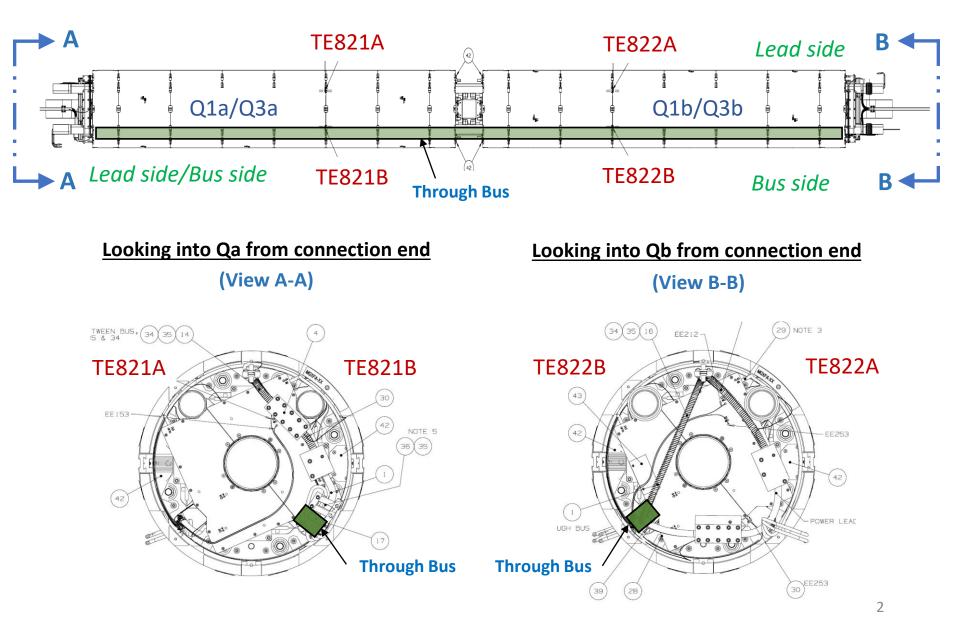
As we believe installed on CA01

Thermometer Labels and identifying numbers from traveler

Consistent with CERN Schematic

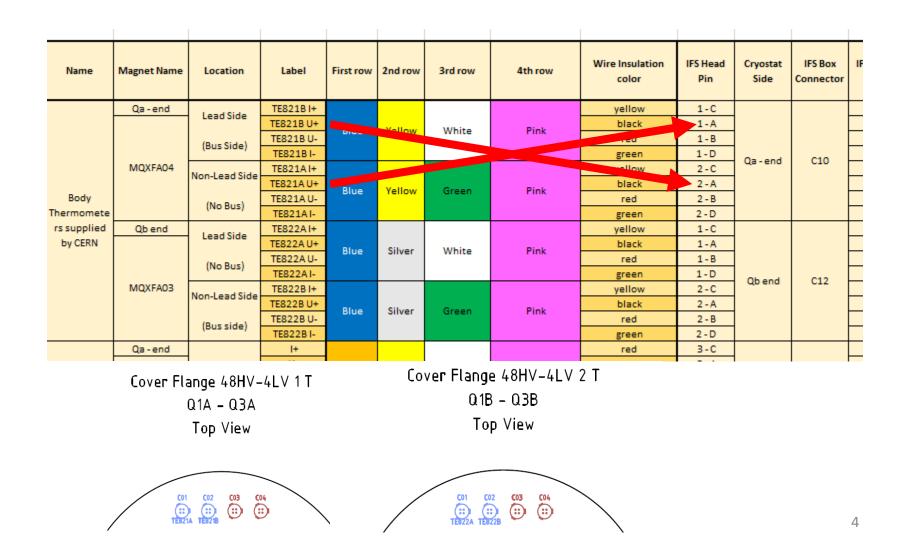
We found one problem when the spreadsheet was created, it should be an issue on the Qa end for CA01. We noticed that in the assignment we mixed up the Pin1 TE821A & Pin 2 TE821B assignment.

- We might have the CERNOX location on the assembly wiring reversed from the expectation to CERN
- We implement edchanges for CM & CA assembly to prevent this in the future (excl. CA02, which is completed and from data shows the first issue persisted)

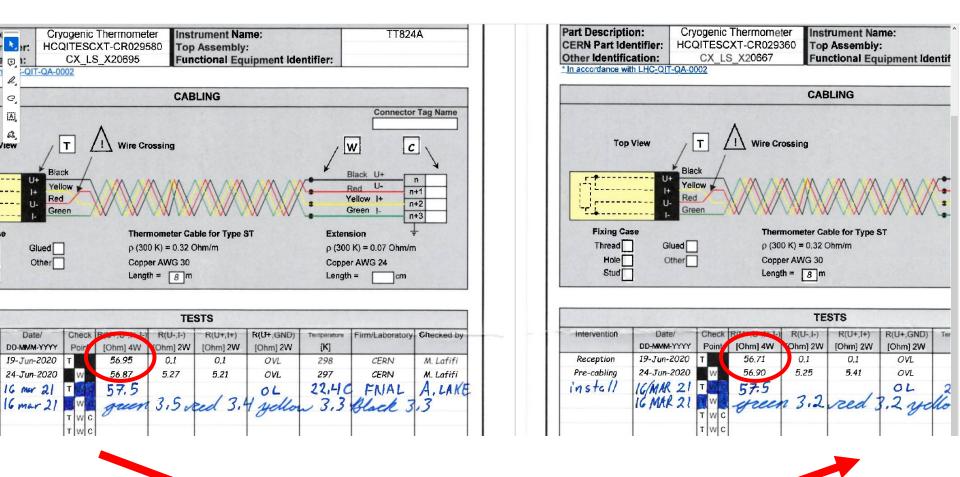
We also note that there is an indication the sensor on the Qb end are swapped, they are really close in value and on the CERN sheet moved opposite in value. We can see from our cold data a small offset between the two values

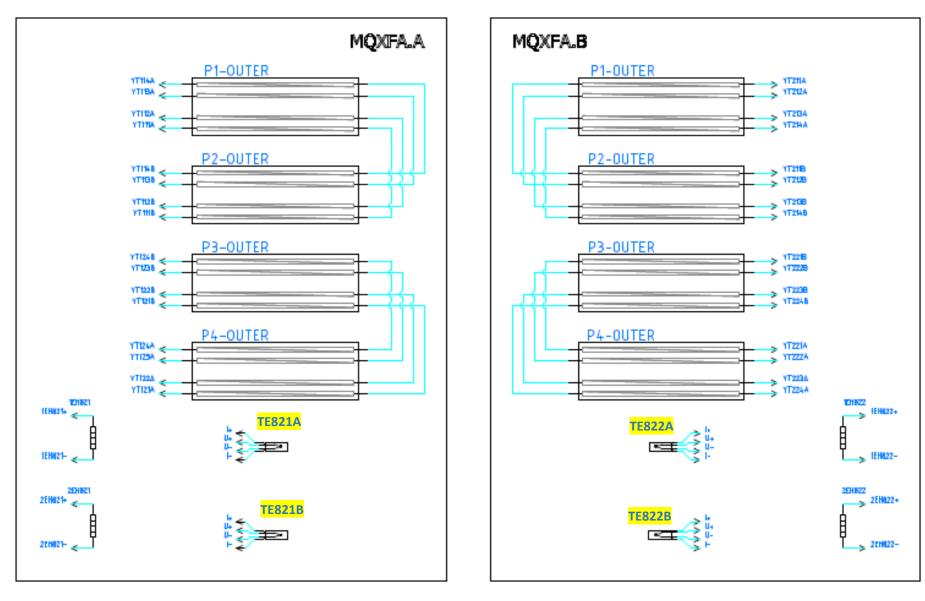
CERN Schematic showing RTD positions in plan view (updated in 2022, past CM01 assembly)

TE821B = CX_LS_X20707 TE821A = CX_LS_X20677 **TE822B = CX_LS_X20667**

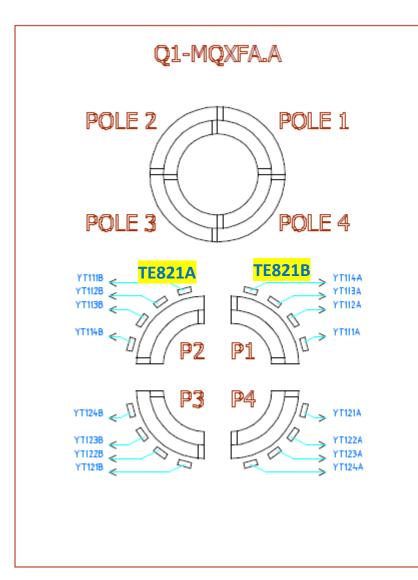
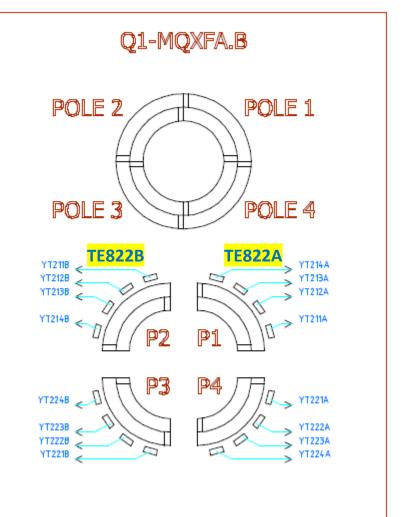
CERN Schematic showing RTD positions in end views

QHs - LMQXF Convention - View from connection side of coil
