2024 ACTIVITIES SUMMARY & XCED DIAPHRAGM ALIGNMENT

M. Santos et. all - BE-EA

CEDAR

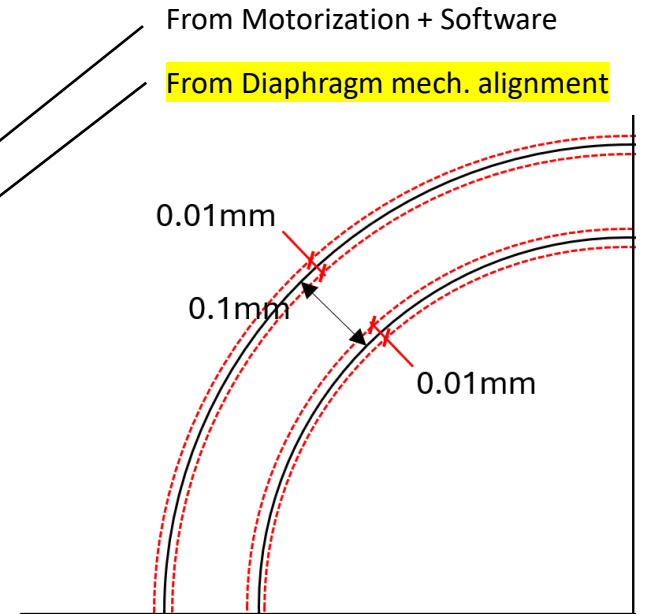
Min. Aperture scheme
Not to scale

Note: Errors can be non symmetric but in total always bellow 0.02 mm

TOLERANCE mm
	BASELINE VALUES
Outer Circle Circularity	0.01
Inner Circle Circularity	0.01
Gap Profile	0.02

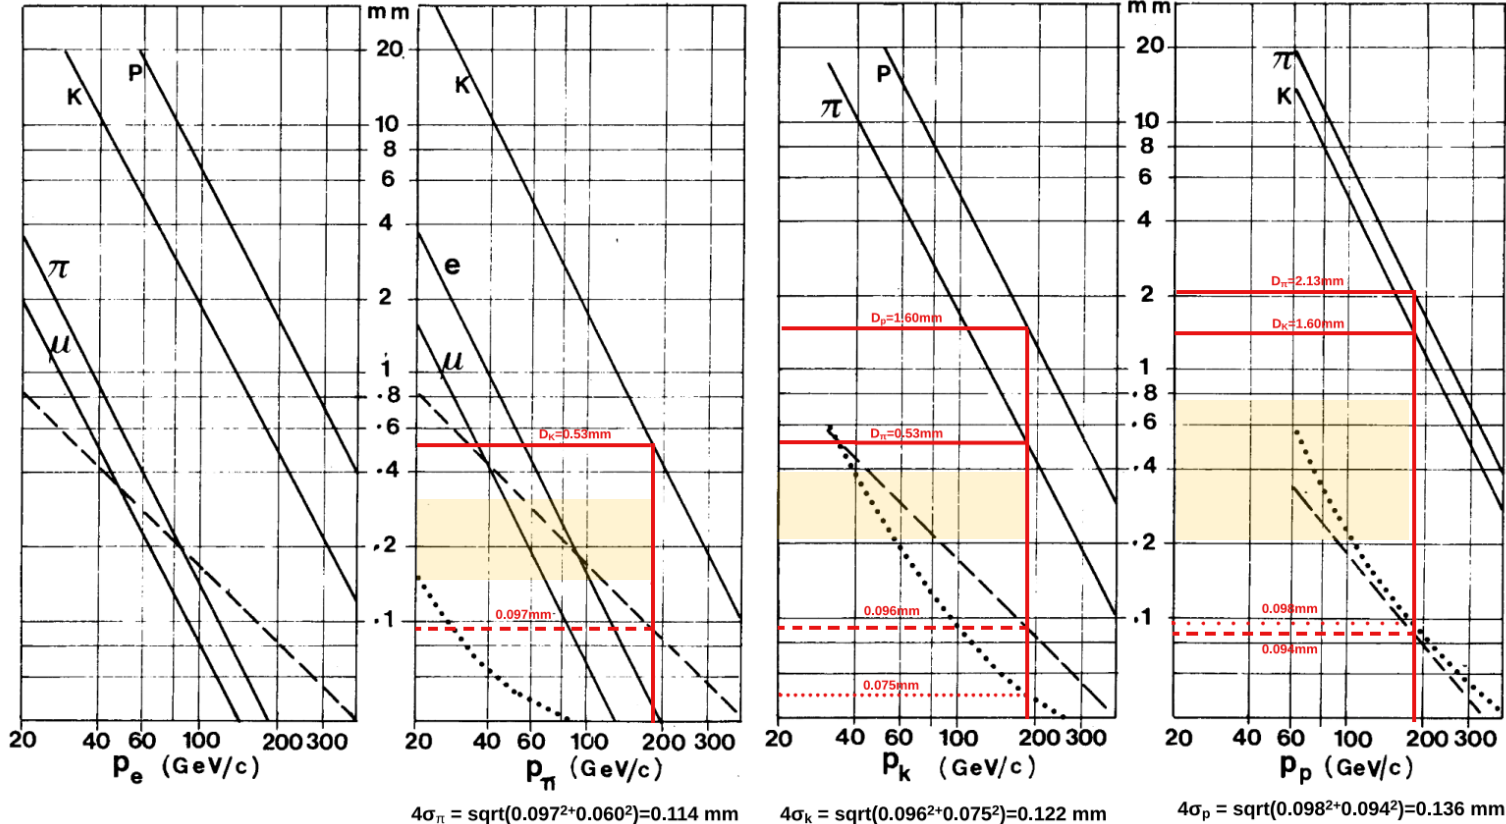
From CERN CEDAR Yellow Report page 26 , Figure 21

For the current and future experiments AMBER requires to tag kaons at 190 GeV/c that the diaphragm is set more than the light ring and multiple scattering and less than the pion ring, so **between 200 μm and 400 μm** .

Radial distance of rings of wanted and unwanted particles vs. beam momentum, dotted line = width of the light spot (4σ), dashed line contributin multiple scattering (4σ)

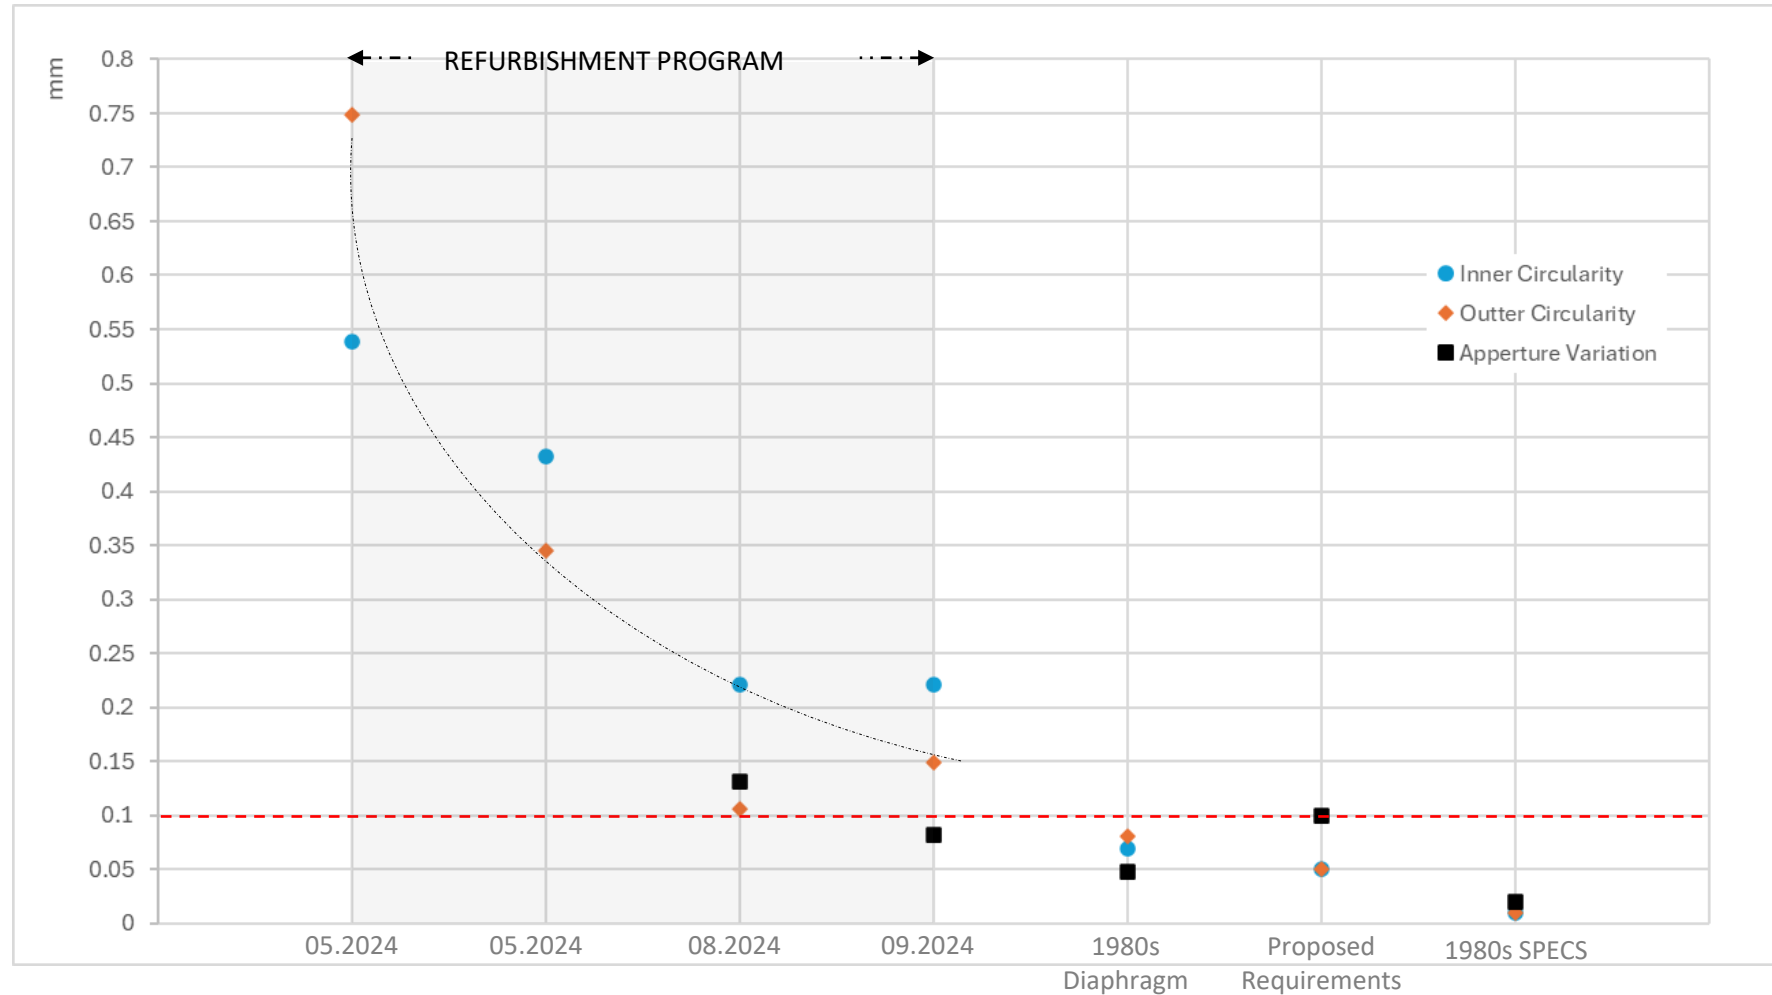
From 5 different measurements to 4 different diaphragms during 2024

- Progressive improvement since the beginning of 2024 → Learning Curve
- Reaching a limit? More data needed however current aperture variation ~ values of 1980s
- Current method suitable for AMBER?: Aperture variation > 0.1 mm
- Inner and outer circularity are limiting min. aperture. → Not a direct indicator of the aperture variation
- Relative position between gaps was not evaluated **yet** → **new reports will include it in any case is correlated with inner/outer circularity**

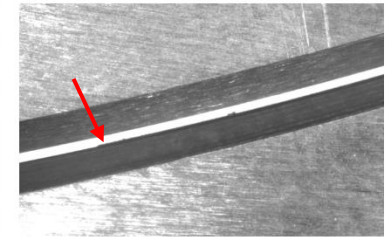
Segment No. 13

Comment upon visual inspection

Visible "steps" on the profile of the segments, which affect the gap of the diaphragm. Defects can be seen on segments number: 9,10,13,14,16. Photos on the last page

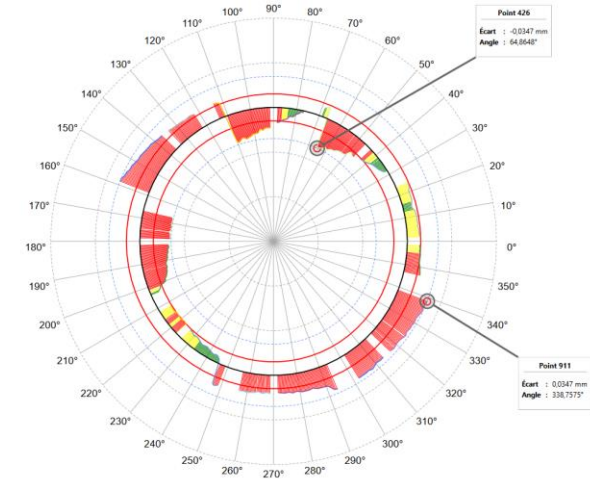
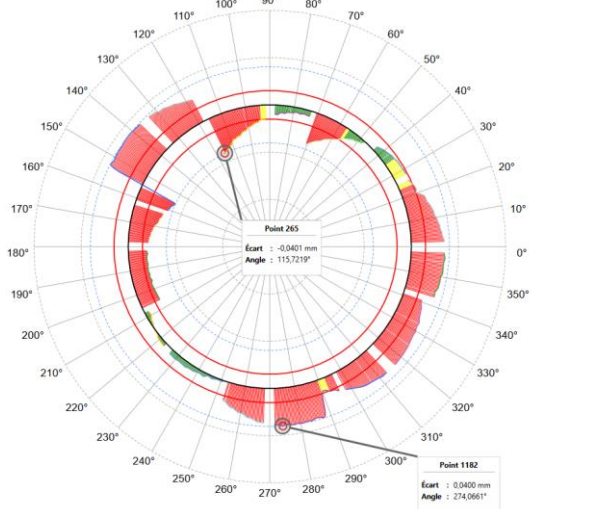
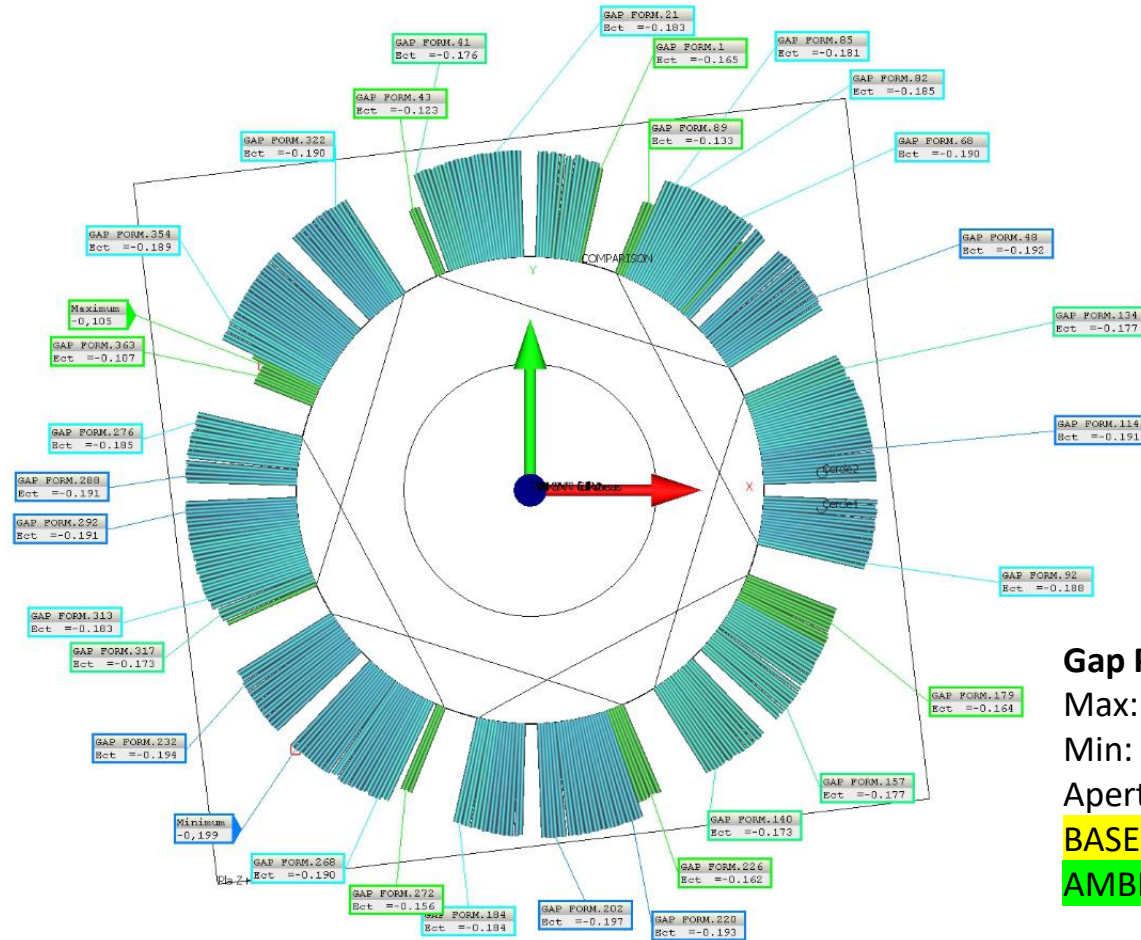
EDMS3152574 - J3094591 CEDAR N06 diaphragm

Gap Profile
 Max: 0.105 mm
 Min: 0.199 mm
 Aperture variation: +/-0.047 mm
BASELINE: OUT OF TOLERANCE
AMBER: OK

Very good repeatability measured between ~3-4 μm , (metrology error is $2.2+L/250 \rightarrow \sim 3.5 \mu\text{m}$)

Outer Circle Circularity Tolerance 0.08 mm
Inner Circle Circularity Tolerance 0.069 mm

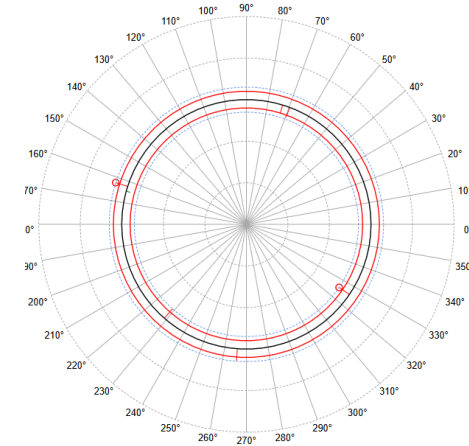
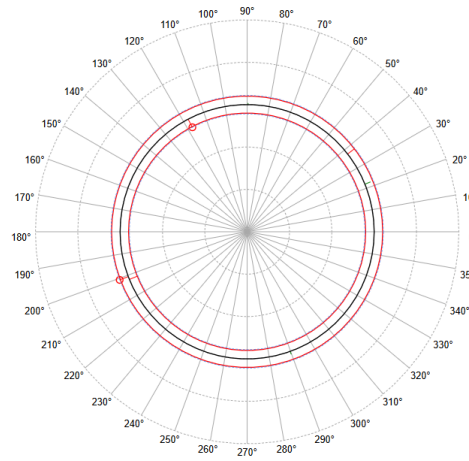
DIAPHRAGM 1

Inner Circle Circularity Tolerance 0.539 mm
Outer Circle Circularity Tolerance 0.749 mm
Without alignment tooling
Out of tolerance

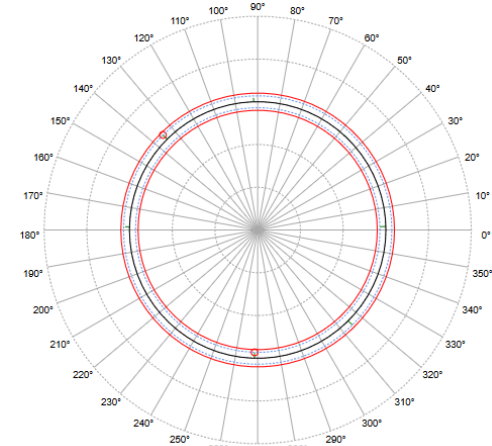
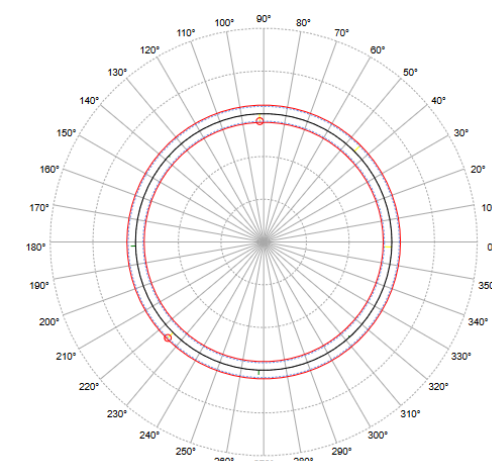
DIAPHRAGM 2

Inner Circle Circularity Tolerance 0.432 mm
Outer Circle Circularity Tolerance 0.345 mm
With alignment tooling
Out of tolerance

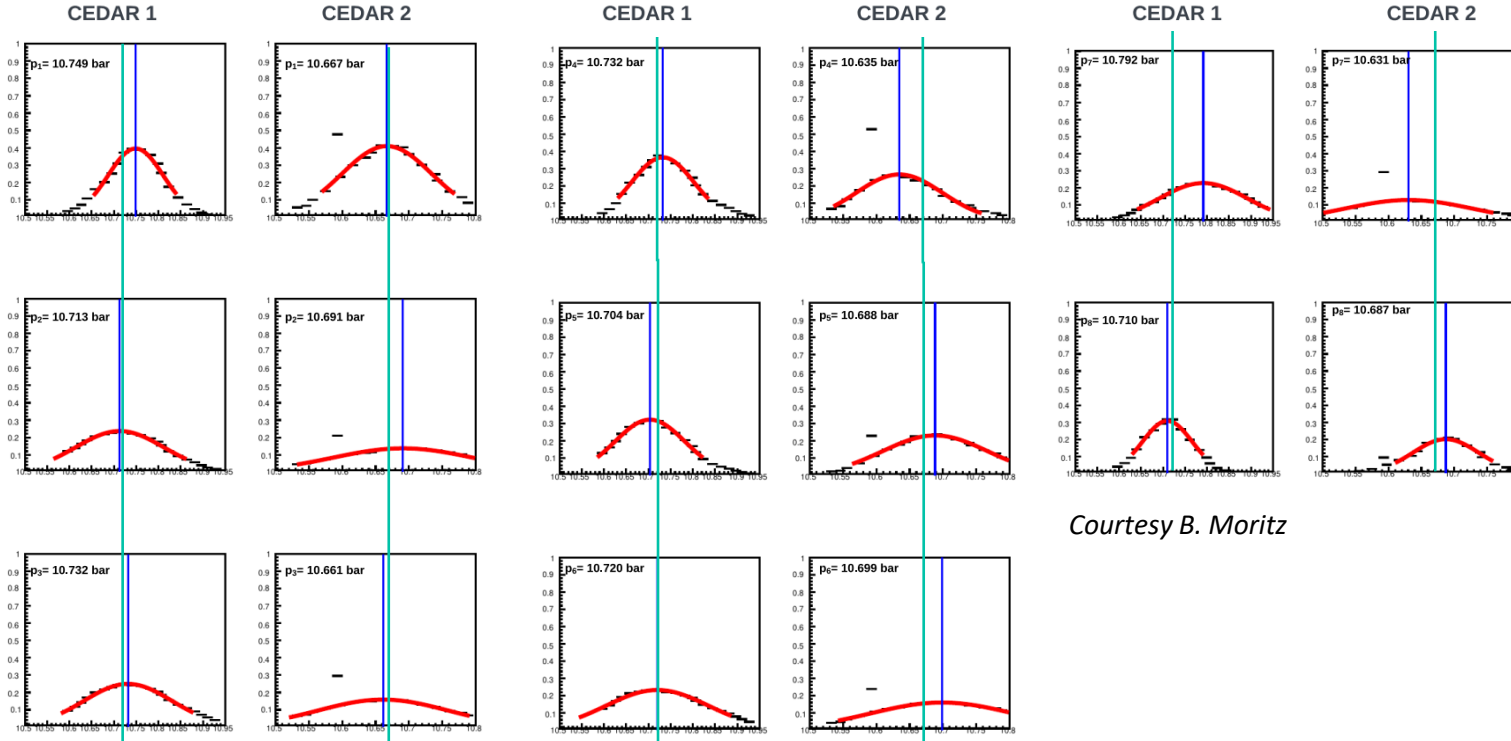
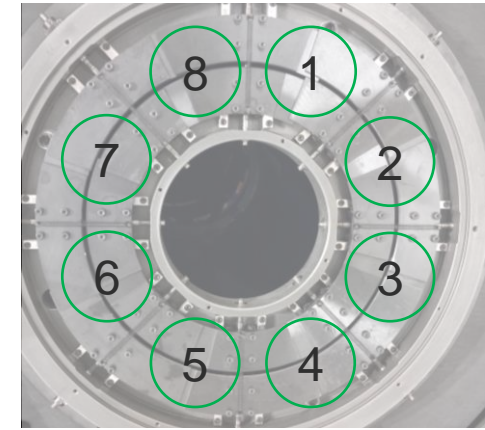
PMT	CEDAR1 [μm]	CEDAR2 [μm]
1	290	30
2	70	210
3	110	90
4	120	360
5	170	180
6	0	280
7	710	390
8	100	170

Confirmed by AMBER (B.Moritz) 10 mbar pressure translates to about 100 μm offset

The largest deviation between shutters translates then: 0.071 bar = **710 μm** for the **CEDAR1** - SPXCEDN001-CR000002 7 PMT position

The deviations are off tolerance by at least 1.5 x order of magnitude for most shutters !!

The largest deviation is bigger than the min aperture requirements

NOTE this CEDAR1 Diaphragm was aligned without tooling - CEDAR2 was aligned with tooling

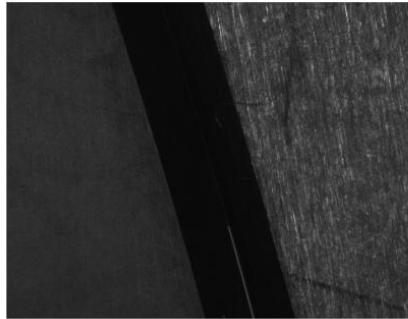
Section No 26 - GAP CLOSED

Visible "steps" on the profile of the segments, which affect the gap of the diaphragm.

Section 26 completely closed

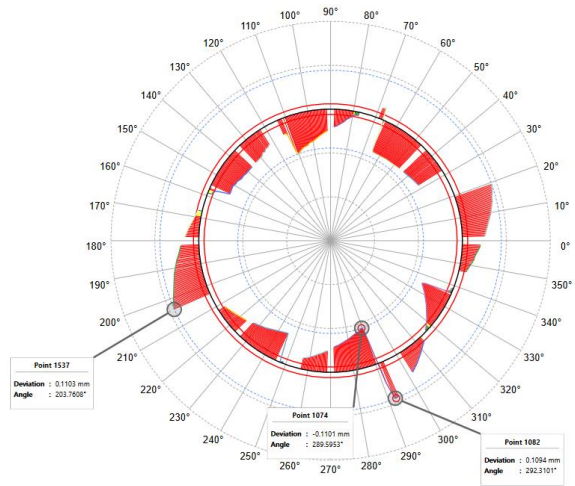
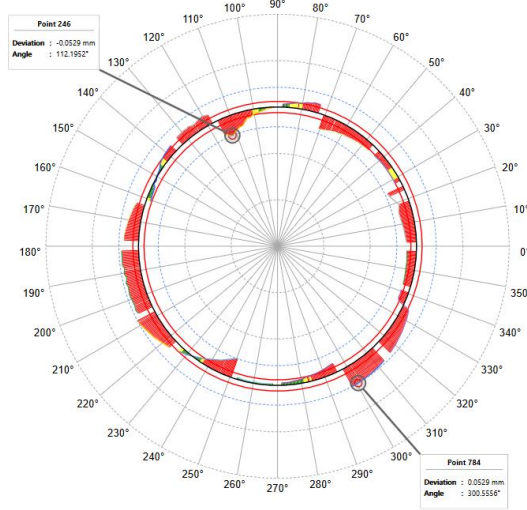
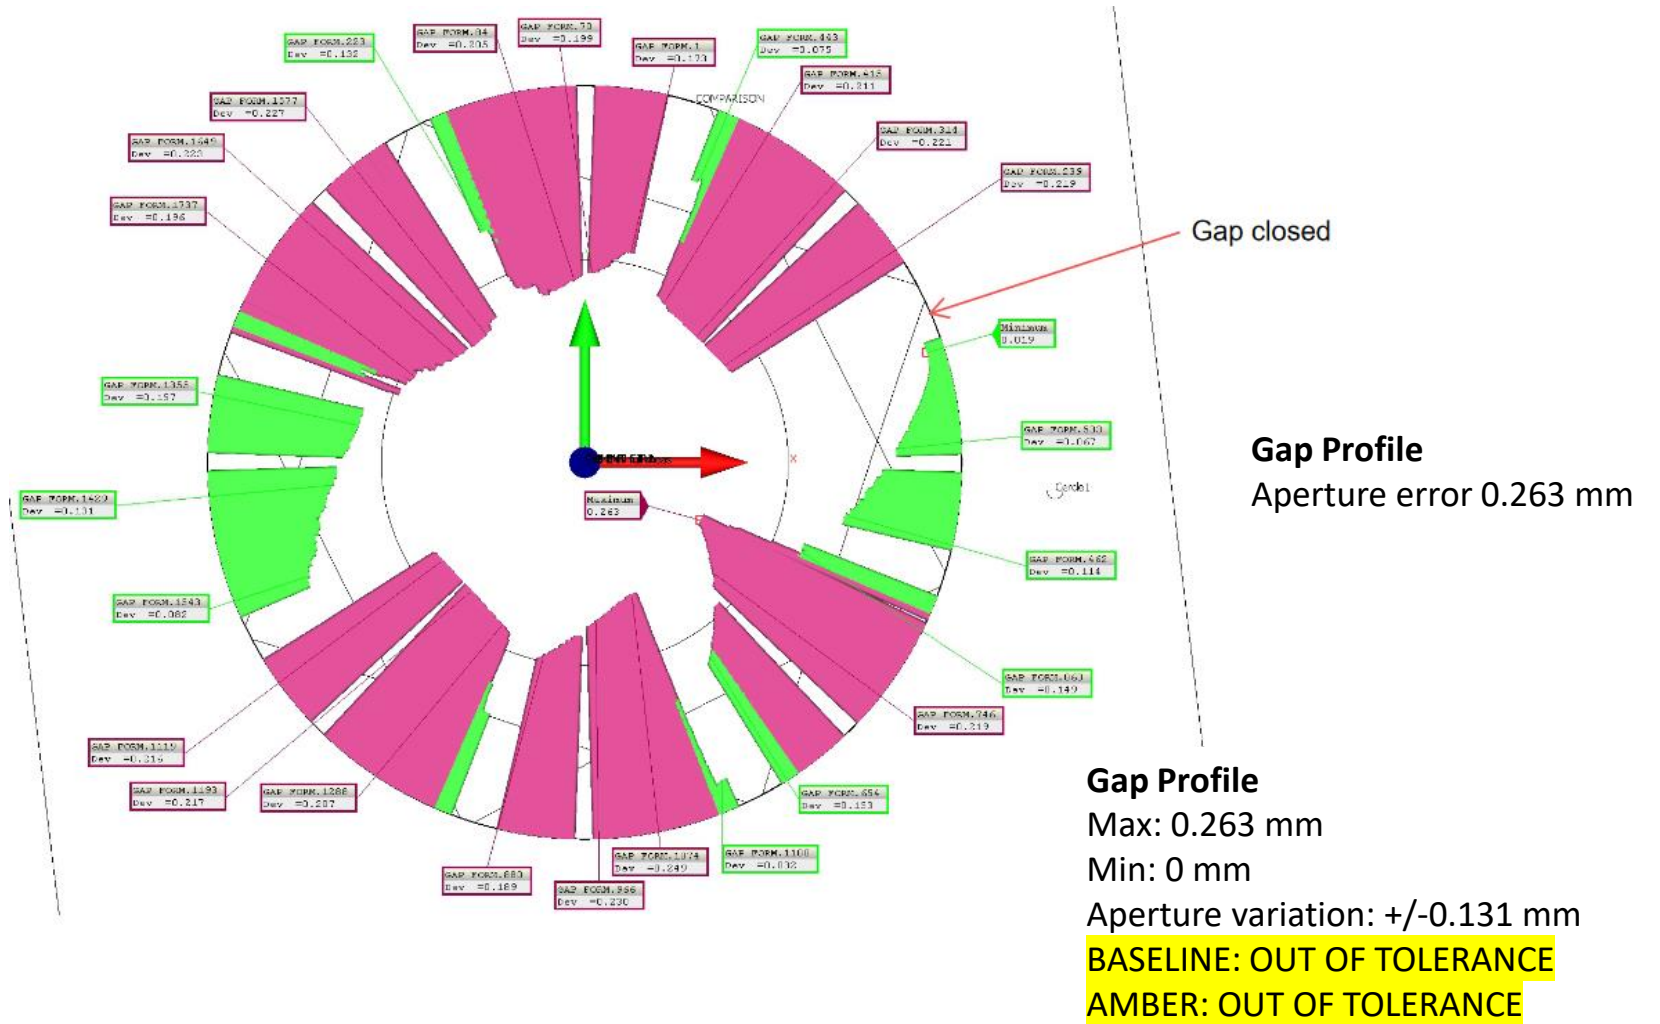
[EDMSJ3094591](#) - J3094591 CEDAR N01 diaphragm
[EDMS.3152574](#) J3094591 CEDAR No1.pdf

Gap Profile
Max: 0.263 mm
Min: 0 mm
Aperture variation: +/-0.131 mm
BASELINE: OUT OF TOLERANCE
AMBER: OUT OF TOLERANCE

Outer Circle Circularity Tolerance 0.106 mm
Inner Circle Circularity Tolerance 0.221 mm

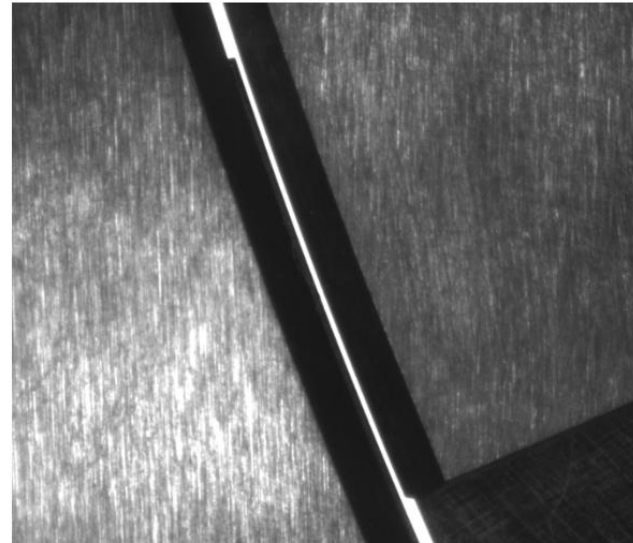
minimum gap size

Comment upon visual inspection

Visible "steps" on the profile of the segments,
which affect the gap of the diaphragm.

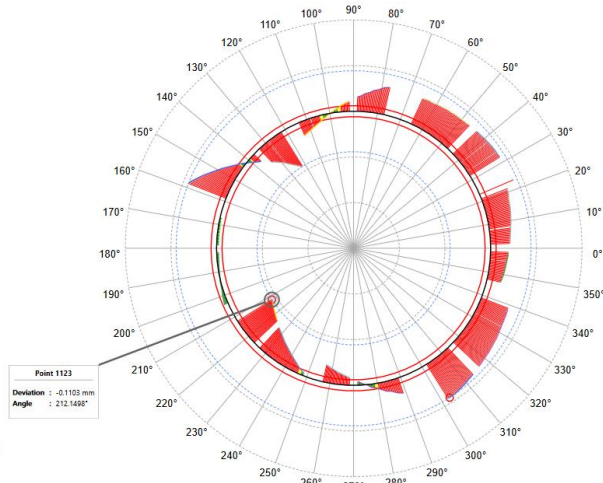
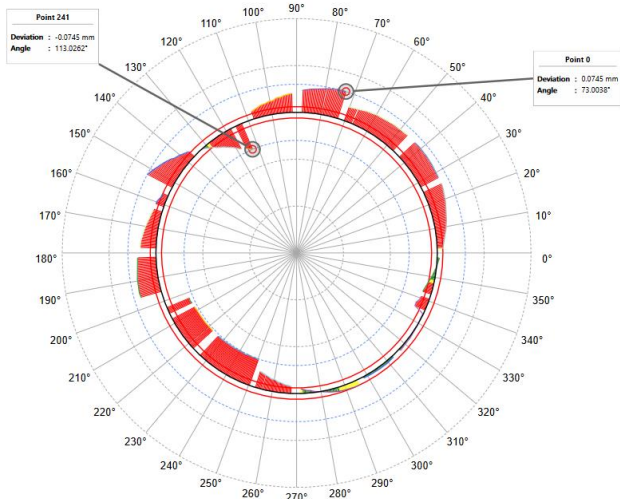
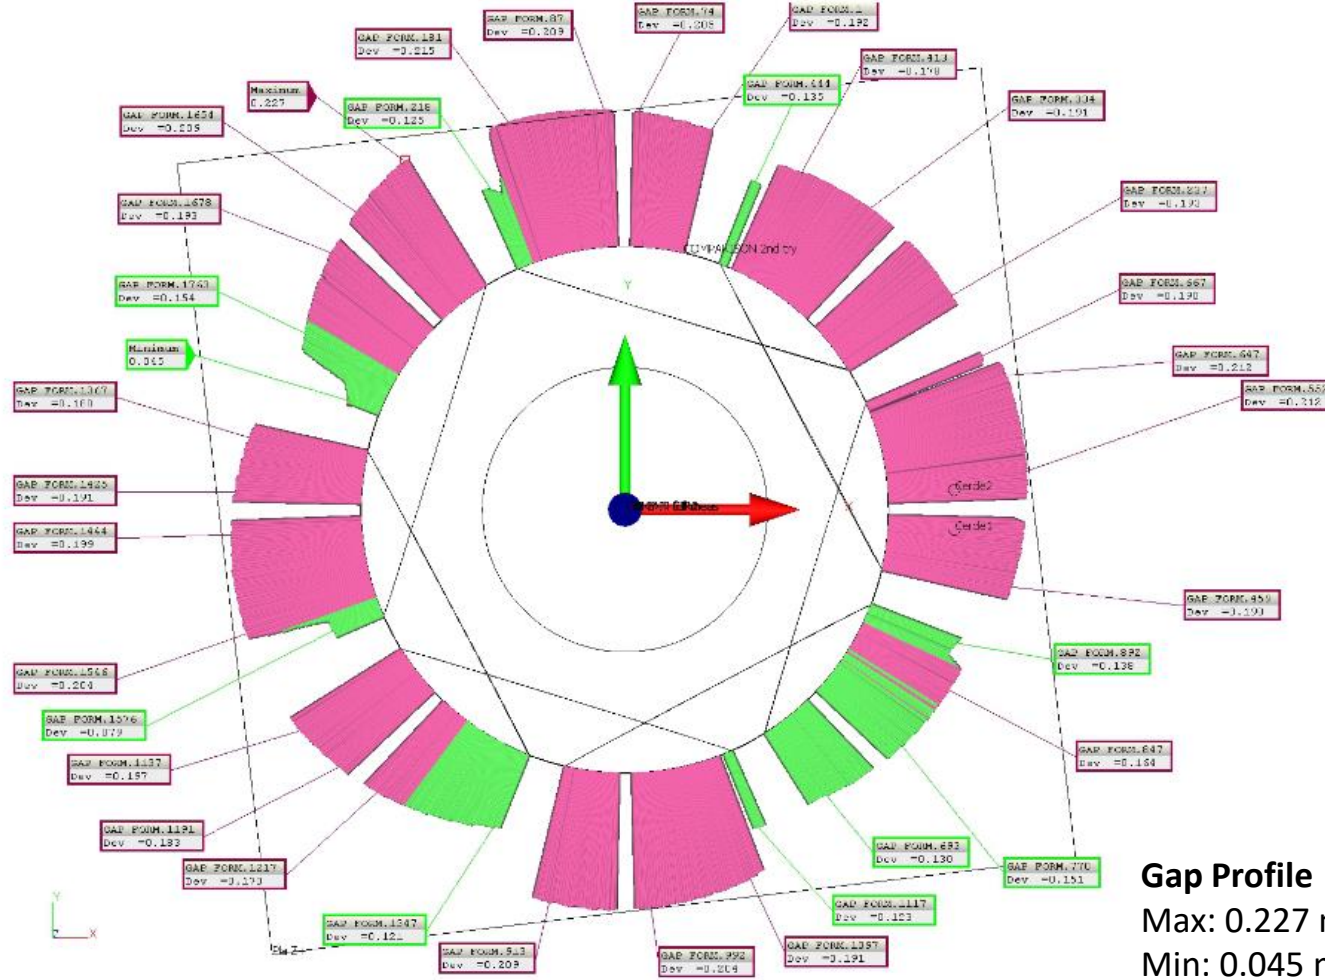
[EDMSJ3094591](#) - J3094591 CEDAR N01 diaphragm
[EDMS.3152574](#) J3094591 CEDAR No1 after repair.pdf

Outer Circle Circularity Tolerance 0.149 mm
Inner Circle Circularity Tolerance 0.221 mm

Gap Profile
Max: 0.227 mm
Min: 0.045 mm
Aperture variation: +/-0.082 mm
BASELINE: OUT OF TOLERANCE
AMBER: OK

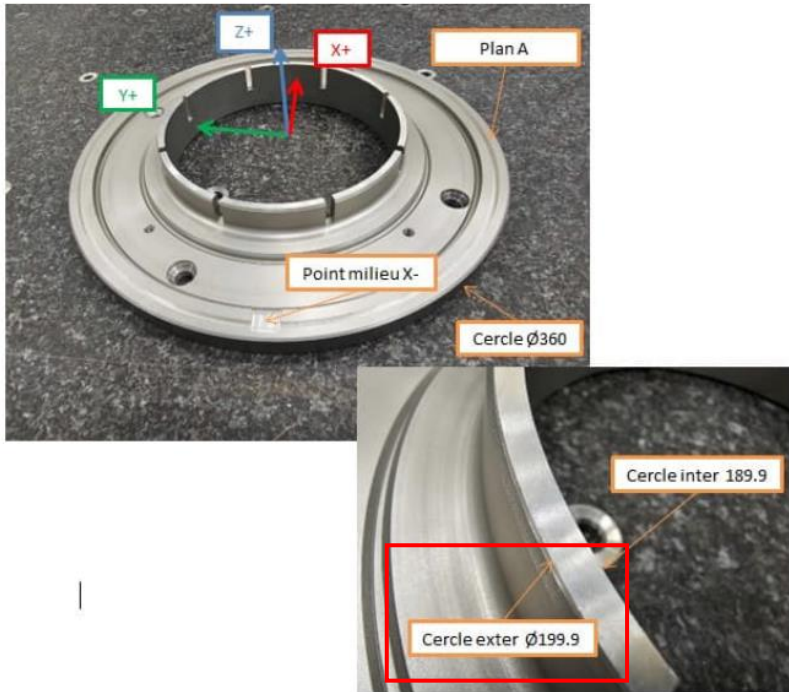
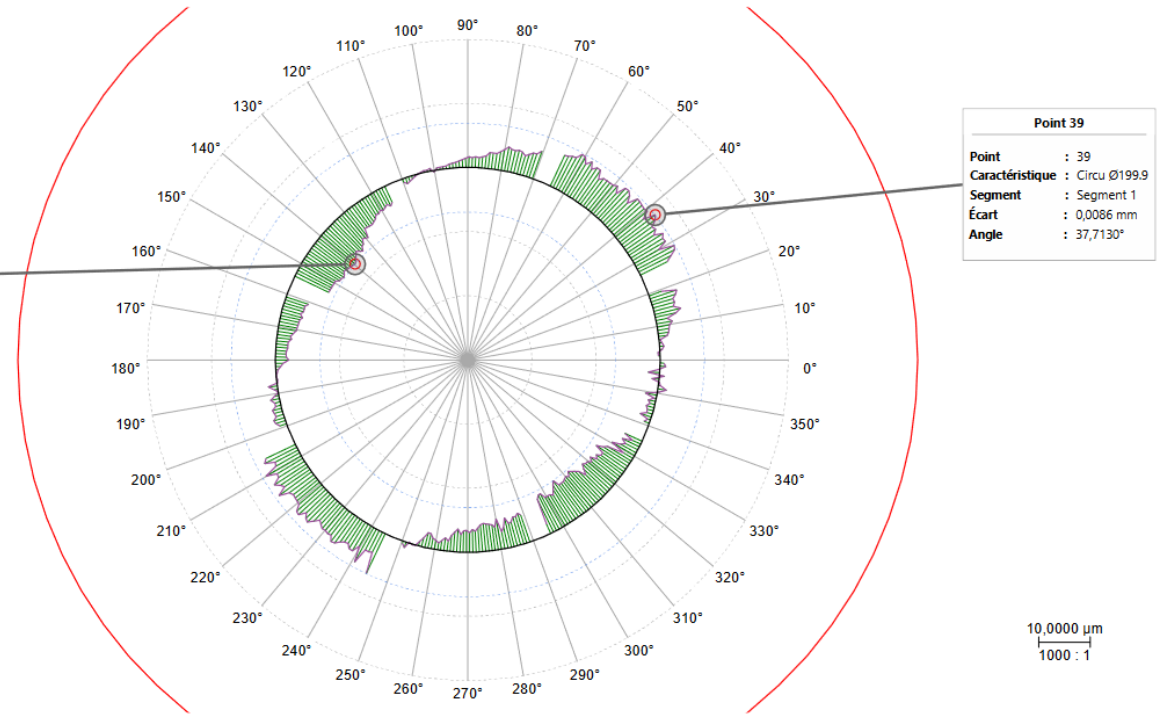
DIAPHRAGM ALIGNMENT TOOLING

Point 145
Point : 145
Caractéristique : Circu Ø199.9
Segment : Segment 1
Écart : -0,0086 mm
Angle : 139,6899°

Point 39
Point : 39
Caractéristique : Circu Ø199.9
Segment : Segment 1
Écart : 0,0086 mm
Angle : 37,7130°

Nom	Valeur mesurée	Limite supérieure	Points	Filter type	Lc	upr	Probe radius	Vmess[mm/sec]	Evaluation method
○ Circu Ø199.9	0,017	0,100	329	Pas de filtre	-	-	0,502	5,000	Élément minimum

Tolerance 0.017 µm

Tolerance required < 0.01µm

Out of tolerance

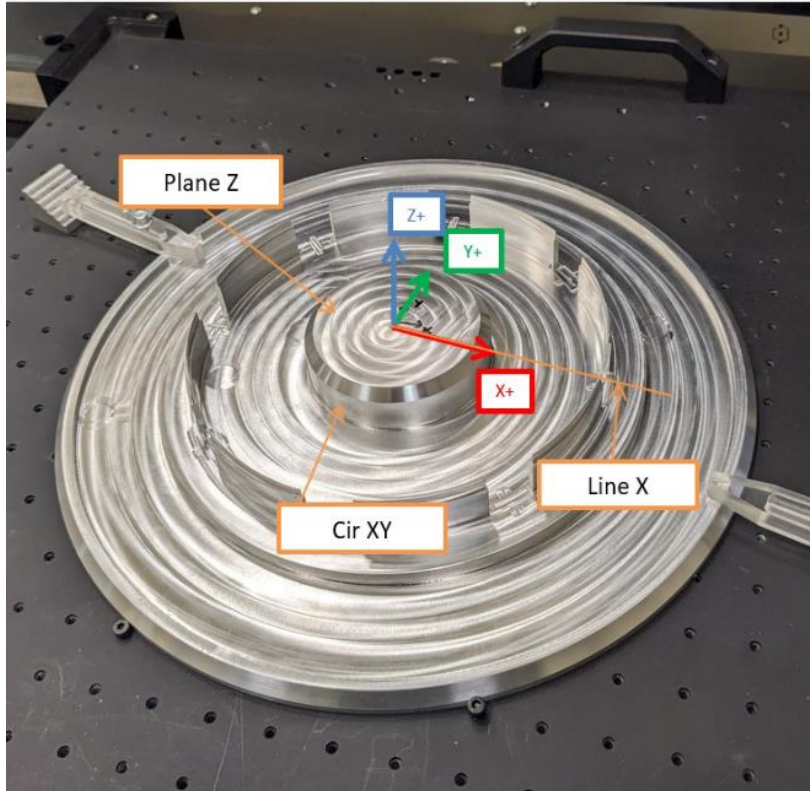
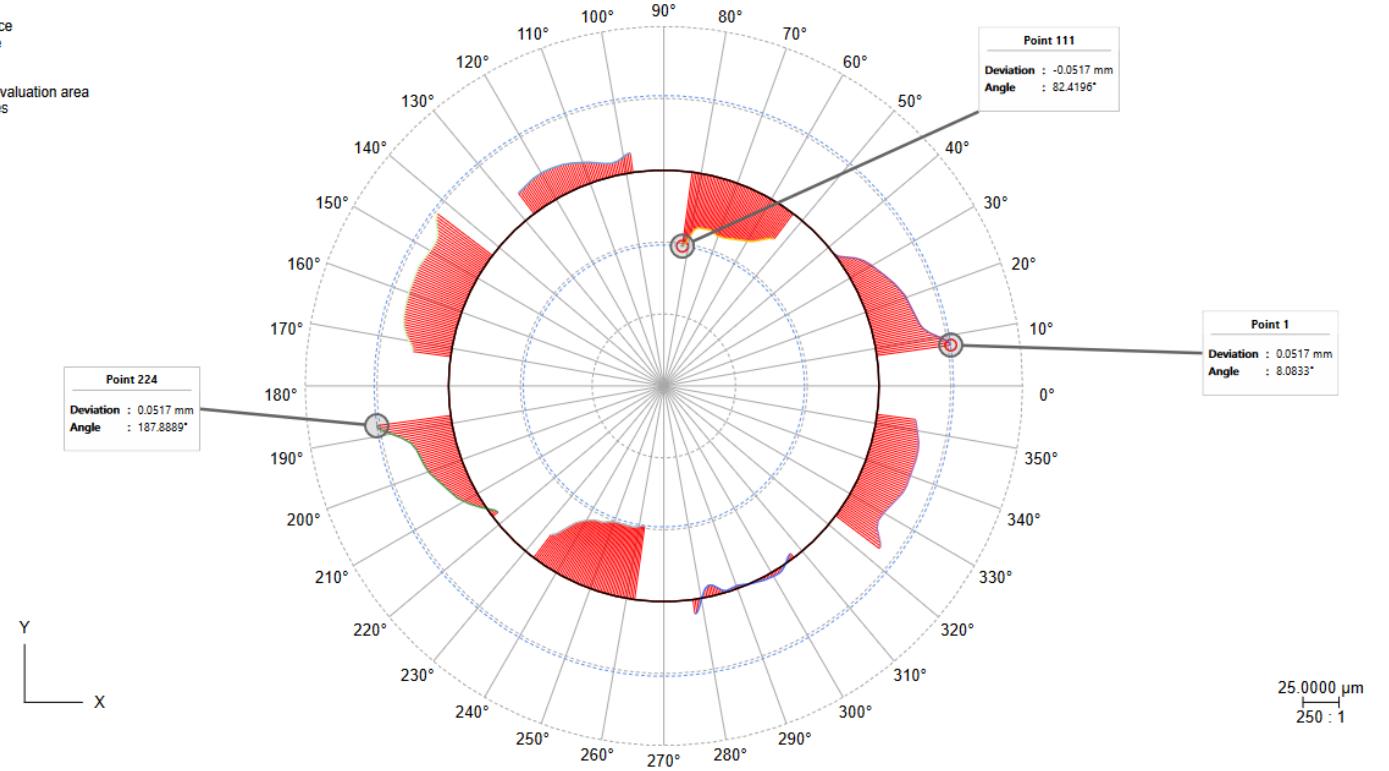
EDMS3160745 - J3094591 CEDAR adjustment tool

Name	Measured value	Upper limit	Points	Filter type	Lc	upr	Probe radius	Vmess[mm/sec]	Evaluation method
○ Roundness External	0.103	0.000	439	Low-pass Spline	-	50 -	2.500		Minimum Feature

Tolerance 0.103 μm

Tolerance required < 0.01 μm

Out of tolerance – Still allowed to understand the old tool
