Master's Thesis: Towards Novel Electrical Insulation Systems for Nb₃Sn High Field Magnets (EDMS 3168202)

Dante Polvani (TE-MS-C-SMT)

26/09/2024

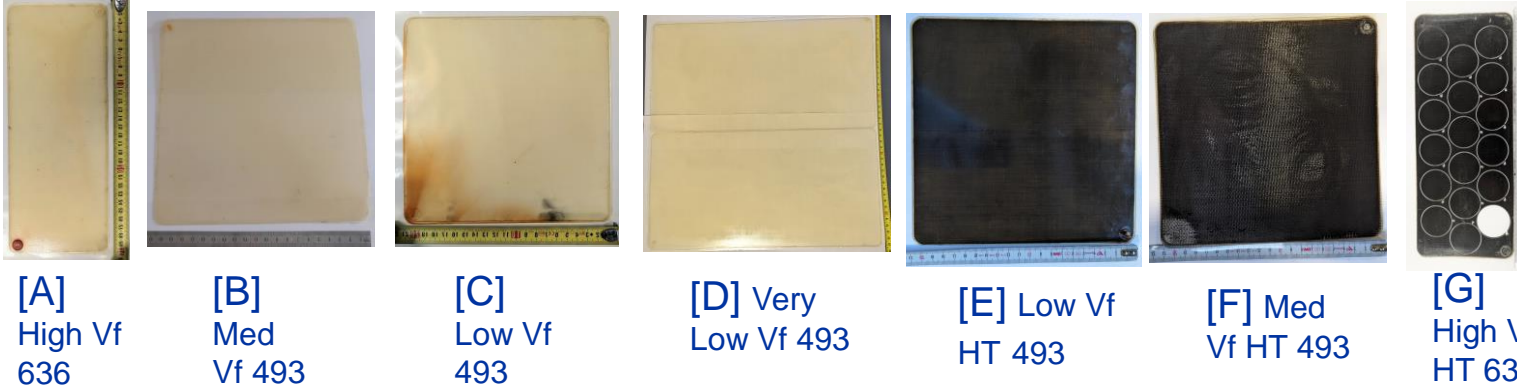
[A] High Vf 636
 [B] Med Vf 493
 [C] Low Vf 493
 [D] Very Low Vf 493
 [E] Low Vf HT 493
 [F] Med Vf HT 493
 [G] High Vf HT 636

- Study the effects of fiber content and of Heat-Treatment (48h plateau at 650°C in Argon)
- Plates with High, Medium, Low Vf, are all made with same fiber layout respectively
- S2 Glass fiber impregnated with CTD101K epoxy (baseline)

Plate	[A]	[B]	[C]	[D]	[E]	[F]	[G]
Number of Mats	15	7	2	1	2	7	15
Tex	11	33	66	66	66	33	11
Sizing	636	492	493	493	493	493	636
Heat Treatment	No	No	No	No	Yes	Yes	Yes
Nominal Mat Thickness (mm)	0.05	0.09	0.25	0.25	0.25	0.09	0.05
Plate thickness (mm)	0.755	0.691	0.598	0.366	0.575	0.639	0.773
Plate weight (g)	49.23	51.76	43.34	92.30	42.10	49.10	48.70
Plate Area (mm ²)	35914.00	44014.00	44014.00	159914.00	44014.00	44014.00	35914.00
Plate density (g/mm ³)	1.82E-03	1.70E-03	1.65E-03	1.58E-03	1.66E-03	1.75E-03	1.75E-03
Fabric weight (g/mm ²)	6.18E-05	1.03E-04	2.69E-04	2.69E-04	2.69E-04	1.03E-04	6.18E-05
Volume fraction (layers method)	0.50	0.42	0.37	0.30	0.38	0.46	0.49
Volume fraction (density method)	0.48	0.39	0.34	0.29	0.36	0.42	0.43
EDMS	3010815	3026056	3010825	3026060	3026058	3033576	3078008

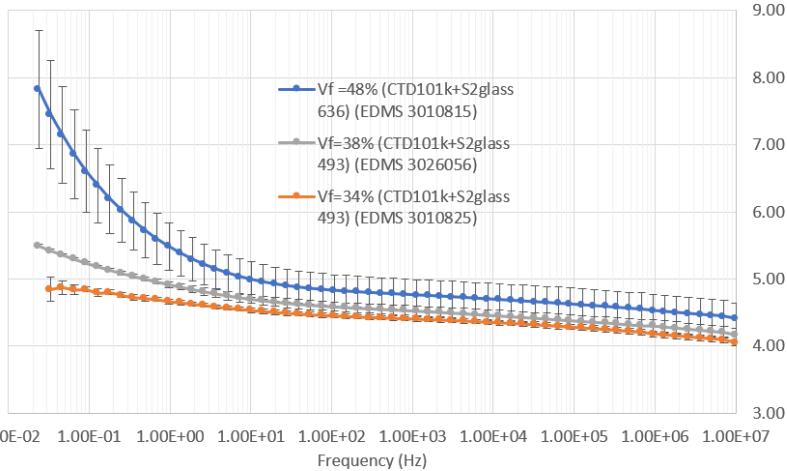
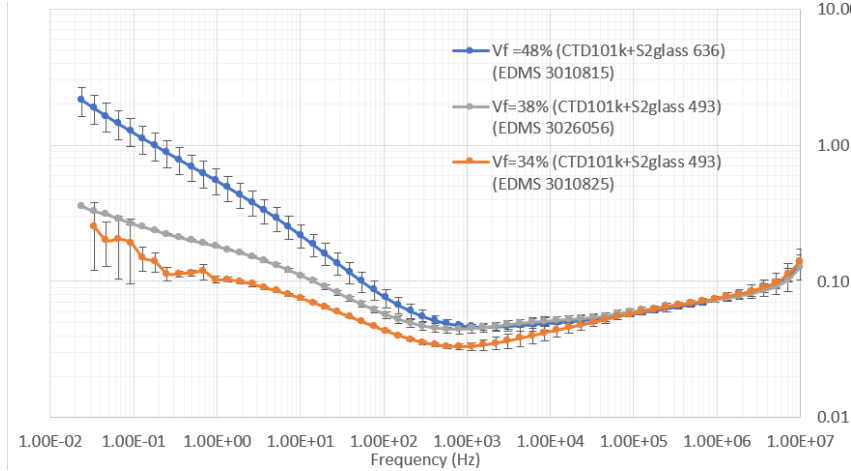
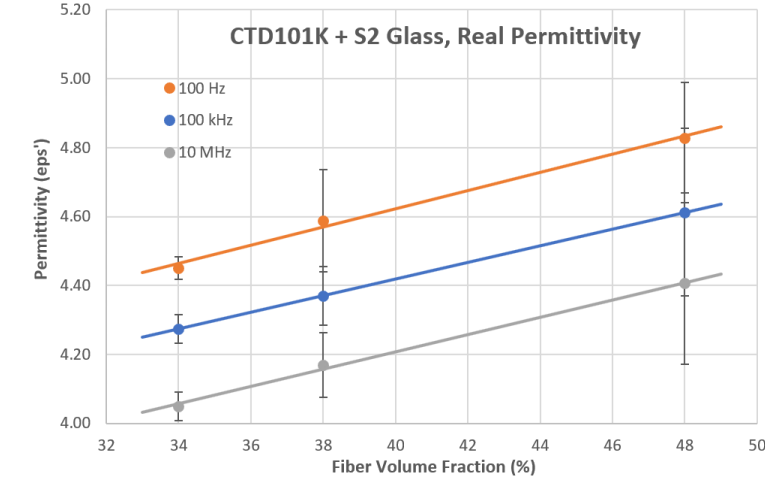
As-Received Fiber + CTD101k Samples:

- **Linear increment of epsilon with fiber content**
- At low frequencies, a convolution of peaks due to interfaces in eps''

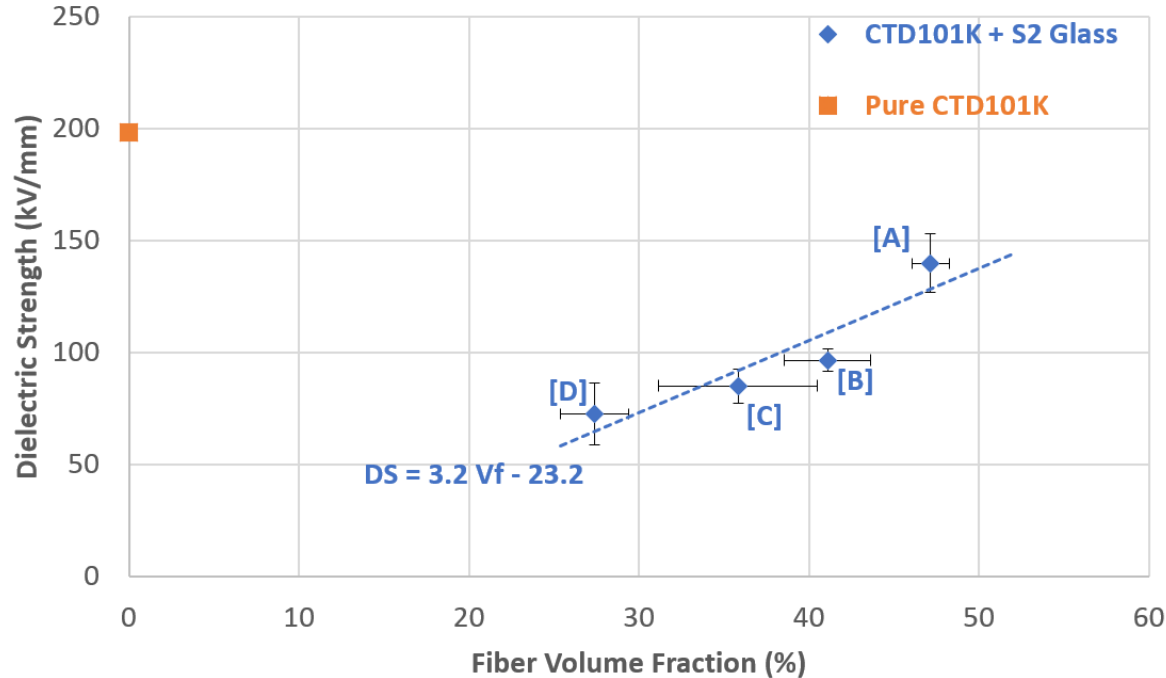
Non-HT Samples at Room Temperature

- Decline in dielectric strength from pure CTD101K to the composite material at low fiber fractions (field amplification on interfaces).
- Later, **rule of mixture is applicable**: glass has higher dielectric strength than epoxy (+higher treeing resistance).

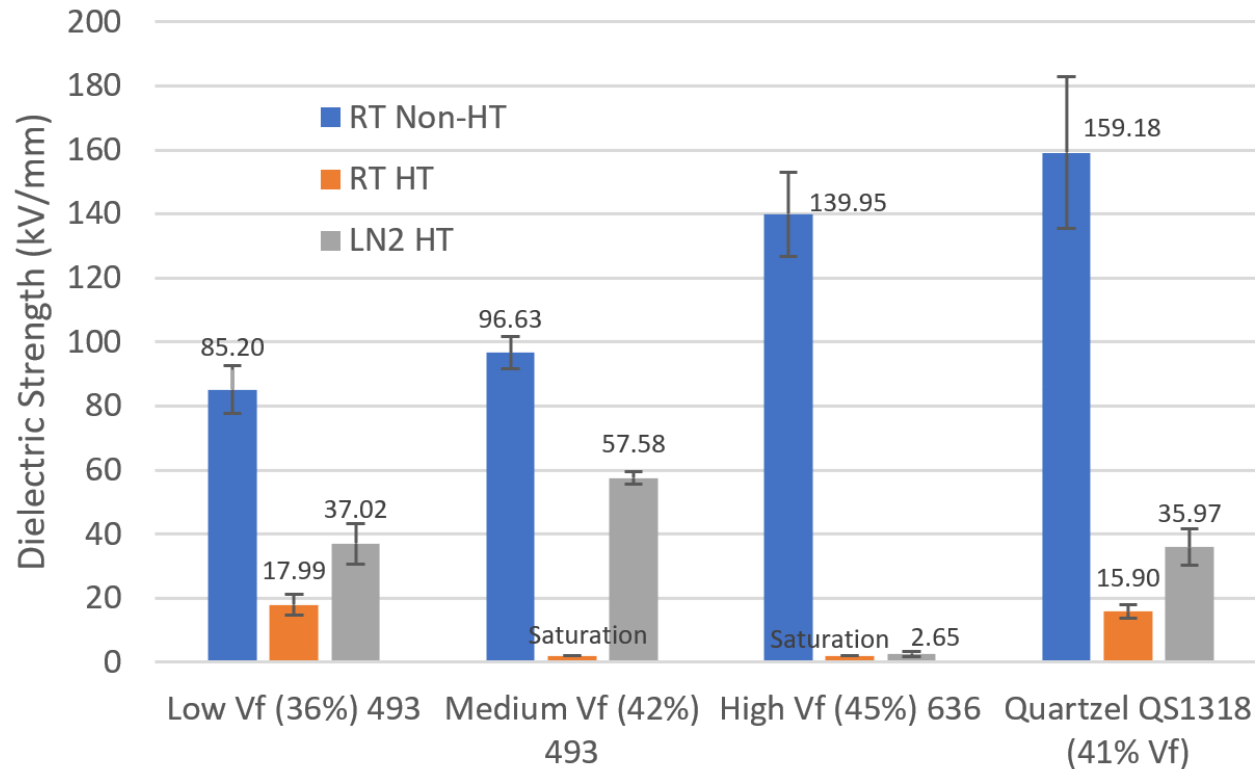
- Decline in dielectric strength from as-received (Non-HT) to heat-treated (HT) fibers.

At cryogenic temperatures (LN2) conductive component of the current is suppressed.

- Higher fiber content (not too high!) showed improved dielectric strength as at room temperature
- High Vf (45%) and 636 sizing still above percolation threshold

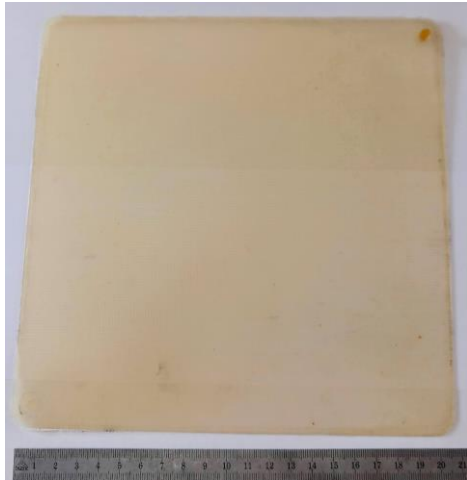
*Epoxy impregnated S2-
Glass fiber plate*

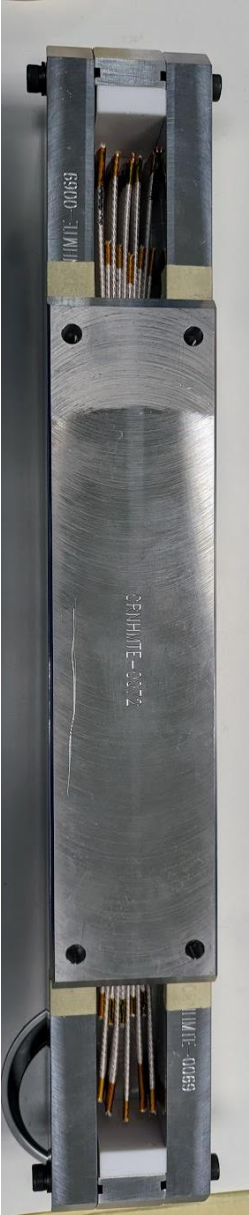
Open Impregnation Mould for HV 10-Stack

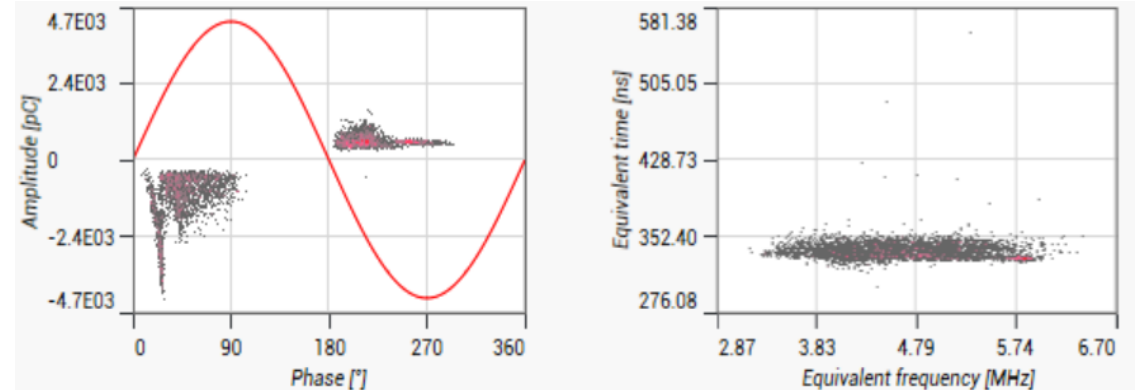
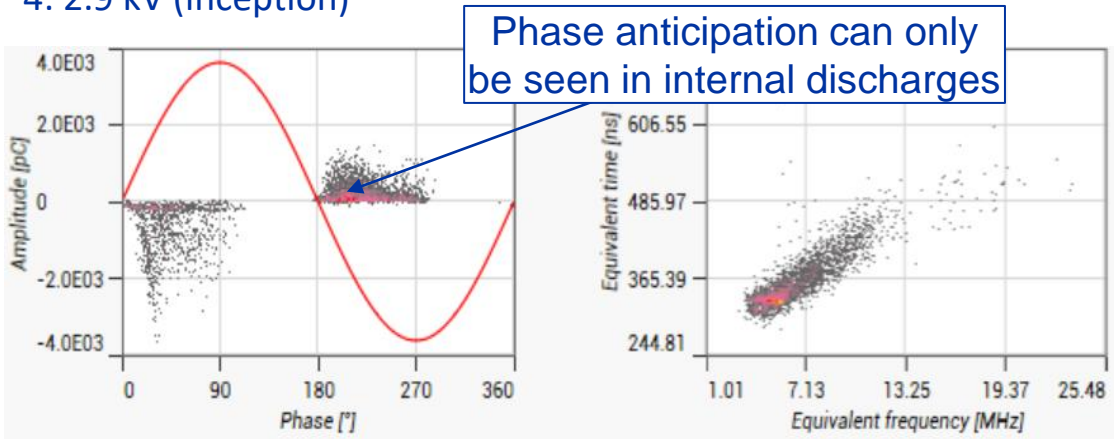
- A2 tested in oil
- Internal with surface behaviour (along cracks or delaminations)

4: 2.9 kV (inception)

4: 4 kV

4: 3.5 kV

4: 4.5 kV
