# Plans for YETS 2024

1. Summary of Cryo Shift situation of 2024 and outlook for 2025
2. Fixing the heat leak on the 1T bellows
3. Repairing the new 1T MCP assembly
4. Ion sources at AEGLS
5. Installing the anti-sun
6. Repair and redesign of the Hedgehog diagnostics
7. Rearrangement of the Enviro rack
8. New HV Ps for the beamline electrodes
9. Maintenance of beamline equipment

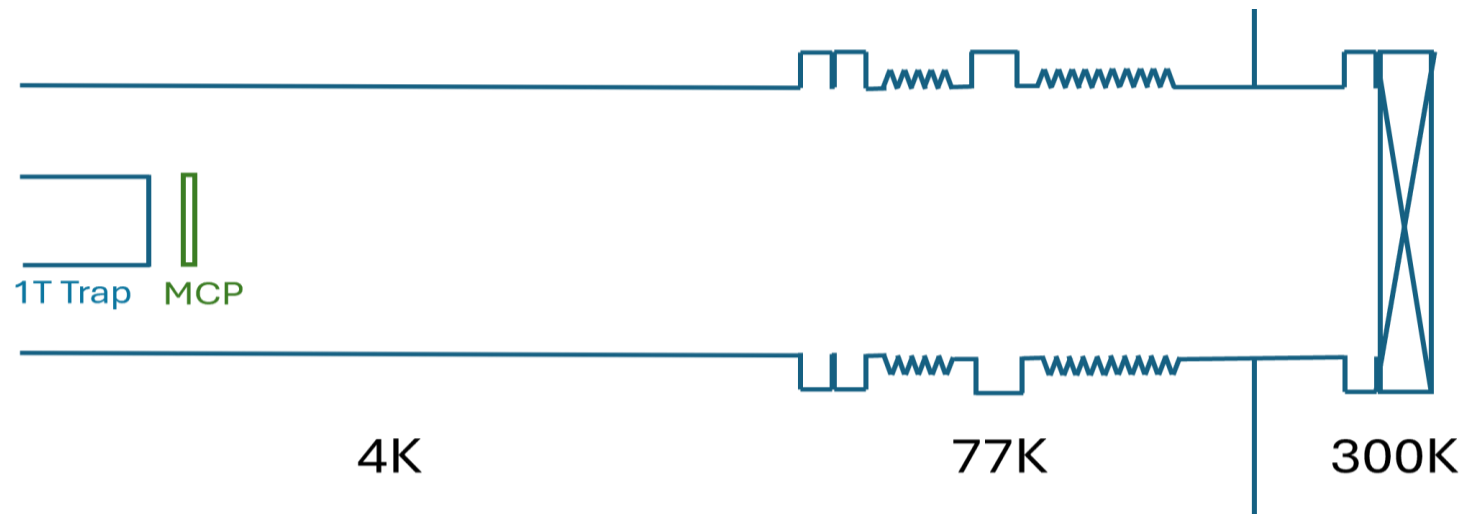
## Origin of the leak:

- We created an unshielded opening of 150 mm- radiative heating directly onto the 4K parts of the experiment
- The thermalization elements that we've foreseen for the 77K parts of the assembly failed
- Combination of both- we estimate 8 Watt going into the experiment, while our preliminary calculations account for 3-4 Watt
- CERN's cryo dept is performing calculations for us that will help estimate and pinpoint the failure

- Technical solution: improve on 1T bellows thermalization elements
- Exchange the 1.5mm cs, M6 attached copper braids with 40mm copper braids soldered to a copper plate
- Double check contact of the thermalization shield with the LN2 vessel

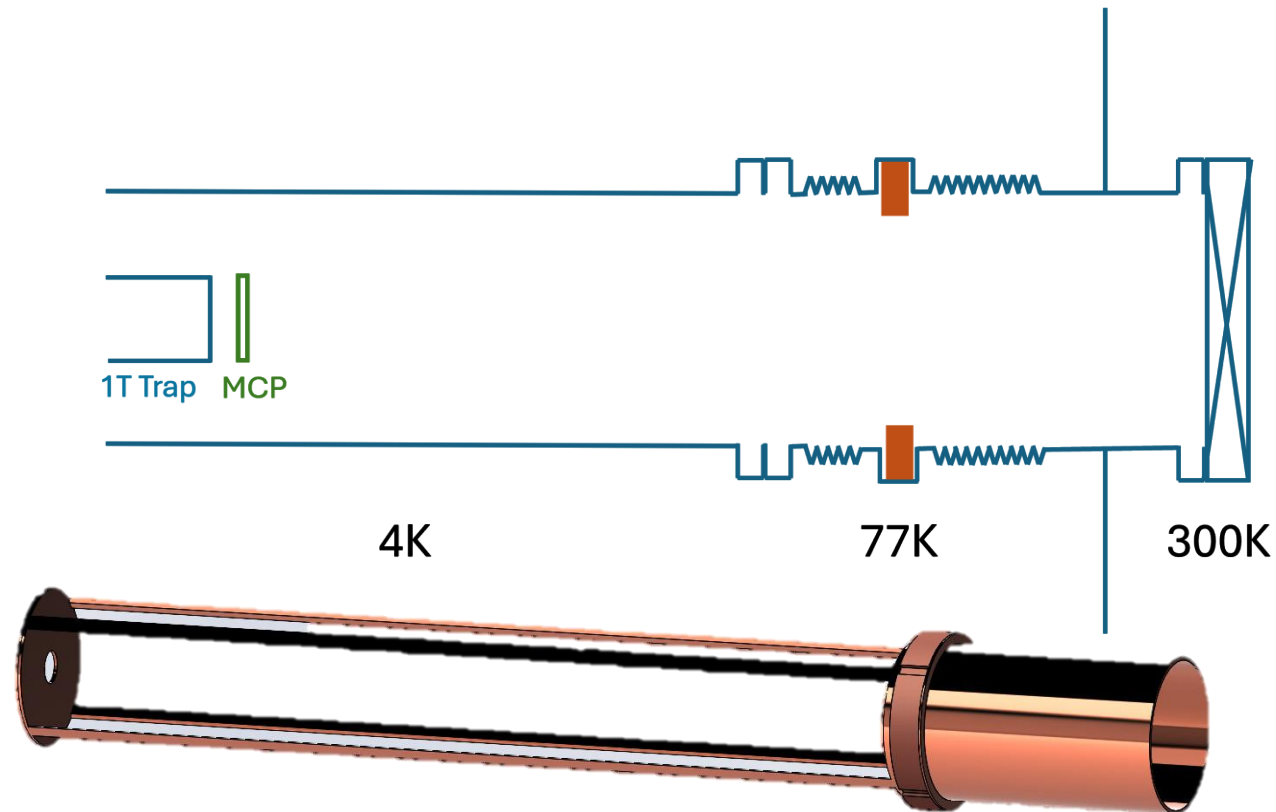
Technical solution: heat collector- a thermalized barrier absorbing the radiative heat

- Technical solution: heat collector- a thermalized barrier absorbing the radiative heat
- Heat absorption has  $x^2$  correlation to the surface
- The barrier will be best in form of a disc with an iris
- We better make sure that the iris is positioned in a place/has diameter big enough to not obstruct the particle beam!

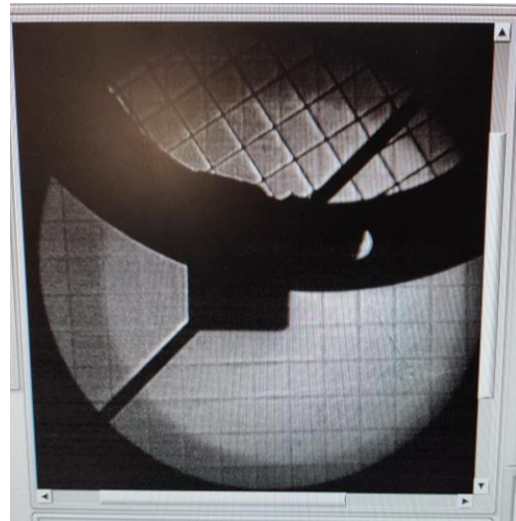
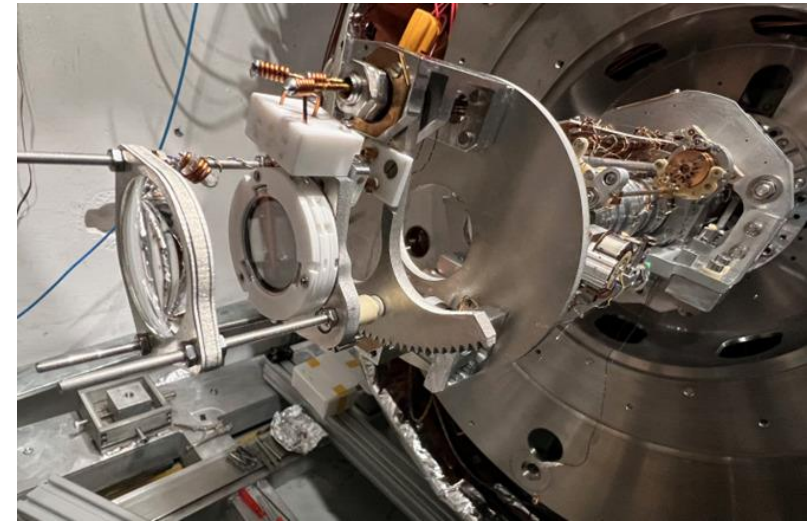
- 1T MCP is supposed to move in and out of the beamline to facilitate Hbar extraction
- During installation, the mechanism got damaged (probably the ceramic ball bearings) and the MCP will not fully move out of the beamline
- Towards the end of the run the MCP front plate has been damaged
- The whole detector will have to be replaced
- Needs to be done as soon as possible, will take 2-3 weeks

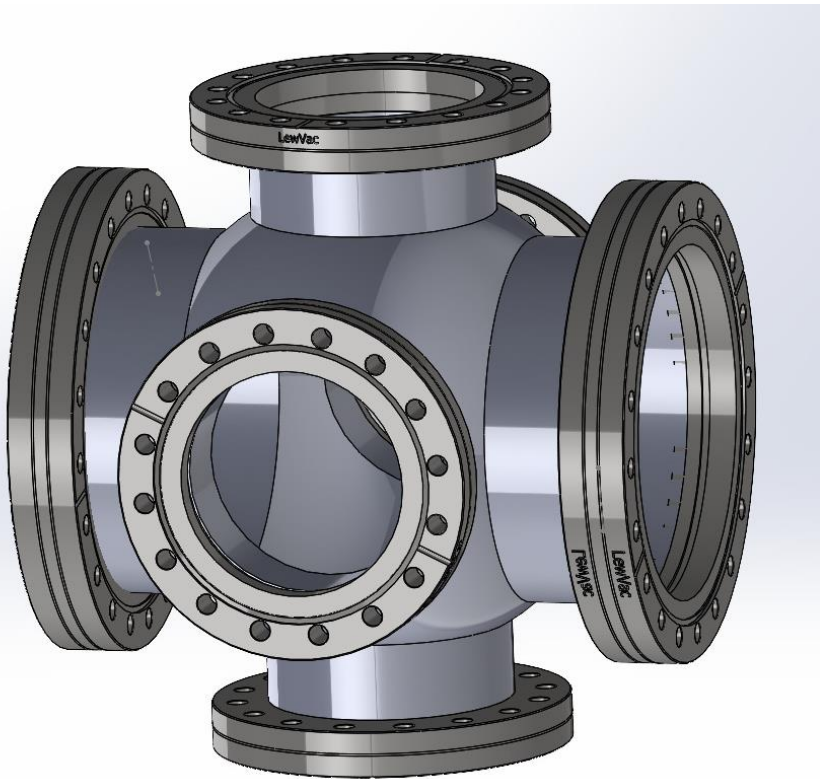
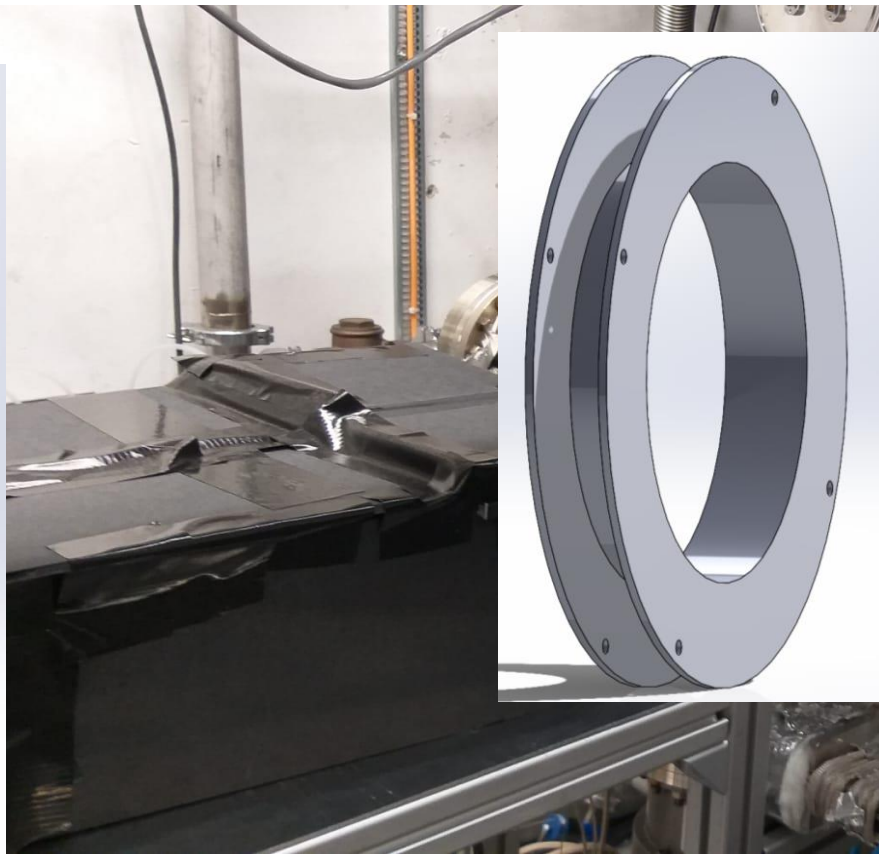
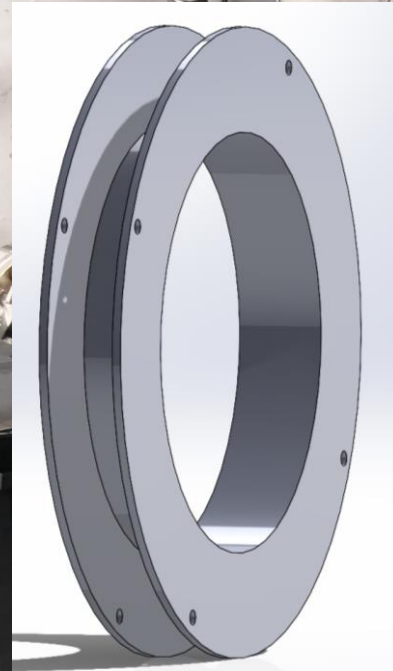
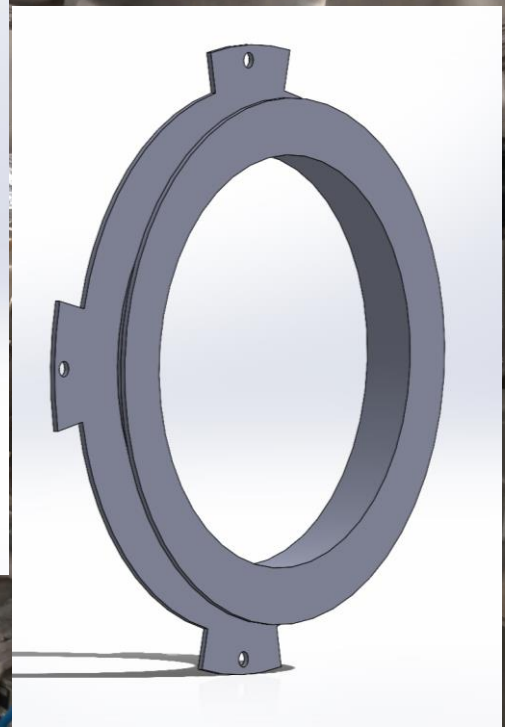
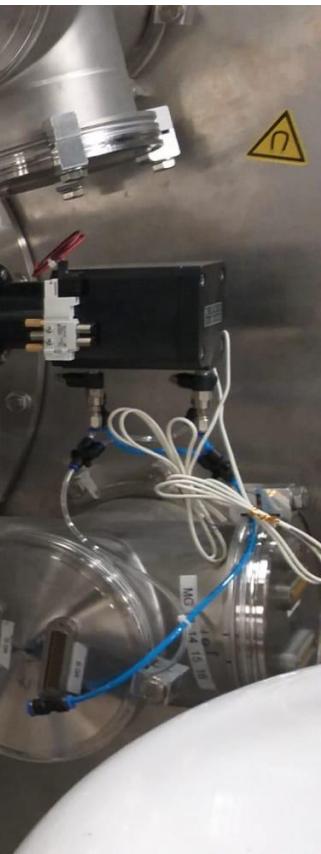
- A chamber on the 1T beamline that has a primary function to take out the 1T MCP signal
- We will need to manufacture and assemble the parts of the retractable mirror holder
- Can technically happen at any time, but since it involves setting up the camera better do it before the beamtime

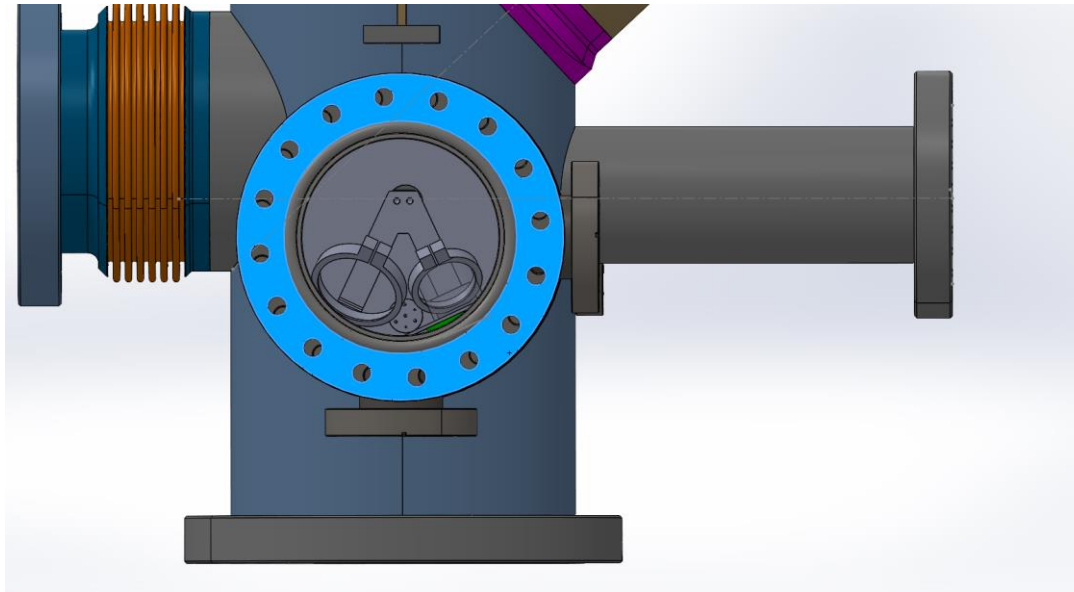
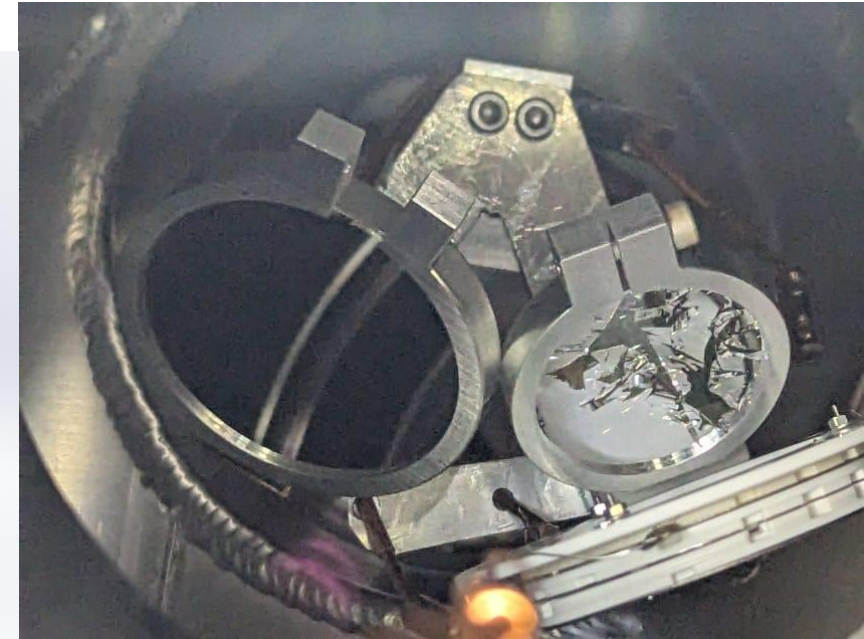
- Replace the broken mirror and change the mirror holder
- Check the cabling on the MCP
- Since we loose beam via collision with the mirror holders, the whole concept needs to be reconsidered
- Conceptually easiest solution is to change geometry of the chamber

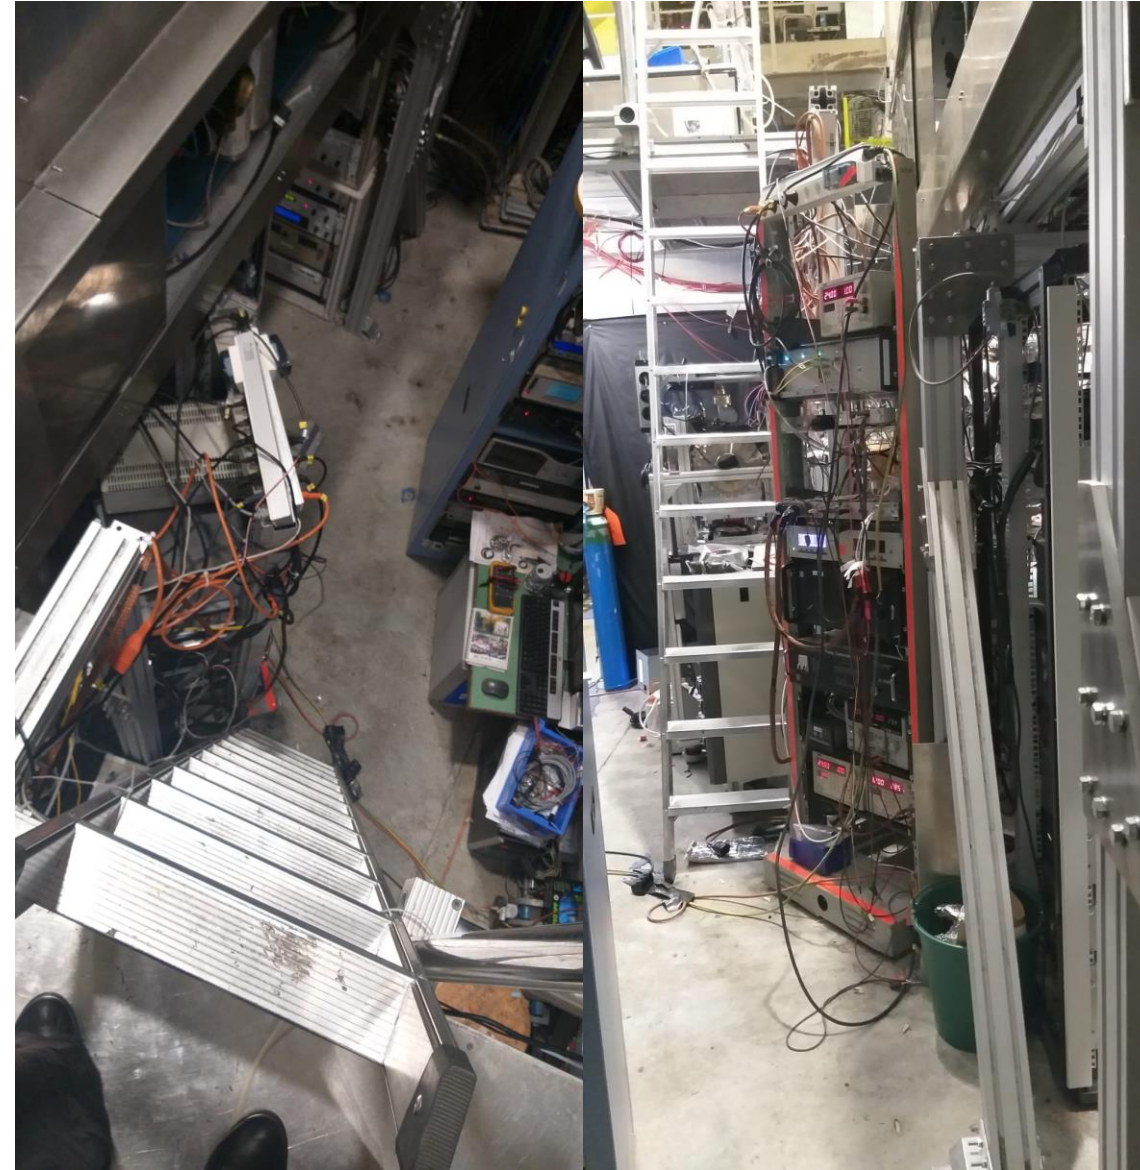
- Moving the rack was necessary for facilitating Giovanni's extraction experiments
- Has been adopted as a temporary solution
- We will not get beam clearance if it won't change
- Safety Unit promised to help and co-finance more optimal distribution of the Enviro electronics

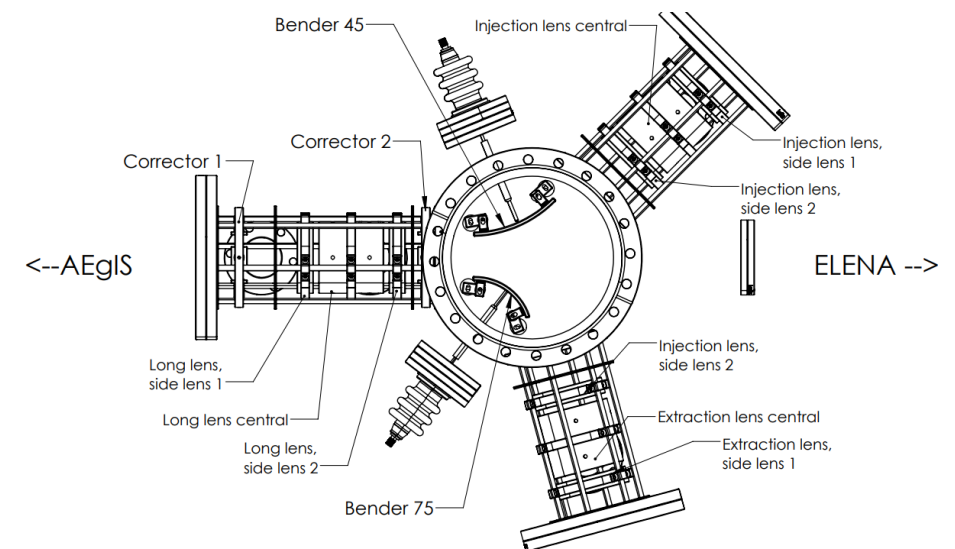
- We are currently renting an EPool CAEN crate and 4 HV modules that allow us to power up Starship electrodes up to 6kV
- New standard CAEN crate and 15 kV modules (POS and NEG) are being purchased
- We should think about investing 12K in bi-polar remotely switchable modules for the corrector electrodes
- New crate should be installed on the electronics island with the magnet power supplies
- Starship needs to be re-cabled
- Intervention of 1-2 days
