ATLAS sTGC

sTGC detector

sTGC setup at GIF++

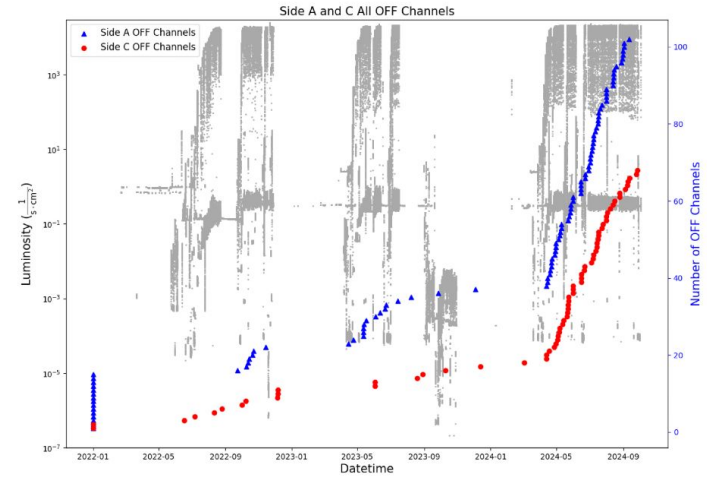
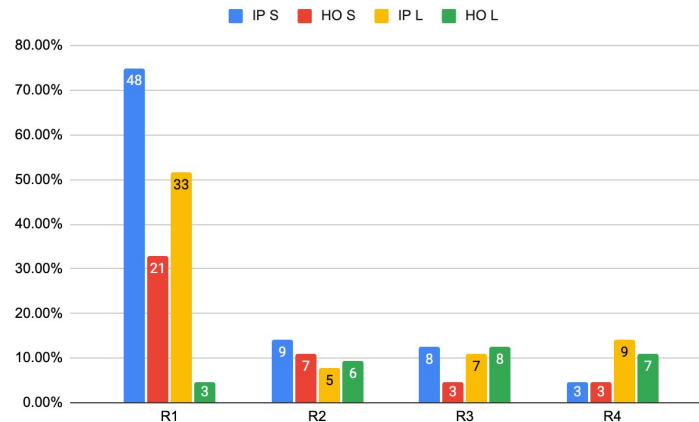
- A number of HV failures observed since installation in 2022
- Seemed to drastically increase this year - cause still unknown
- Could be a number of different effects but there seems to be at least some correlation with radiation
- Aging test at GIF++ one of a number of tests ongoing

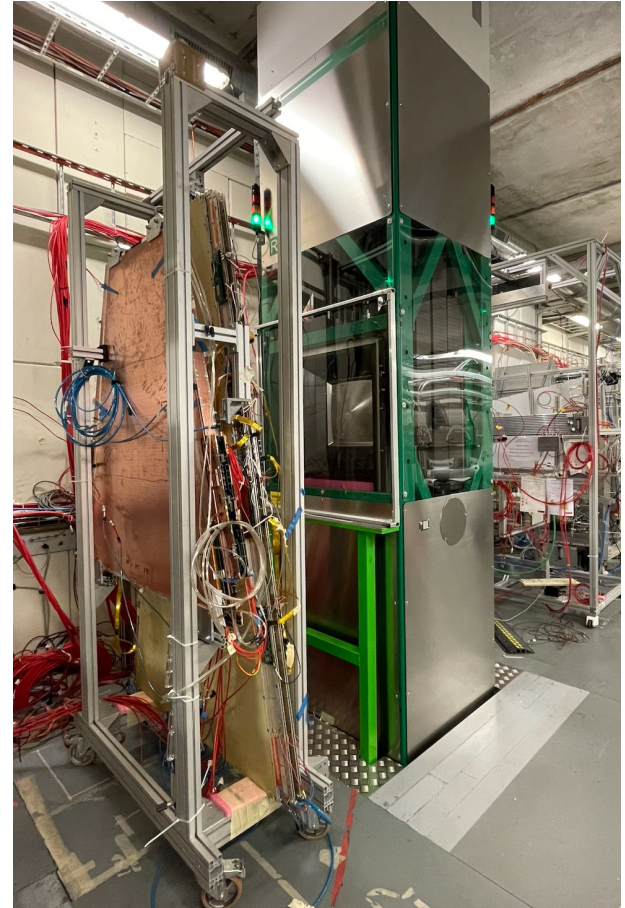
- Installed on a stand with MM chamber
- Adjacent to the source on the downstream side
- Flushing 45:55 npentane-CO₂ mixture, as is used at P1
 - Npentane provided by ATLAS gas team
- Chamber kept at 2.75 kV
- Current ~10x what is seen with the high intensity pp beams at P1

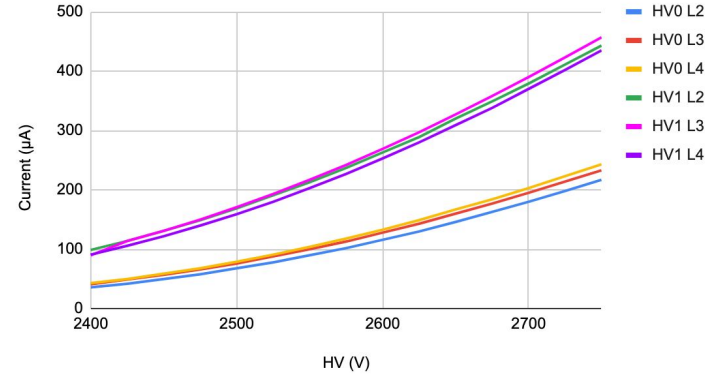
Six active layers, source filter 1, HV scan

- Verified that the chamber stills supports HV at nominal values with CO2 only (three years since last testbeam)
- Flushd with npentane and HV on
 - Npentane tank temperature and pressure monitored on a regular basis
- Performed an HV scan
- Verified that current returns to 0 with the source off as expected
- Observe some fluctuations in the current likely related to atmospheric conditions

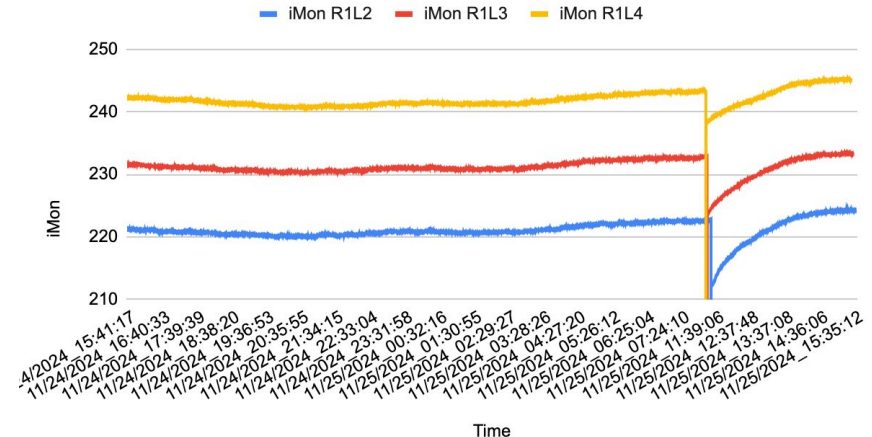
iMon vs. Time

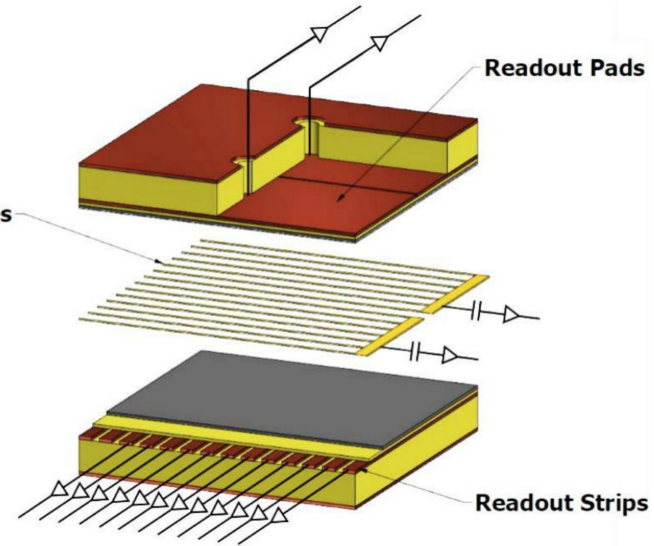
- sTGC - TGC detector type, with a configuration of a multiwire proportional chamber, but with wire to cathode pitch smaller than wire-wire pitch
- What is an STG layer made of?
 - Two cathode planes (sprayed with graphite)
 - Voltage between cathode and wire
 - Pad cathode plane - for readout + trigger
 - Strip cathode plane - providing track positioning
 - Wire groups - providing a second coordinate

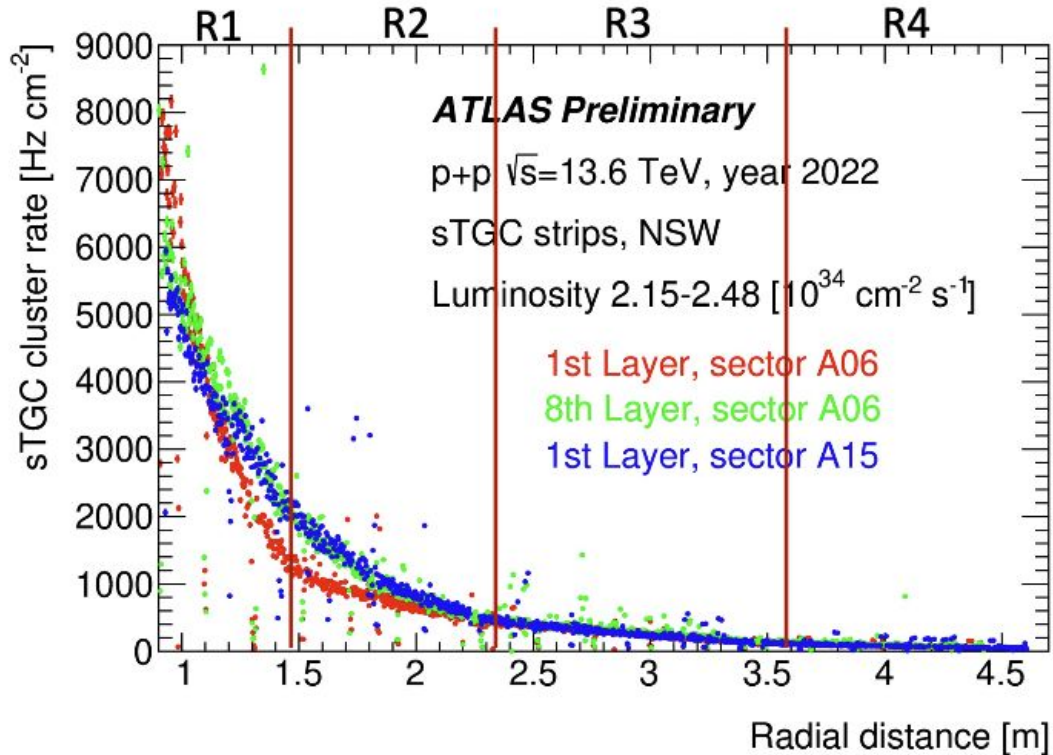
sTGC Rates at P1

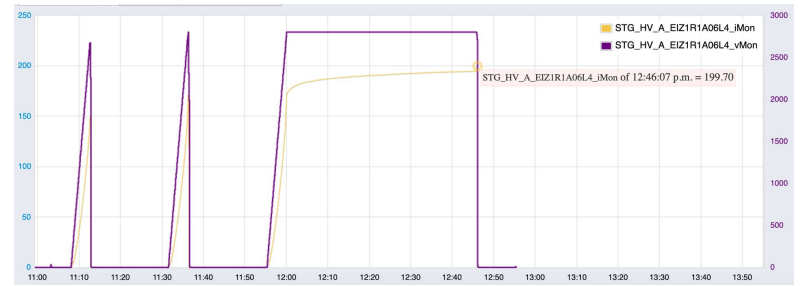
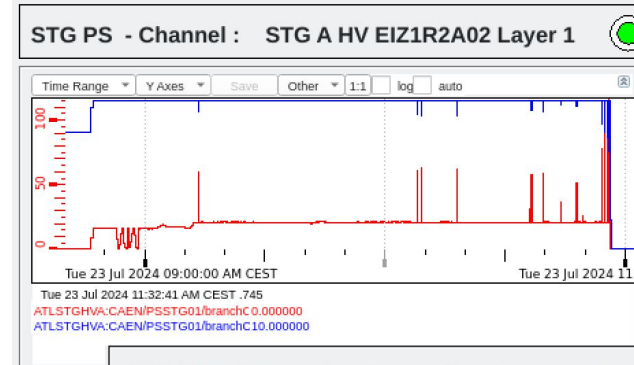
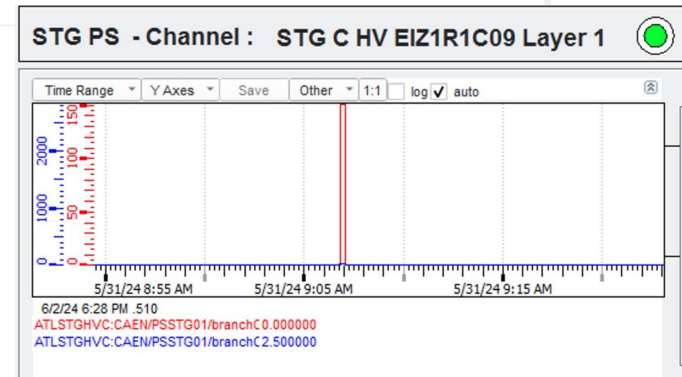
- Most channels that are failing, do so by developing Ohmic-type behavior - current increasing as voltage does
- Often discharges are observed in channels before this begins
- A few channels have shorts
- Two channels show no current response

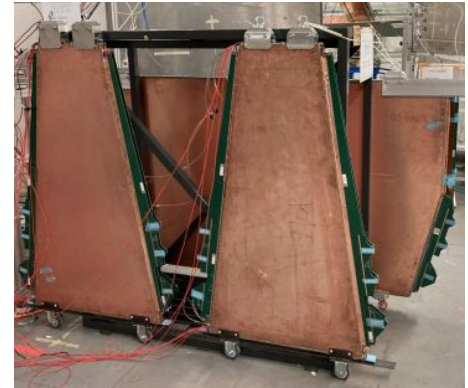
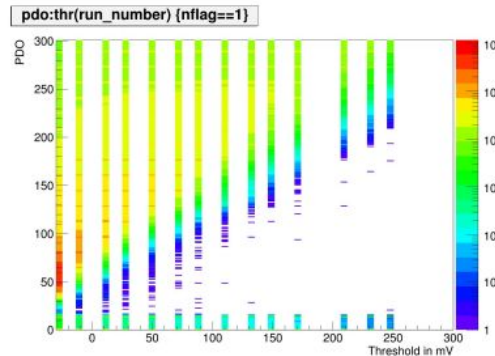
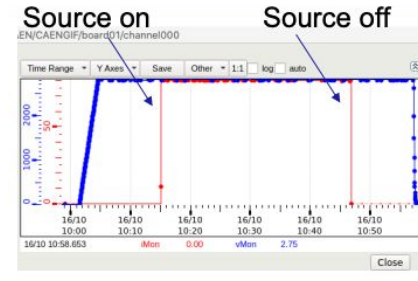
sTGC detector - previously at GIF++

- Reception tests at CERN - all chambers that are now in the sTGC in the NSW were test at GIF++
 - Flushed with npentane and performed a test with radiation for 30 minutes with HV on, check that all returns to normal when source is back off
- Previous testbeams, most recently in 2021 tested sTGC performance under a variety of conditions
 - Changing readout parameters
 - Tilt angle of the chamber
 - Strip and pad thresholds
 - At different HV
 - different filter on the source
