# ALICE GAS SYSTEMS

2024 Activities

03 February 2025

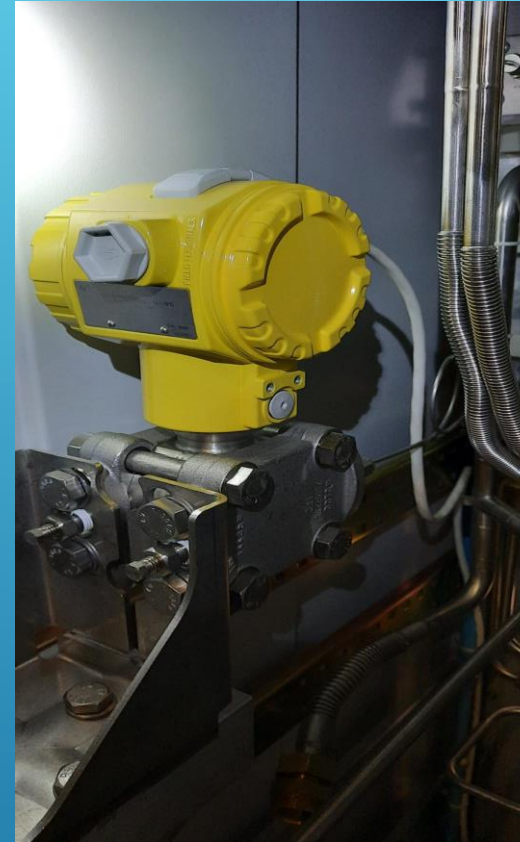
- **Example of intervention on MID**

The system stopped due to the fact that the pressure sensor had a strange behavior and suddenly went to the minimum of the scale (-15 mbars). We swopped the regulation from this chamber sensor to the output distribution sensor. It was running like this before the installation of the chamber sensor.

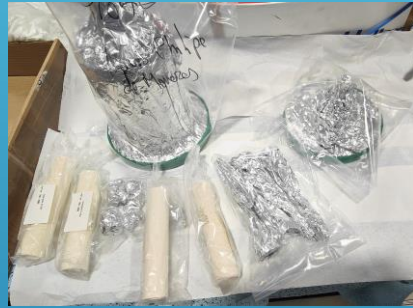
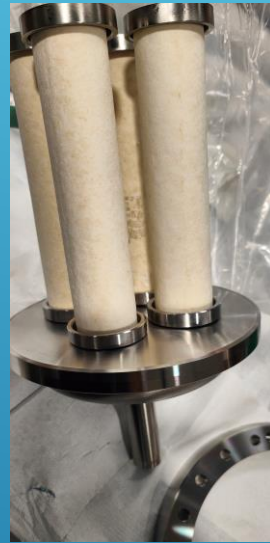
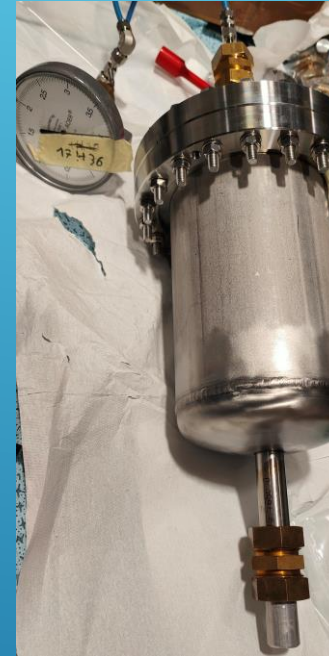
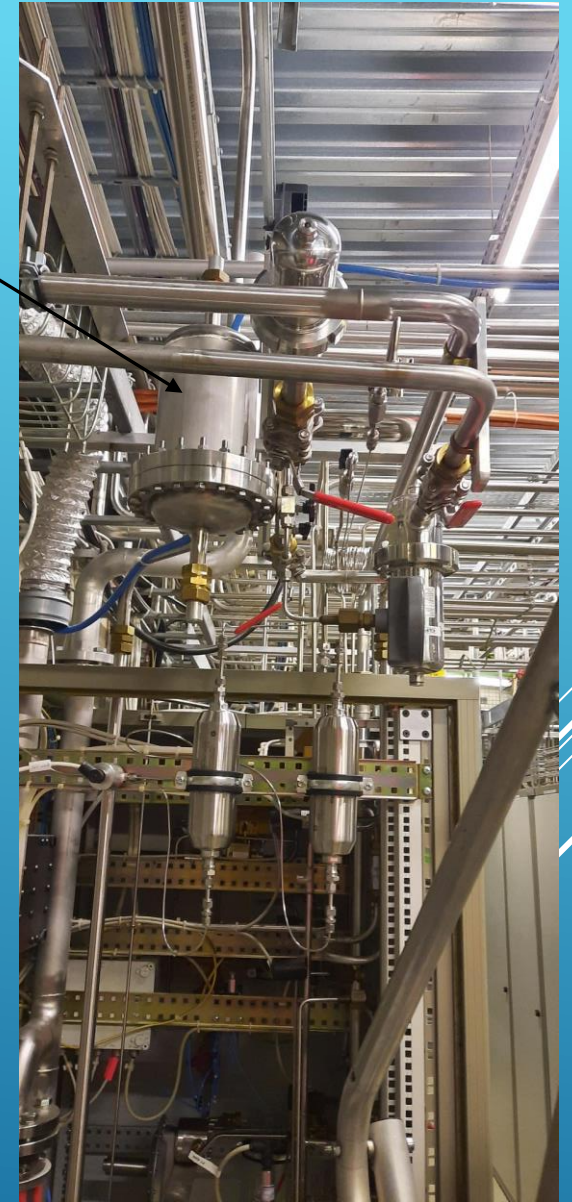
- Example of intervention on TPC

Construction and installation of a new small filtration low delta P filter ( 0.02 microns and 20mbars)

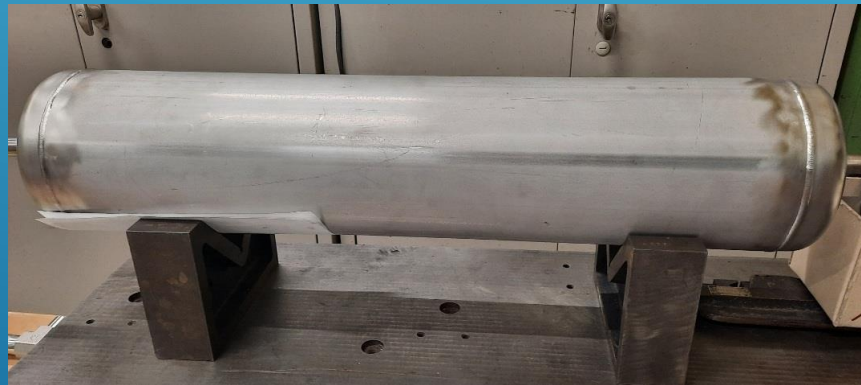
- TRD Leak search
- TPC pump dumper
