Observation of Radiation Damage in the ATLAS Pixel Detector

Markus Keil

On behalf of the ATLAS Collaboration

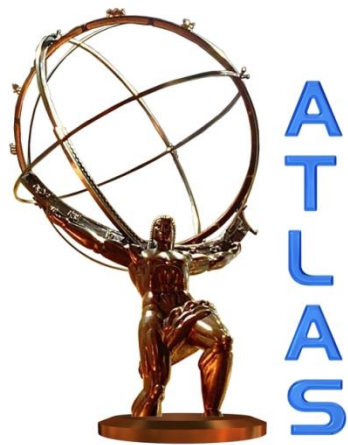
- 3 hit-system for $|\eta| < 2.5$
 - 3 barrel layers
 - 2 x 3 endcap discs
- 1744 modules,
80M readout channels
- Innermost barrel layer at 5 cm
 - Radiation tolerance
 $500 \text{ kGy} / 10^{15} \text{ 1MeV } n_{\text{eq}} \text{ cm}^{-2}$
- Evaporative C3F8 cooling integrated
in local support structures
→ Module temperatures $< 0^\circ\text{C}$
(Average temperature -13°C ,
warmest module at -5°C)

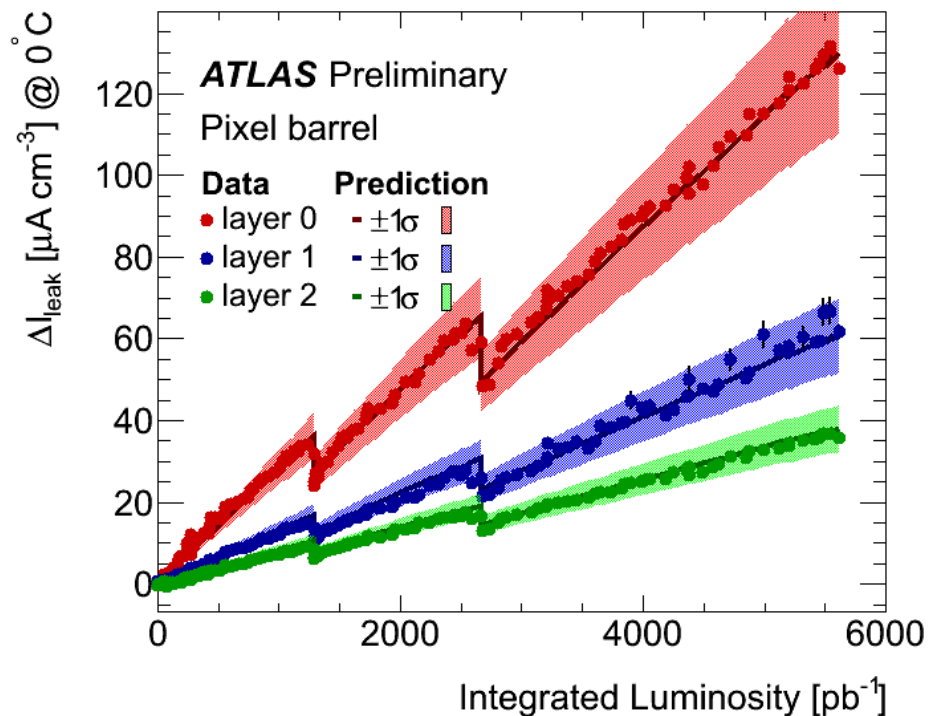
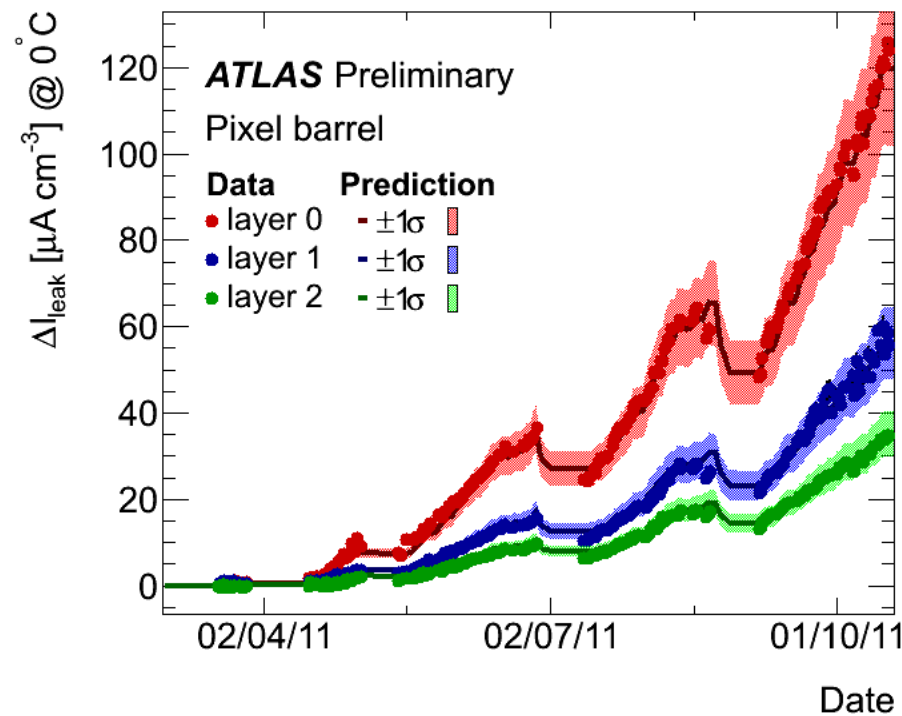
- Leakage current follows integrated luminosity; steps consistent with annealing during warm-up periods
- Prediction and measurement qualitatively agree very well, however prediction had to be scaled up
 - Layer 0: +15%, Layer 1 and 2: +30%

- Several measurement methods to monitor reverse-bias current and depletion voltage
 - Reverse-bias current: Per 6/7 modules, per module, per pixel
 - Depletion voltage: track based (after type inv., but validated now), calibration scan (before type inv.)
- Qualitatively measurements show clear signs of radiation damage as expected
 - Increase of leakage current with accumulated fluence
 - Decrease of depletion voltage
 - Signs of annealing in periods with no cooling
- For reverse-bias current (power supply measurement) quantitative agreement is obtained when scaling the expectation up by 15 (30)%

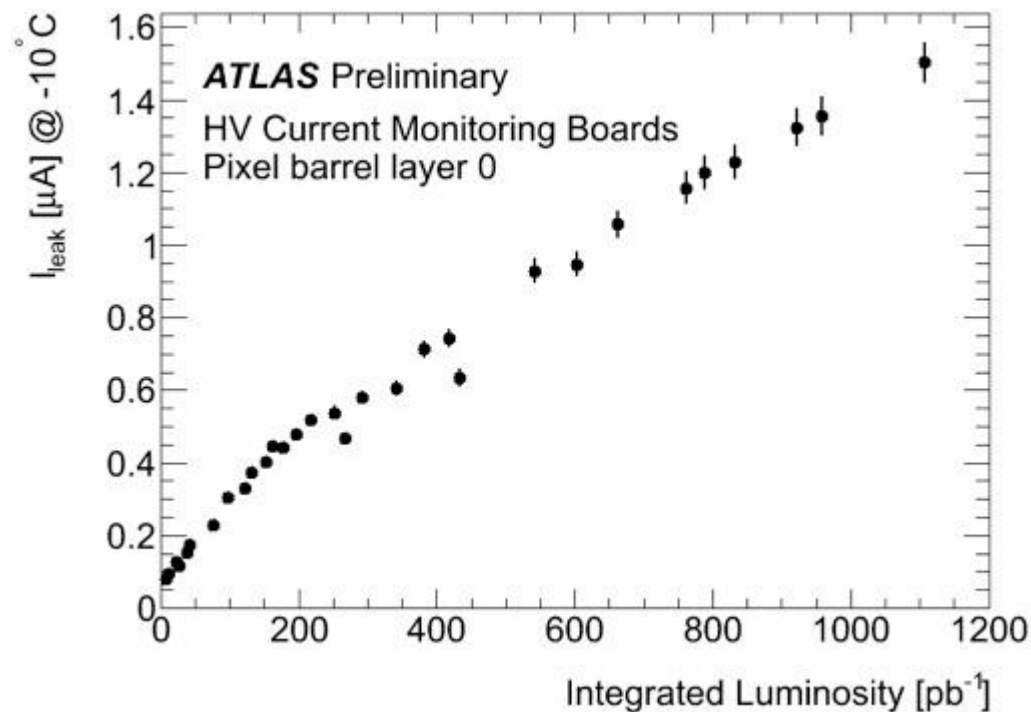
- Alternative measurement: started to install current monitoring boards in the HV-fanout crates in the counting room
 - One measurement per module, precision ~ 10 nA
 - Up to now 56 modules of the innermost layer instrumented, more during next shutdown
 - Work on calibration ongoing

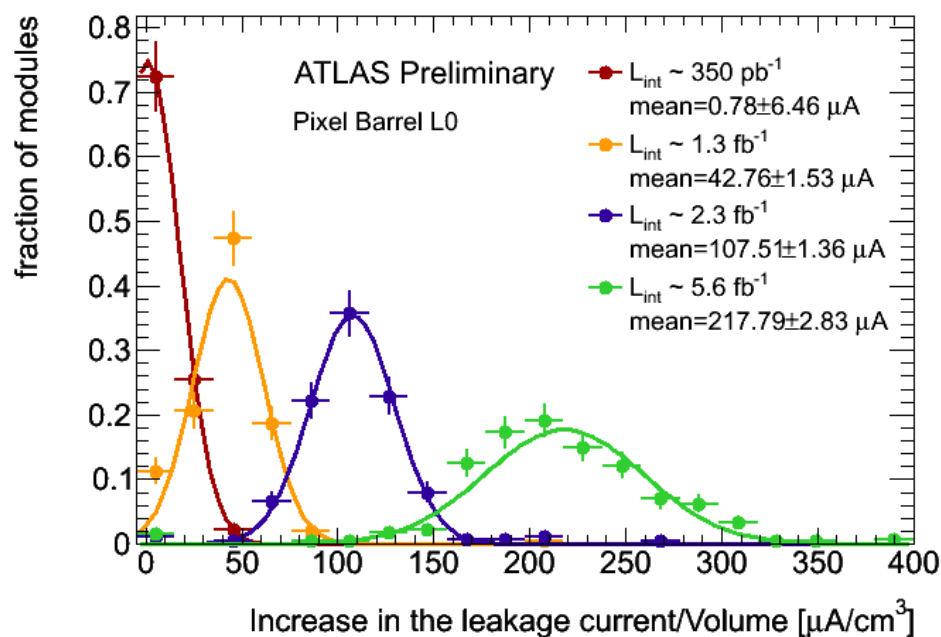
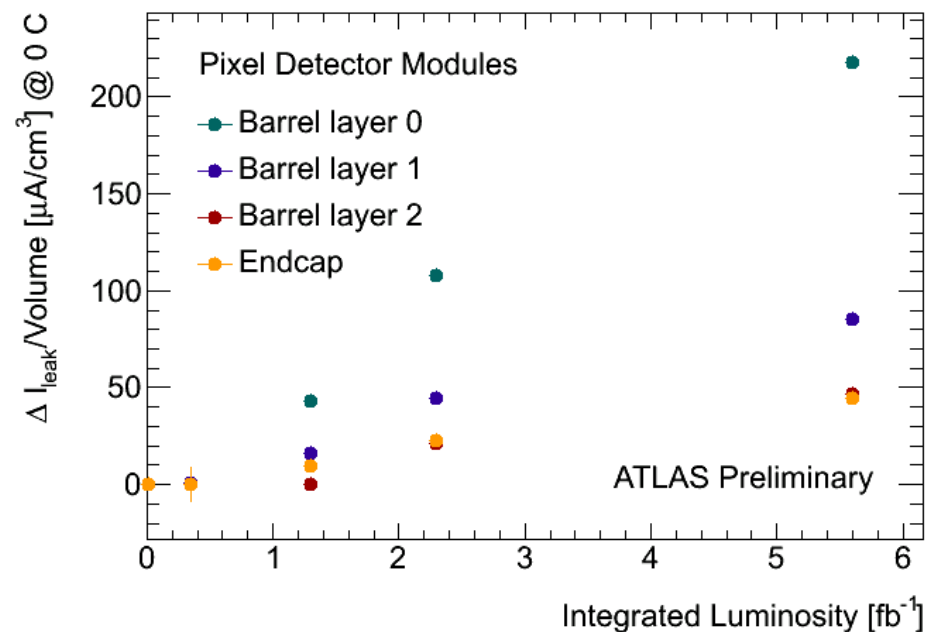
- Reverse-Bias Currents per module determined from Monleak data
 - Left: B-Layer, right development for all layers
- Absolute calibration and comparison with model still ongoing
- But allows already some toy examples with inhomogeneous distributions

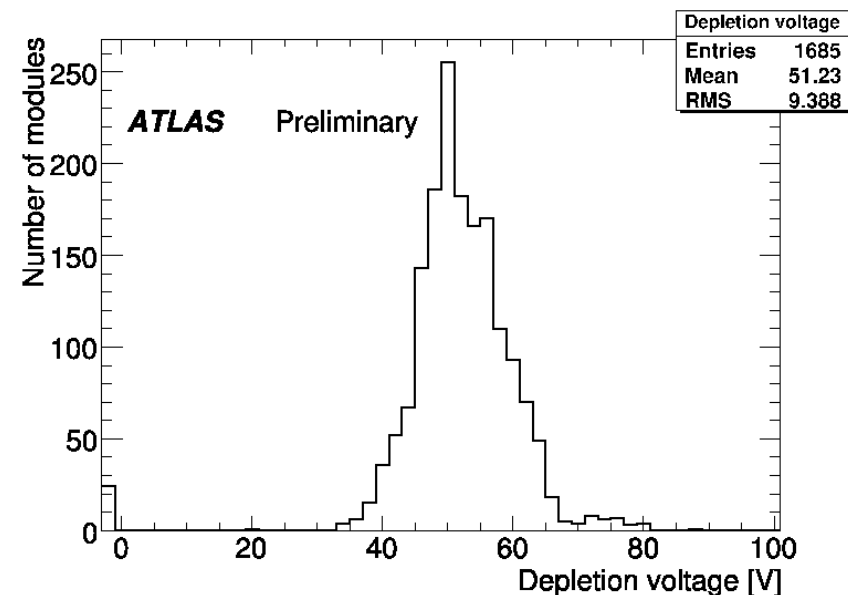
- Estimate point of full depletion from number of pixel with no hits
- Example shows decrease of depletion voltage from July to August (datataking)
- Between June 22 and July 8: 5 ½ days without cooling (sensors at room temperature), increase of the depletion voltage due to annealing
- More quantitative analysis and comparison with models underway
