Workshop on Quality Issues in
Present and Future Silicon Detectors
CERN, 3-4 November 2011

Experience with the Test and Qualification of ALICE Double-Sided Microstrip Sensors

Luciano Bosisio

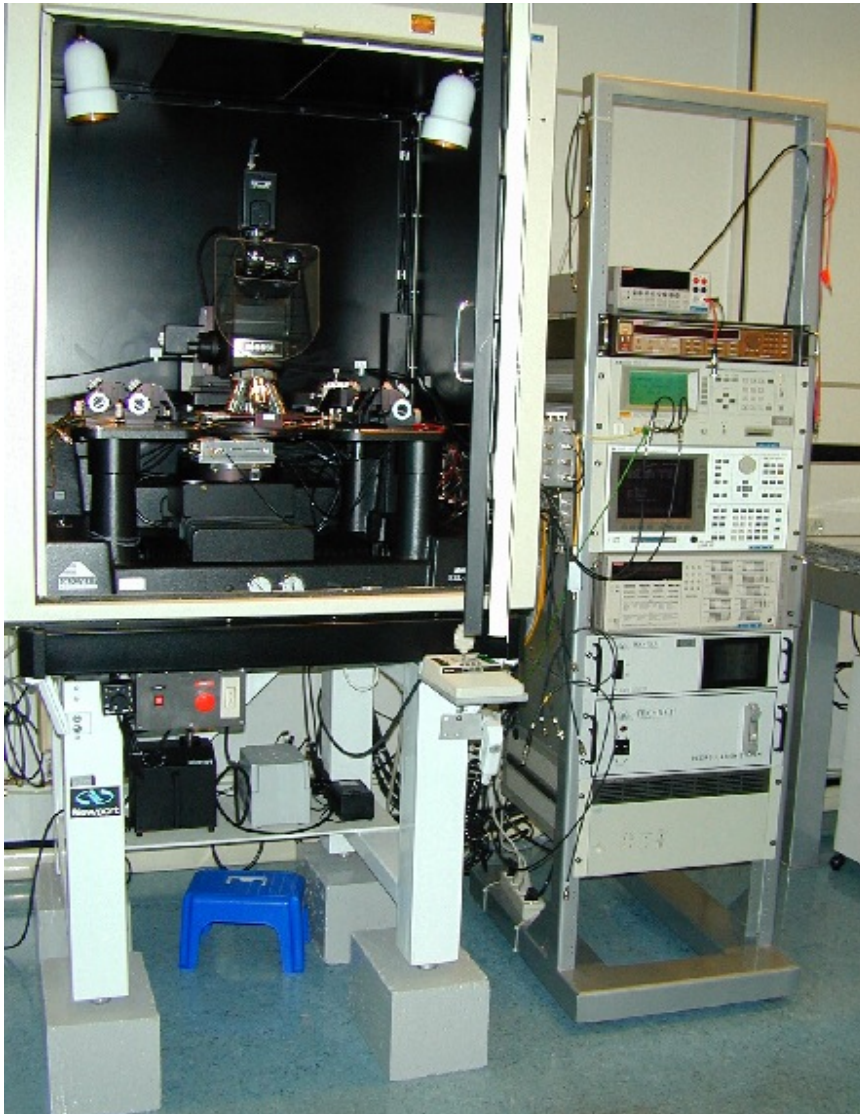
Sensor testing in Trieste

Hardware:

- Alessi REL55 **semi**-automatic prober
- I - V and C - V testing instruments + scanner

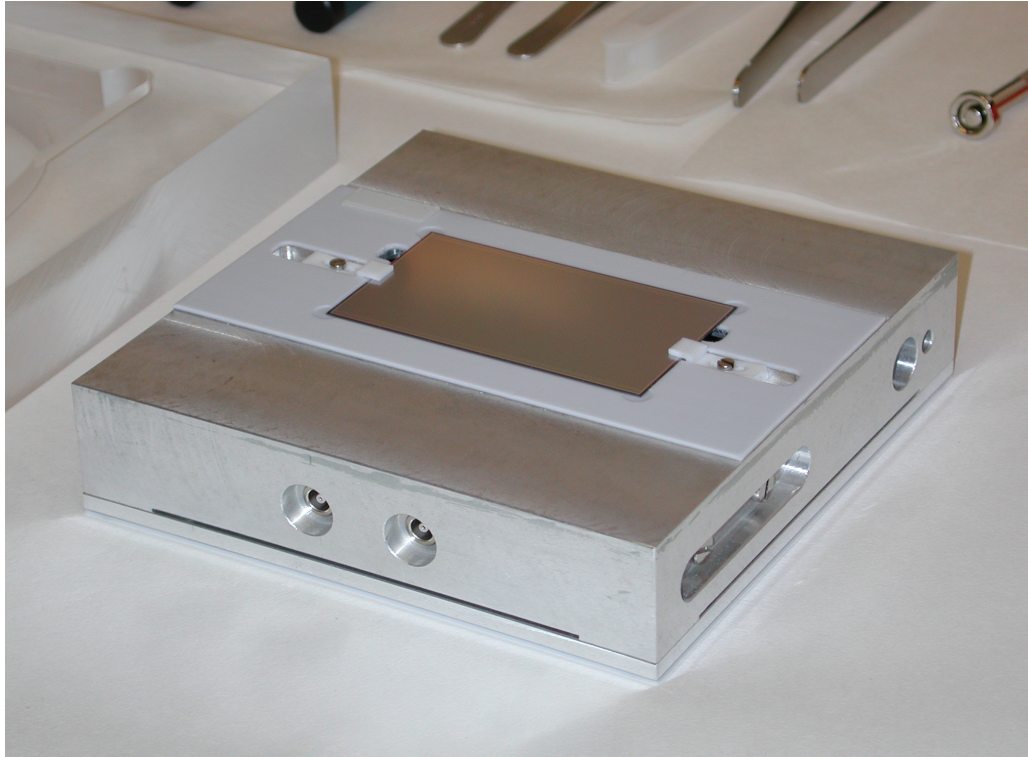
Set-up for sensor testing

Sensor held on
dedicated support

- teflon-clad mounting surface
- plastic clamps (delrin)

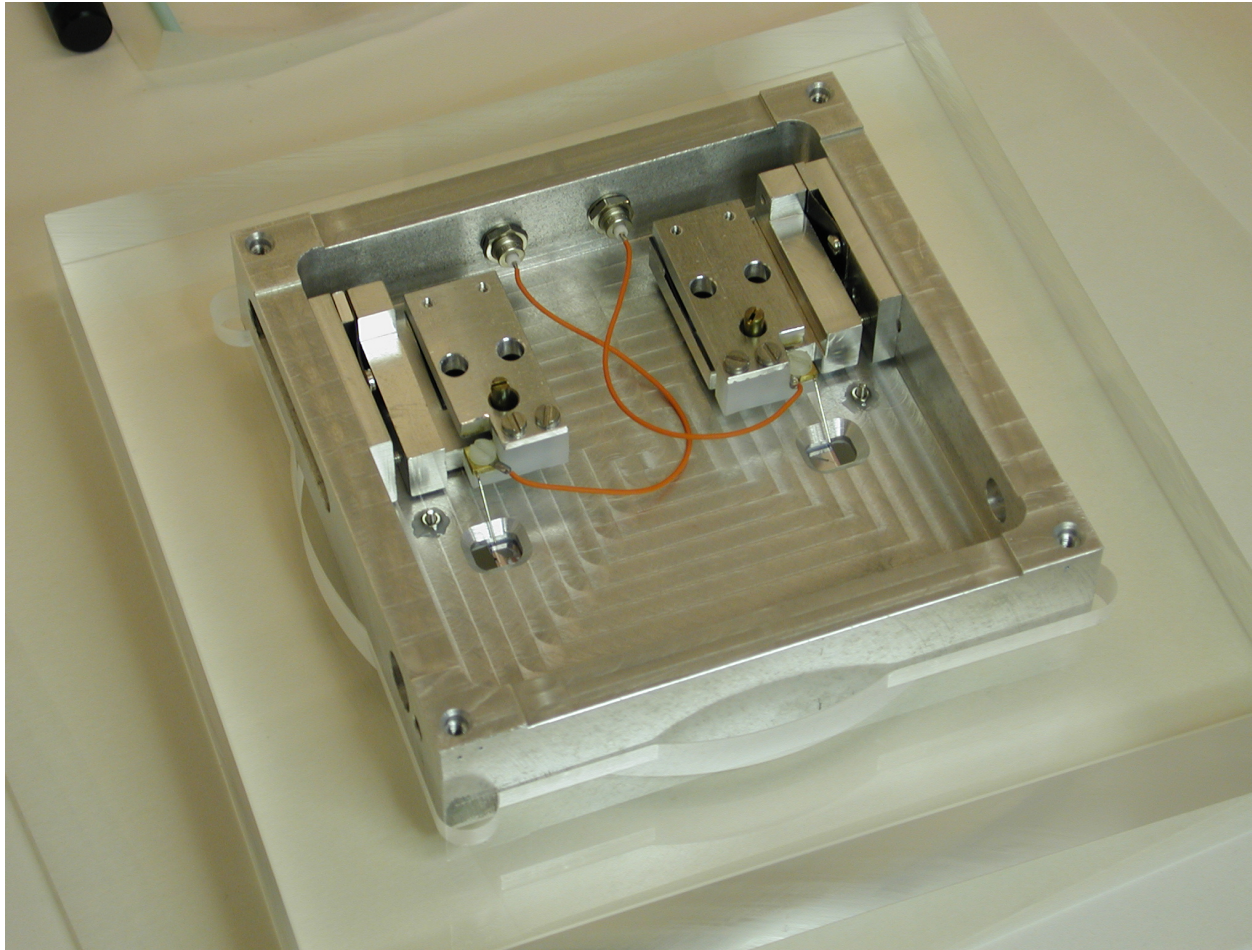
Set-up for sensor testing

Contacting
back-side
Guard Ring
and Bias Ring
by two small
manipulators
inside the
detector support

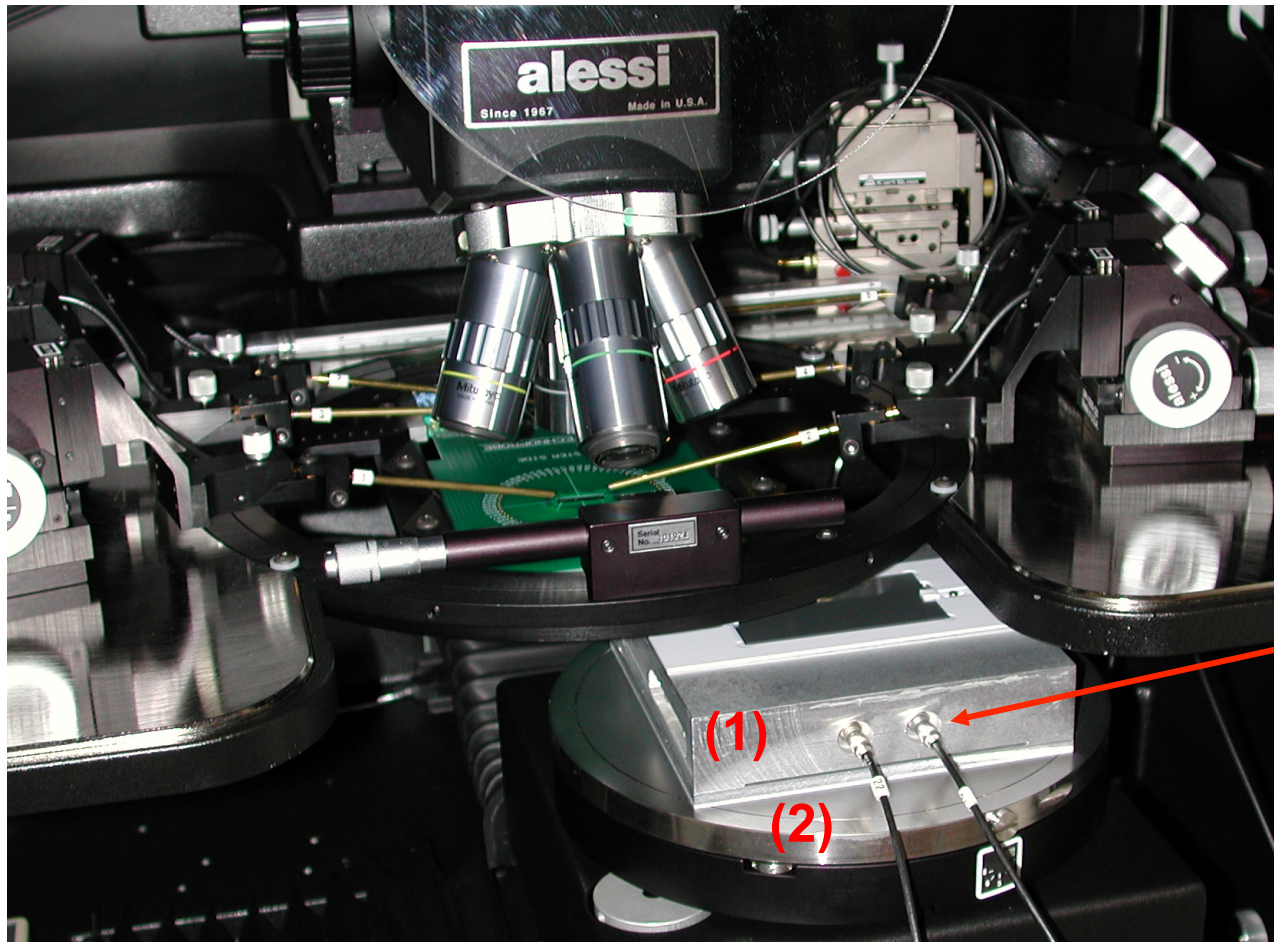
Set-up for sensor testing

The detector support (1) is mounted on the probe station chuck (2)

- held by vacuum
- contacts to backside Bias and Guard Rings available through two coaxial connectors

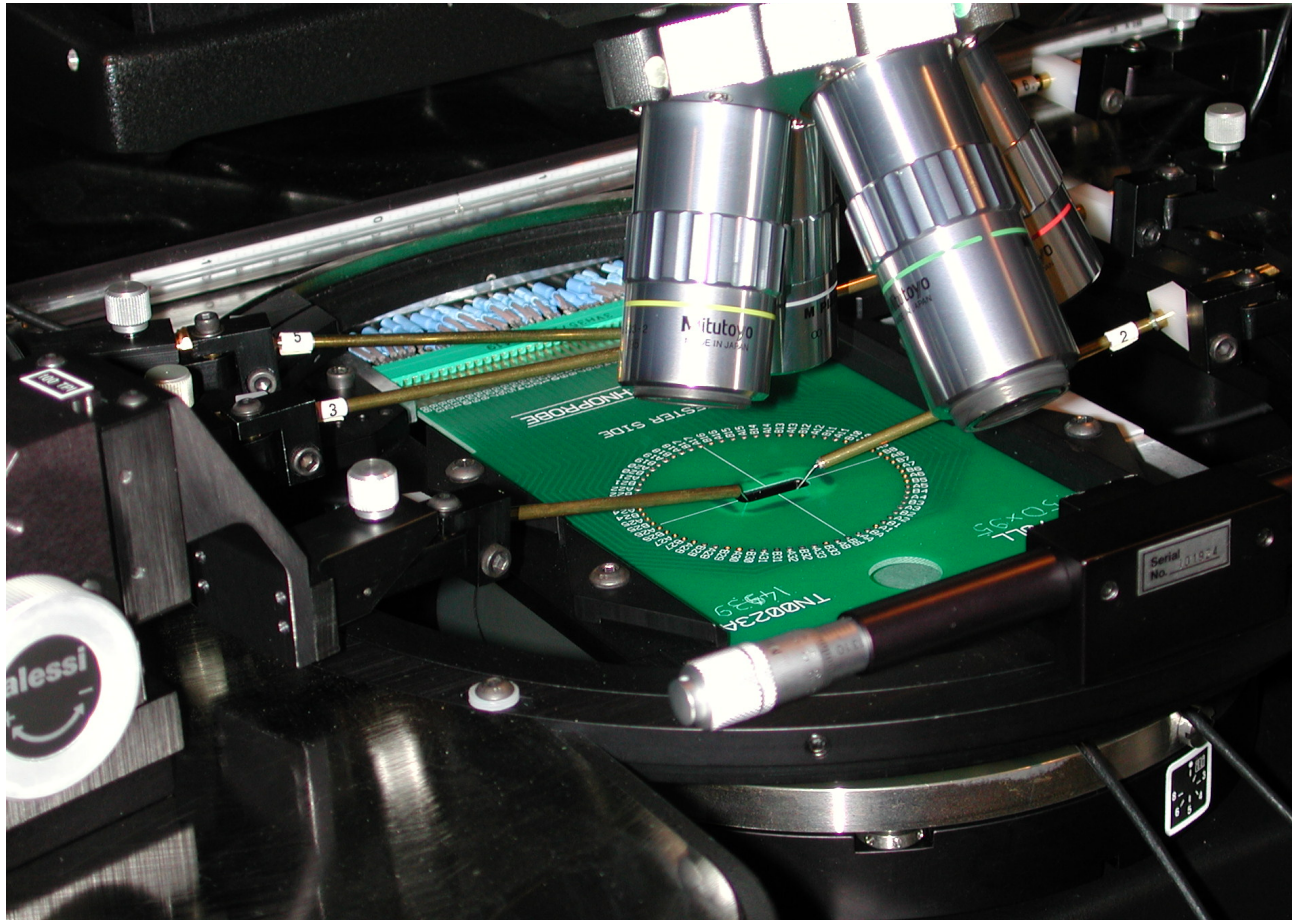
Set-up for sensor testing

Probing the detector top side with:

- a probe card to contact 50 strip pads
- two manipulators for Bias Ring and Guard Ring

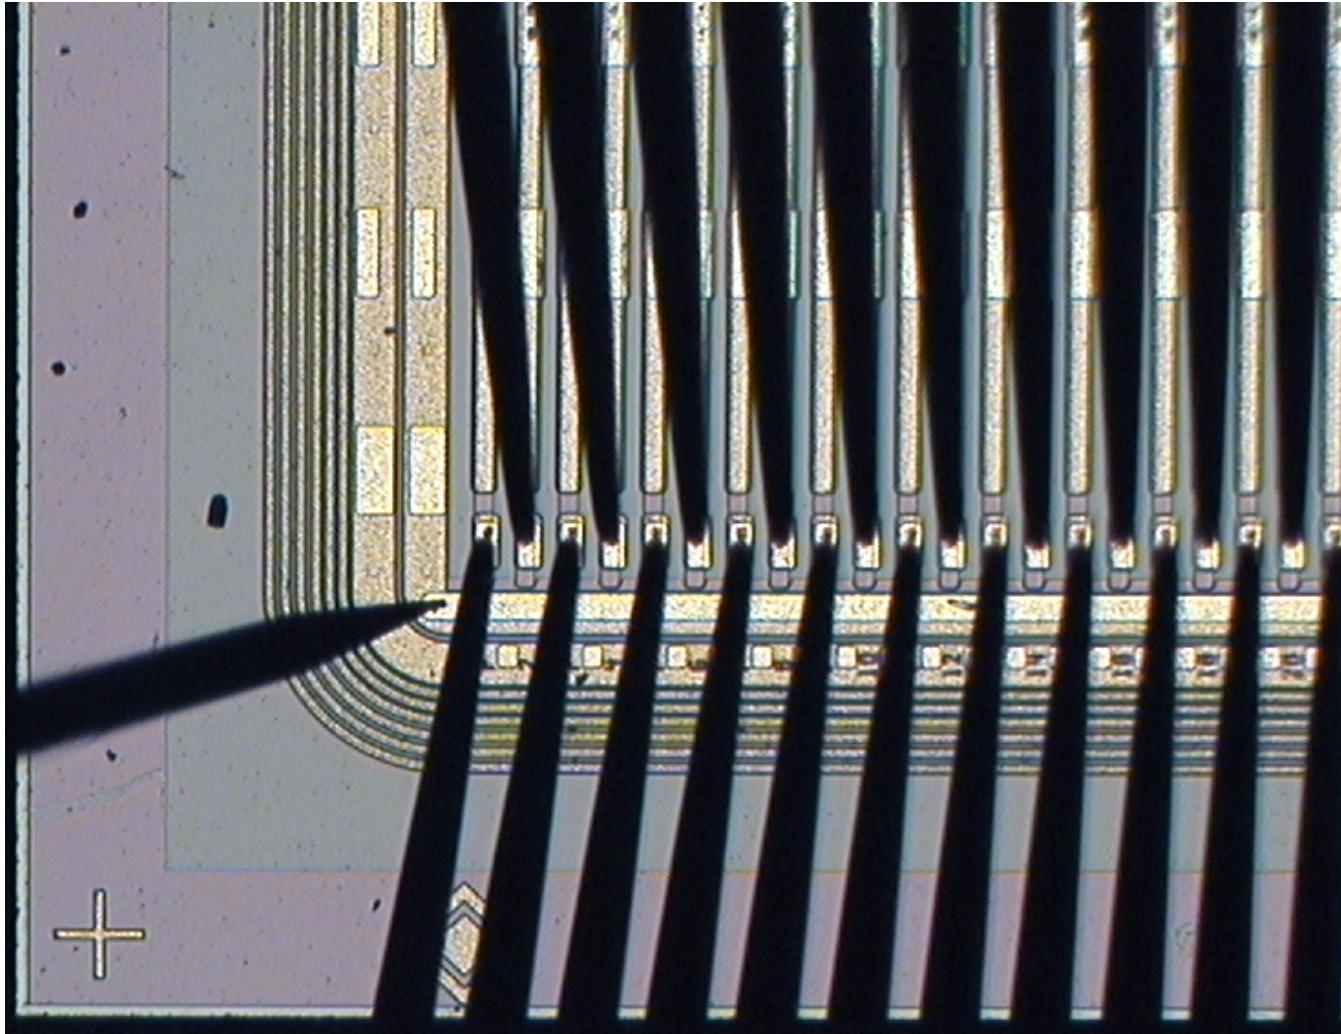
Set-up for sensor testing

Measuring the 'DC' pads of a detector

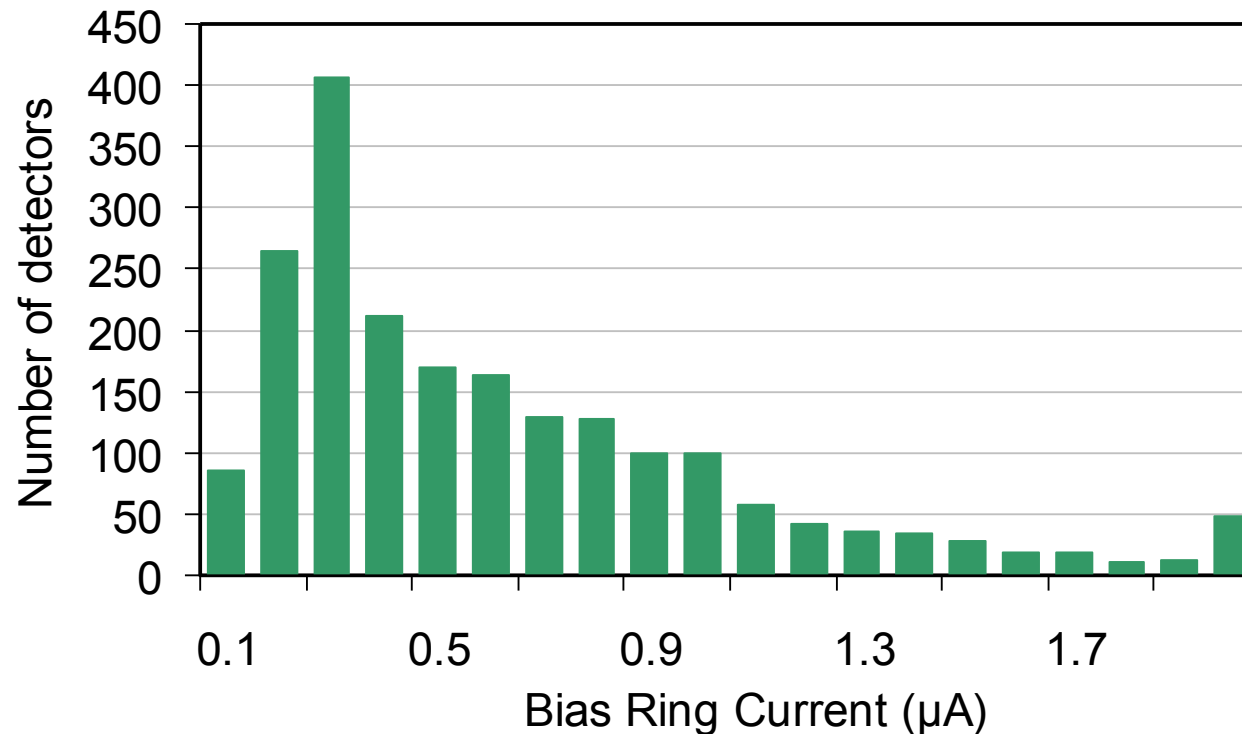
Bias Ring leakage current distribution

Specifications:

- Bias ring current $< 2 \mu\text{A}$ (Measured average $0.61 \mu\text{A}$)
- Guard ring current $< 5 \mu\text{A}$ (Measured average 41 nA)

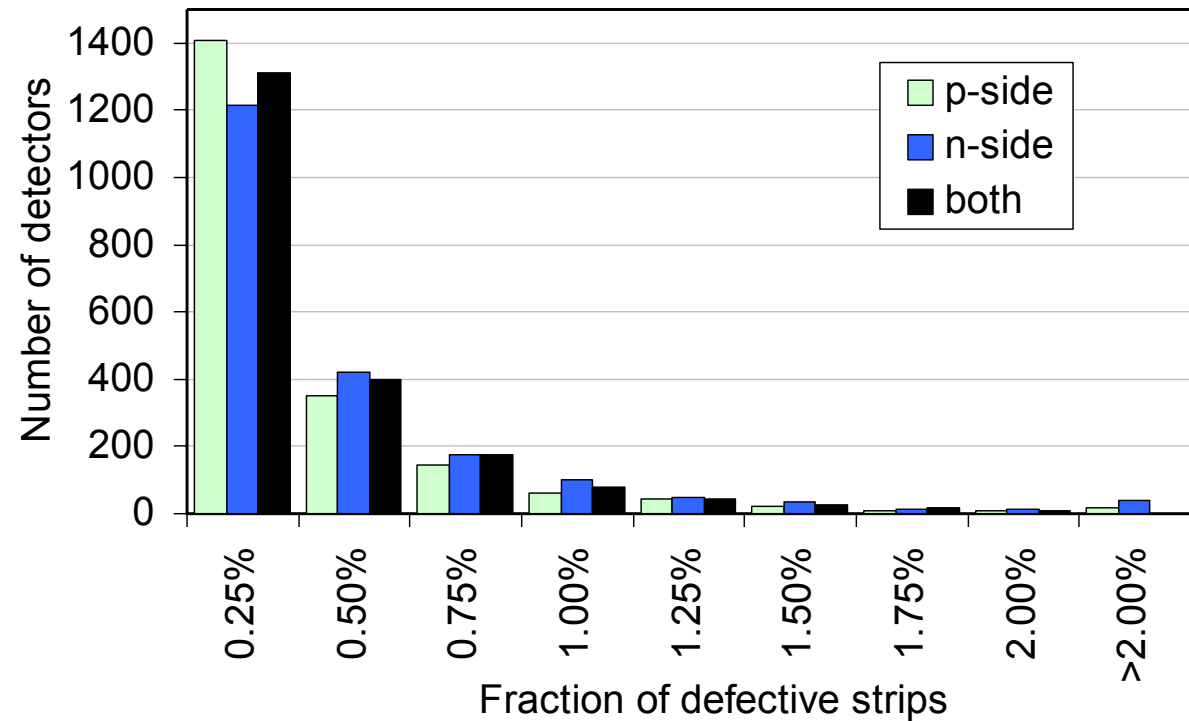
Distribution of defective strips

Defective strips are strips with either:

- Leakage current > 20 nA
- Insulation resistance < 50 M Ω
- Broken AC capacitor
- Metal electrode shorted to adjacent ones
- Open metal electrode

The specification on defective strips is:
total number
(sum of both sides) < 30
($\Rightarrow \sim 2\%$ of all strips).

The total defect number is well within specification (2%).

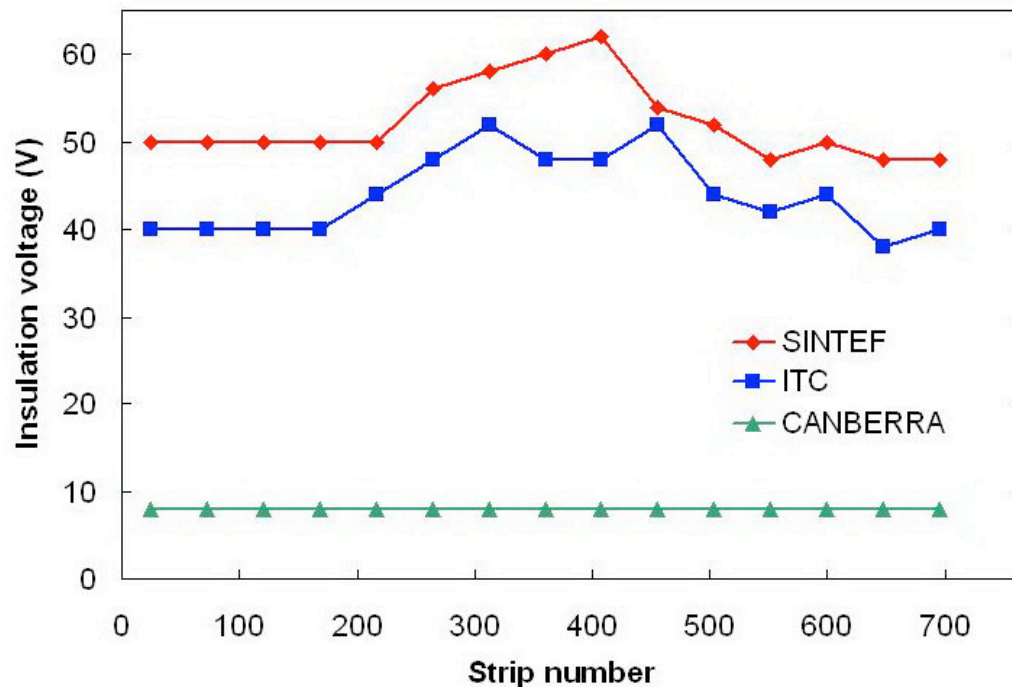
- We can profile the depletion voltage across the sensor by measuring the voltage at which n -side strips become insulated (routinely done at 15 points on every sensor)
- On FBK and SINTEF sensors there is an increase of 10-20 V from edge to center, reflecting the characteristic doping variations of FZ Si

- Canberra sensors show exceptionally low depletion voltage ($\Rightarrow \rho \approx 30 \text{ k}\Omega \text{ cm}$) and even more surprising uniformity across the sensor ($\approx 70 \text{ mm}$ on a 100 mm wafer)
- Exceptional quality of the substrate \Rightarrow lower electric fields at junction edges \Rightarrow less susceptible to high currents associated with small defects

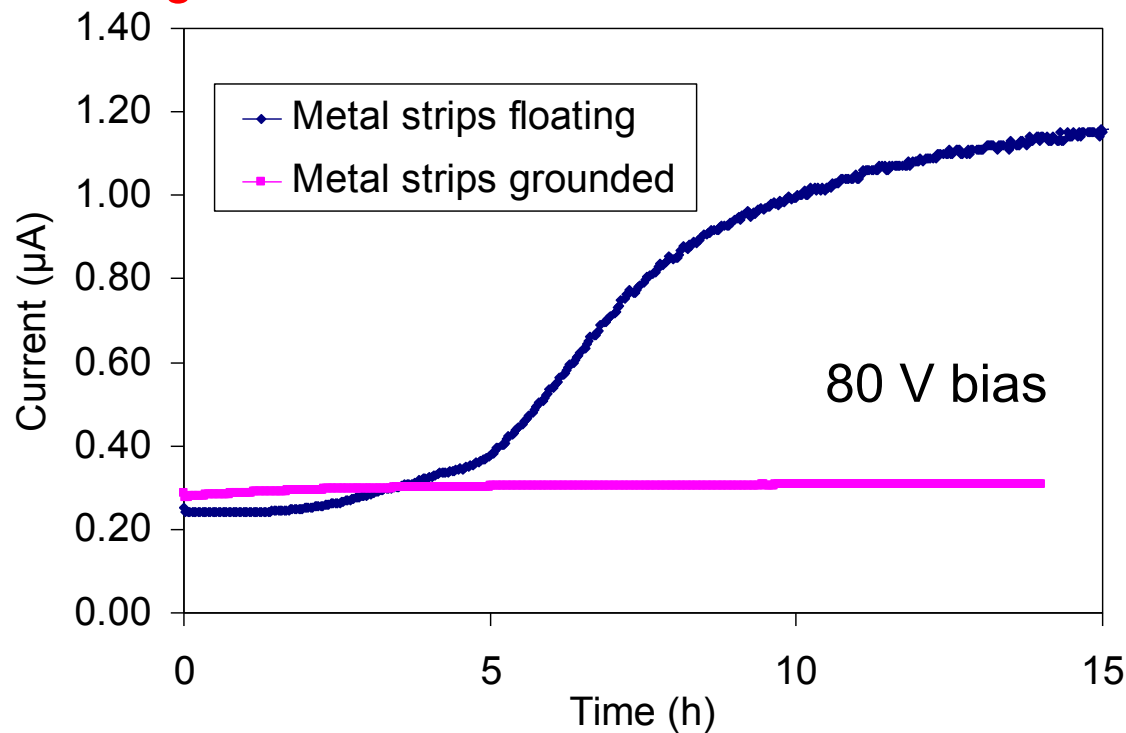
On some FBK sensors the current did increase after a few hours under bias, when the **metal strips were left floating**.

The high current originated from a single *p*-side strip, often showing a small visual defect at the implant edge.

The current was low and stable when the metal strips were grounded.

It has been found that the metal strips tend to charge at slightly positive potential w.r.t. the implanted strips, thus increasing the E field at strip edges. In the presence of defects this can lead to avalanche.

Grounded metal strips are a few V negative w.r.t. the implant (sitting at punch-through voltage) thus decreasing the edge fields.

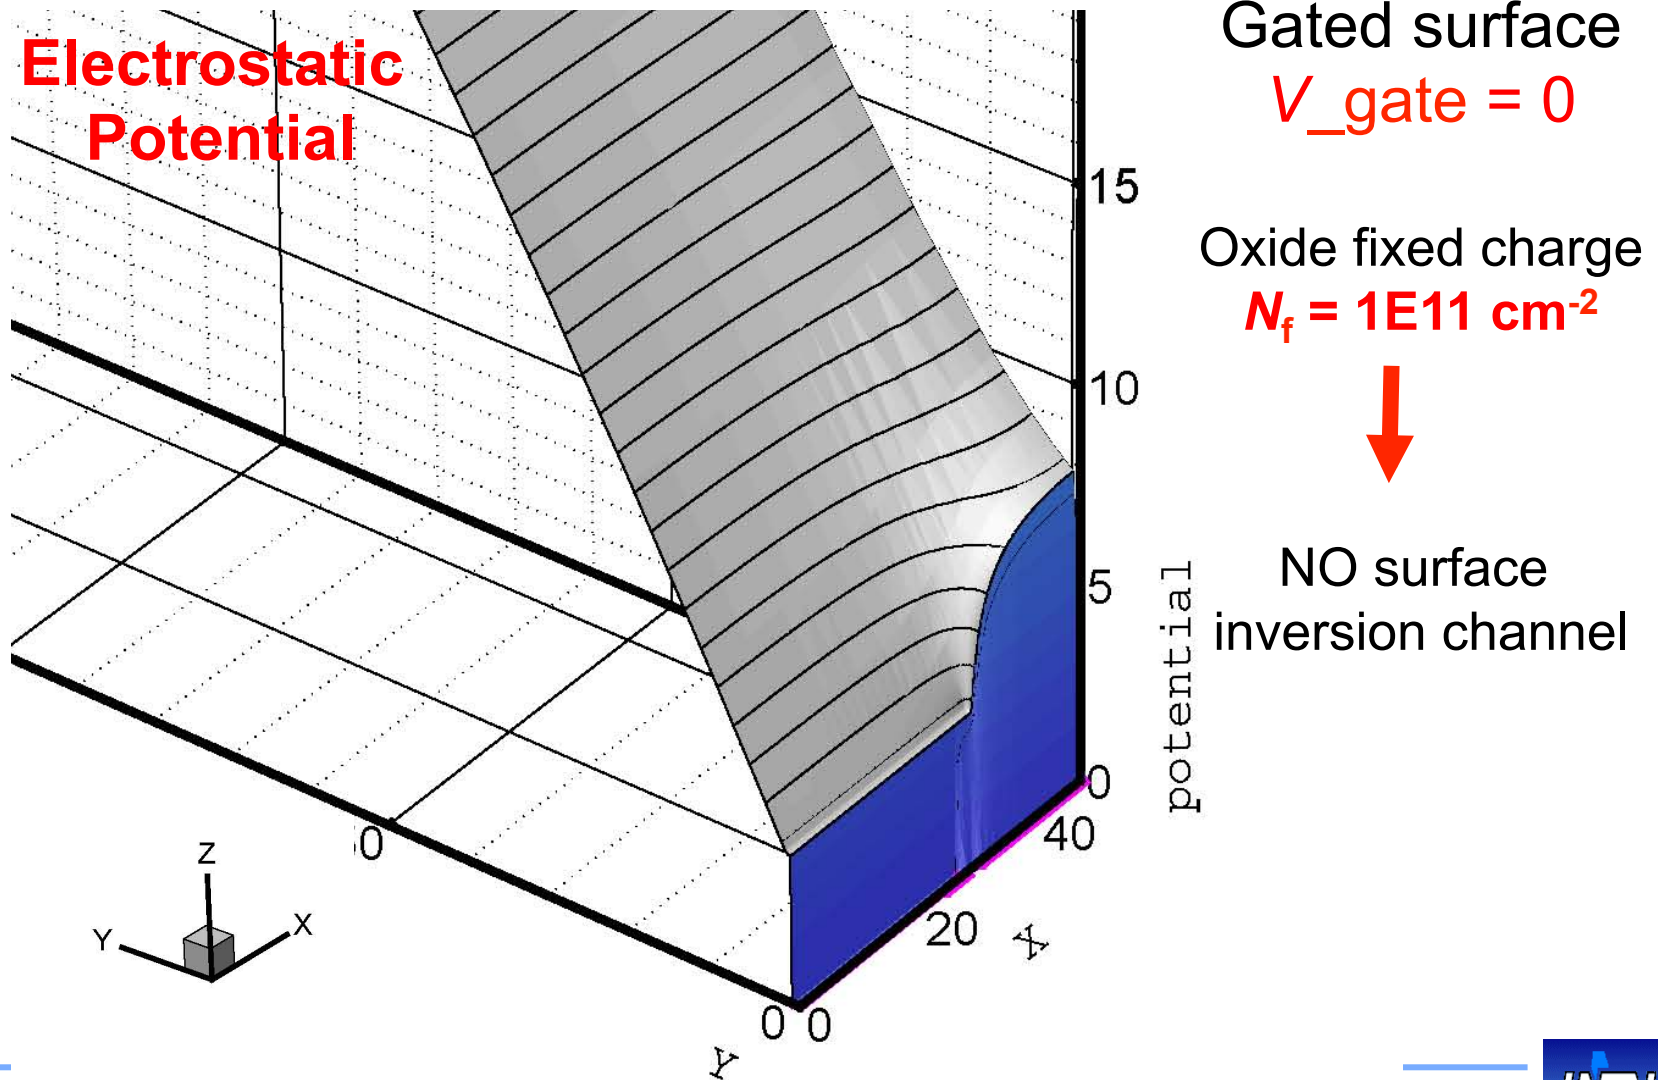
Simulation of interstrip region – High N_f

When N_f is high ($2-4 \times 10^{11} \text{ cm}^{-2}$ for FBK sensors, fabricated on (111) wafers), this has the beneficial effect of decreasing the peak electric fields, thus rising the breakdown voltage and decreasing the leakage current.

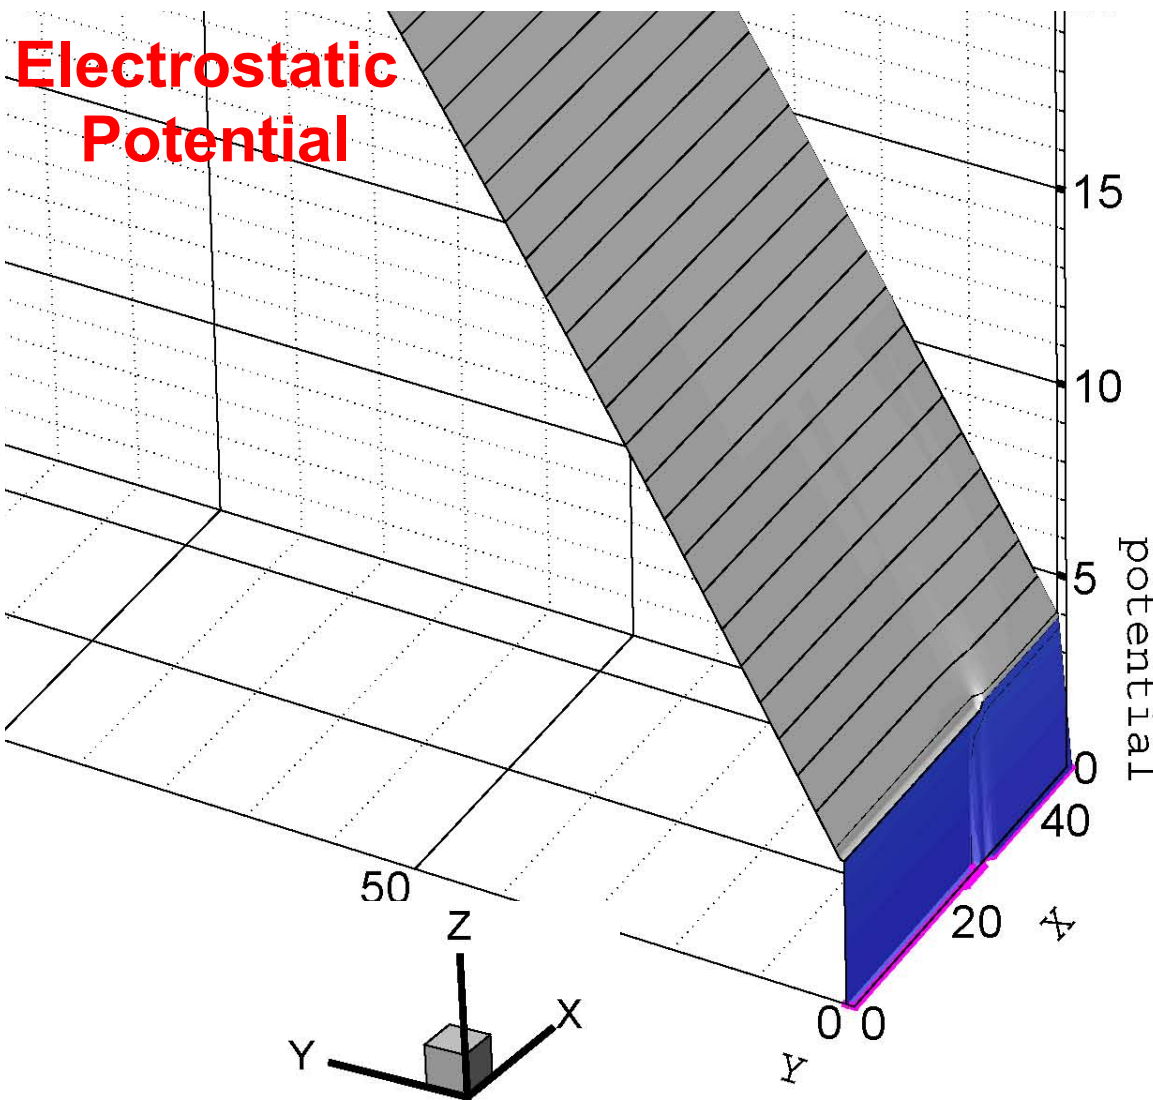
Simulation of interstrip region – Low N_f

Gated surface
 $V_{\text{gate}} = 0$

Oxide fixed charge
 $N_f = 1\text{E}10 \text{ cm}^{-2}$

Surface inversion
channel is formed

But when N_f is low ($\approx 10^{10} \text{ cm}^{-2}$ for SINTEF sensors), this negative 'gate' may turn on the parasitic MOSFET between p -strips, thus shorting them together.

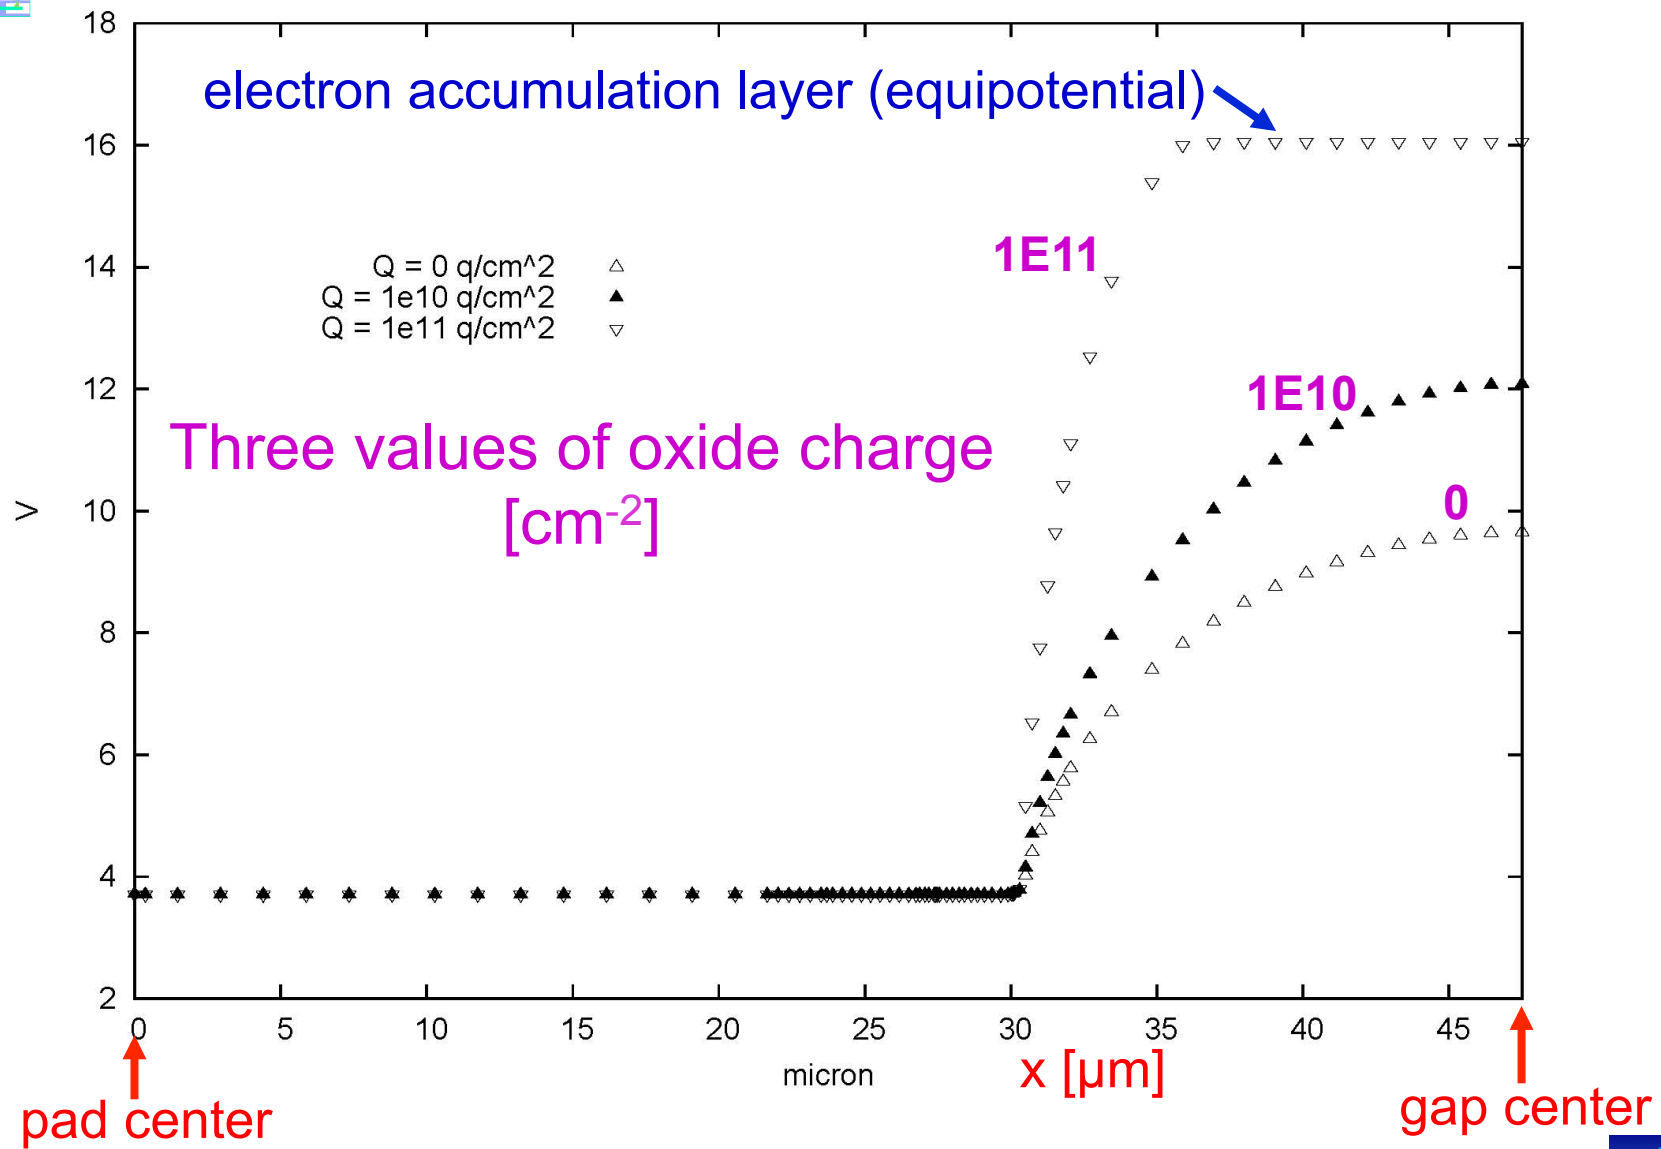
Electrostatic potential along the surface - No Gate

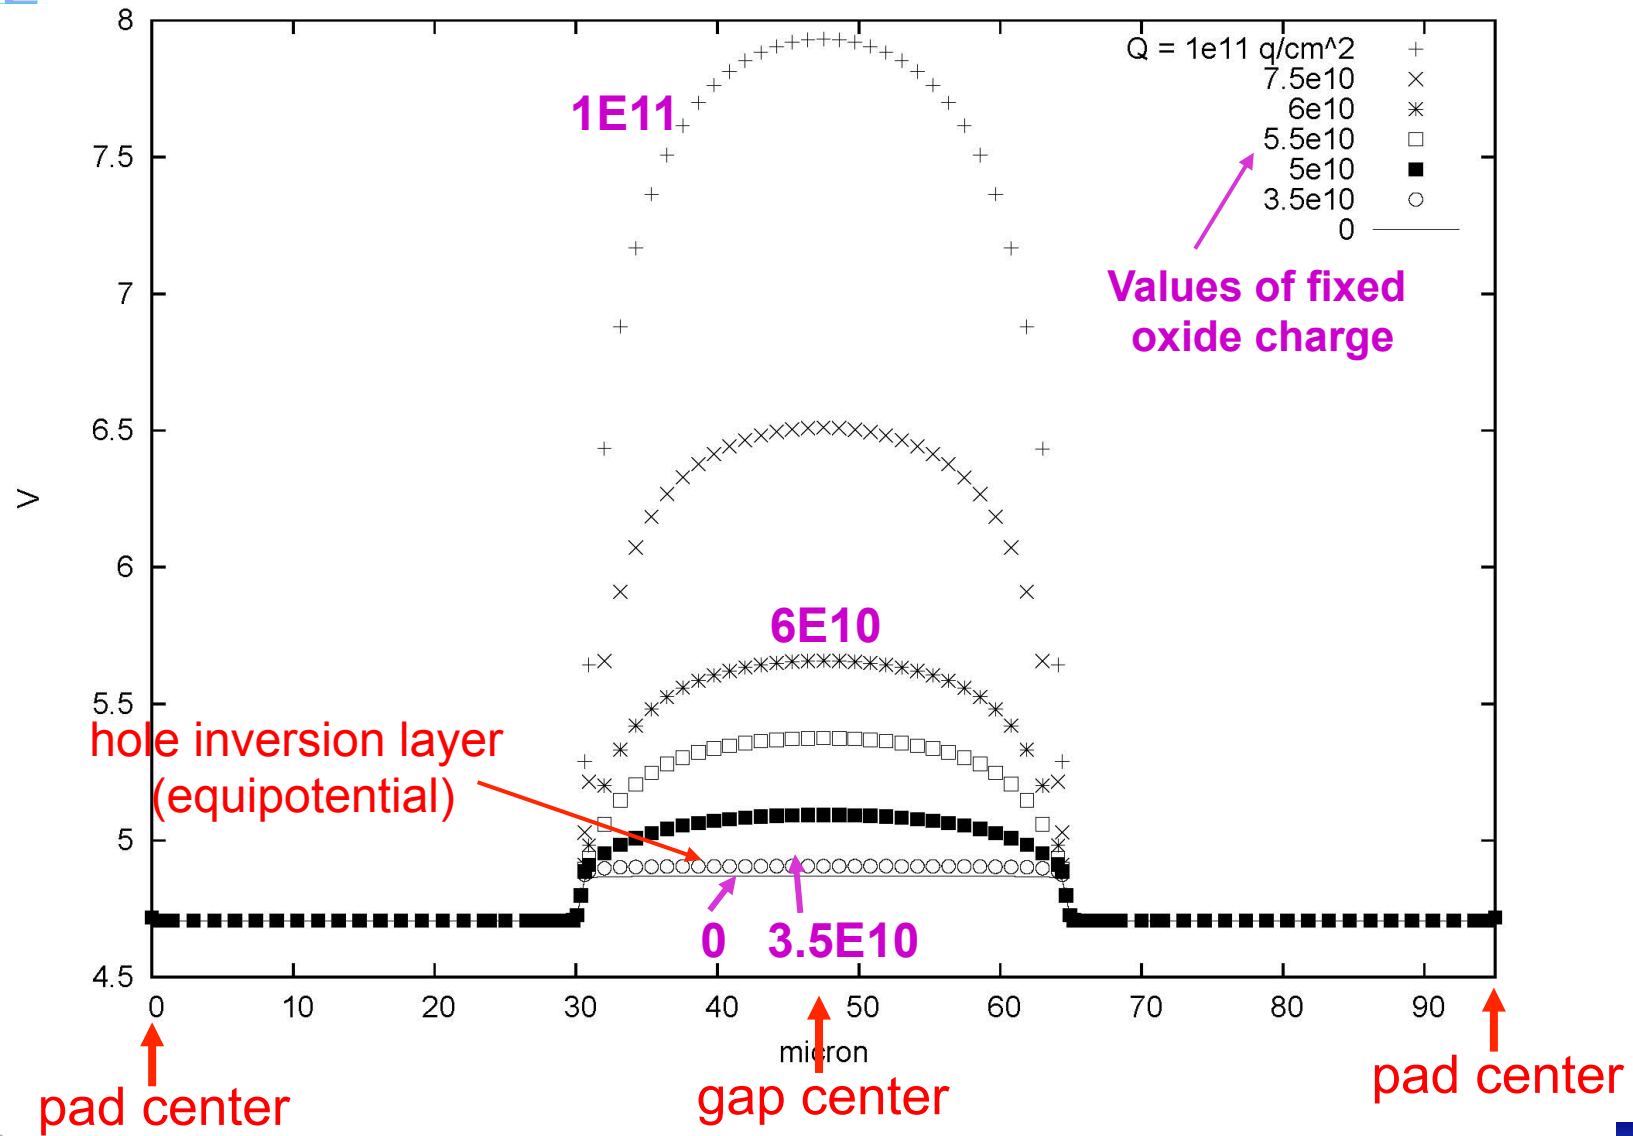
Electrostatic potential along the surface $V_{\text{gate}} = 0$

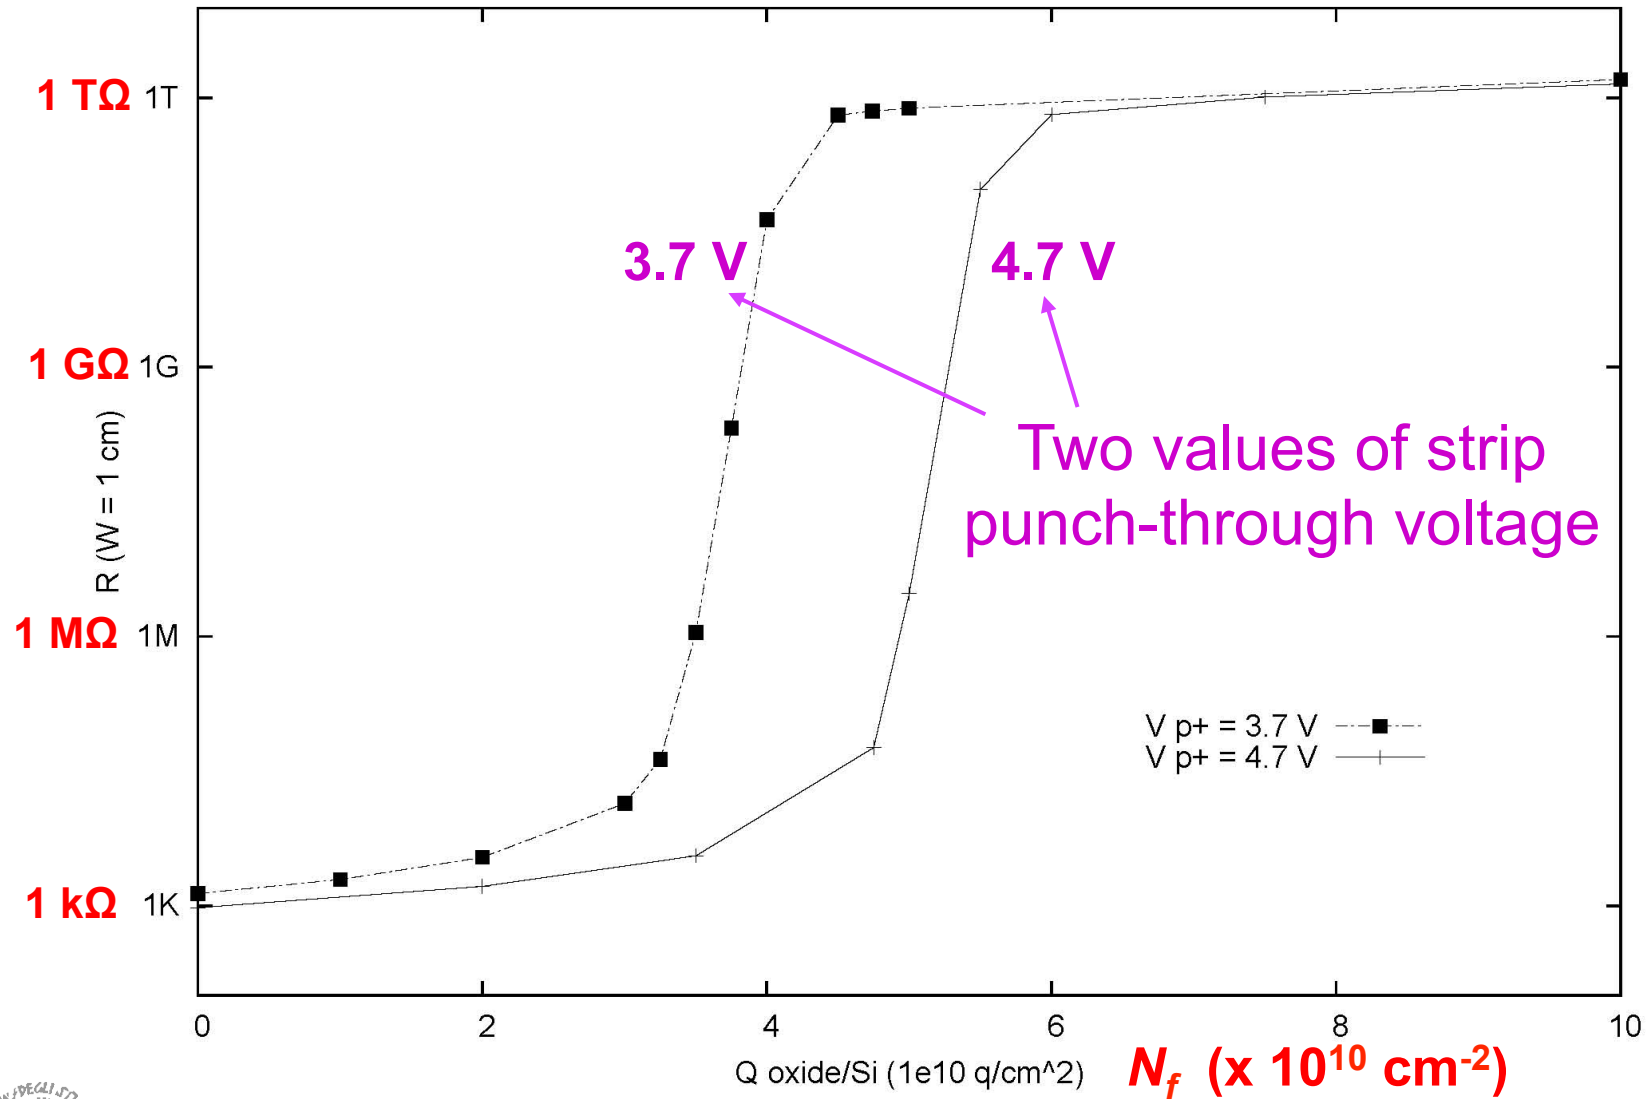
Interstrip resistance vs. oxide fixed charge $V_{\text{gate}}=0$

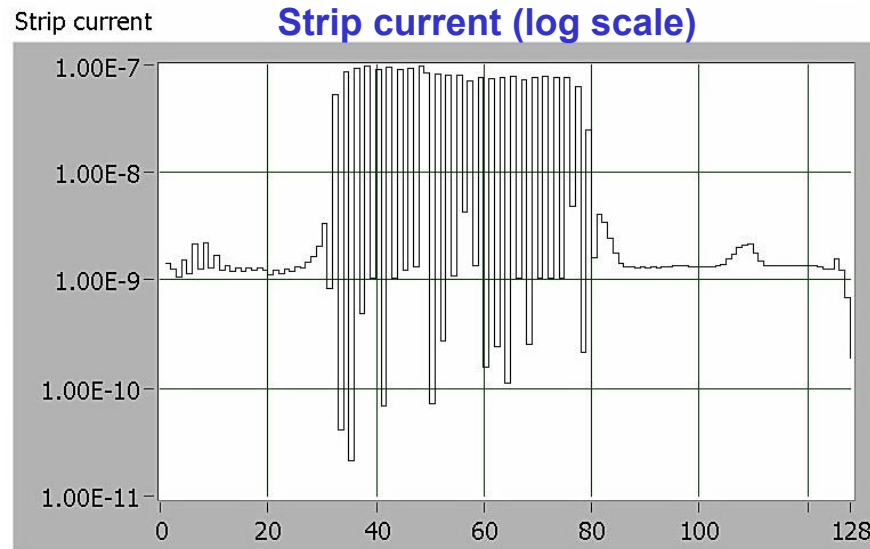
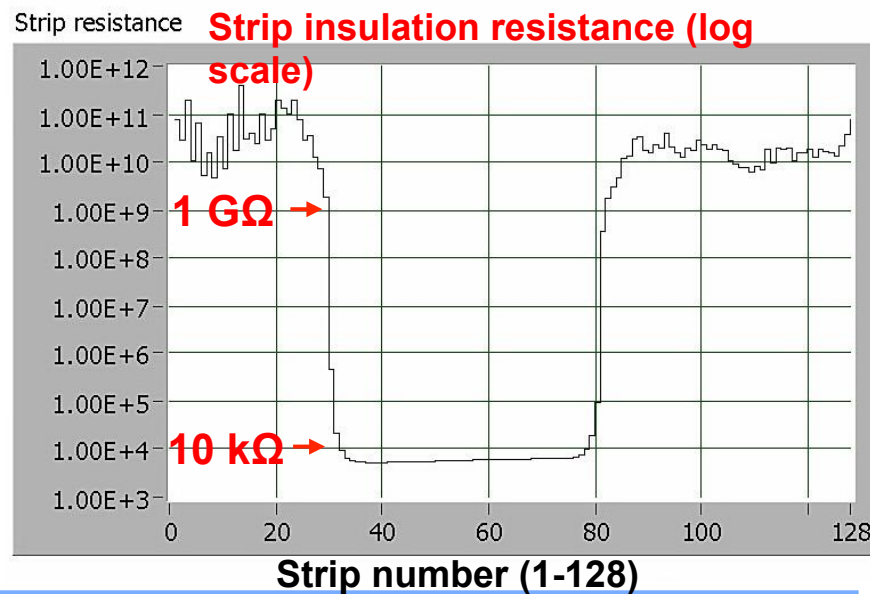
Scan of P-side DC pads on non-irradiated test sensor

- Metal strips # 31-80 grounded with probe card for ~1 h with sensor under bias

- 12 h under bias with AC strips floating before making the scan

Low resistance between DC strips #31-80

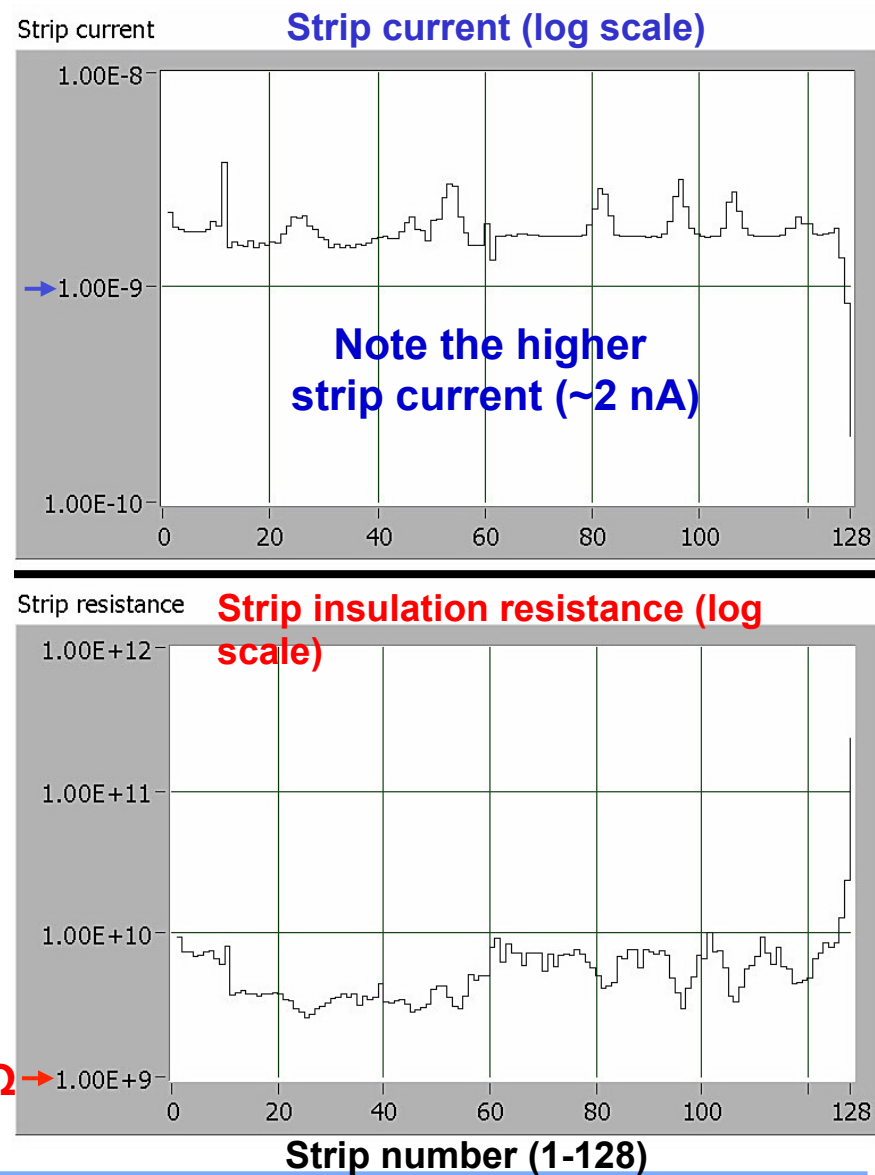
Scan of P-side DC pads on irradiated test sensor

- Metal strips # 31-80 grounded with probe card for ~1 h with sensor under bias

- 12 h under bias with AC strips floating before making the scan

No low-resistance strips
