Workshop on Quality Issues in
Present and Future Silicon Detectors
CERN, 3-4 November 2011

Experience with the Test and Qualification of ALICE Double-Sided Microstrip Sensors

Luciano Bosisio

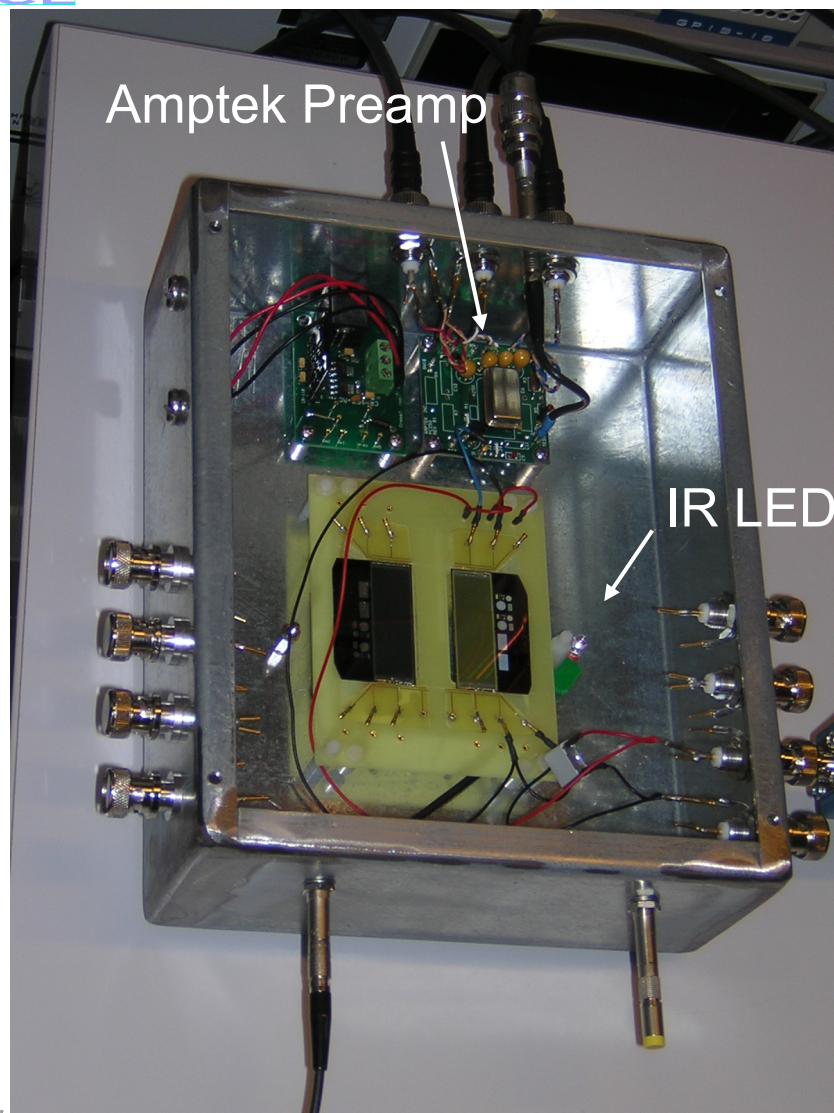
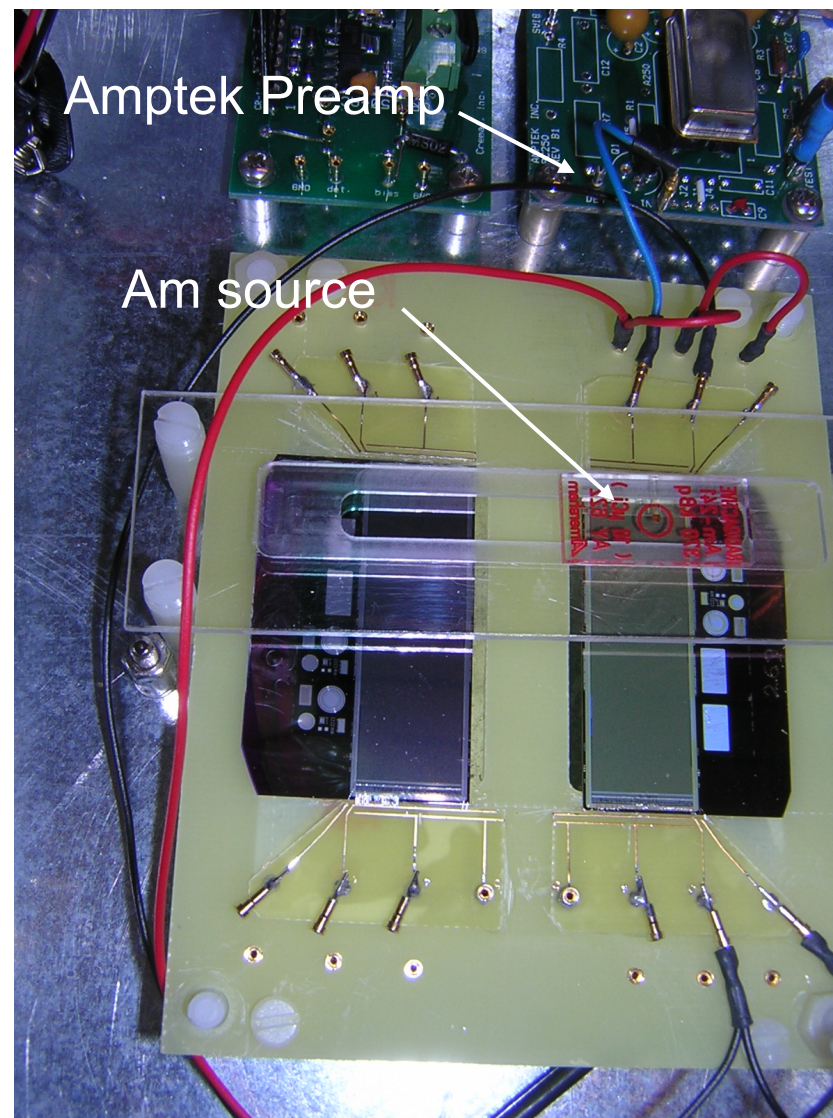
Noise Measurements: Setup

- Test sensors glued and bonded to PCB board
 - AC and DC pads of one strip per side bonded to external terminals
 - all other AC strips bonded to a common bus
- Amptek A250 preamplifier with 2SK152 external input JFET
- Amptek PX4 pulse processor with digital filter
- ^{241}Am 60 keV X-ray source for calibration (~2/3 of a m.i.p.)
- IR LED to increase the leakage current by photogeneration
- Single-channel measurement \Rightarrow no C.M. subtraction possible
 \Rightarrow very sensitive to pick-up \Rightarrow good shielding and filtering needed

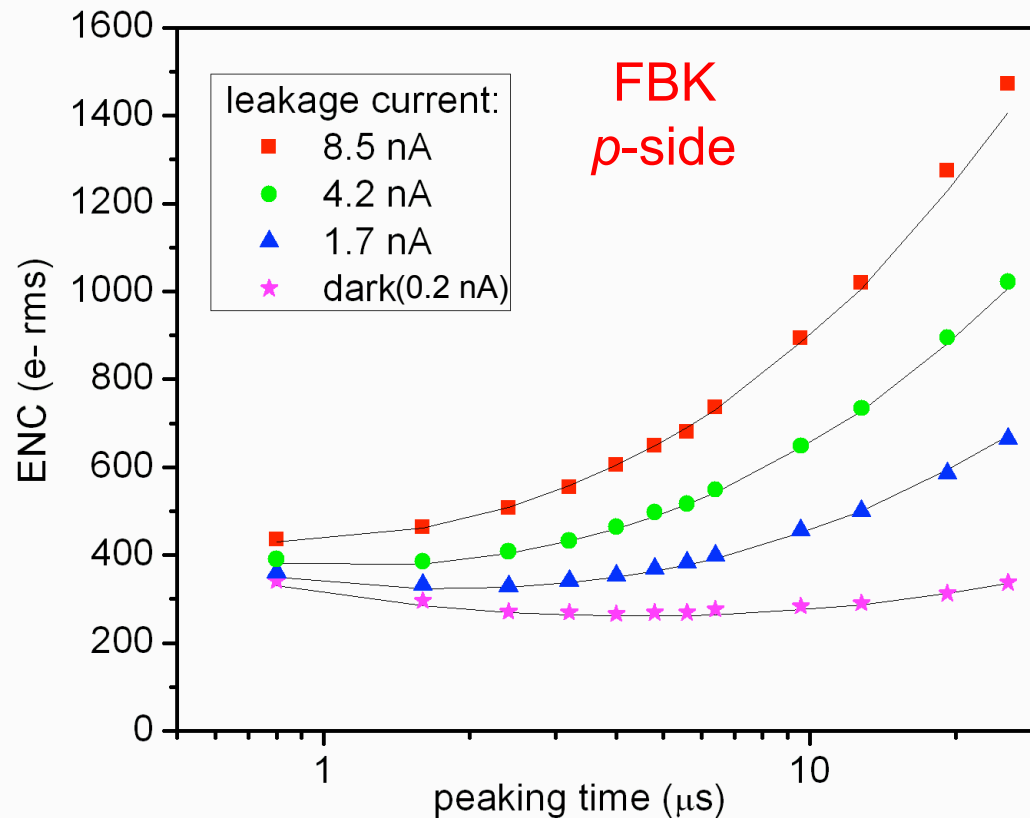
Noise vs. peaking time and leakage current

Continuous lines: calculated from Eq.(1)

- Leakage current varied by photogeneration
- The measured noise agrees well with the prediction of Eq.(1), with:

- g_m, R_f, C_{det} determined by direct static measurements
- C_{input}, R_S, A_f evaluated from noise measurements with open amplifier input

- The noise contribution of punch-through is as expected

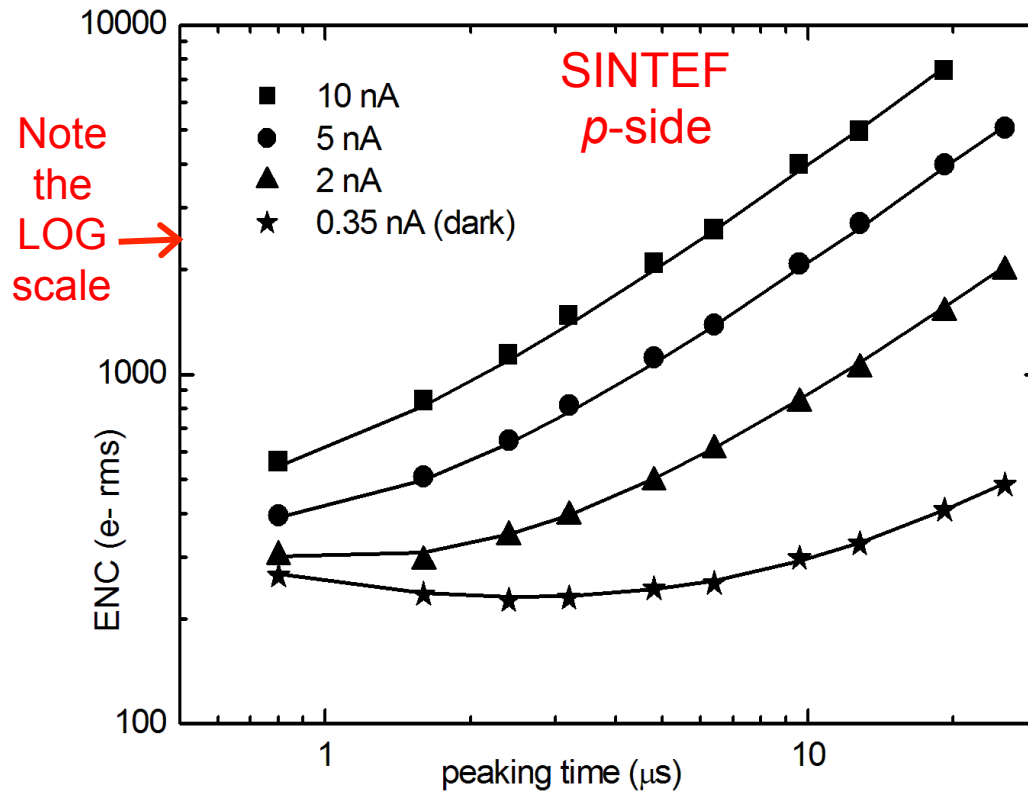
Excess Noise on p -side of SINTEF Sensor

Continuous lines: calculated from Eq.(1) with the extra noise term (2), where the value of A is defined by fitting the data

- Photogenerated current
- At high τ and/or I_L values, noise is
 - much higher than expected
 - directly proportional to both τ and I_L
- There is an excess noise term

$$q^2 ENC^2 = A \tau^2 I_{PT}^2 \quad (2)$$
 added in quadrature (A = dimensionless constant)
- Spectral power density of this current noise is $\propto 1/f$: ‘parallel flicker noise’

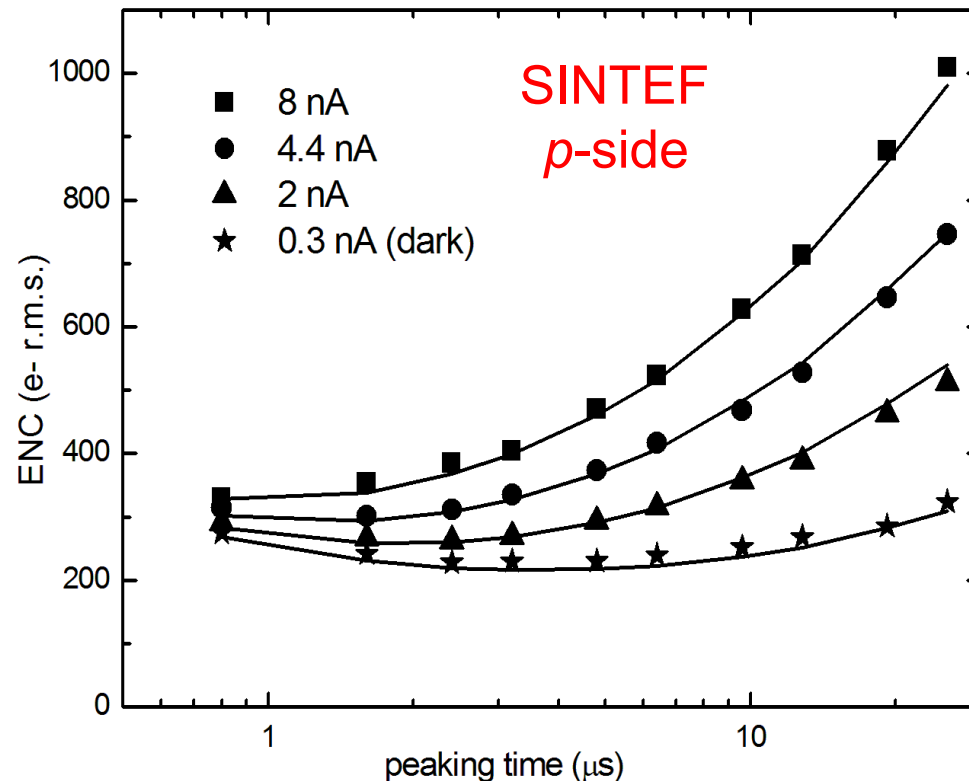
Noise when the P-T current is suppressed

- Photogenerated current
- Strip polarized through an external resistor (470 MΩ) connected to the DC pad
- ⇒ NO Punch-Through current
- ⇒ NO extra noise term
- Confirms that the extra noise is due to the punch-through current

Continuous lines: calculated from Eq.(1)

with the added thermal noise of the bias resistor: $q^2 ENC^2 = \frac{\tau}{3} \left(\frac{4kT}{R_{bias}} \right)$

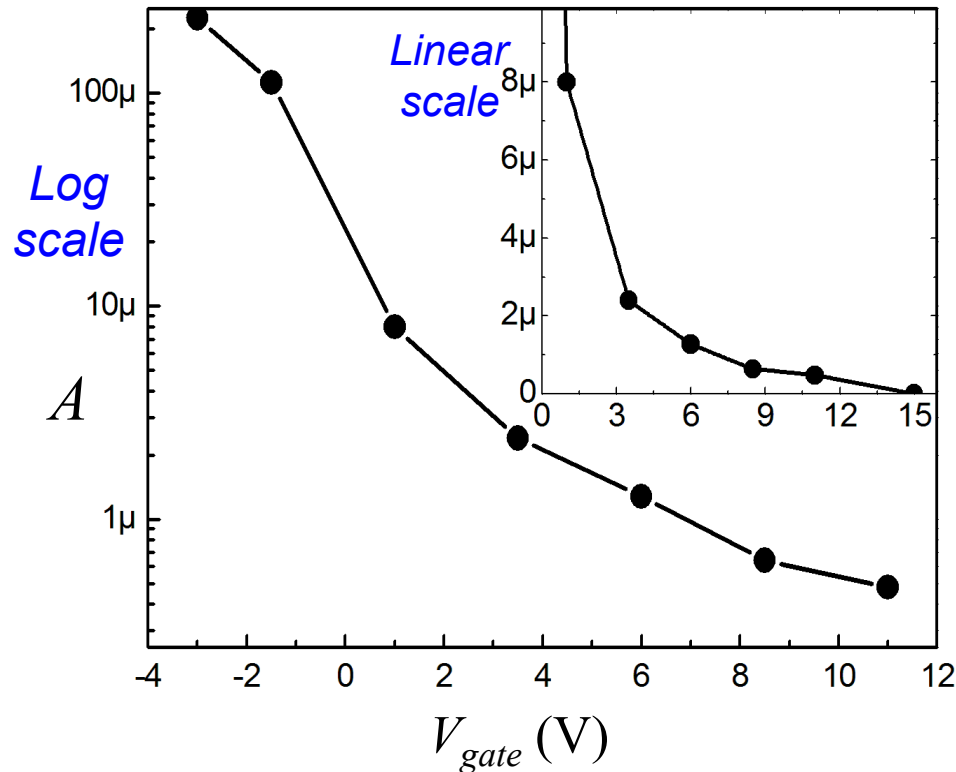
Effect of gate over the Punch-Through region

- SINTEF sensors have a (floating) metal gate above the P-T region
- Noise measured versus voltage applied to gate
- Excess noise (Eq.(2)) extracted and dimensionless constant A plotted vs. gate voltage
- Negative V_{gate} suppresses the excess noise, positive V_{gate} enhances it

- Interpretation: Due to the low oxide fixed charge of Sintef sensors, the P-T hole current runs close to surface, where it is affected by $1/f$ noise due to interface traps (as for the channel current in a MOSFET).
- Positive V_{gate} pushes the P-T hole current away from the surface, suppressing the excess noise.

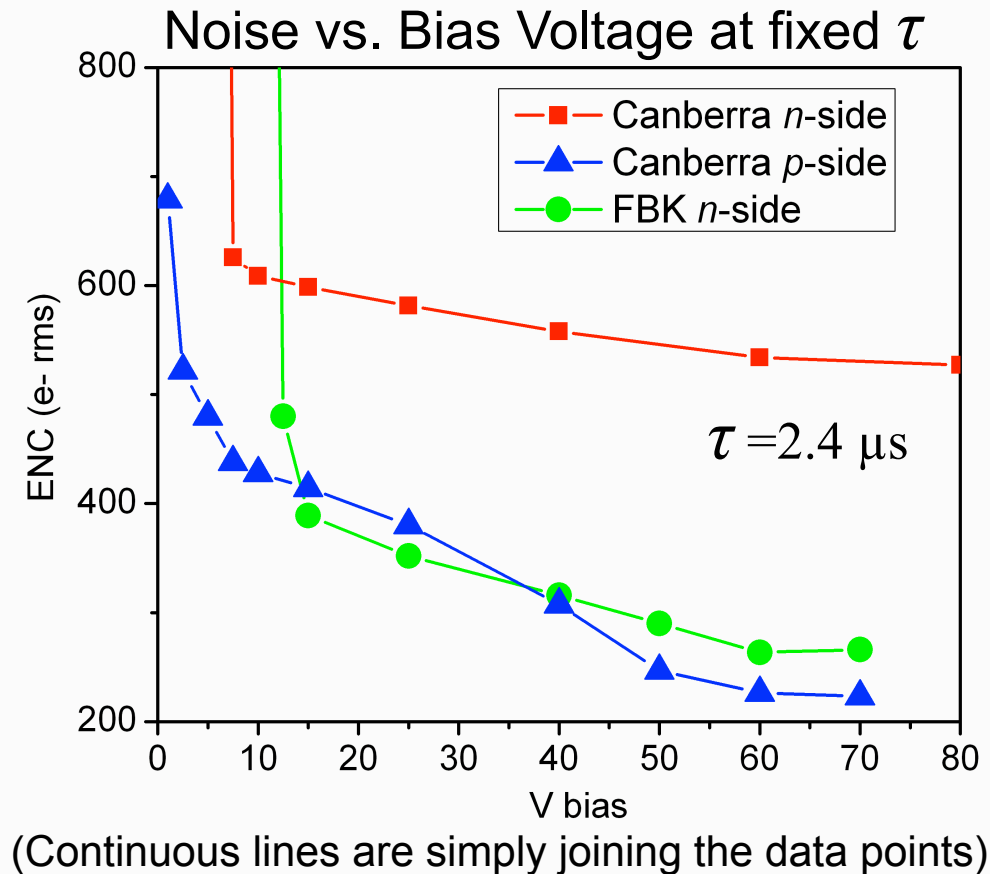
Further Excess Noise Contribution

- On **Canberra *n*-side** the noise decreases slowly with bias above total depletion (~ 8 V), but is ~ 2 X higher than expected
- **Canberra *p*-side** and **FBK *n*-side** (total depletion ~ 15 V) show an excess noise between depletion and ~ 60 V.
- The **dependence** of this noise on **peaking time** has been found to be **rather odd**: $q^2 ENC^2 = K\sqrt{\tau}$
where $K \approx 10^{-30} \text{ C}^2 \text{ Hz}^{1/2}$, independent of the current

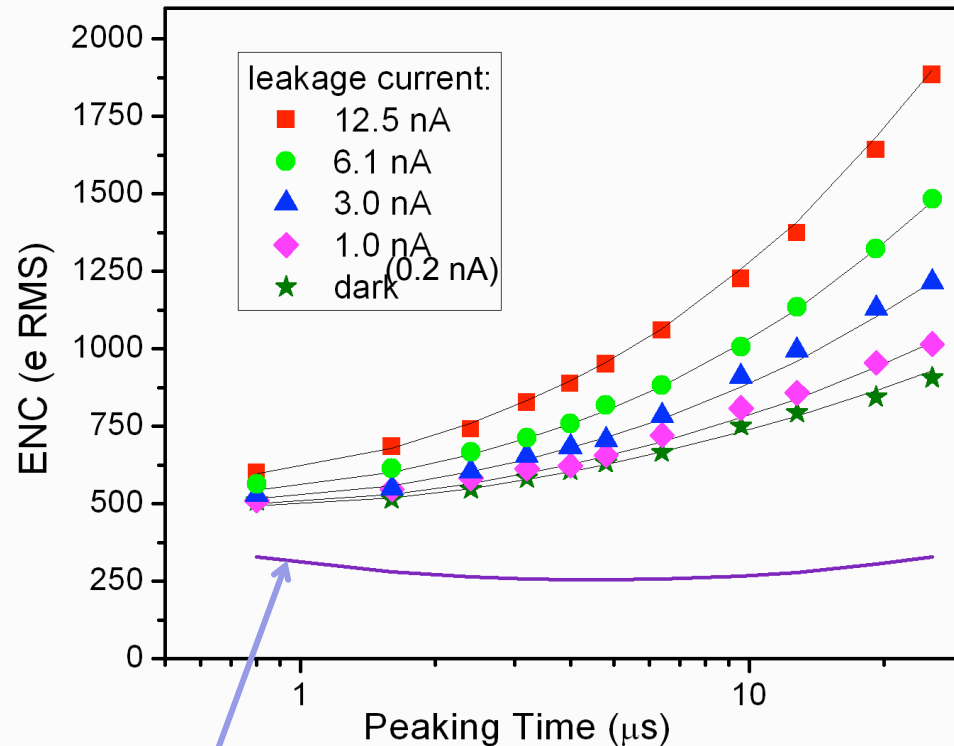
Canberra *n*-side 80 V bias

0.2 nA , calculated from the model,
without excess noise

⇒ The excess noise is dominant over other
noise sources

- Comparison with measurements of strip capacitance and dissipation factor vs. frequency and bias voltage suggest that this noise term may be due to continuous resistive layers at the interface, extending over the whole sensor:

- electron accumulation layer on *p*-sides and on FBK *n*-side
- *p*-spray on Canberra *n*-side

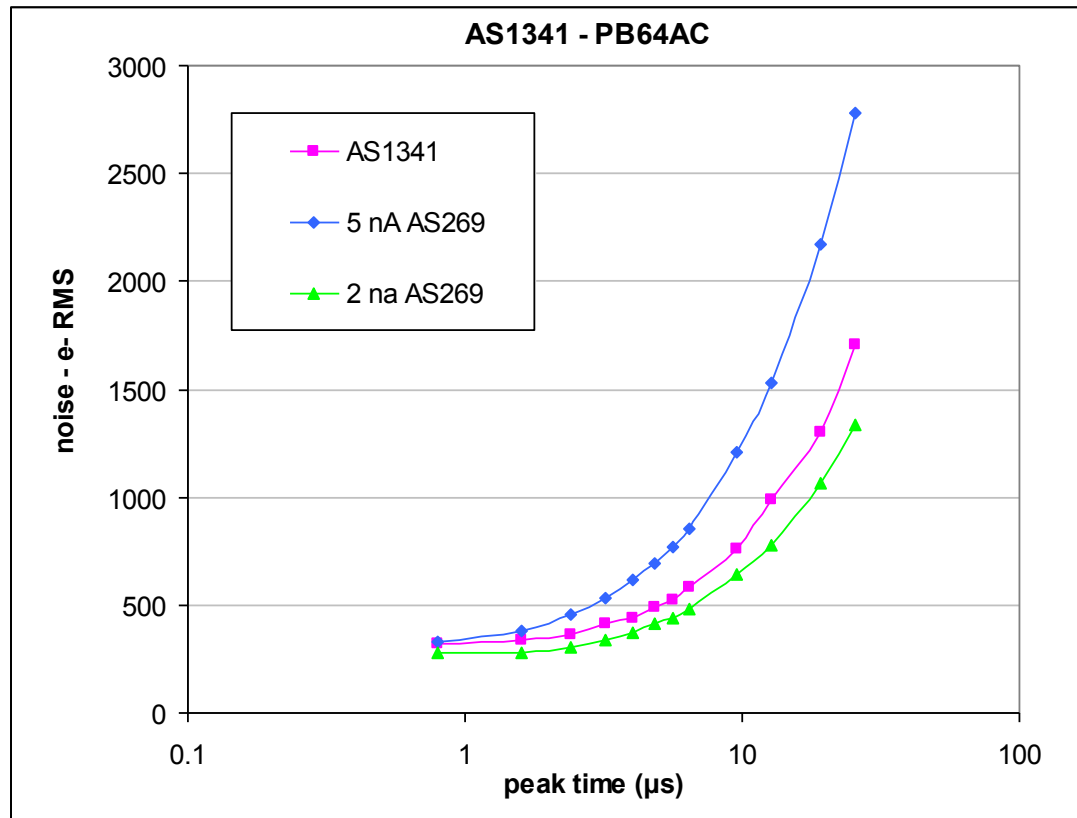
Comparison between irradiated (AS1341) and non-irradiated (AS269) sensors, for comparable values of leakage current

- Noise of irradiated sensor is compatible with its higher leakage current (given the observed contribution of punch-through current)
- No further contribution to noise was found
- ENC < 400 e r.m.s. at shaping times of 1-2 μs

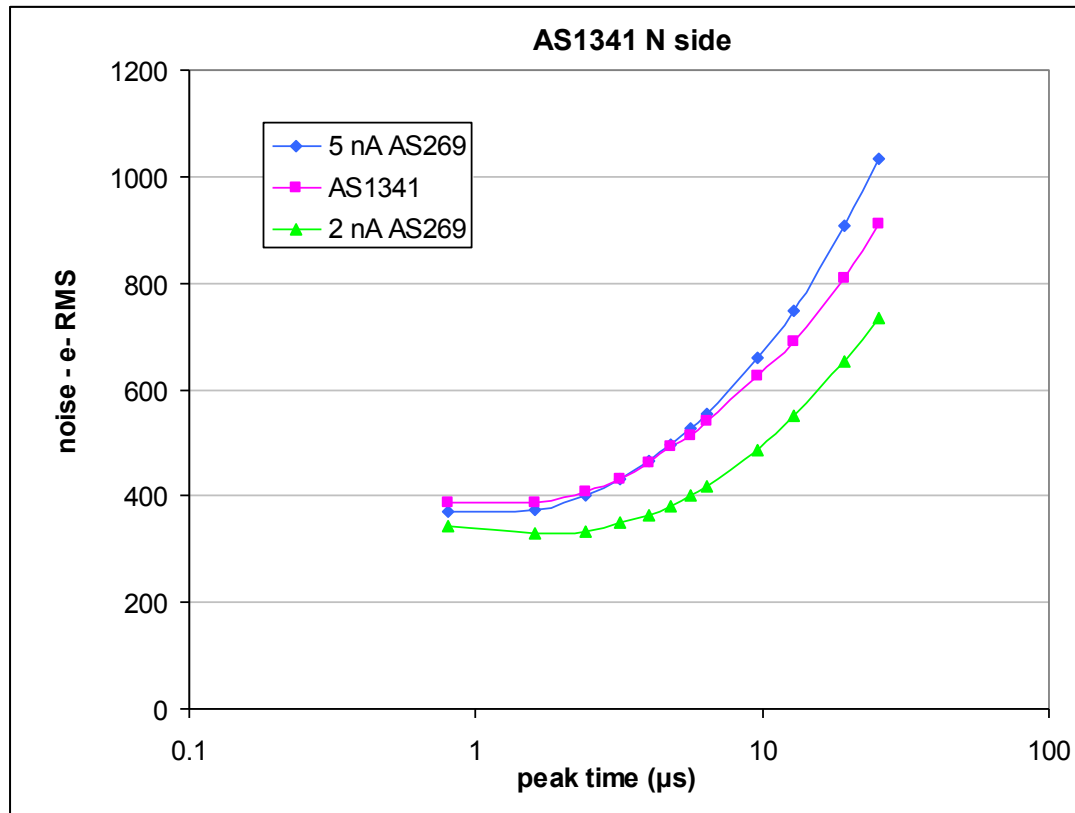
Comparison between irradiated (AS1341) and non-irradiated (AS269) sensors, for comparable values of leakage current

- Noise of irradiated sensor is roughly compatible with its higher leakage current (a few nA)
- ENC is still < 400 r.m.s. at shaping times of 1-2 μ s
