Sensor Quality Assurance for the ATLAS SCT

Dave Robinson Cambridge University

Workshop on Quality Issues in Current and Future Silicon Detectors
CERN 3-4 November 2011

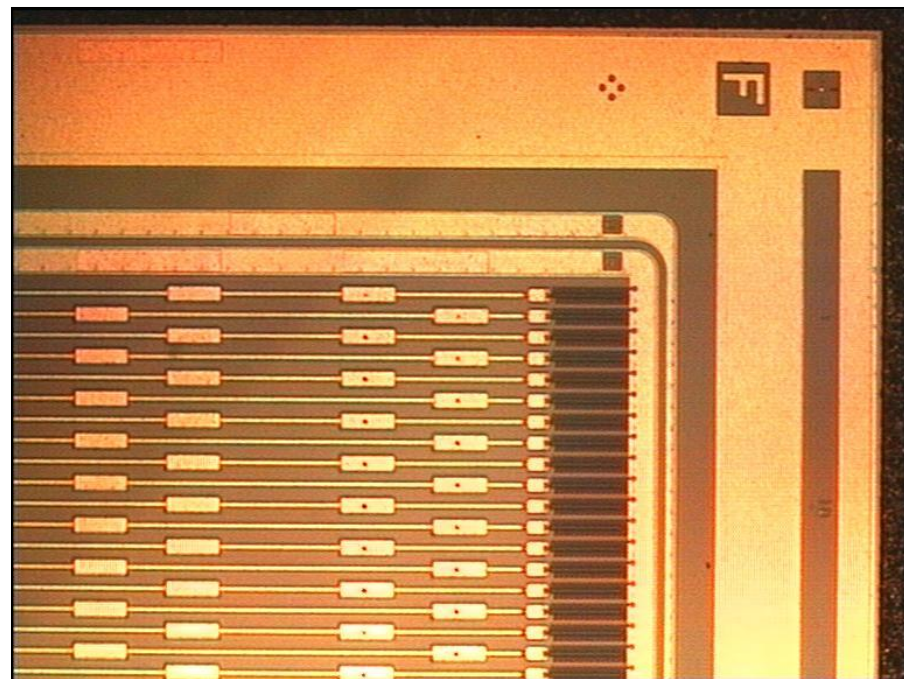
- Single sided p-on-n
- $\langle 111 \rangle$ substrate, $285\mu\text{m}$ thick
- 768+2 AC-coupled strips
- Polysilicon ($1.5\text{M}\Omega$) Bias
- Strips reach-through protection $5\text{-}10\mu\text{m}$
- Strip metal/implant widths $20/16\mu\text{m}$

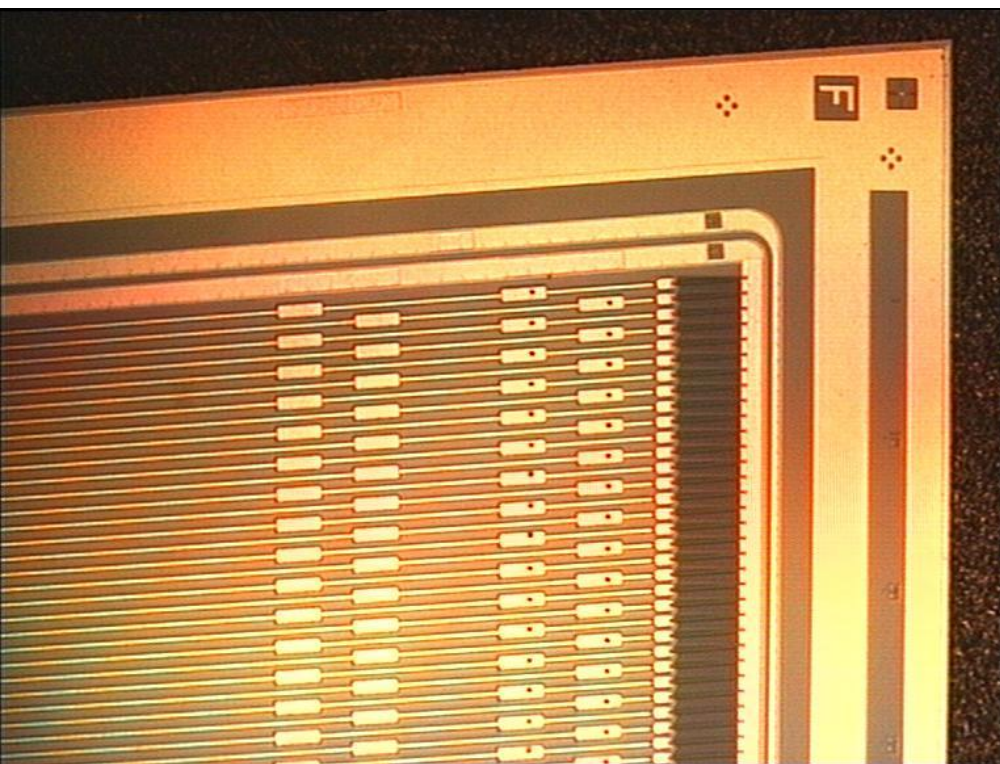
- 8448 barrel sensors
- $64.0 \times 63.6\text{mm}$
- $80\mu\text{m}$ strip pitch
- all supplied by Hamamatsu

- 6944 wedge sensors
- $56.9\text{-}90.4\mu\text{m}$ strip pitch
- 5 flavours
- 82.8% Hamamatsu
- 17.2% CiS

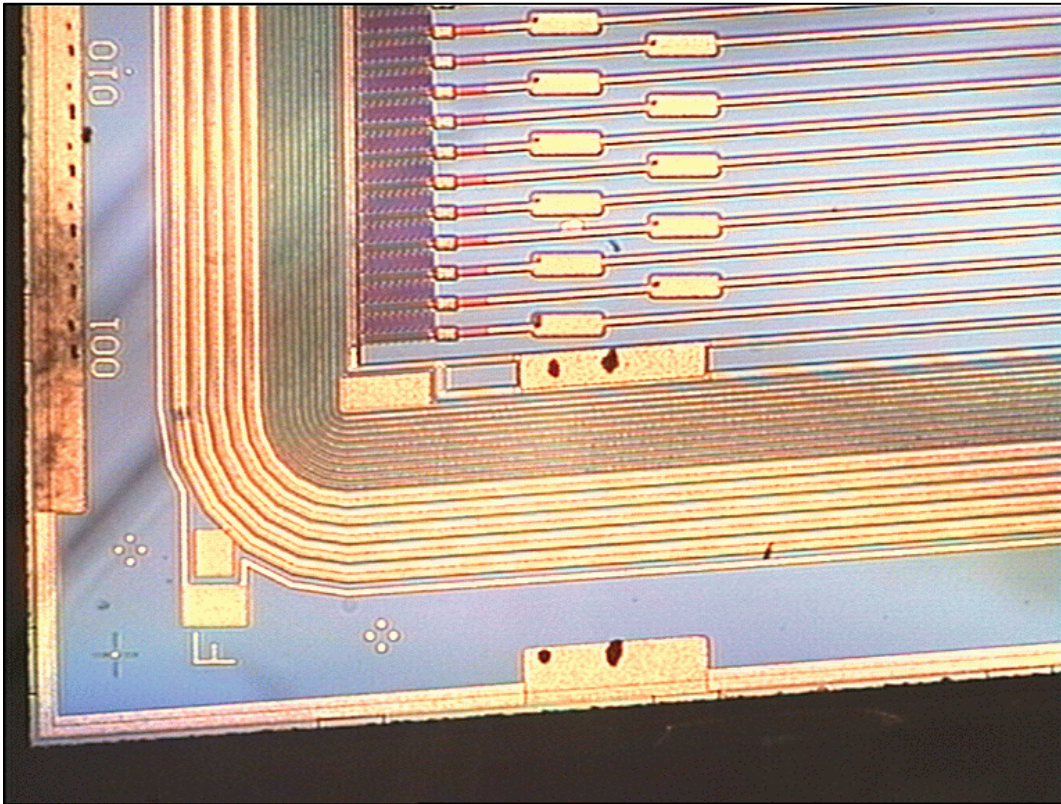
The SCT CiS Sensors – “Same spec, different species”

Hamamatsu	CiS
Bias Resistors ($1.5\text{M}\Omega$)	Polysilicon	Implant
Strip metal/implant widths (μm)	20/16	16/20
Guard design	Single floating	Multi-guard
Barrels supplied	8448	0
Wedges supplied	6944	1196

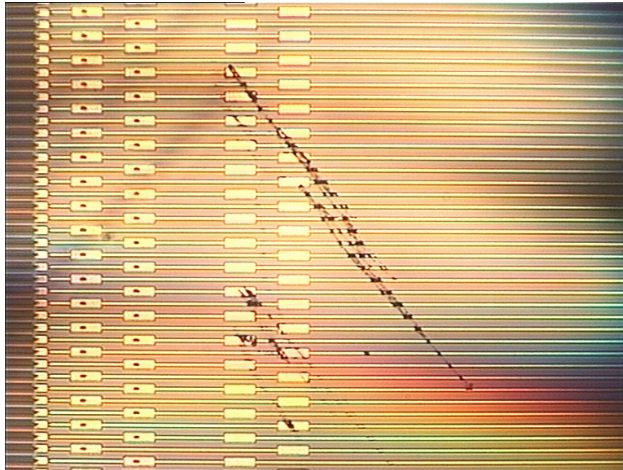
REJECT

Full sensor area scanned under a microscope (automated probestation). Sensor must be free from “gross defects and scratches” and edge chips must not exceed 50µm. But what is a “gross defect”?

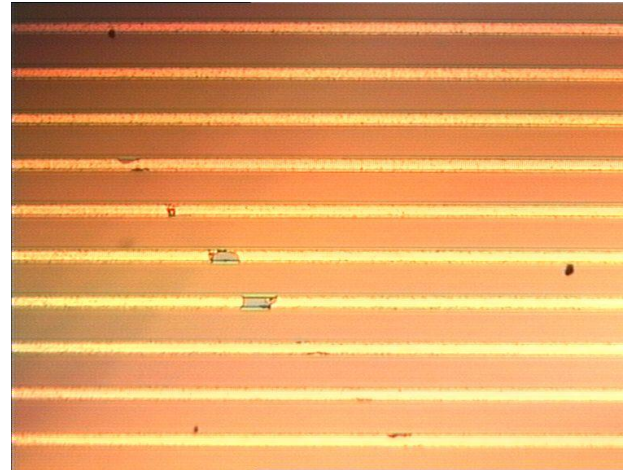
ACCEPT

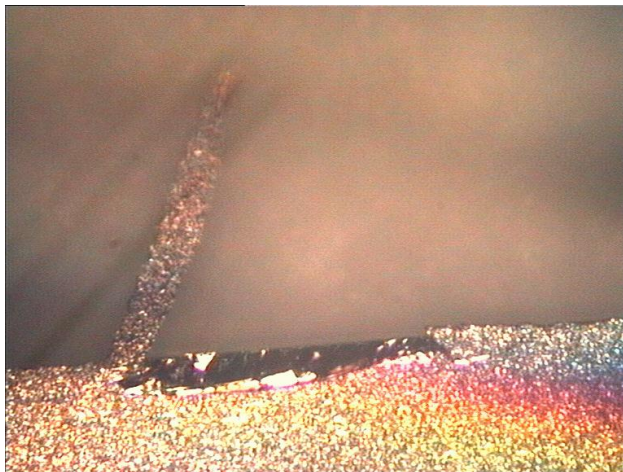
Rear Edge Chip REJECT

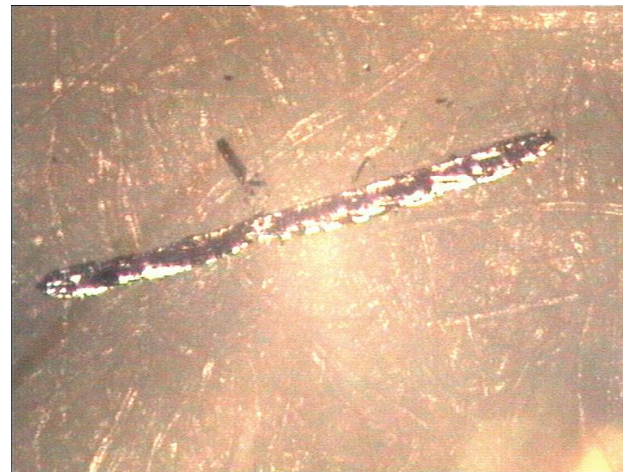
Debris in packaging REJECT

- The overall quality and consistency of the Hamamatsu sensors were outstanding, with a negligible number rejected for use by SCT.
- Two issues identified during preseries stage, never observed again during production:
 - Poorly diced edges, with Si debris in sensor envelopes
 - Deformed polysilicon resistors, unnoticed until identified by full strip test

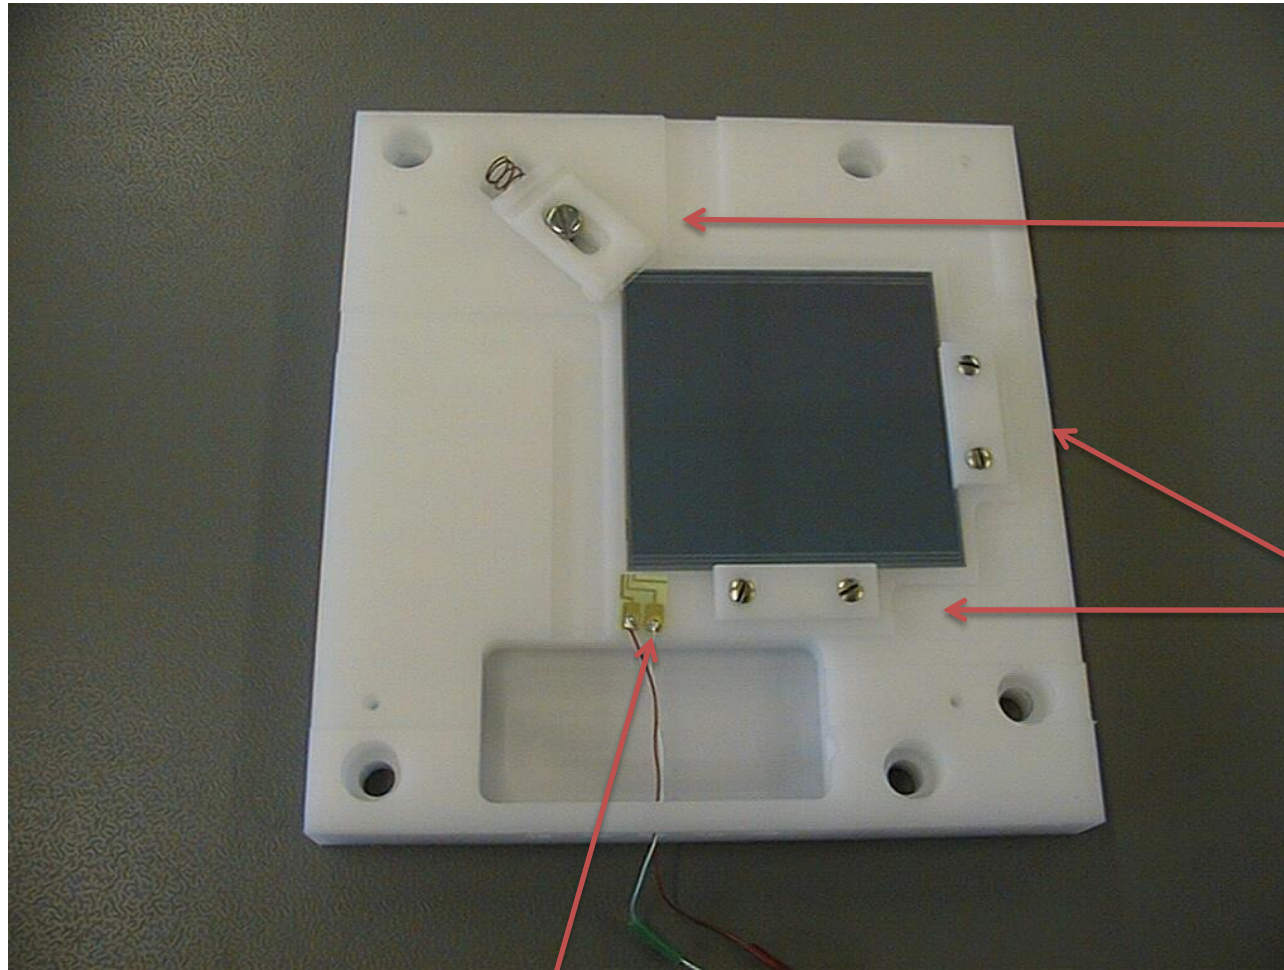
Sensor Support Frame for full tests

Delrin clamp with
spring loading

Delrin blocks

Bias Connection (two bonds)

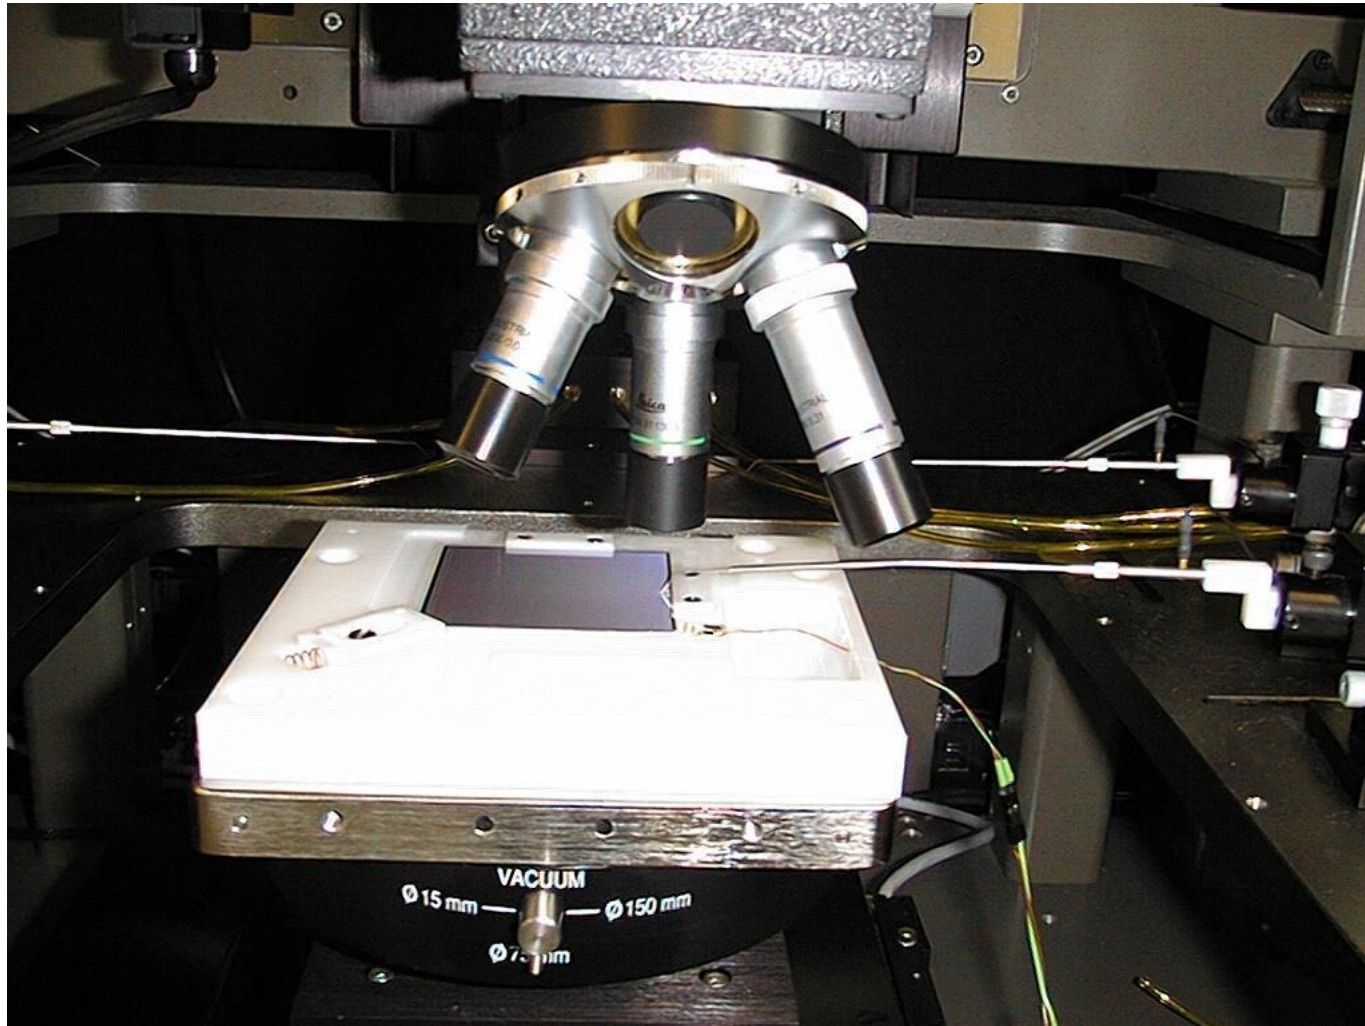
Frame supported sensor on chuck during sensor strip test

Machining tolerance of delrin block means sensor is perfectly flat
O-ring on underside of block ensures grip by chuck vacuum

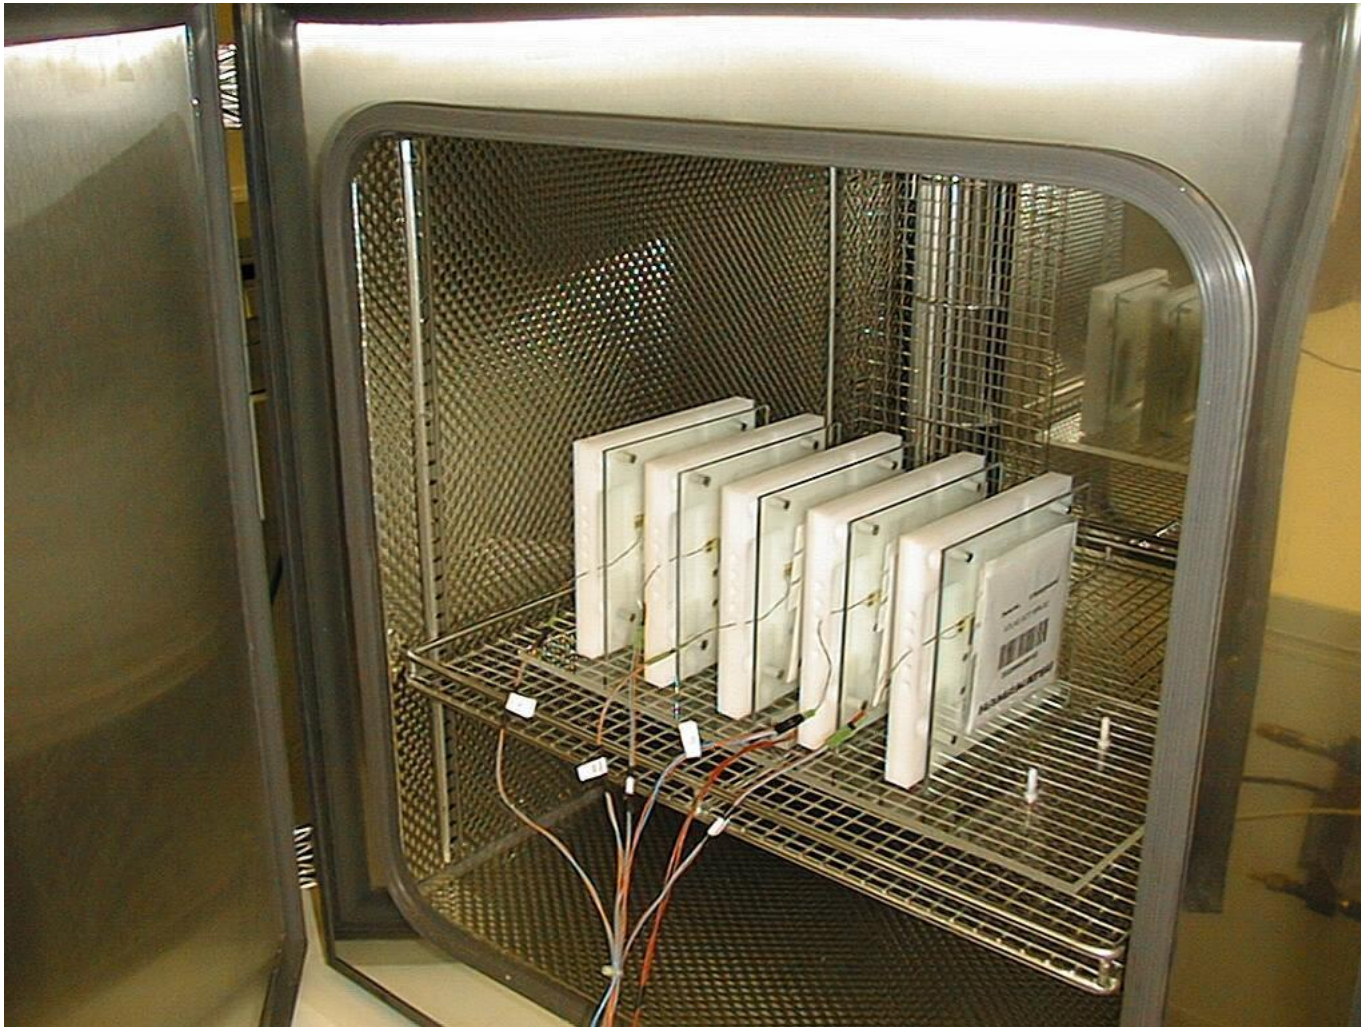
Leakage current stability tests of multiple sensors in parallel (using Keithley with switching matrix)

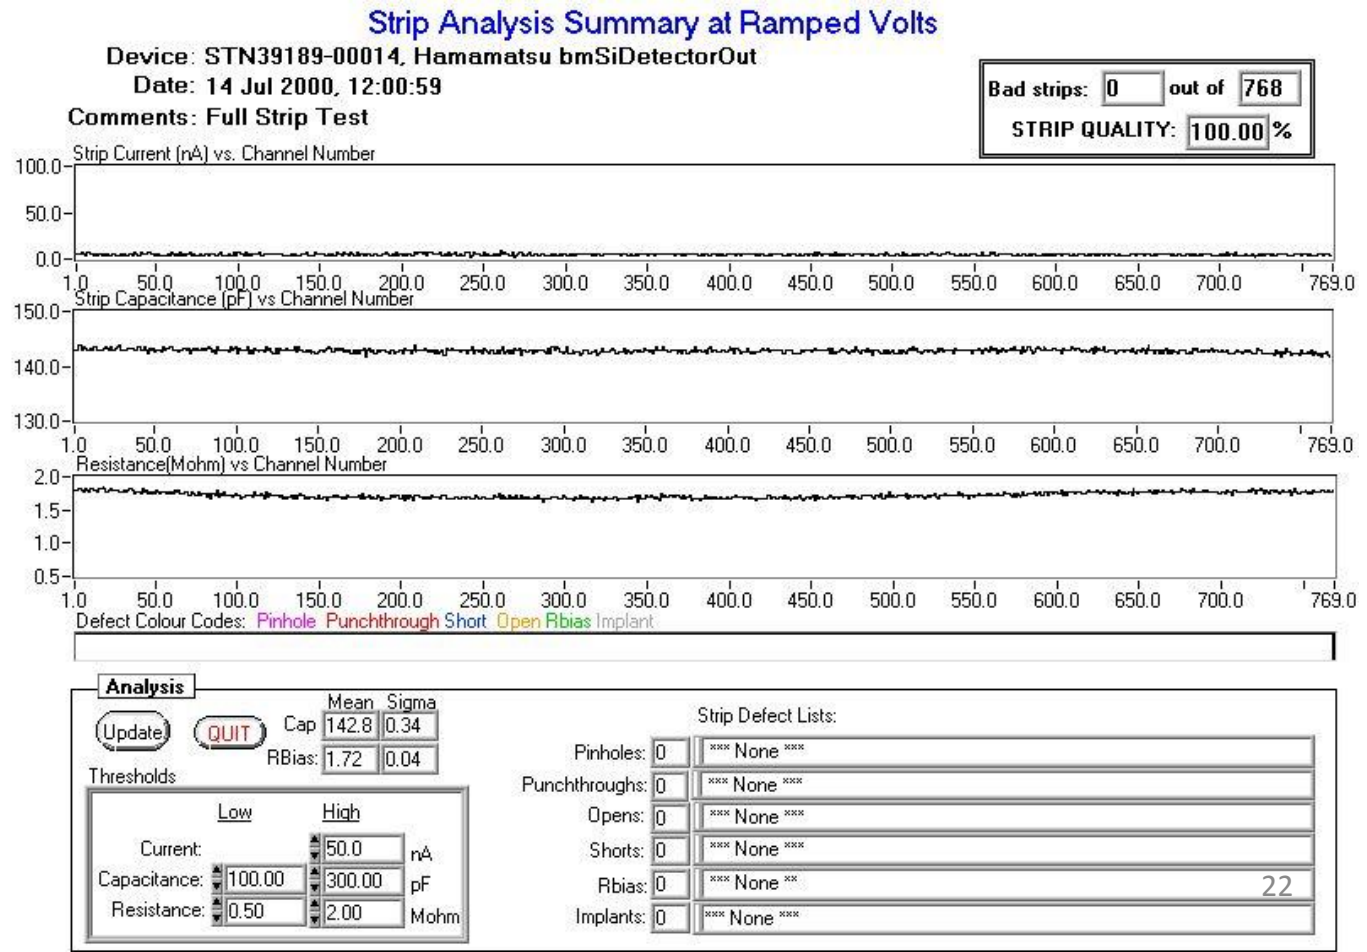
Full Strip Test

The “flagship” test for highlighting strip side processing defects

With the sensor partially biased (to ~50% of full depletion voltage), step through every strip to probe the strip metal. For every strip, apply 100V across strip dielectric to determine robustness of dielectric, then return strip metal to ground and model CR in series on the measured impedance @100 Hz between strip metal and bias rail

$$C = C_{\text{coupling}} \quad R = R_{\text{bias}}$$

Sensitive to any strip defect, and any general processing defect that may effect operation of sensor, and yields the bias resistance and coupling capacitance for every strip.

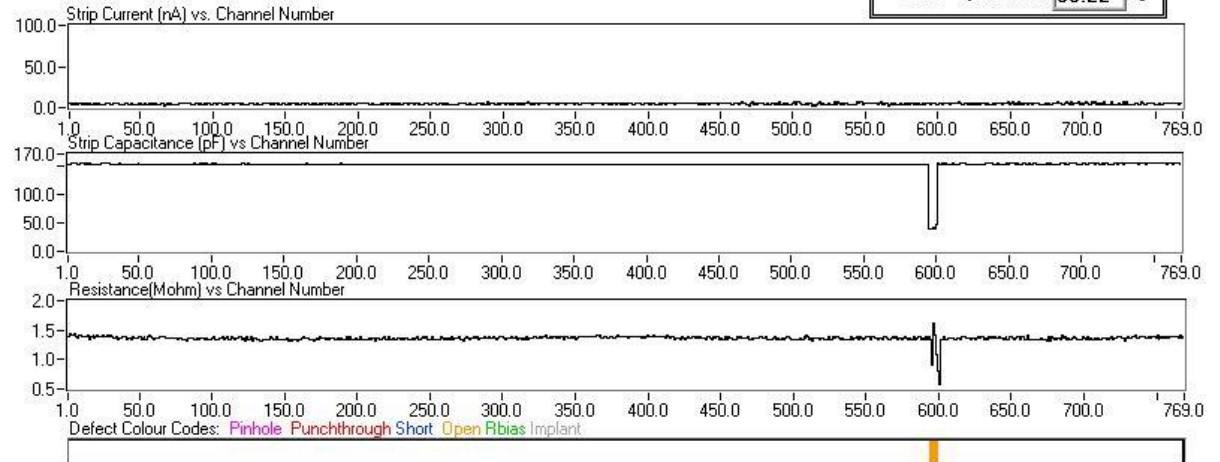
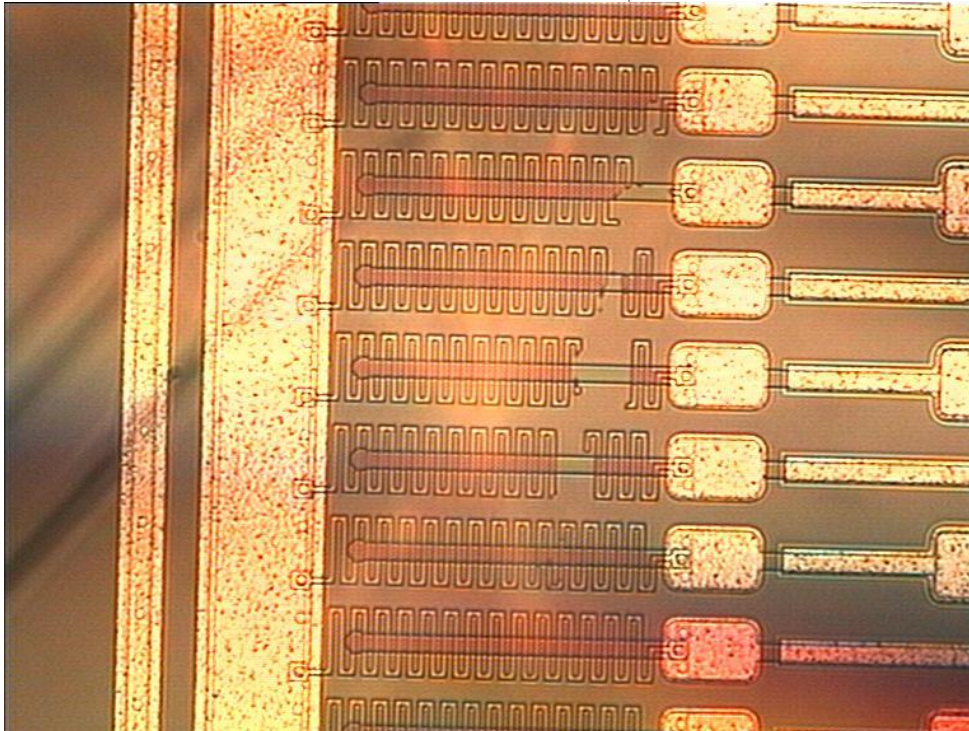
Example 1

Bad strips: 6 out of 768
STRIP QUALITY: 99.22 %

Strip Defect Lists:	
Pinholes:	0 None
Punchthroughs:	0 None
Opens:	6 595, 596, 597, 598, 599, 600
Shorts:	0 None
Rbias:	0 None
Implants:	0 None

Detection of resistor breaks

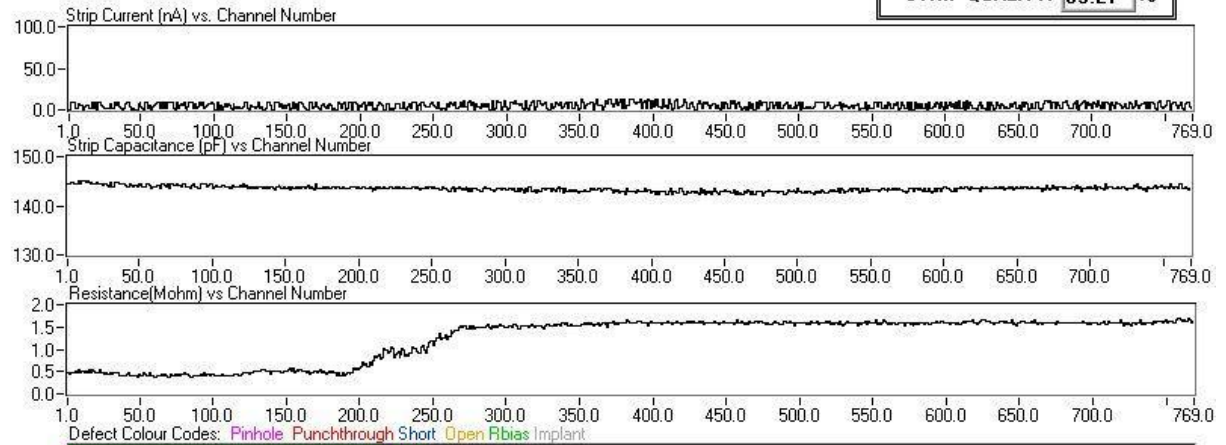
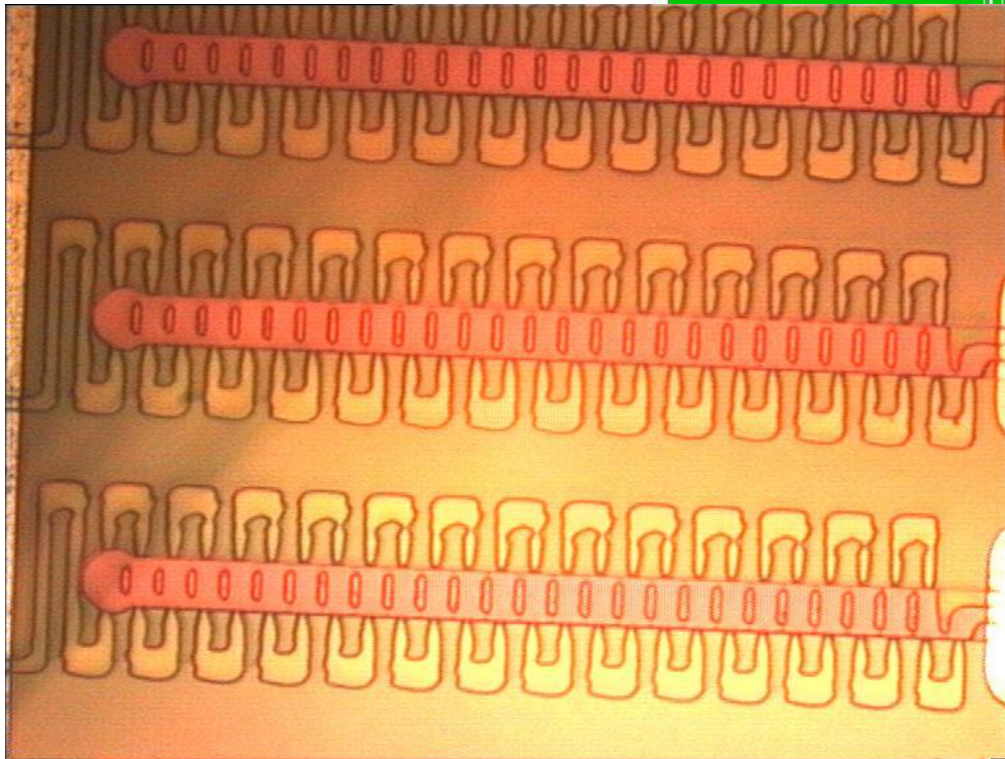
Example 2

Detection of resistor processing defects

Bad strips: 236 out of 768
STRIP QUALITY: 69.27 %

Strip Defect Lists:	
Pinholes:	0 None
Punchthroughs:	0 None
Opens:	0 None
Shorts:	0 None
Rbias:	236 1,2,3,4,5,6,7,8,9,10,11,12,13,14,15,16,17,18,19,20,21,22,23,24,25,26,27,
Implants:	0 None

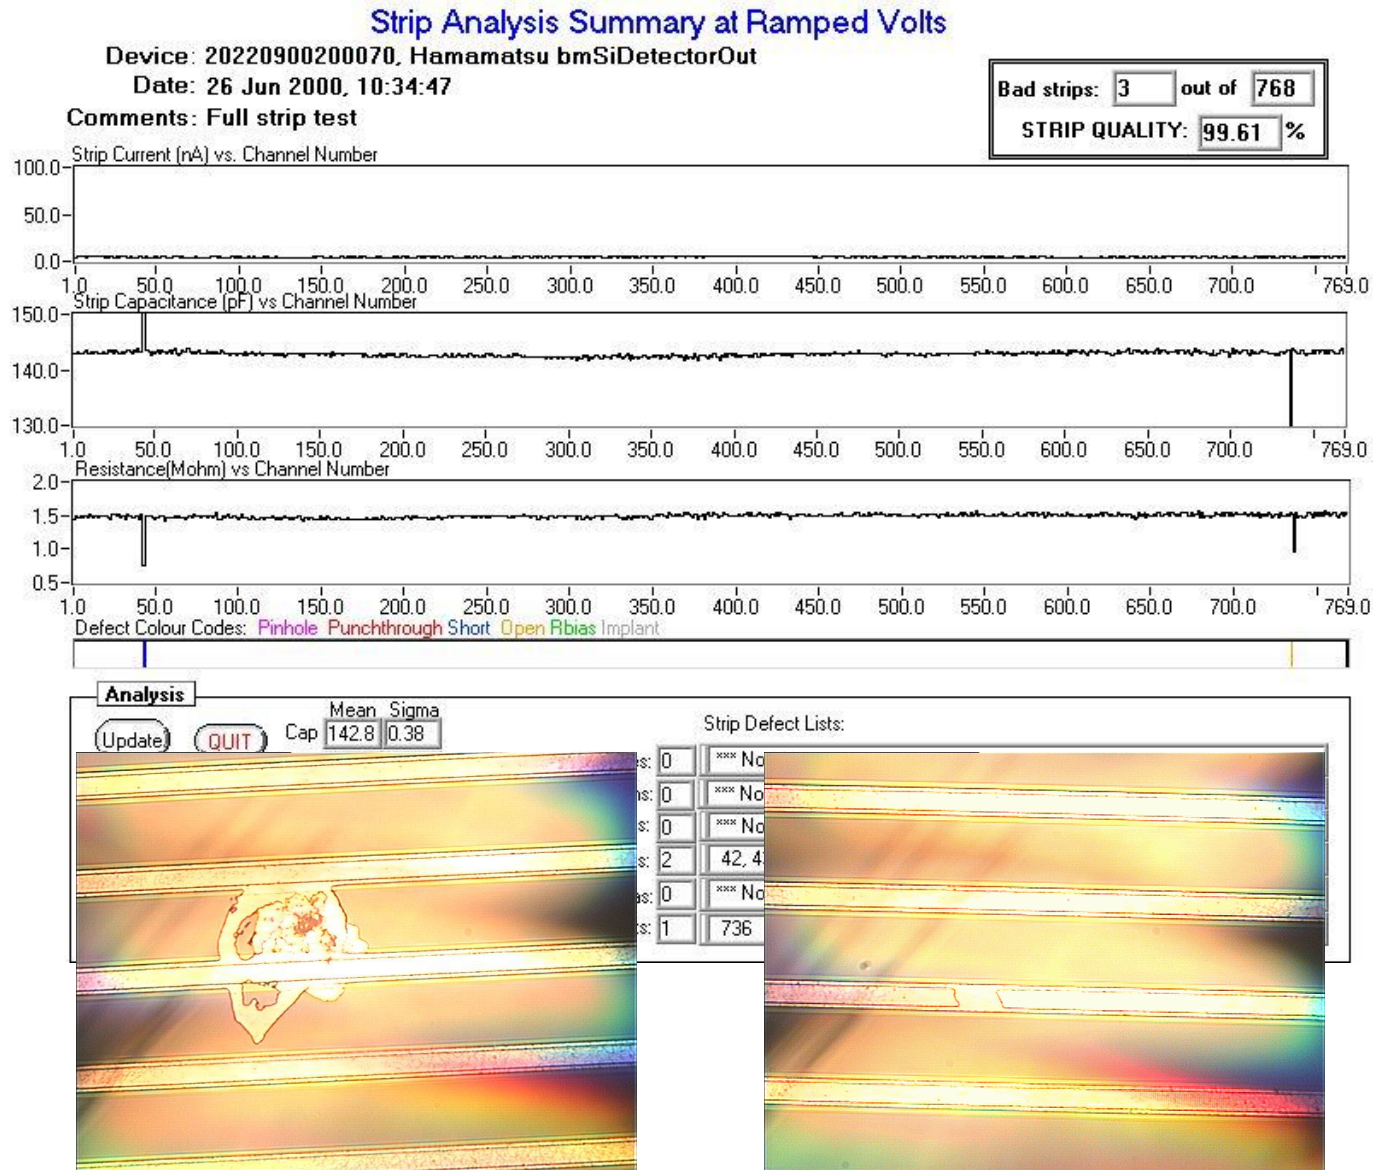
Example 3: Detection of metals shorts and strip implant breaks

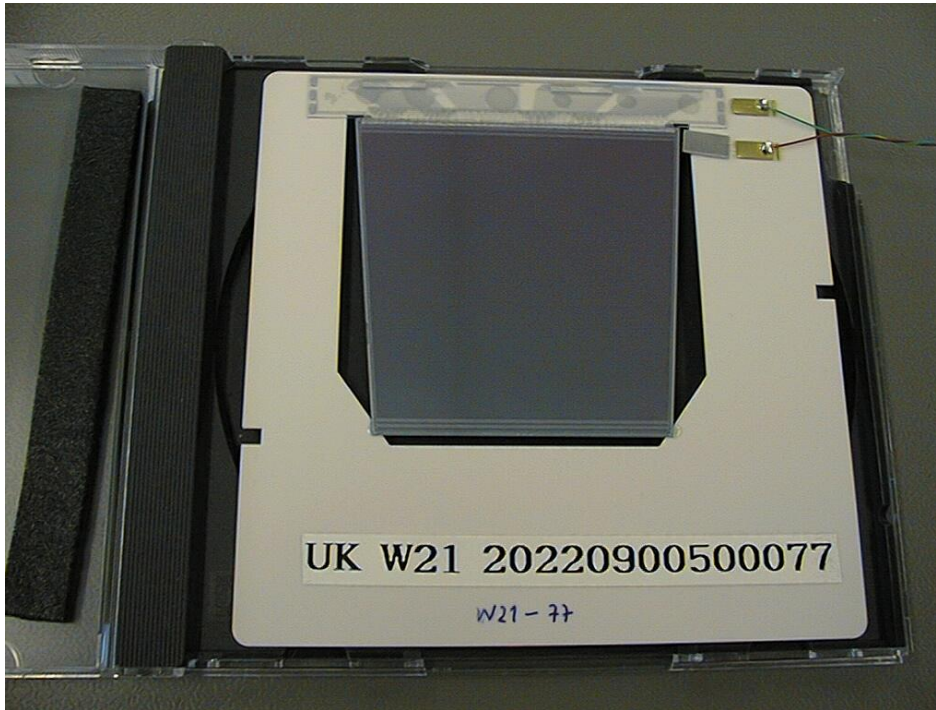
Strips wire bonded to 6cm/12cm pitch adaptors.

Bias and gnd bonded via Al tab.

Ceramic frame for sensor irradiation, sensor spot glued in all 4 corners.

A small (~1%) sample of sensors were selected regularly throughout the production deliveries for irradiation with 24 GeV/ protons to $3 \times 10^{14} \text{p.cm}^{-2}$ at the T7 irradiation facility at the PS. During irradiation, sensors were chilled in nitrogen to -8°C , and biased at 100V with all strip metals grounded. The irradiation took typically 6-10 days, and following irradiation the detectors were annealed for 7 days at 25°C to bring them to the minimum of the anneal point.

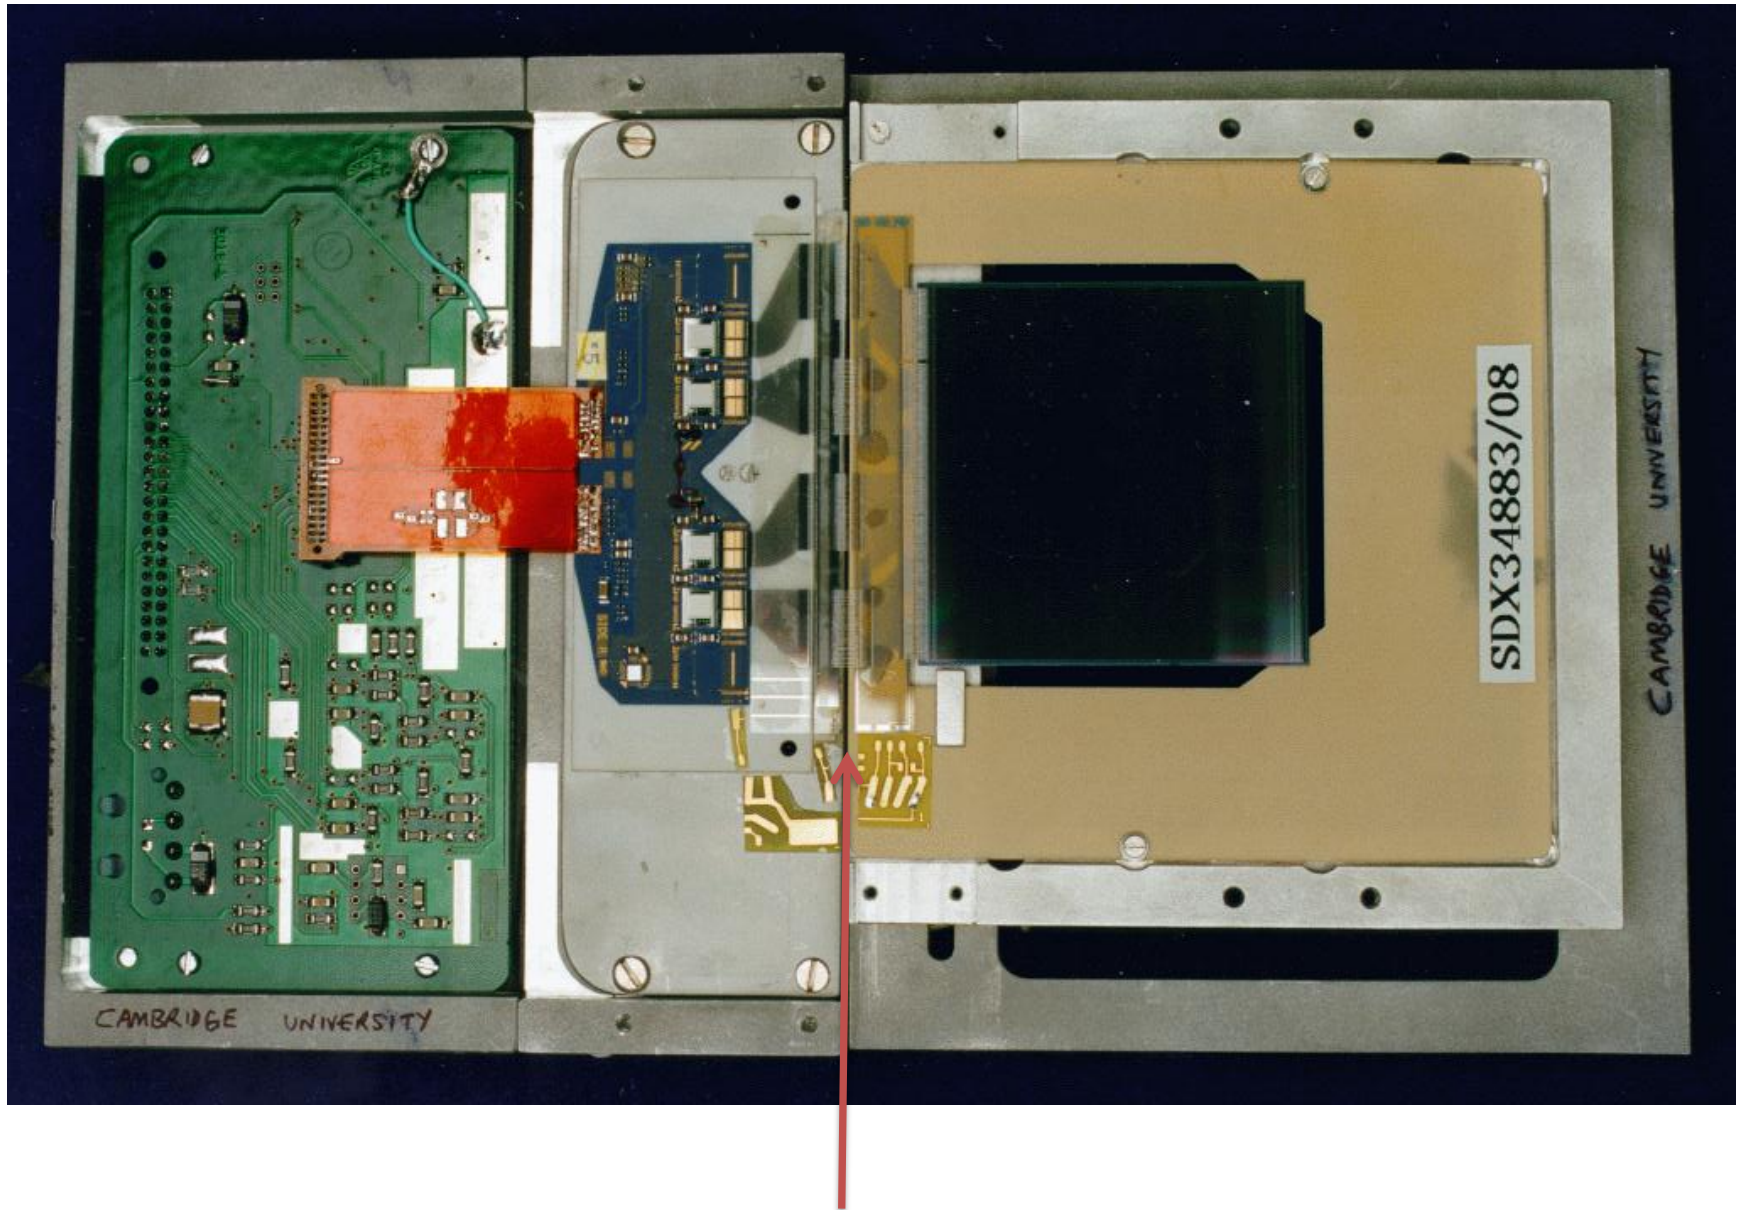
Strip noise measurements of irradiated sensors

Rebondable interface

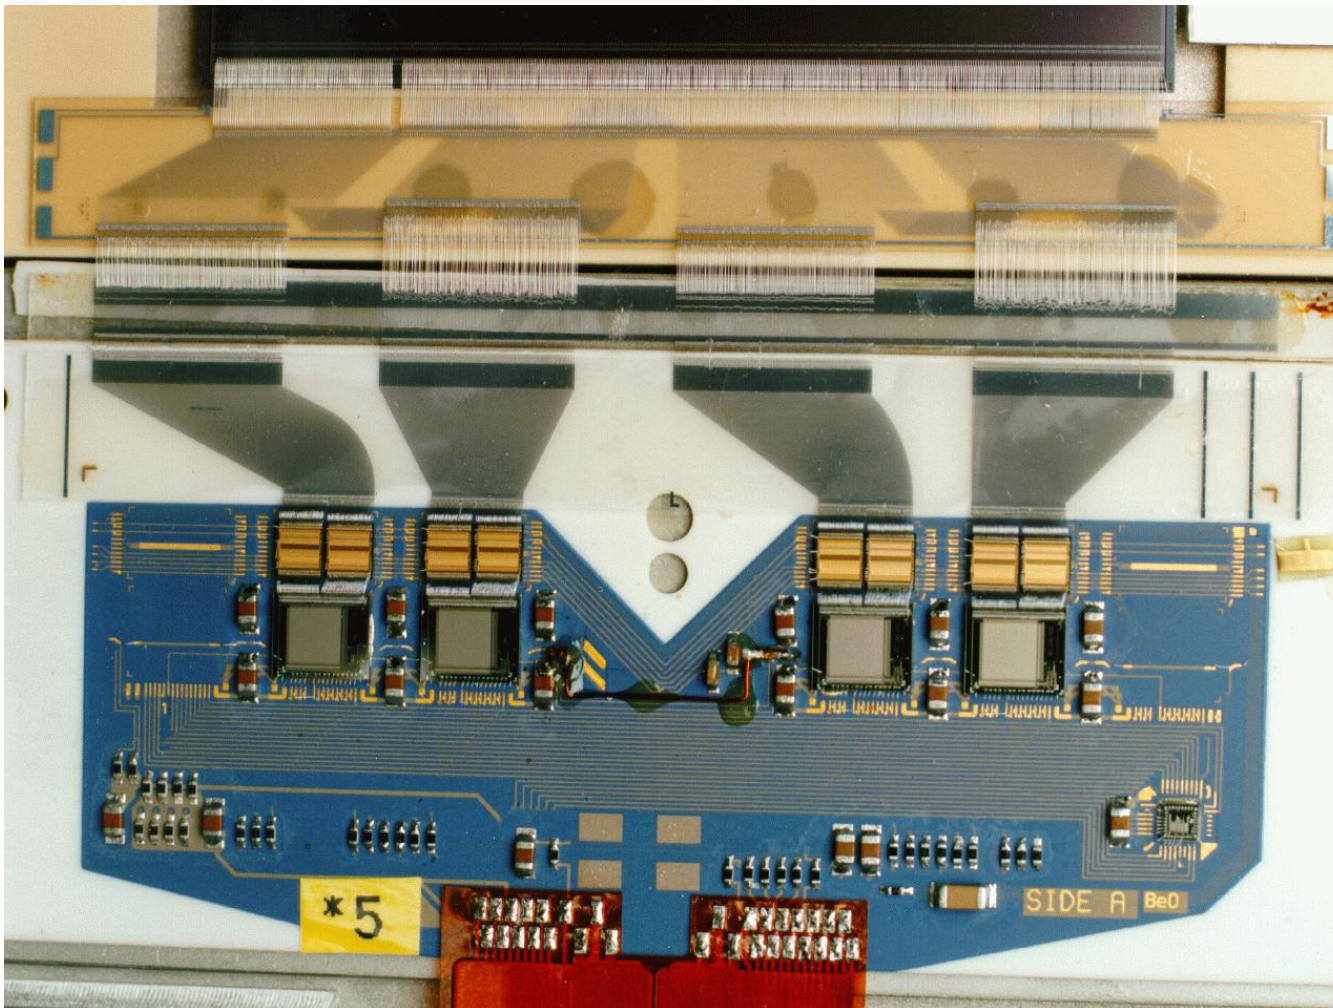
Bonding Details – Remountable sensors

Effective strip length connected to chip:

6/12cm adaptor

Replaceable
intermediate
adaptor
(100µm pitch)

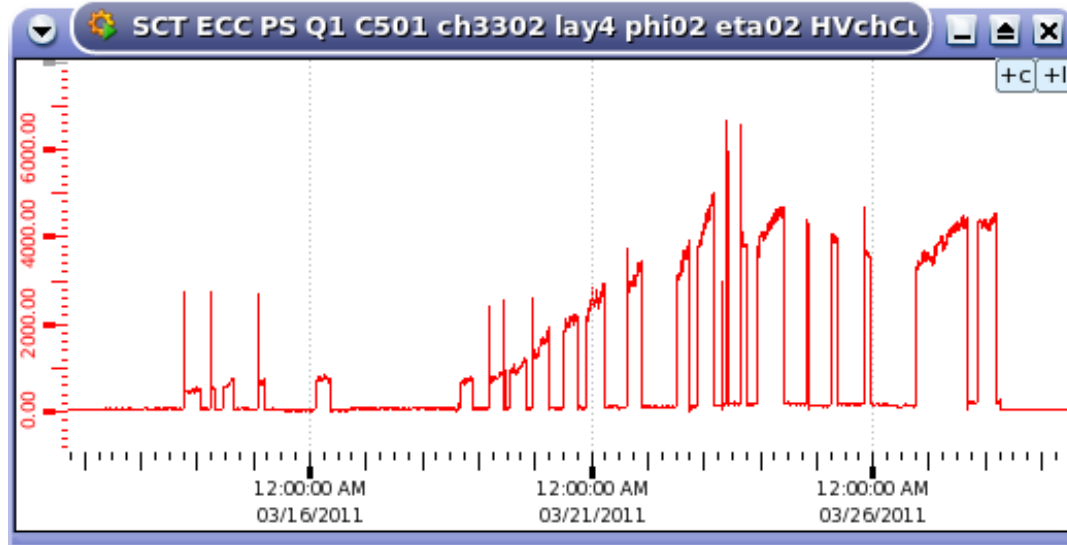
Example of leakage current deterioration from anomalous CIS-equipped modules

Dramatic increase in current at 150V in April 2011 (but not for 50V) - breakdown

- We have had a small but significant (~30) number of modules which have developed anomalously high leakage currents this year
- Almost all were constructed with CIS sensors, and all showed IV breakdown above 150V during production QA tests
- We believe that oxide charge buildup from ionising radiation is shifting the breakdown voltage downwards
 - Decreasing HV and increasing current limits means we can keep operating these devices with full efficiency so far

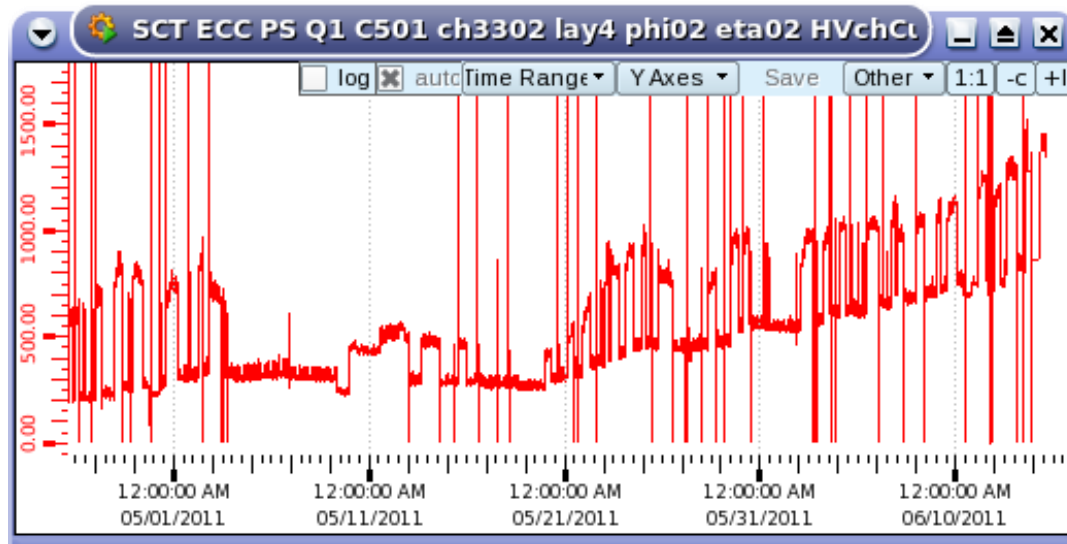
“Normal” behavior in June, albeit at 80V – bulk damage

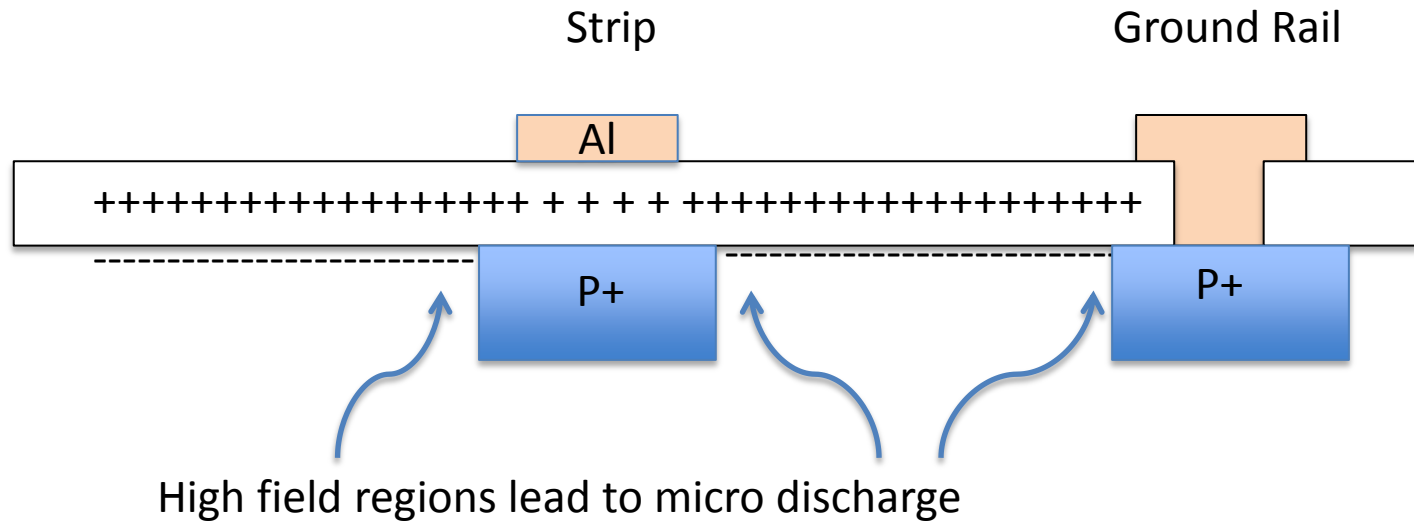
CiS Sensor strip schematic

Build up of positive charge in oxide (which starts from a non-zero offset and steadily increases and eventually saturates with ionising radiation) leads to increasing electron accumulation layer at the Si-SiO interface, giving high field region at the edge of the implant. CiS sensors were known to have improved breakdown at high humidity because surface charge is always negative which suppresses the electron accumulation layer.

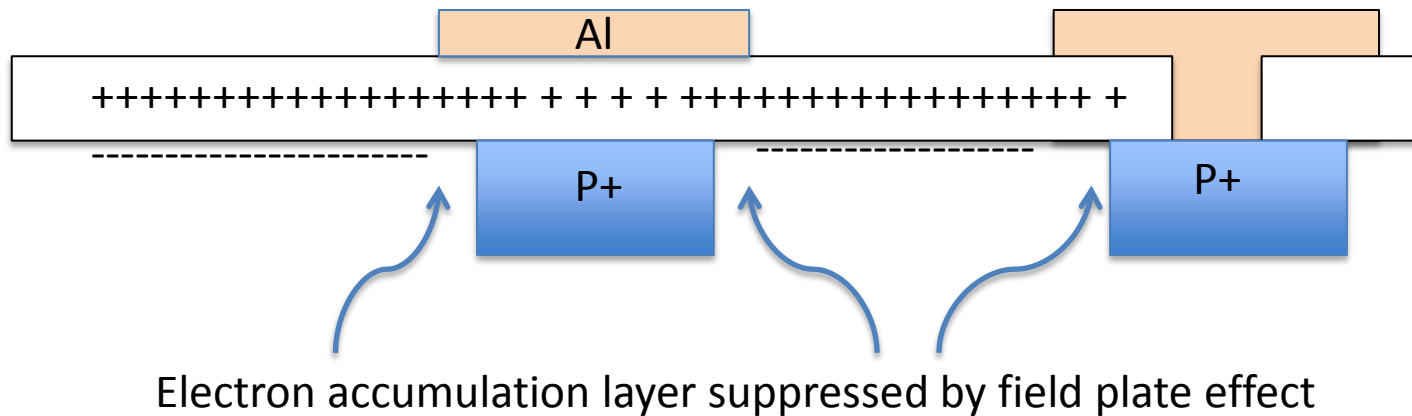
Hamamatsu Sensor strip schematic

Field plate effect suppresses electron accumulation layer (because strip metal is at negative potential wrt implant underneath it), lower field strength at edge of P+ implant, much less prone to micro discharge and less sensitive to humidity.
