# The Silicon Strip Sensors of the CMS Tracker

Thomas Bergauer (HEPHY Vienna)

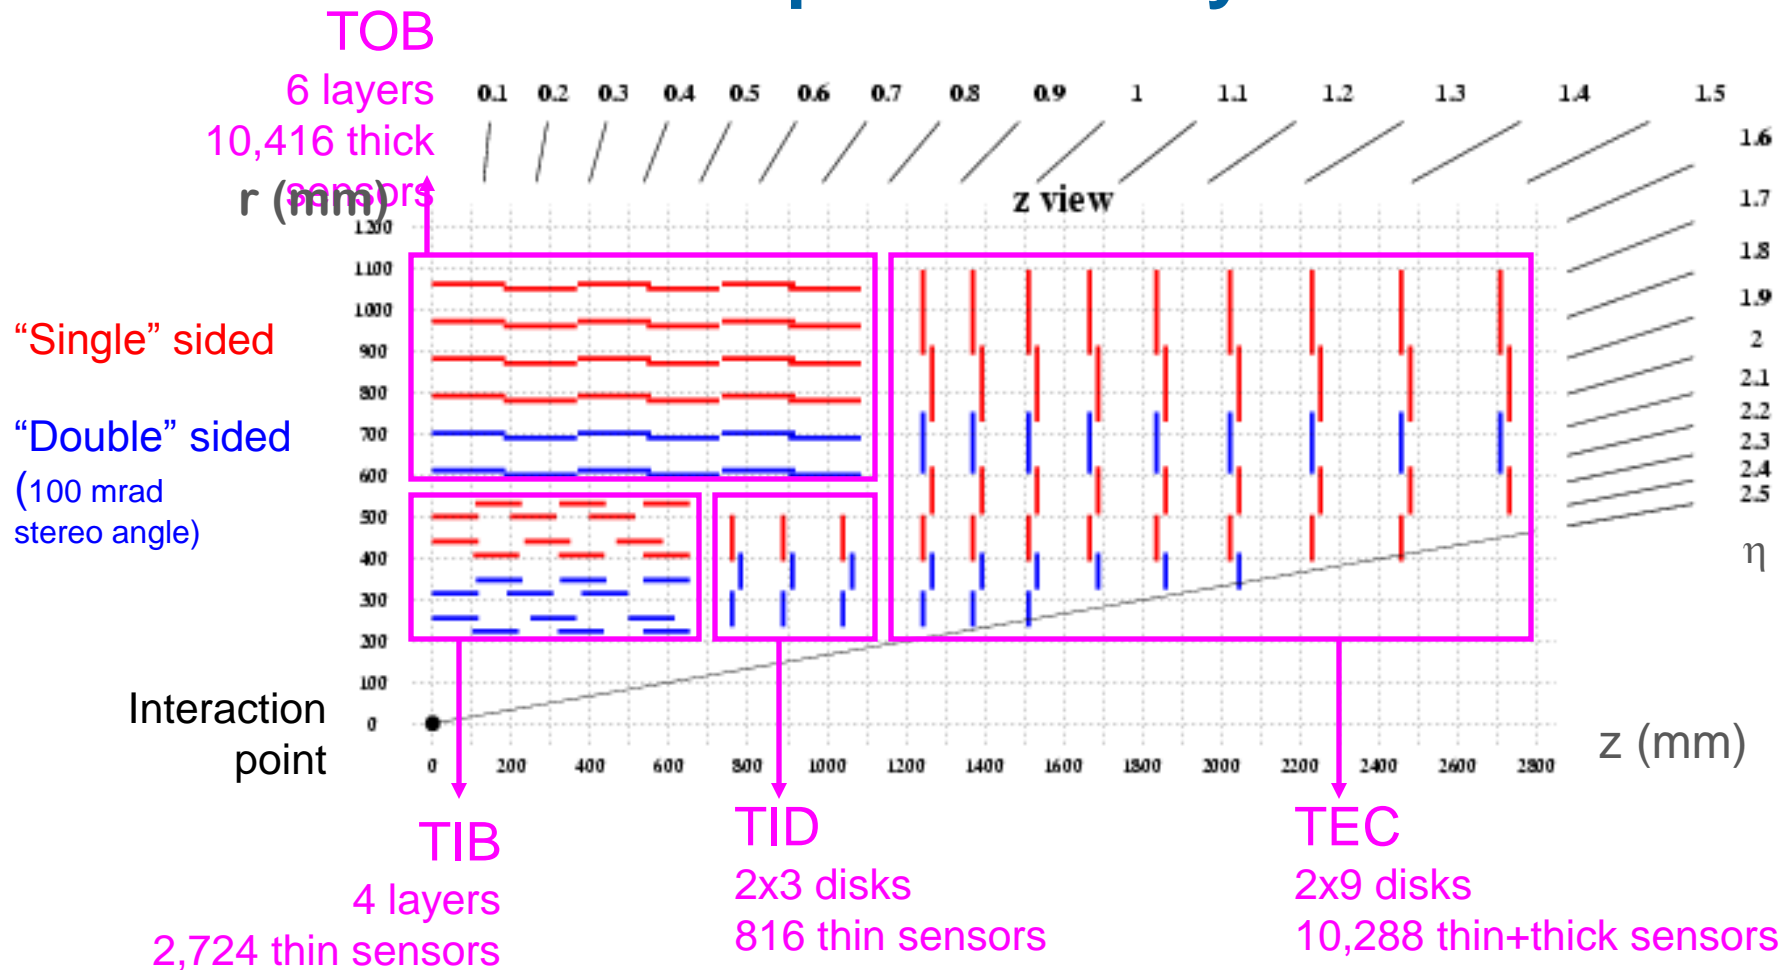
# CMS Strip Tracker layout

**24,244 pieces (200 m<sup>2</sup>) of sensors necessary; >35,000 delivered**  
**→ Complex Logistic & Quality Assurance**

Barrel: strips parallel to beam  
 End cap: strips in radial direction

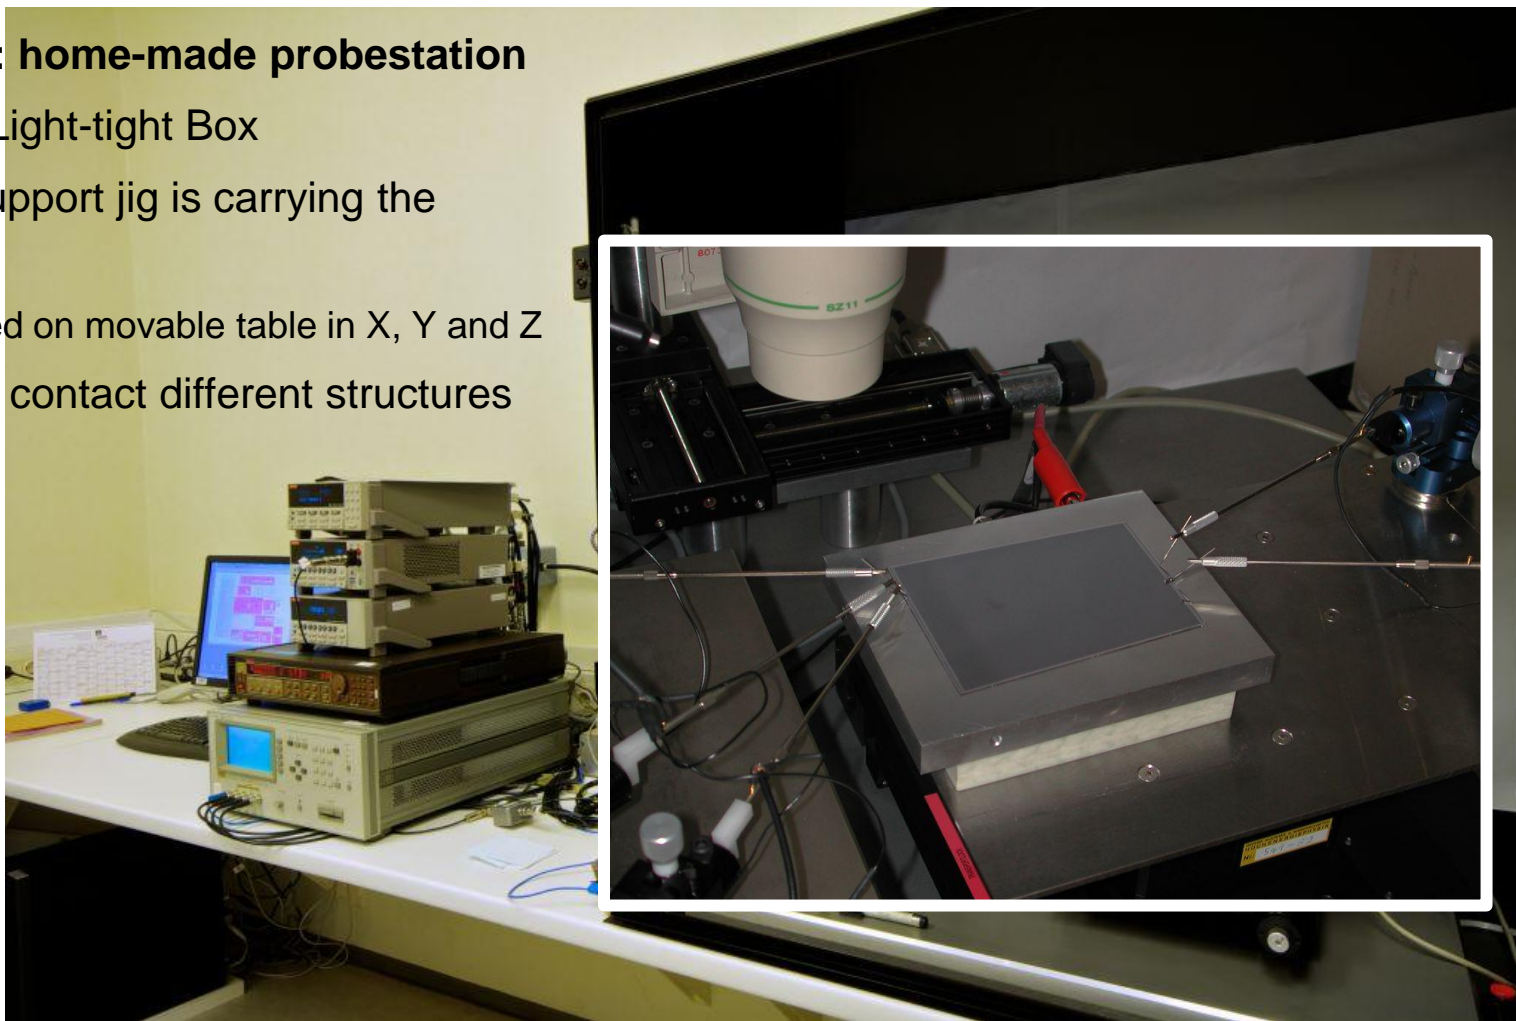
## Strip-by-strip Test Setup Vienna

### Vienna Setup: home-made probestation

- Sensor in Light-tight Box
- Vacuum support jig is carrying the sensor
  - Mounted on movable table in X, Y and Z
- Needles to contact different structures on sensor

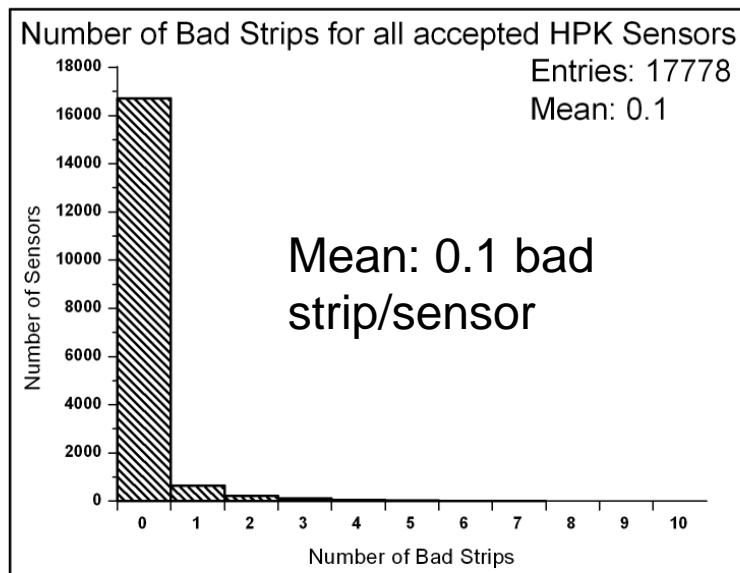
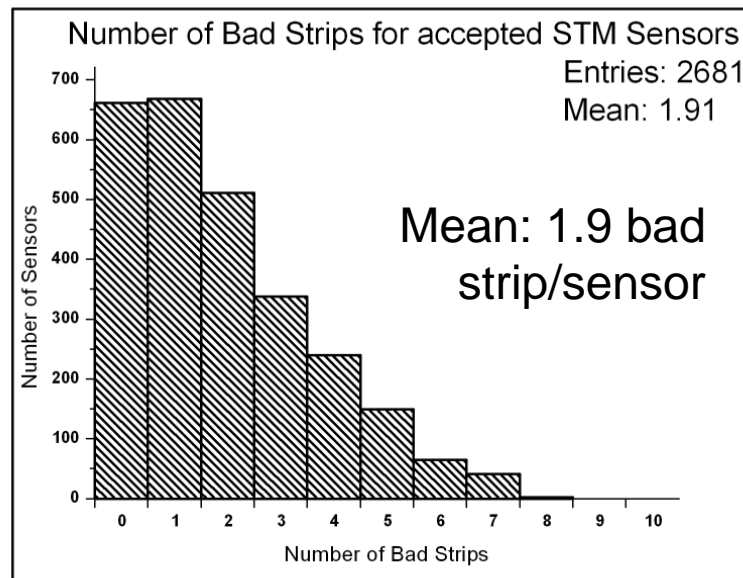
## Number of Bad Strips

Number of bad strips per sensor (pinhole, bad poly-resistor, Al short, broken Al, open implant, leaky strip,....)

Specification: max 1% of 512/768 Channels

Percentage of bad strips: 0.018%

0.305%

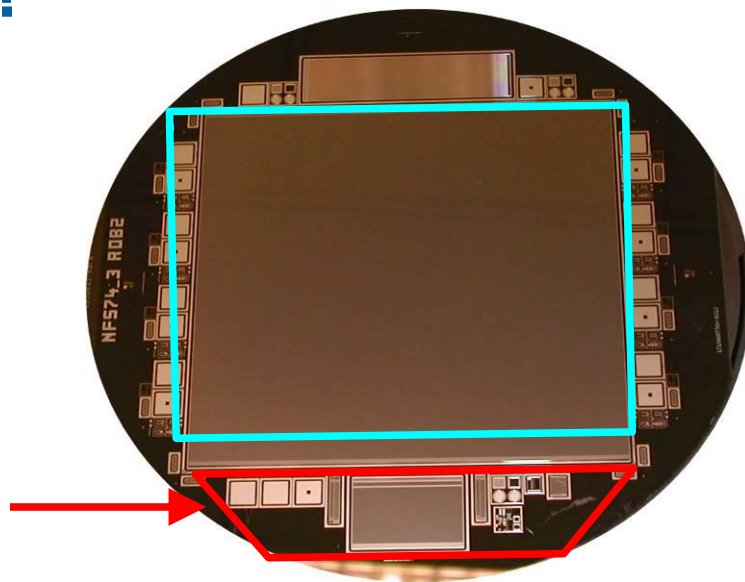
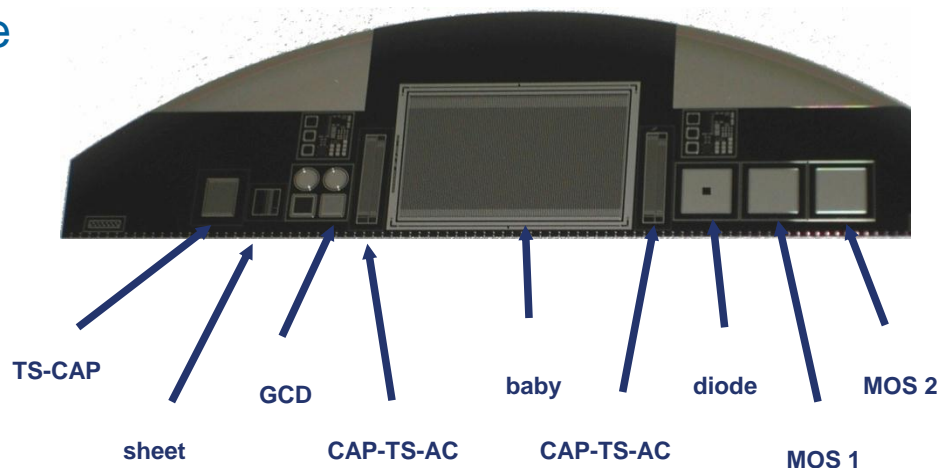
## What is Process Monitoring?

- Each wafer hosts additional test structures around main detector
- “standard” set of test structures is called “half moon” (because of its shape)
- Assuming that sensor and test structures behave identically
- Some parameters are not accessible on main detector (e.g. flat-band voltage of MOS)
- **PQC results often affect complete batch!**

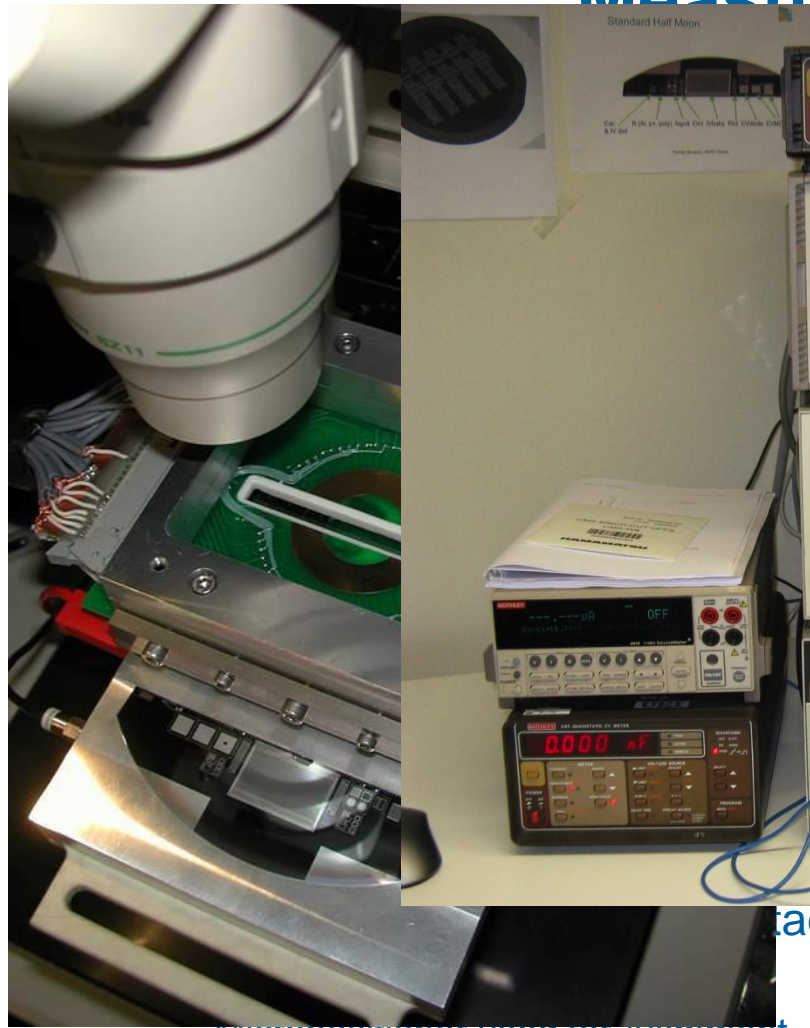
## Measure

contacts all pads of test structures in parallel

– Micropositioner used for Alignment

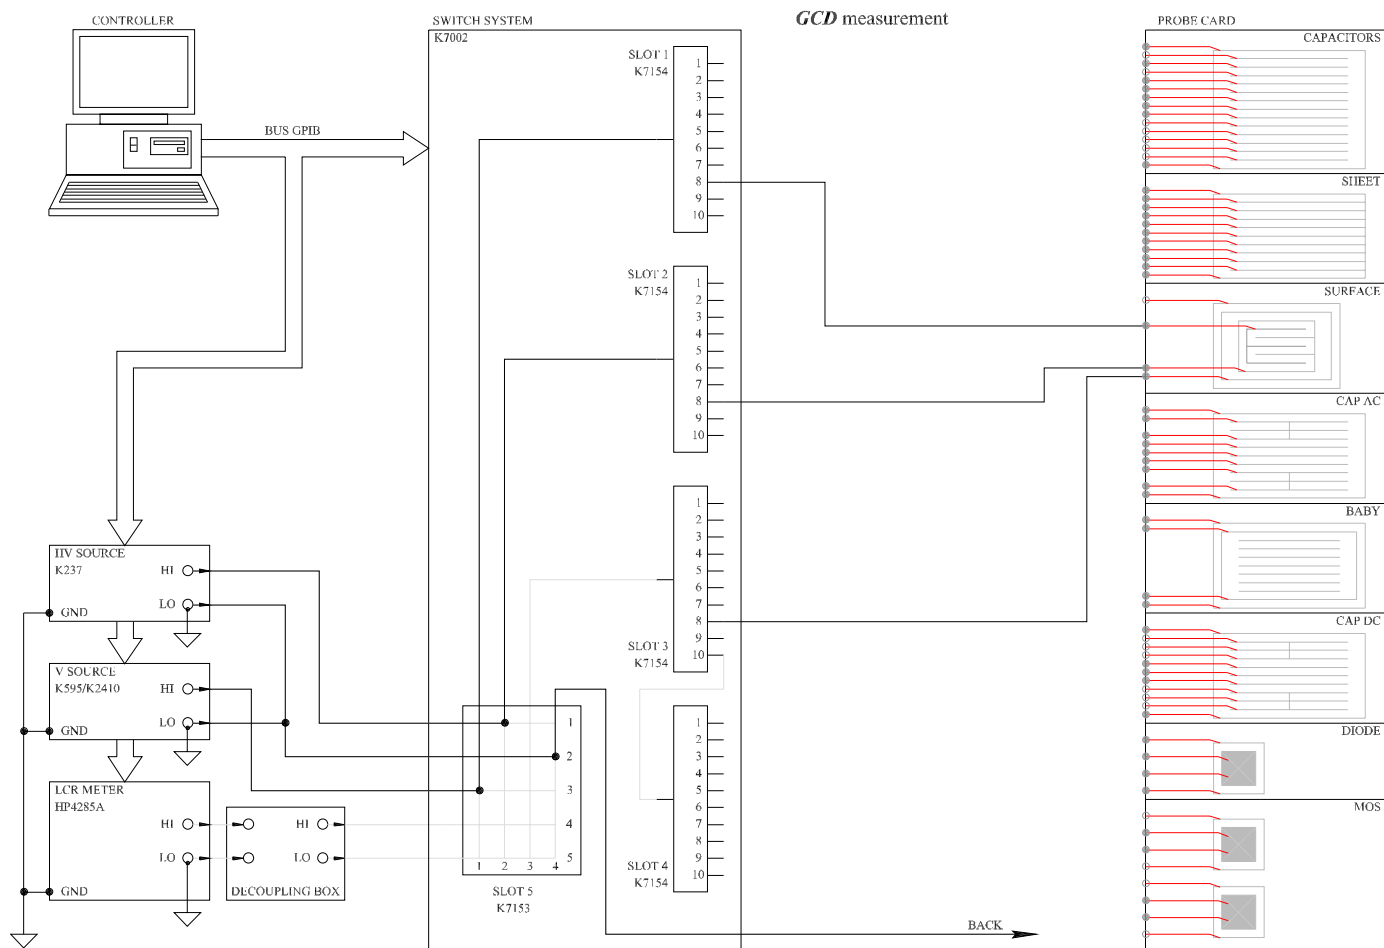
# Example for switching scheme: GCD

Process Quality Control system (Vienna configuration)

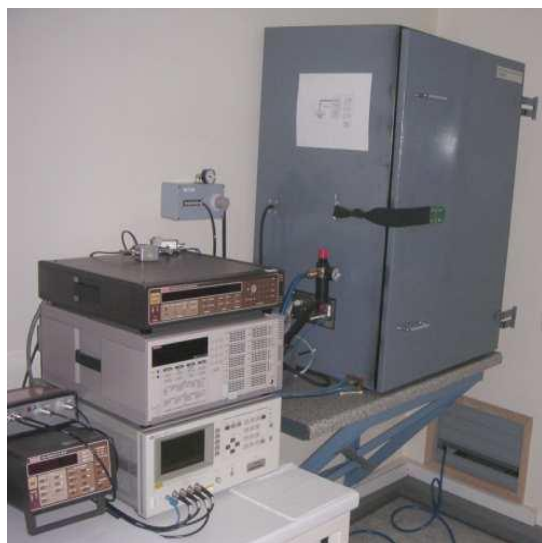
Vienna

PQC devices for each lab

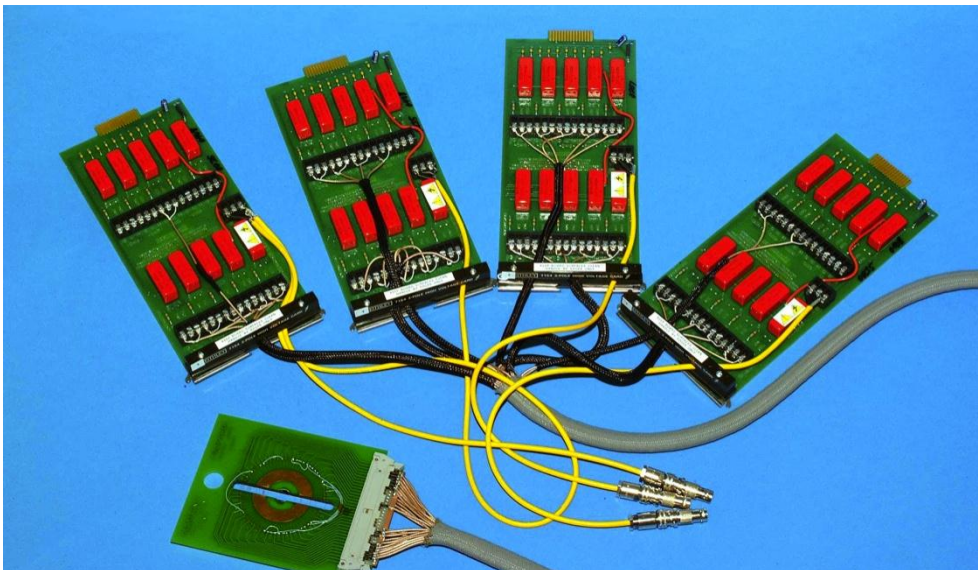
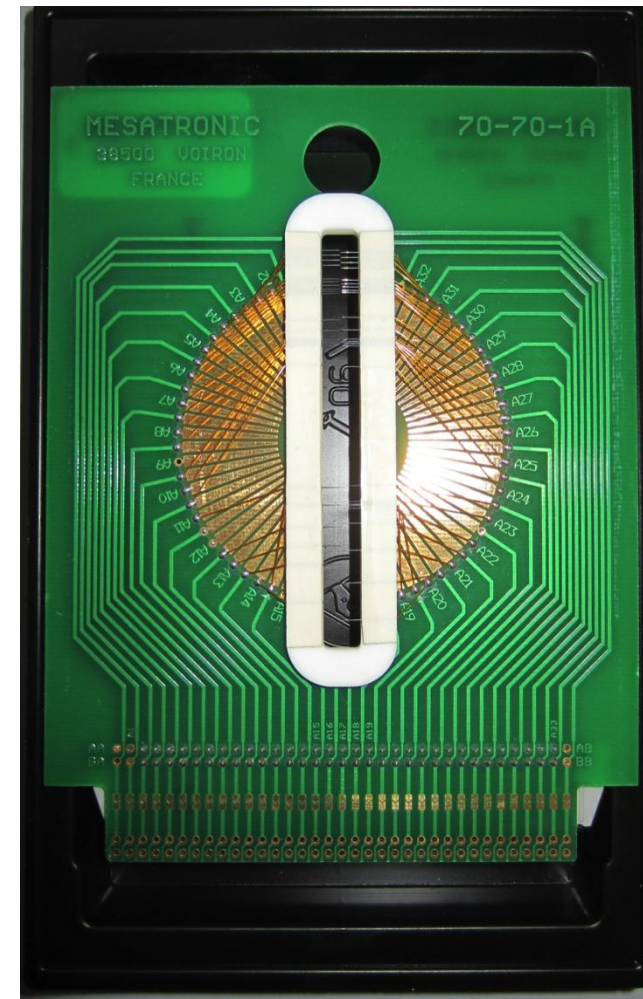
## Probe Card

Printed Circuit board

- Size approx. 10x16 cm
- 49 needles to fit pads of all TS at once
- IDC connector (not shielded)

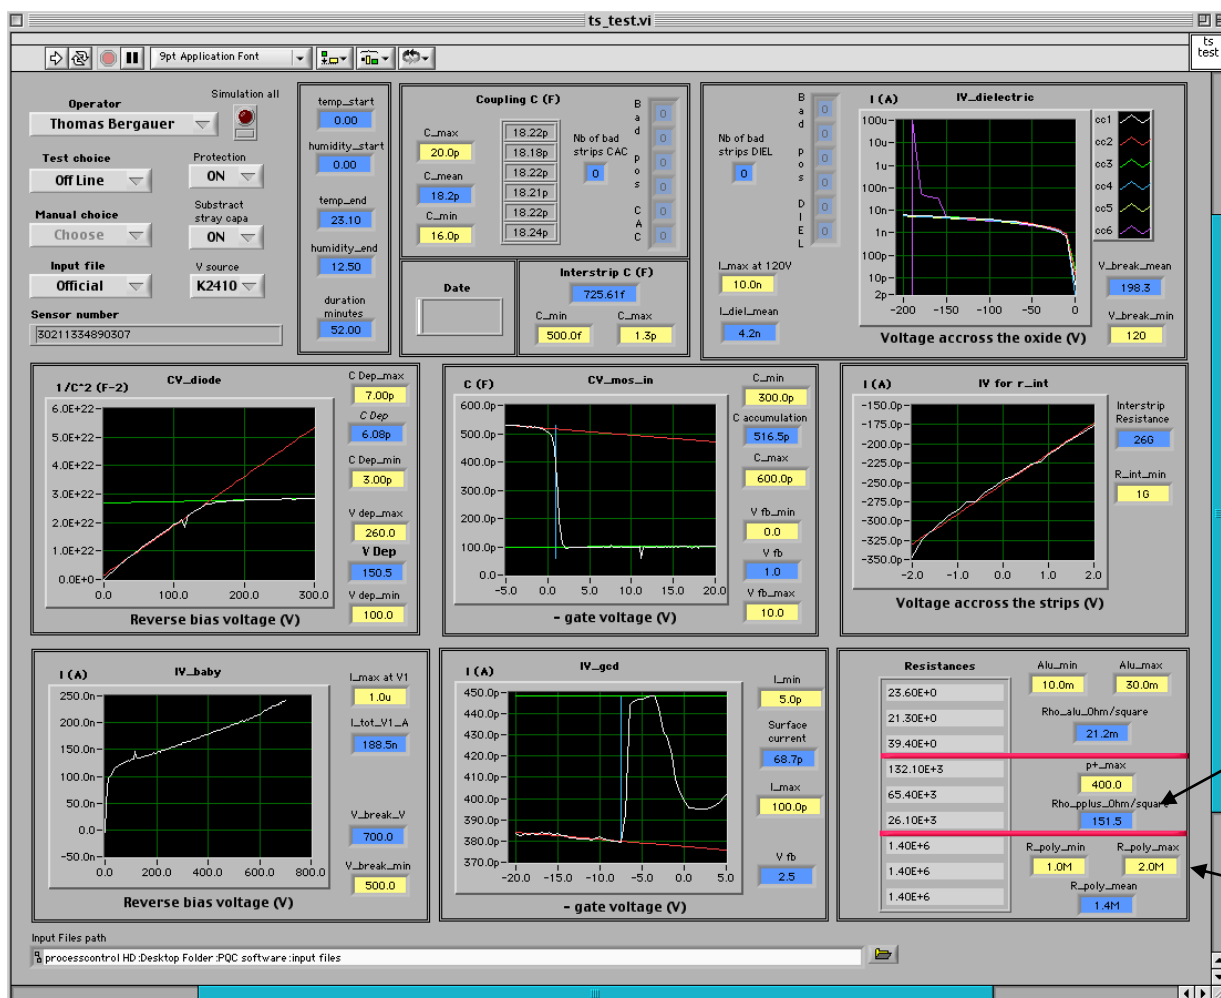
# Measurement Procedure

- TS put on chuck (held by vacuum)
- Alignment and contacting of TS in respect to probe card
- Start Labview program to perform all measurements
- Full characterization: 35 minutes

### Blue Fields:

Obtained results extracted from graph by fits

### Yellow Fields:

Limits and cuts for qualification

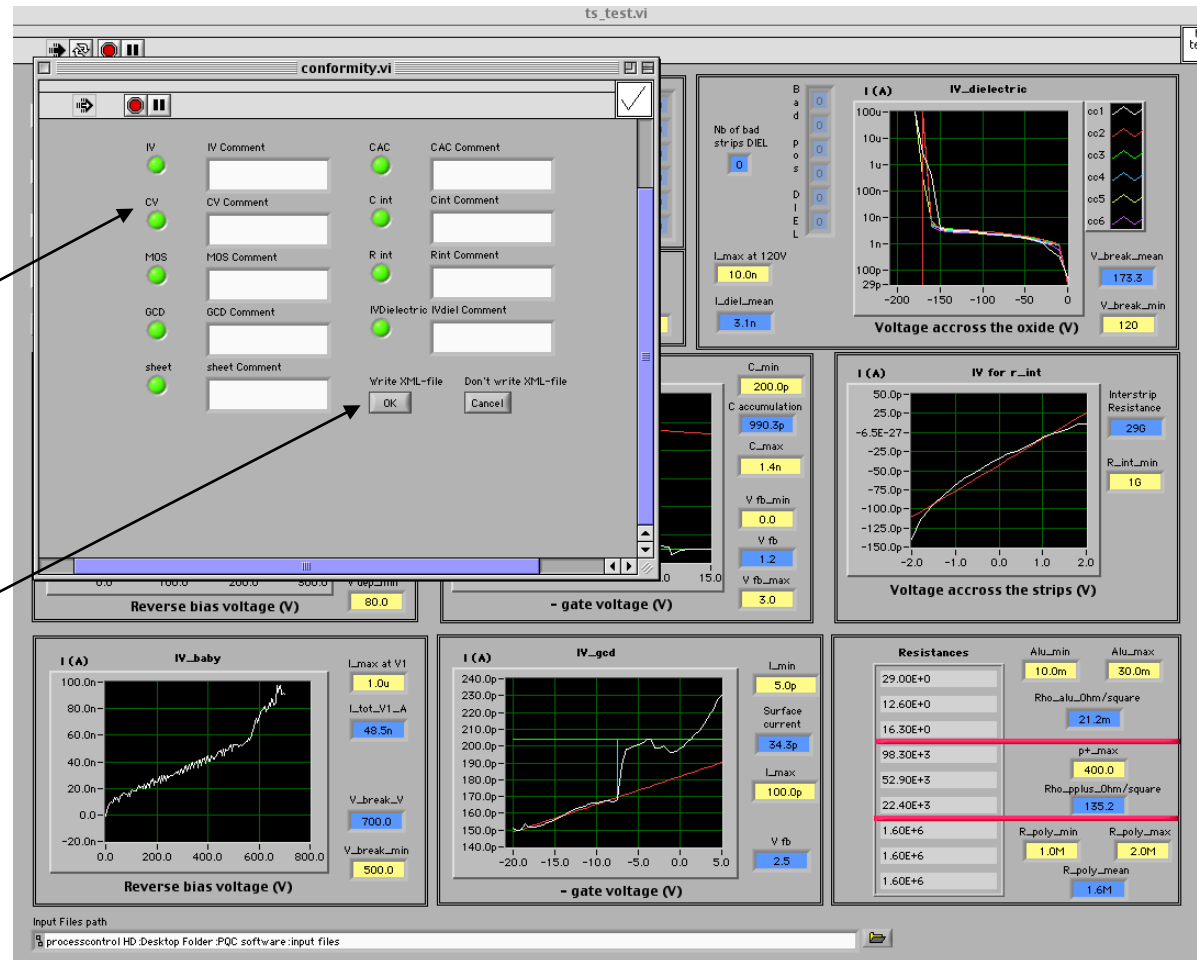
# Passed/Not Passed Lights

- After all measurements finished
- Window pops up
- One light for each test
  - Green: within limits
  - Red: out of limits
- Allows immediate judgment about quality
- Pressing “OK” button writes XML file containing all data ready to upload to CMS Tracker Construction DB

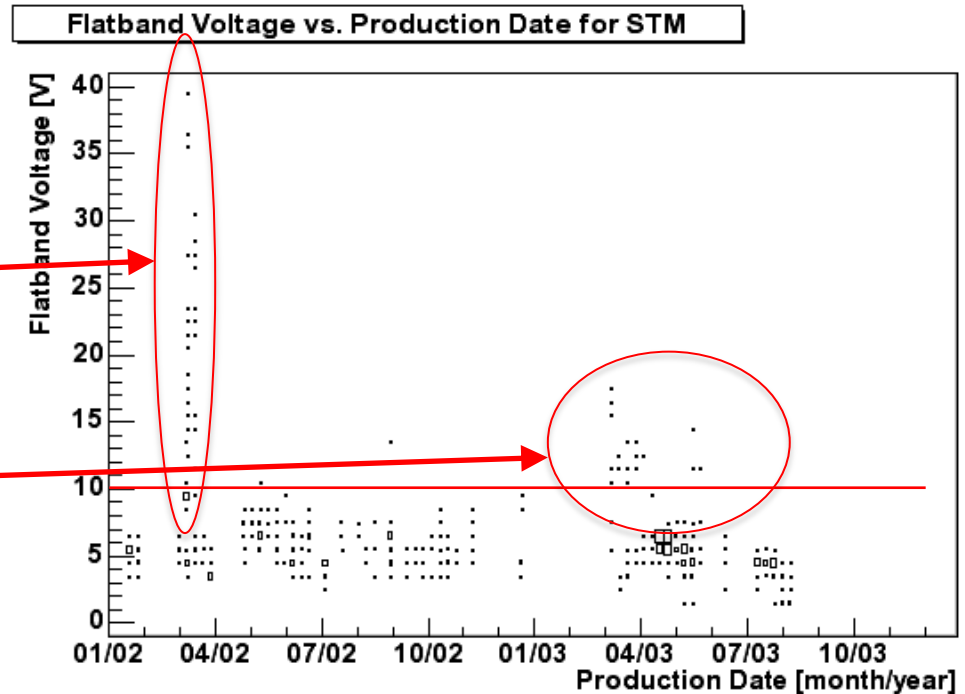
# Results: High flat-band voltage

- Measured by CV on MOS
- Initial limit of 10V
- No problem with HPK (~1.5V)
- STM: values up to 40V in week 10/02
- Some batches suffer from contamination of production line even later on

- Issues here have been cross-checked with inter-strip capacitances before/after irradiation

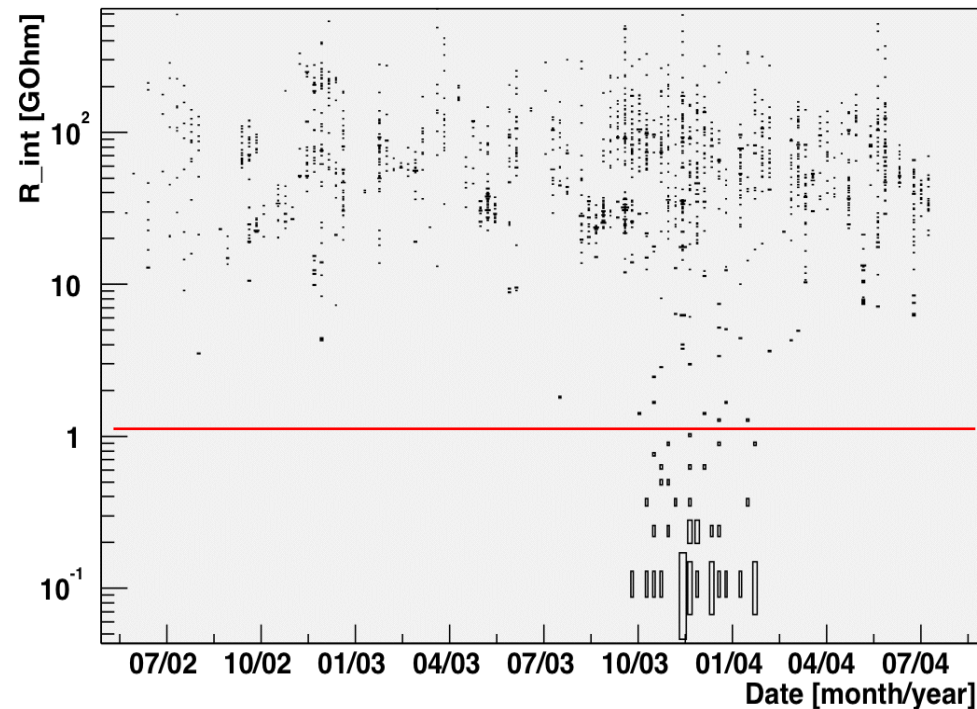
**$R_{\text{int}}$  vs. Date of Measurement for STM**

Shortly after 2nd incident of high flat-band, STM suffered from very low  $R_{\text{int}}$  values

- contamination of production line was addressed by remedy which had bad influence on  $R_{\text{int}}$

~1000 sensors affected

- **all rejected**

Lower limit:  $R_{\text{int}} > 1 \text{ G}\Omega$

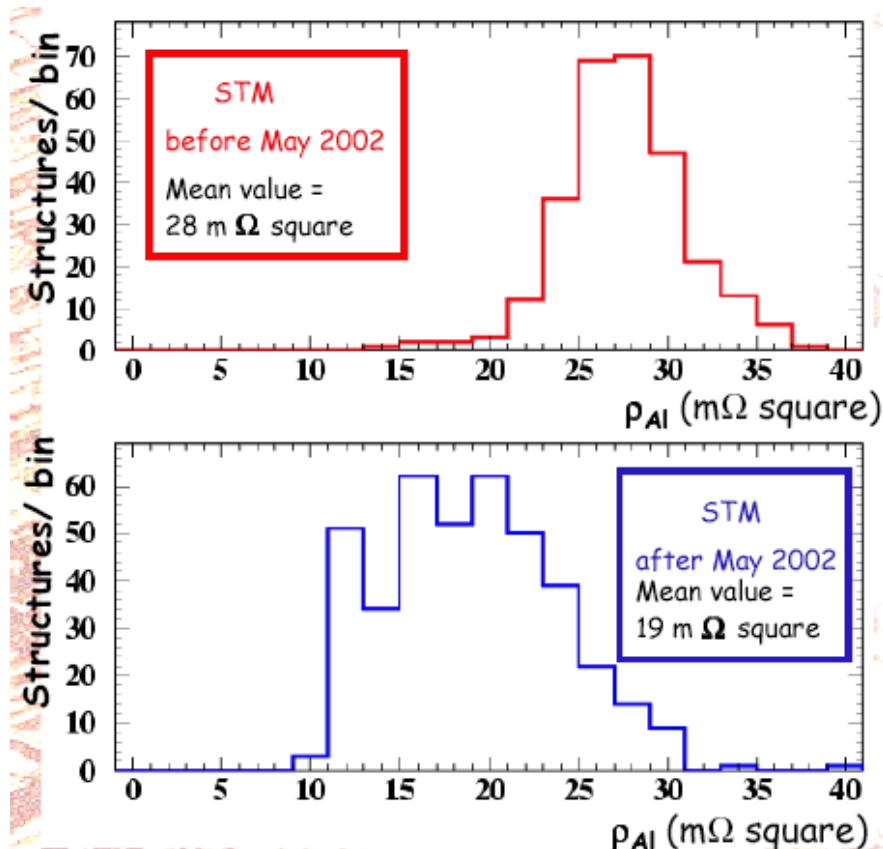
## Aluminum resistivity

- Aluminum resistivity too high for STM up to May 2002
  - Limit:  $<25 \text{ m}\Omega/\text{sq.}$
  - Affects noise of APV
- After discovered, STM was informed by the problem
  - increased Al layer thickness to  $1.2\mu\text{m}$

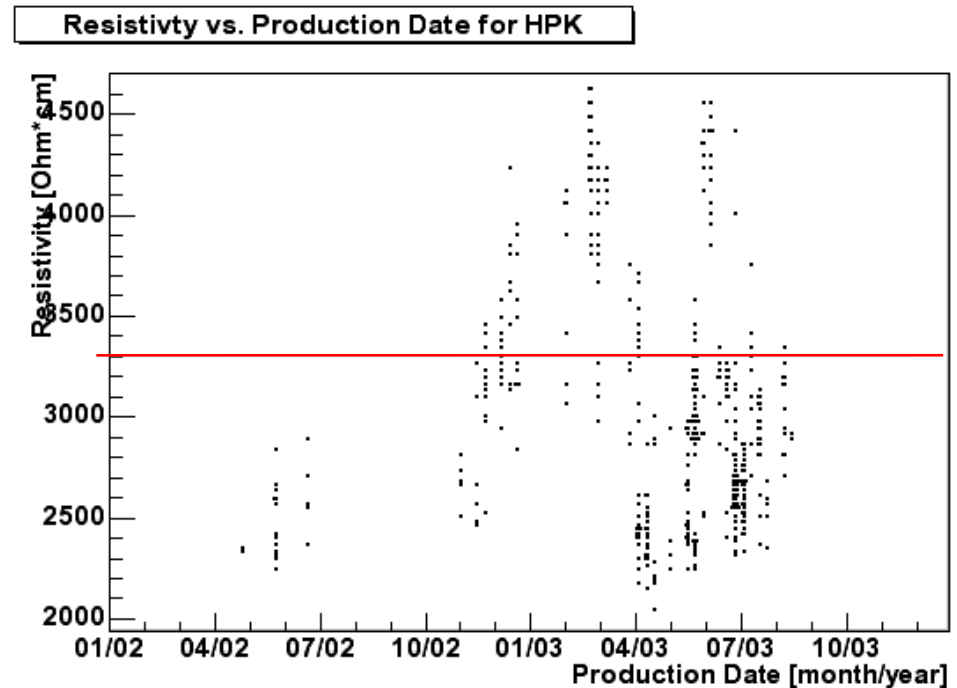
# Results: Bulk Resistivity

- $V_{\text{depl}} < 400\text{V}$  after 10 years of LHC operation

- $1.25 < \rho < 3.25 \text{ k}\Omega\text{cm}$  (inner tracker=thin sensors=HPK)
- $3.5 < \rho < 7.5 \text{ k}\Omega\text{cm}$  (outer tracker=thick sensors=STM)

- Agreement: CMS accepted all wafers, but uses the ones with lower resistivity in the inner layers.

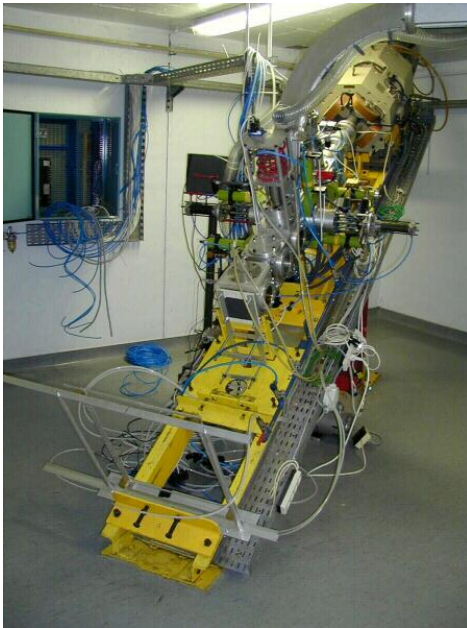
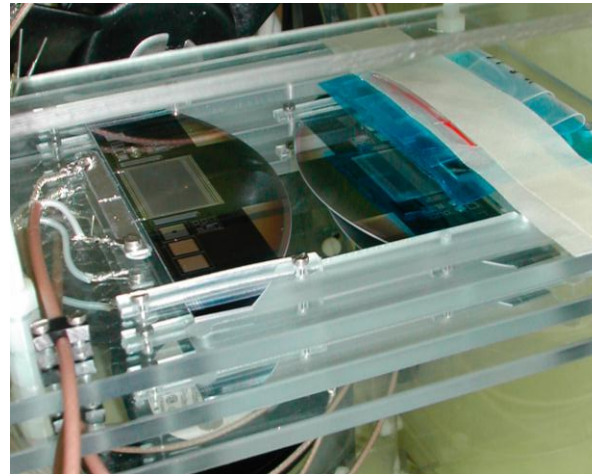
# Neutron Setup at Louvain-la-Neuve

- Fast neutrons (to create bulk damage) by using reaction  ${}^9\text{Be} + d \rightarrow n + X$ .
  - Practically, this is done by steering a 50 MeV deuteron beam on a 1 cm thick beryllium target. (T2 beam line)
  - Deuteron beam is accelerated by the LLN isochronous cyclotron

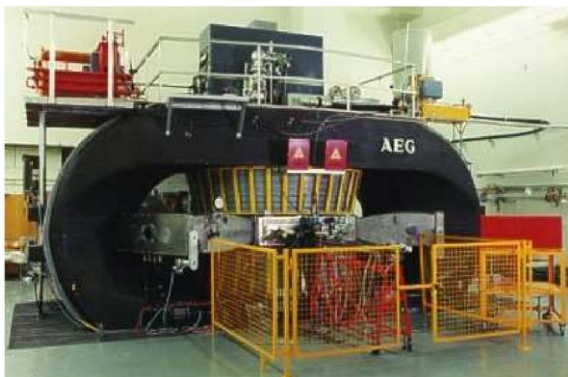
## Proton Setup at Karlsruhe

- 25 MeV protons at Karlsruhe Cyclotron
- Beam-spot size 4-8 mm, so samples need to be scanned
- Samples sit in cooled box

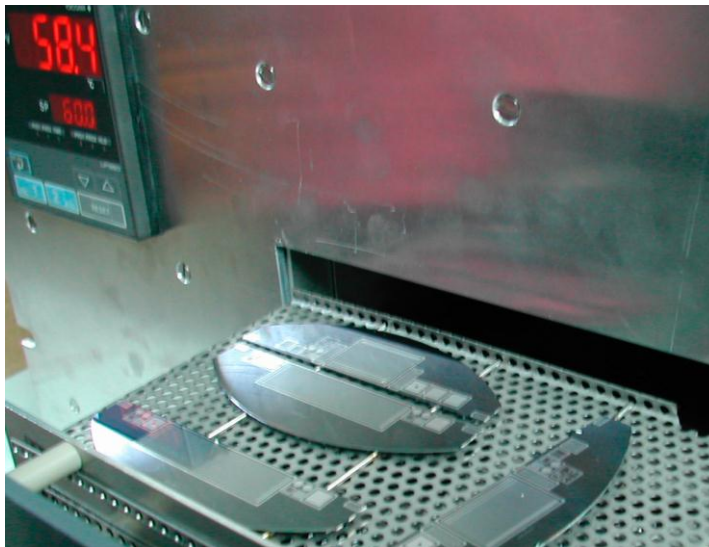
# Annealing

- Measurements should be preformed at defined annealing time to get comparable results
- For a stable full depletion voltage we chose the minimum in  $U_{fd}(t)$ , which turned out to be at 80min at 60°C (or about 10 days at RT)

Measurement of  $U_{fd}(t)$  on 320 $\mu$ m mini-sensors  
with HH-model fit

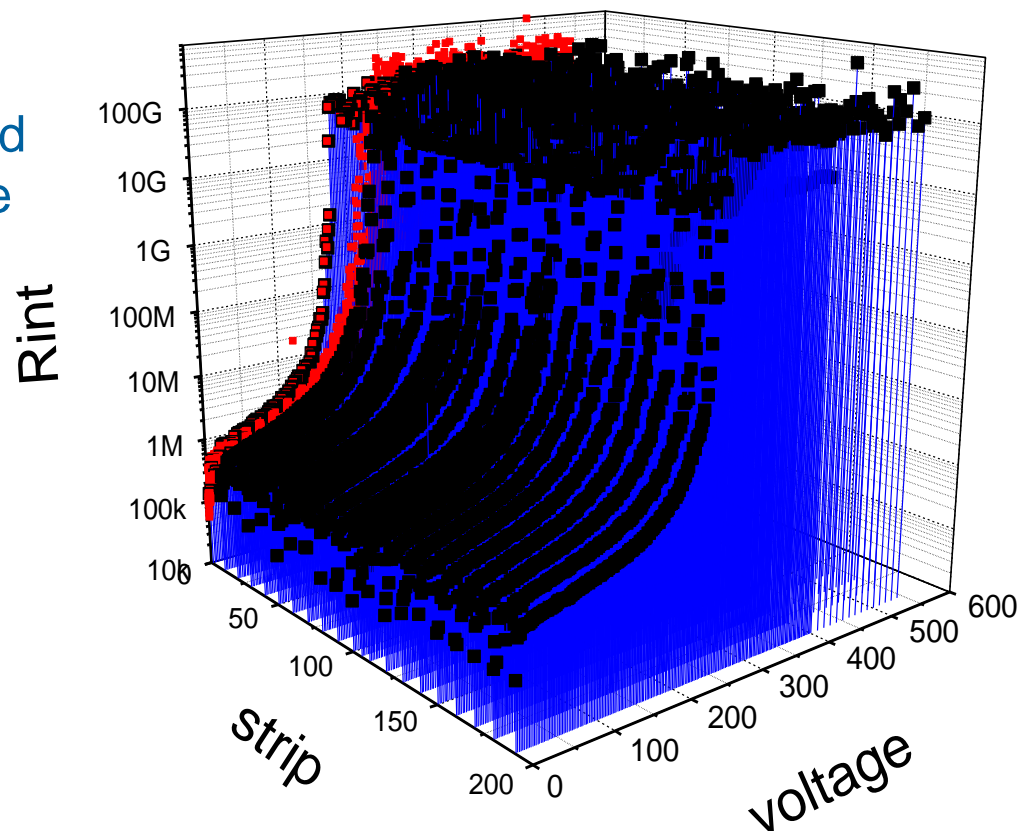
# Measurement/Irradiation Procedure

“Standard” electrical characterization was twice, before and after irradiation ( $T=-10^{\circ}\text{C}$ )

- **Global:** IV, CV
- **Strip:** (all parameters are scanned against the voltage to be sensitive to unexpected behavior)
  - leakage current
  - $R_{\text{poly}}$
  - $I_{\text{diel}}$
  - Coupling Capacitance
  - Inter-strip resistance
  - Inter-strip capacitance

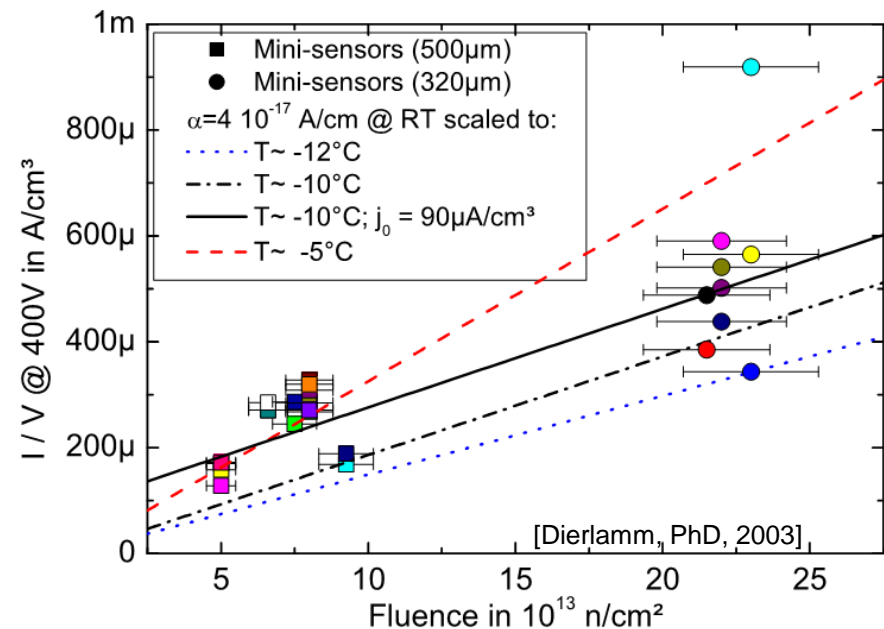
# Total leakage current

Check if leakage currents are within expectations

- I/V increase vs. F was shown to be universal for bulk generated current (PhD thesis Moll)
- Can be used to identify additional current sources or problems
- Essential to estimate power budget and cooling power

Measurements on CMS mini-strip sensors in operation mode (guard ring floating)

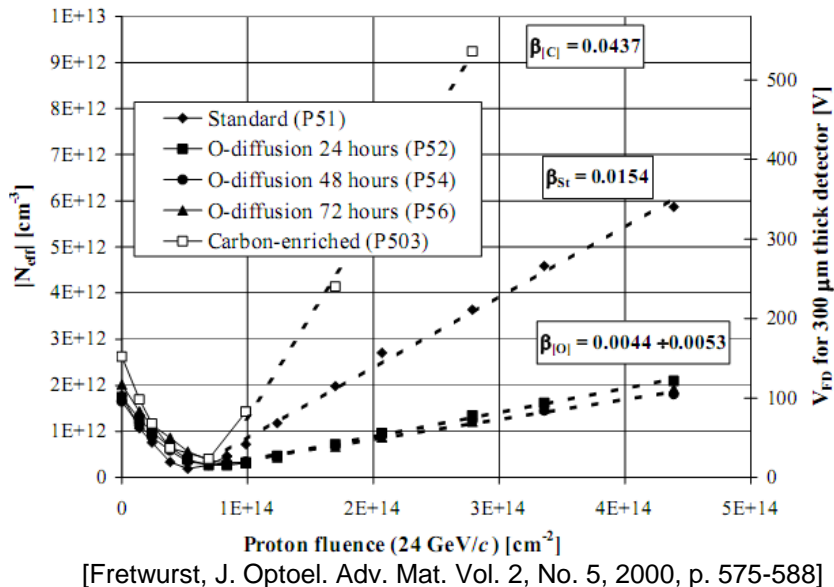
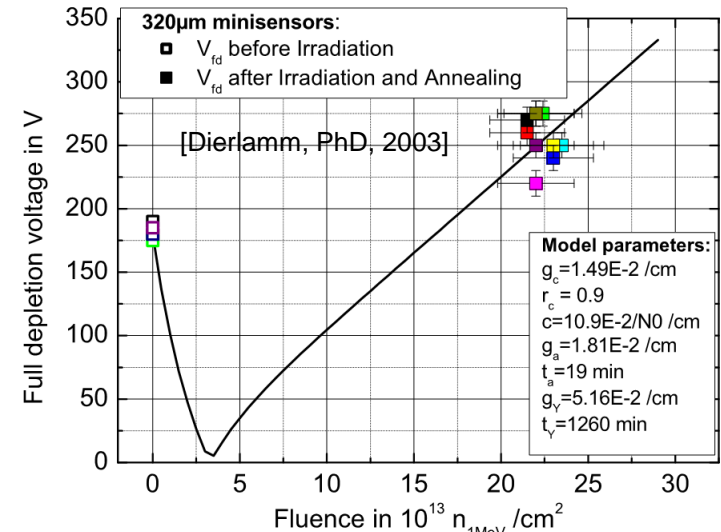
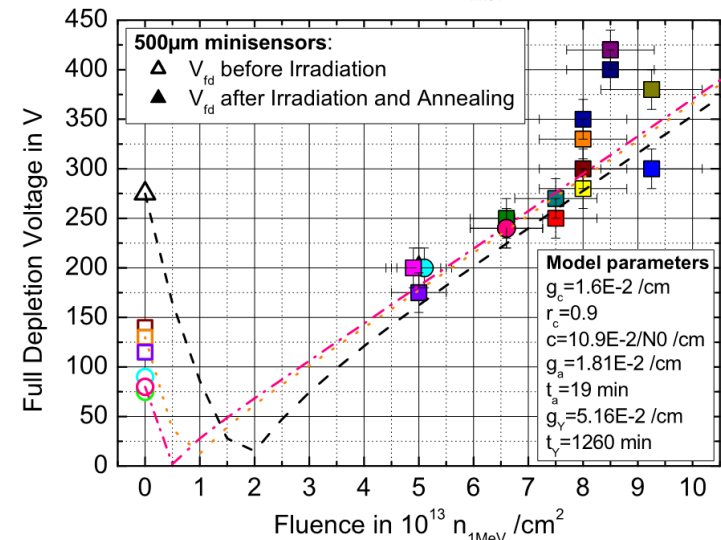
# Full Depletion Voltage

- $U_{fd}(F)$  depends on material and particle type
  - might reveal material contaminations
- Favorable to have several fluence steps
- Parameterization can be used to model certain operation scenarios

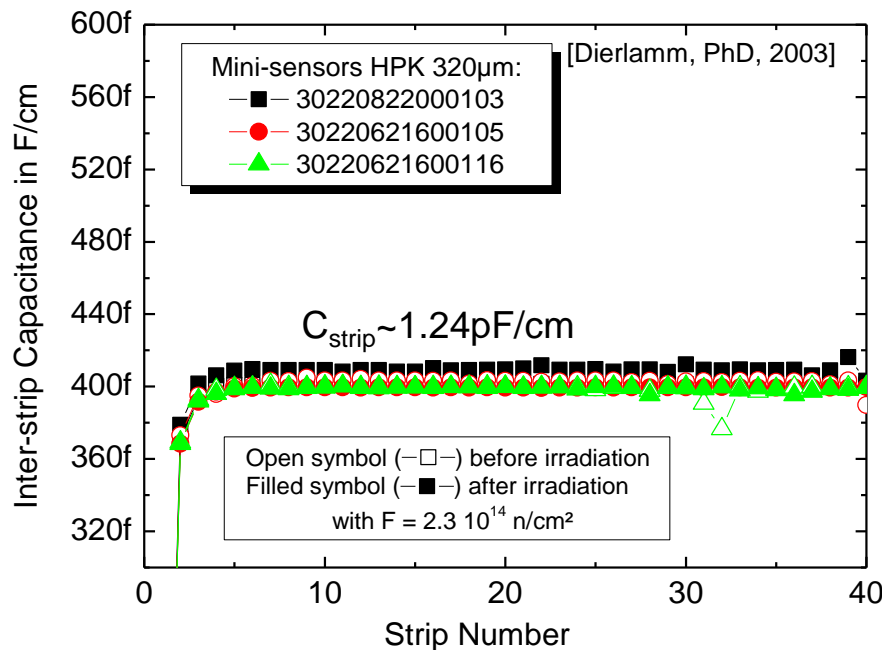
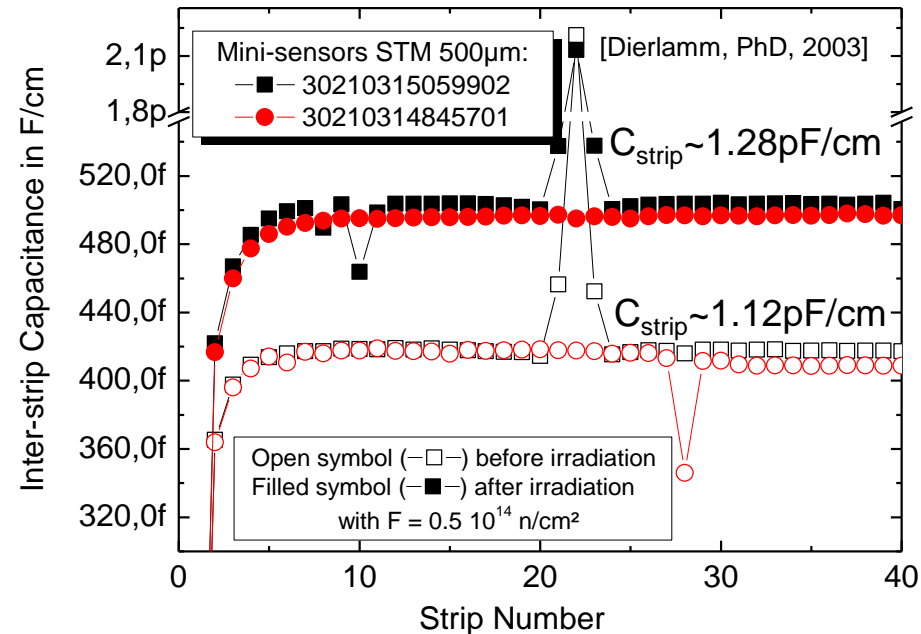
# Inter-strip Capacitance

- Thin HPK sensors showed marginal increase after high irradiation
- Thick STM sensors showed significant increase ( $\sim 15\%$ ) already after low dose
  - this indicated some weakness in the ST production

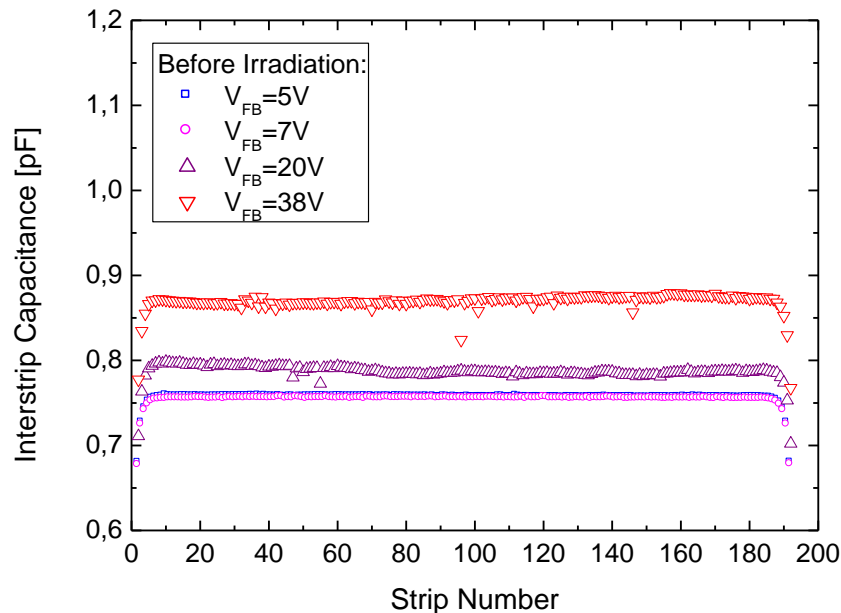
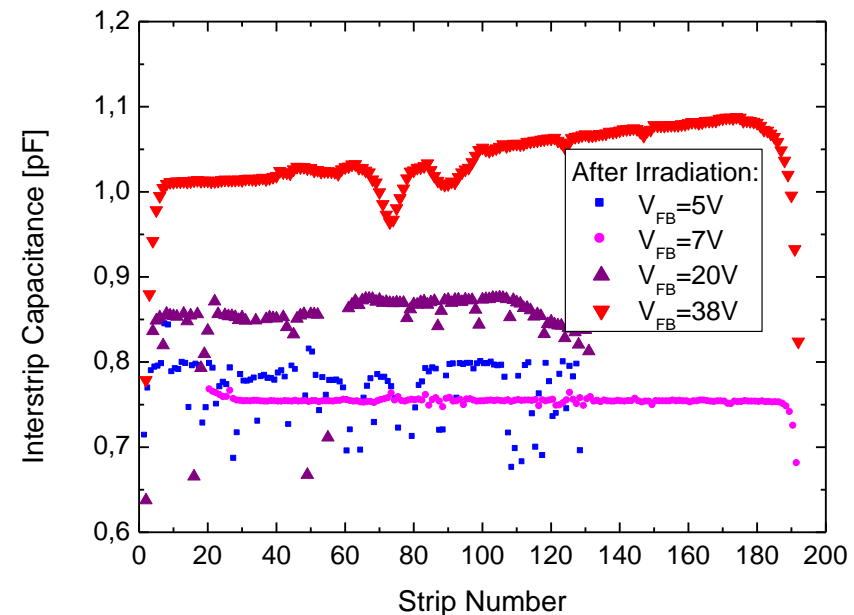
# Inter-strip Capacitance variations for different flat-band voltages

Increase in  $C_{\text{int}}$  scales with  $V_{\text{FB}}$  before and after irradiation !

→ new limit for  $V_{\text{flat}}$  acceptance at PQC:  $<7\text{V}$

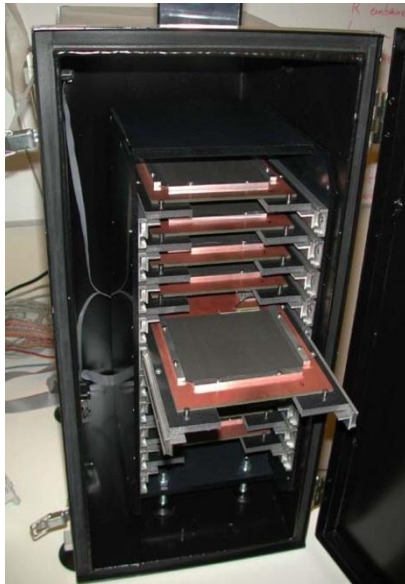
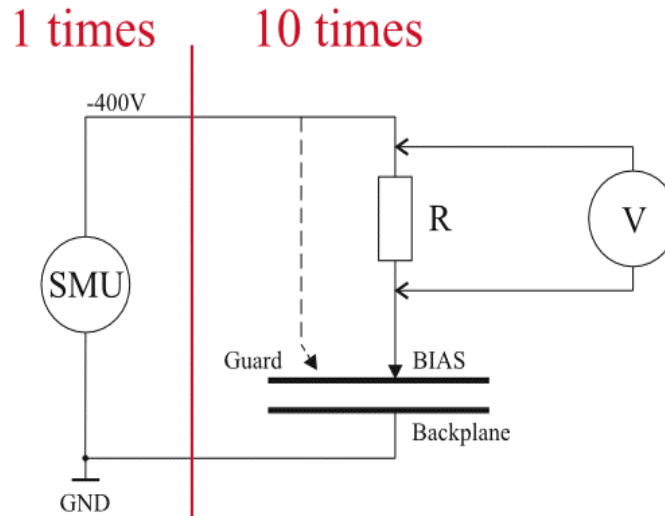
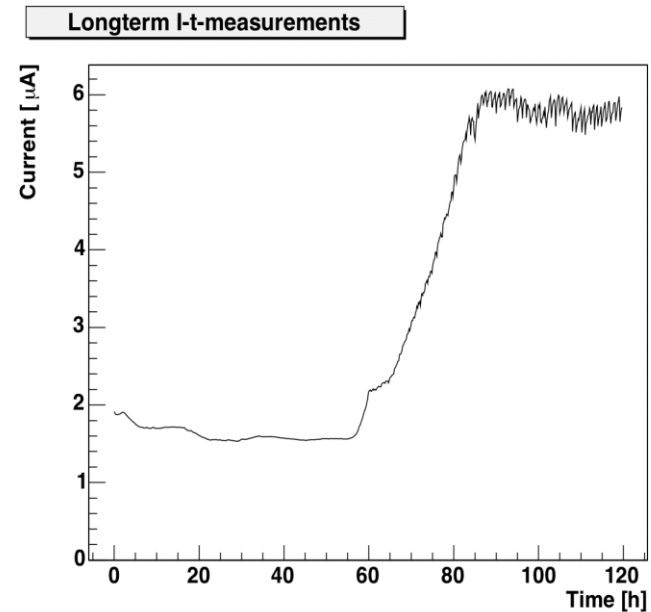
# Long-term stability

Monitoring of leakage current over certain timescale, usually 1 week

- Regularly at room temperature
  - Humidity control by nitrogen blow
- Special investigations also at -20 degC in Vienna Box
