# The Silicon Strip Sensors of the CMS Tracker

Thomas Bergauer (HEPHY Vienna)

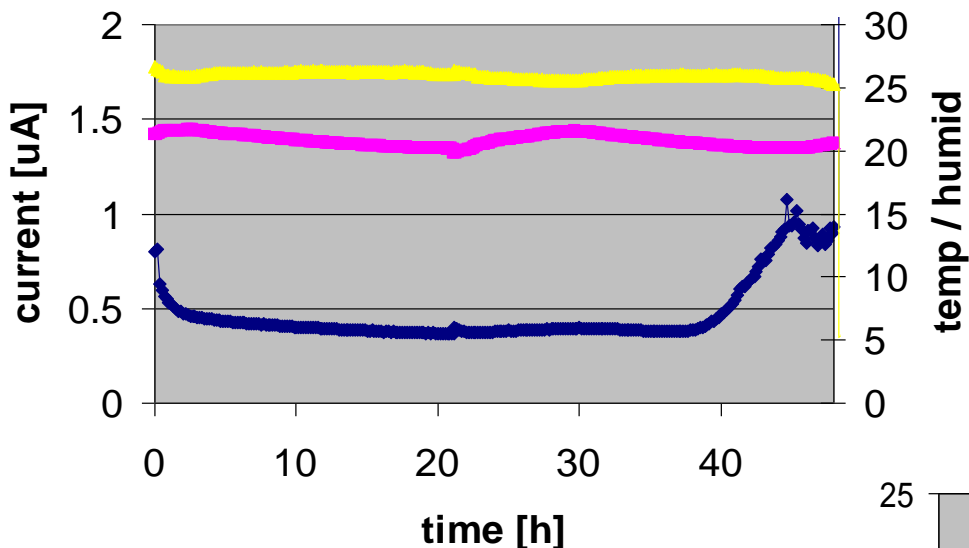
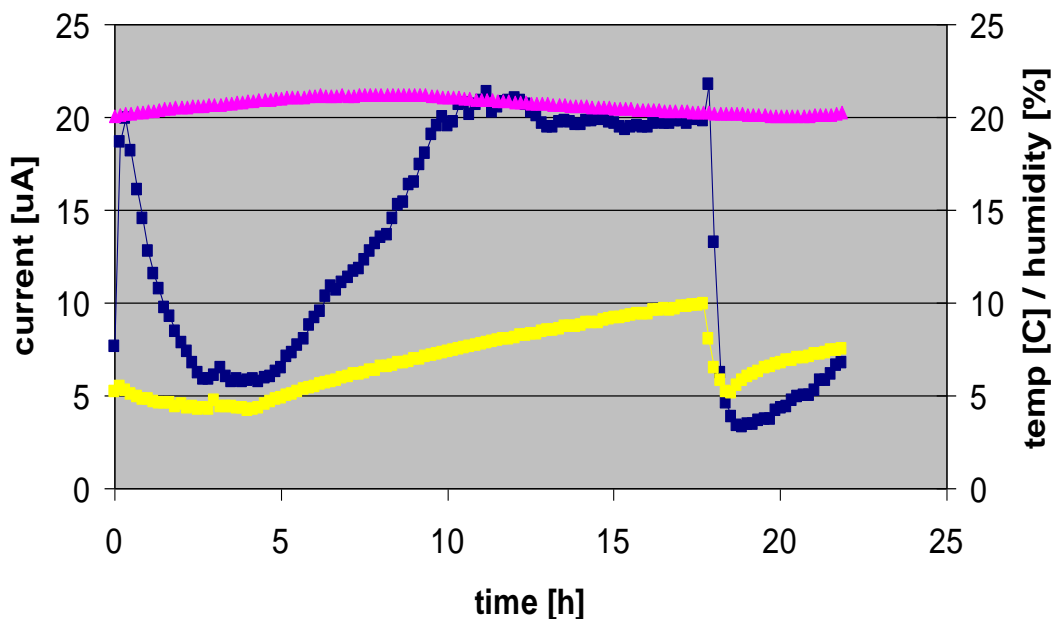
# Influence of humidity

Sensor 3021 13 331 24002

- current increase after 40 hours
- Re-measurement shows clear correlation with humidity (5-10% range)

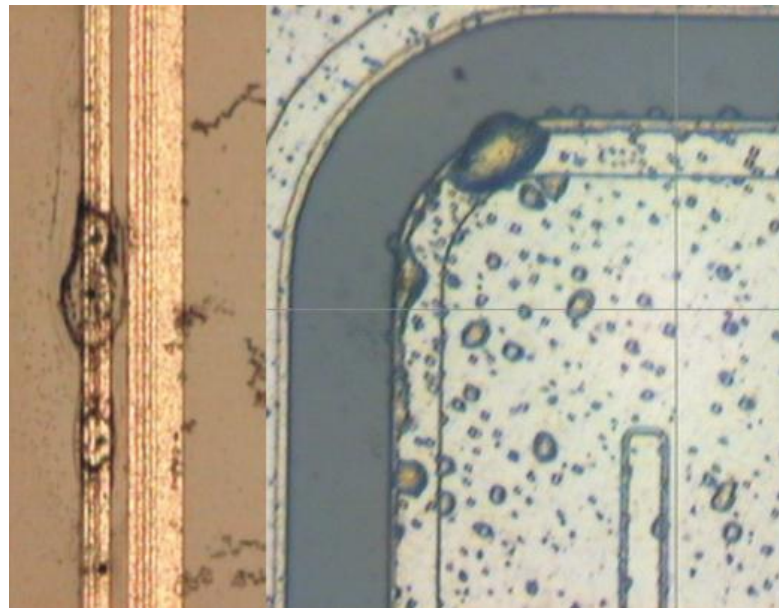
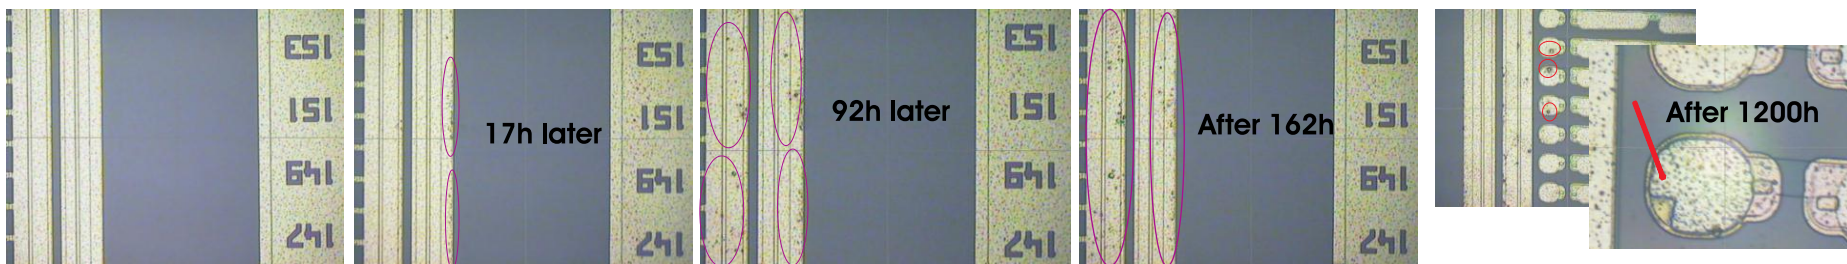
## Corrosion

Chemical reaction:  $\text{Al} \rightarrow \text{Al}_2\text{O}_3$

- fueled by water (air moisture)
- heated by electricity (HV needed)
- Catalyzed by impurities like potassium
  - Leftover from  $\text{SiO}_2$  etching
- $\text{Al}_2\text{O}_3$  non-conductive, the corrosion may affect our high voltage stability

Ultimate trigger to drop almost all STM sensors from CMS Tracker

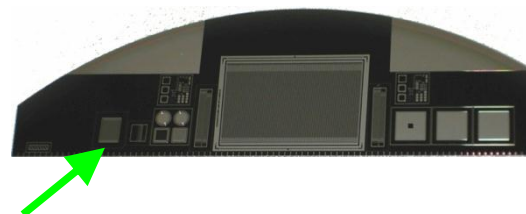
## TS CAP

- Array of 26 AC-coupled strips
- Test of Coupling Capacitance
  - Oxide Thickness can be calculated
- Test of dielectric breakdown
  - Destructive !

- **TS-CAP:**
  - Coupling capacitance  $C_{AC}$  to determine oxide thickness ( $> 1.2$  pF/cm per  $\mu\text{m}$  of implanted strip width)
  - IV-Curve: breakthrough voltage of oxide  $> 120$  V (destructive!)

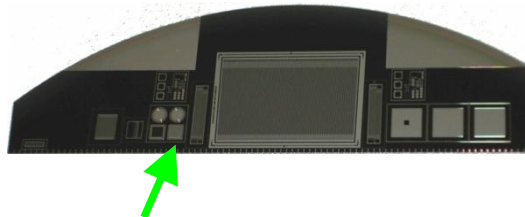
## CAP-TS-AC

- Measurement of inter-strip capacitance
  - Between single central strip and two neighboring ones
  - Outer strips on top and bottom are shorted and connected to ground (directly on the structure)
  - While biasing of structure is mandatory
- Parameter related to noise and SNR of readout chip

- **CAP-TS-AC:**
  - Inter-strip capacitance  $C_{\text{int}}$  (within 10% of parameterization)
- **Baby-Sensor:**
  - IV-Curve for dark current ( $< 100$  nA/cm<sup>2</sup> @ 500 V; 21°C)

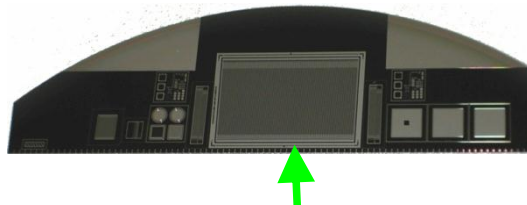
# Baby Sensor

- Structure with 192 AC-coupled strips
- Identical to main detector
- Used to measure IV-curve up to 700 V
  - Breakthrough voltage is determined

- Breakthrough  $> 500$  V
- **CAP-TS-DC:**
  - Inter-strip Resistance  $R_{\text{int}} > 1$  G $\Omega$
- **Diode:**
  - CV:  $100$  V  $< V_{\text{dep}} < 250$  V depending on resistivity

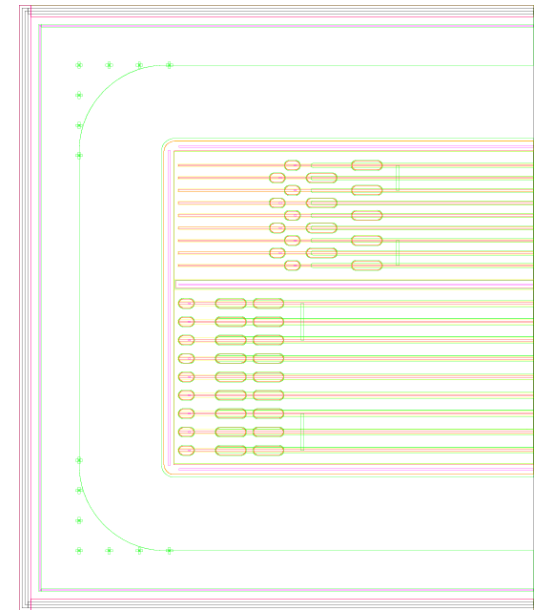
# CAP-TS-DC

- Used to determine inter-strip resistance
- Similar structure like CAP-TS-AC (used for C\_int) but with exceptions
  - no polysilicon resistor (strips do not have a connection to bias ring)
  - p<sup>+</sup> strips are directly connected to Aluminium strips
- High value of inter-strip resistance necessary to have a good electrical separation of strips

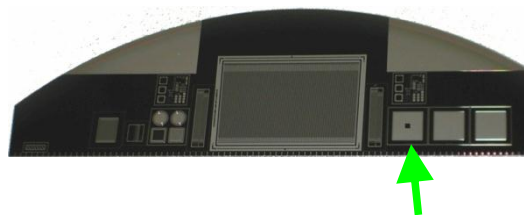
- Simple square diode
- Voltage scan is used to measure Capacitance and to extract
  - total bulk thickness

$$C_{depl} = e_0 e_r \frac{A}{d}$$

- Bulk resistivity

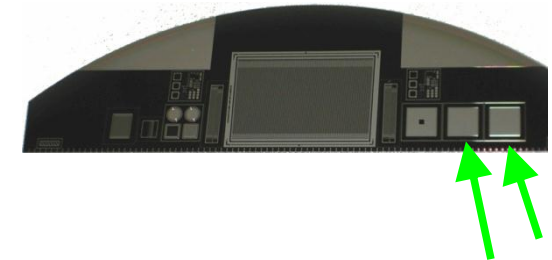
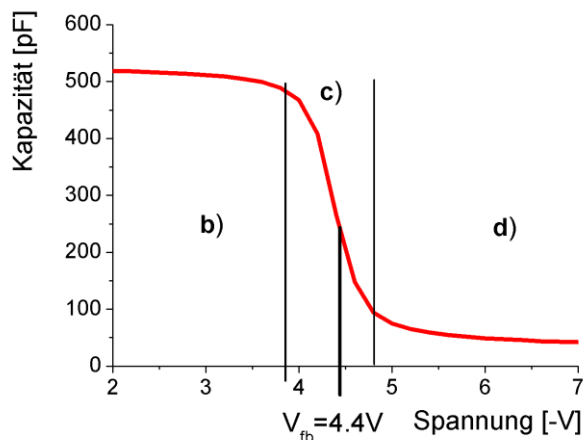
# MOS

- **Metal Oxide Semiconductor**
- Oxide composition represents configuration of
  - Thick dielectric in inter-strip region
  - Thin dielectric underneath strips (right)
- Extraction of **flatband voltage**  $V_{fb}$ 
  - Seen by sharp decrease of Capacitance (between accumulation and inversion)
  - to determine fixed positive charges in Oxide
- Limit defined experimental after test beam

- **MOS:**
  - CV-Curve to extract flatband voltage to characterize fixed oxide charges ( $< 7$  V)
  - For thick interstrip oxide (MOS1)
  - For thin readout oxide (MOS2)
