Quality assurance related to system integration of the VELO detector.

Jan Buytaert, CERN
On behalf of the VELO collaboration.

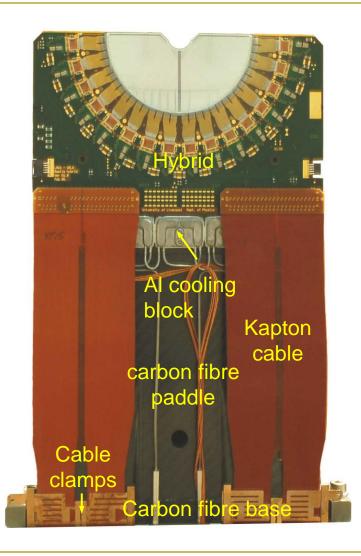
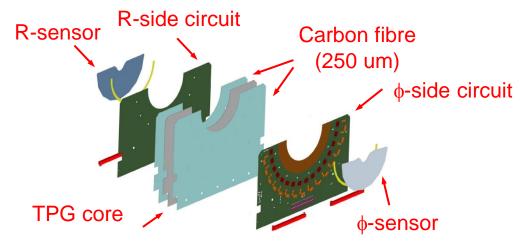
VELO Module

- double-sided symmetric build to balance stresses due to "bi-metallic" effects.
- N-on-n sensors (300um).
- Thermal pyrolitic graphite (400um)
- analogue read-out asic's : 2 x 16 Beetle chips (~18 Watt)
- Cooling: 2-phase CO₂ [silicon tip @ -7° C]
- 3 layer kapton cable for signals and power.

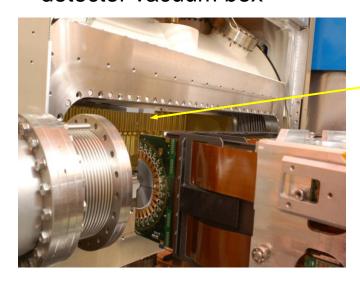
... insertion of one half into detector vacuum box

Thin (300 um) Alu shaped foil separates detector from primary LHC beam vacuum.

Detector box pressure < 10⁻⁴ mbar

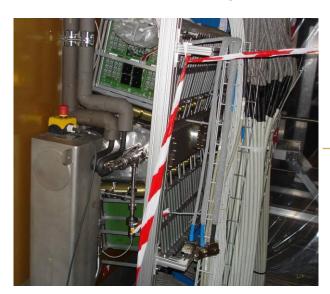
Repeater boards:

- Pre-emphasis circuit for cable transmission.
- Rad-hard power regulators

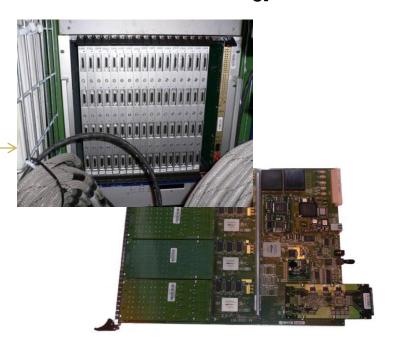
Digitizing board (Tell1):

- 64 channels 10 bit ADC @ 40MHz
- signal processing FPGAs [cross-talk, common mode, pedestal subtraction & clustering]

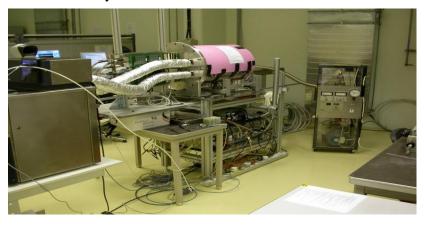
Burn in system

Detailed visual inspection under microscope (3hours)

Thermal cycling 4 x [-22C/+28C] (3h)

Long (24h) power up under vacuum

Monitoring of leakage current and strip noise. Thermal imaging IR camera.

1 module was rejected due to suspicious leakage current evolution.

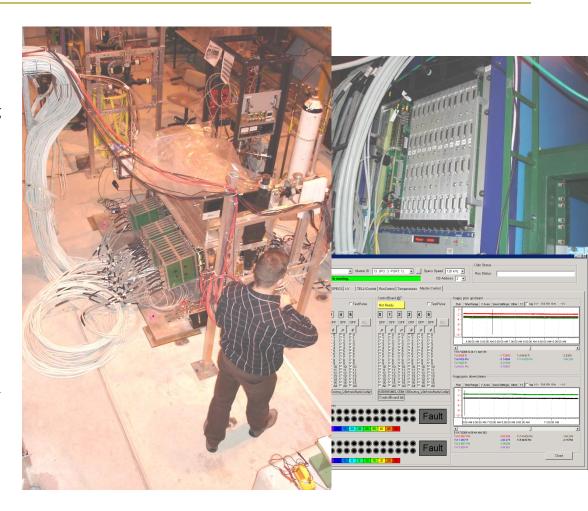
Putting all pieces together.

- 2 test beams in SPS with the aim of integrating :
 - Multiple modules and final mechanics.
 - □ Signal chain : repeater electronics/long cables/TELL1.
 - Final LHCb DAQ HW and event building SW.
 - □ Final LHCb Timing and Fast control ("ODIN")
 - Final low and high voltage systems.(found bug on interlock input of CAEN LV!)
 - Under vacuum and CO2 cooling.
 - □ PVSS based configuration software.
 - □ elog ...
- 'Last check' before installation on LHC.
- Large effort, but it proved there was no showstopper towards the final system!

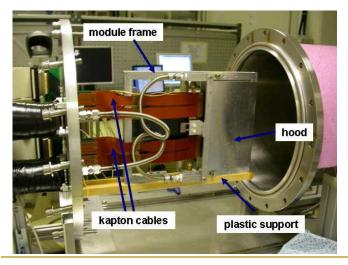
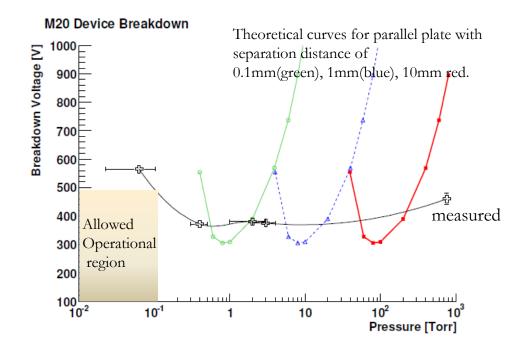
Study of HV breakdown in vacuum

- The expected dependence on pressure is described by Paschen's curve :
- It was measured on a complete module.
- The study was done in air.
- Measured minimum breakdown voltage
 = 370V. The breakdown was likely not on the sensor (looking at strip noise map.)
- Fully described in LHCb note 2007-104, 2007.

$$V \text{ breakdown} = \frac{B.p.d}{(C+\ln(p.d))} \\ B = 365 \text{ V/cm/Torr for air} \\ P = \text{pressure (Torr)} \\ D = \text{distance (cm)} \\ C = 1.18 \text{ for air} \\$$

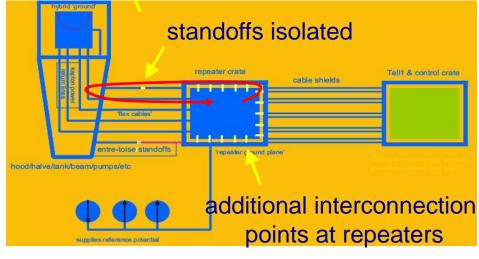
Electrical Oscillations...

- The amplifiers on the repeater boards exhibited unstable behaviour under certain conditions when inserted in their crates.
- It was caused by a feedback through a parasitic path (metallic frame and standoff feet).
- It was solved by modifying
 - the mechanics (isolated standoffs)
 - the grounding scheme (additional interconnections).

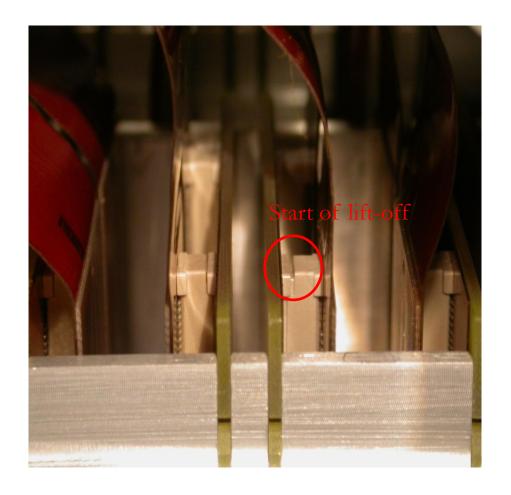
The usual culprits: connectors

- Use of a connector without locking mechanism for the interconnection between the 'short' and 'long' kapton cables.
- The retention force is large, but sometime not sufficient to resist the force from cable torsion.
- It has caused partial disconnection in a pile-up detector module (cables with higher torsion). The Velo detector is not affected.
- Careful last visual inspection ...

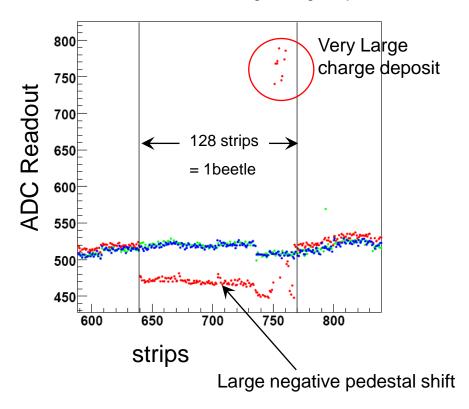
A Beetle weakness.

- Very large charge deposits in multiple channels cause large pedestal shift in all 128 channels of the ASIC
- This was accidentally observed in test beam data. (Rare event).
- The beetle was specified and tested for large charge deposits in <u>single channel only</u>.
- At LHC, these events are 0.1% of the data and can be corrected for by signal processing in FPGA.
- This was not detected despite 'good' specification and QA...

3 consecutive events (green, red, blue). Red event contains large charge deposit.

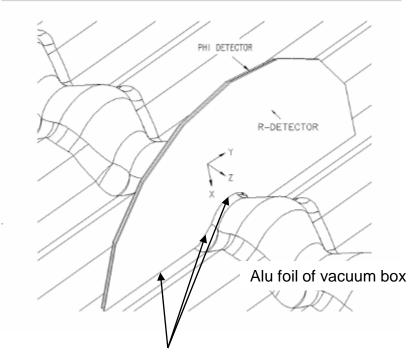
Achieving Sensor-foil clearance ...

By design in general, 1mm clearance

Achieved clearance depends on mechanical precision and stability of the modules, the base plate and the vacuum box foil.
