Wire Bonding Quality Issues

A. Honma and I. McGill, CERN PH/DT

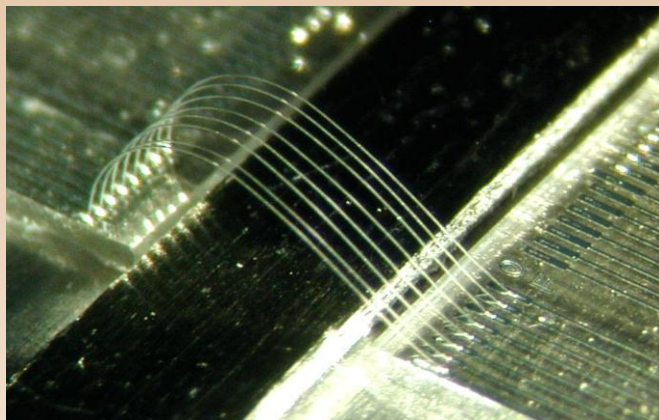
Aluminium wedge ultrasonic

- Room temperature process
- More control (larger parameter window)
- Better at fine pitch
- Excellent reliability on Al bond pads
- Good reliability on PCB/Kapton bond pads

Used almost exclusively for unpackaged
HEP wire bonding applications

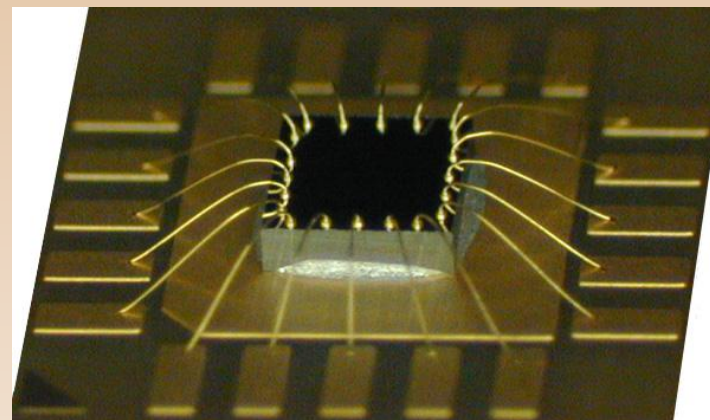
Gold ball thermosonic (industry standard)

- Needs heating of substrate ($>150^{\circ}\text{C}$)
- Smaller parameter window
- Almost as good at fine pitch
- Good reliability on Al bond pads
- Problematic on PCB/Kapton
- Faster

Used in ~90% of industrial packaged
chips but copper wire use increasing

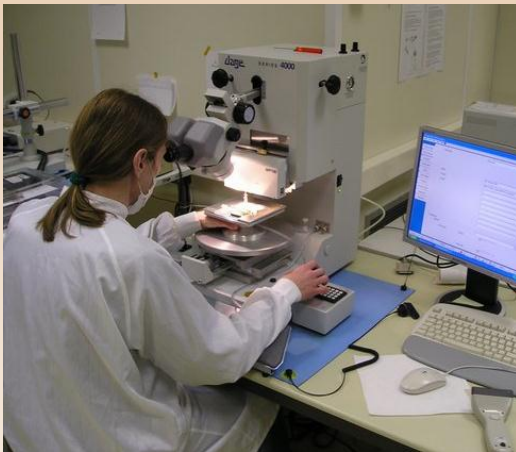
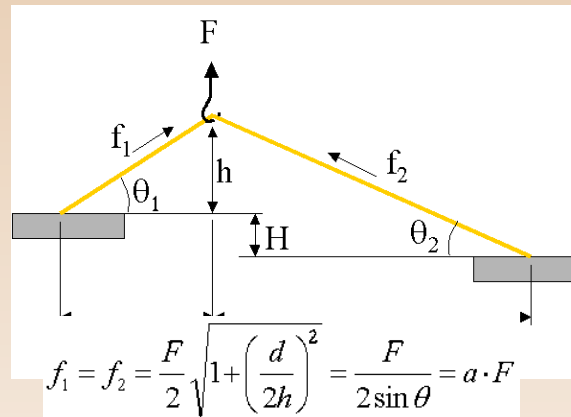
Want high mean strength, low RMS and no “lifts”

Number of tests	11
Minimum load	7.845 g
Maximum load	12.268 g
Mean	10.095 g
StdDev	1.287 g

Grade	Description	Number	Mean	StdDev
1	first bond heel break	6	10.629 g	1.108 g
2	first bond lift	5	9.454 g	1.290 g

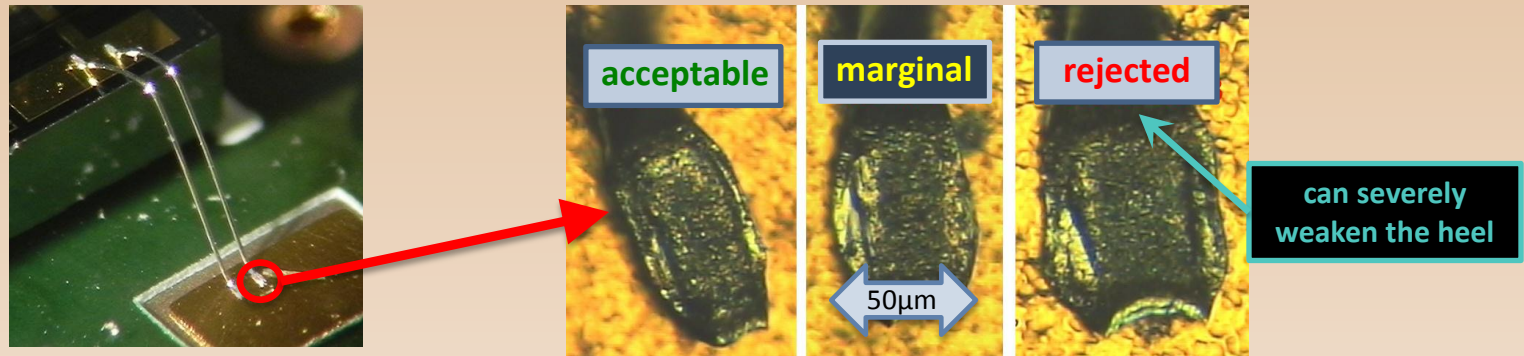
Machine problems: Over-deformation – too much power, force, or time. Can be the result of poor surface quality. Post-bonding visual inspection is important!

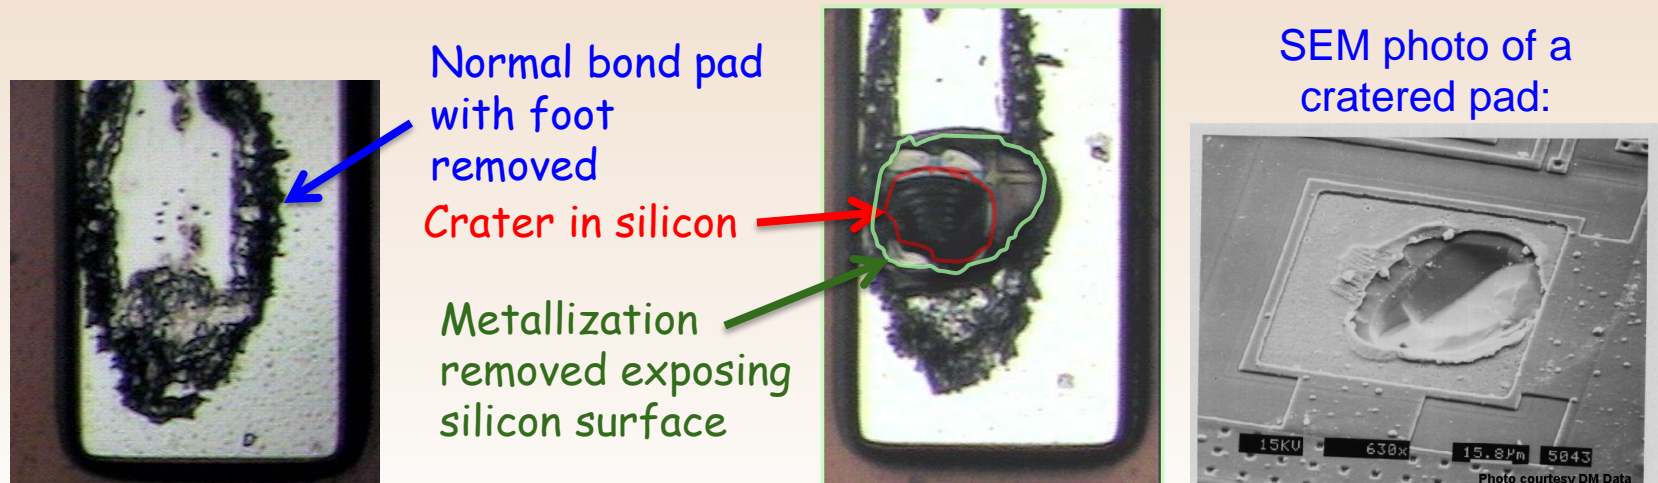
Machine problems: Cratering of silicon – again, too much power, force, or time. Can occur and not be seen unless complete fracture occurs with lift of bond foot. Worst cases detected in pull-tests. Usually “OK” on chips but not on sensors.

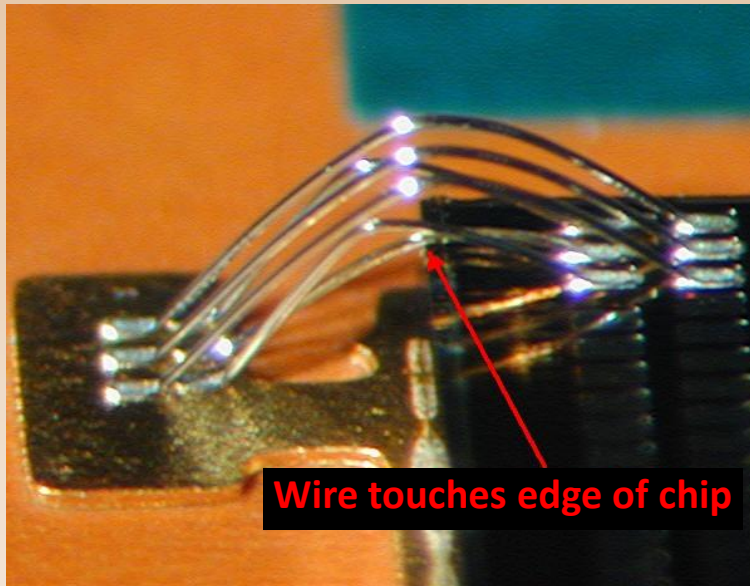
Poor bond loop choice: Bond loop parameters leading to chip edge touching. The solution is simple but seeing the problem may be less obvious.

May lead to short circuit if edge of chip is metallized or at a large potential difference. In the case of a read-out wire at the edge of a biased p-on-n sensor, the edge is at high voltage and a minimum clearance is required (typically 100 μm) to avoid corona discharge.

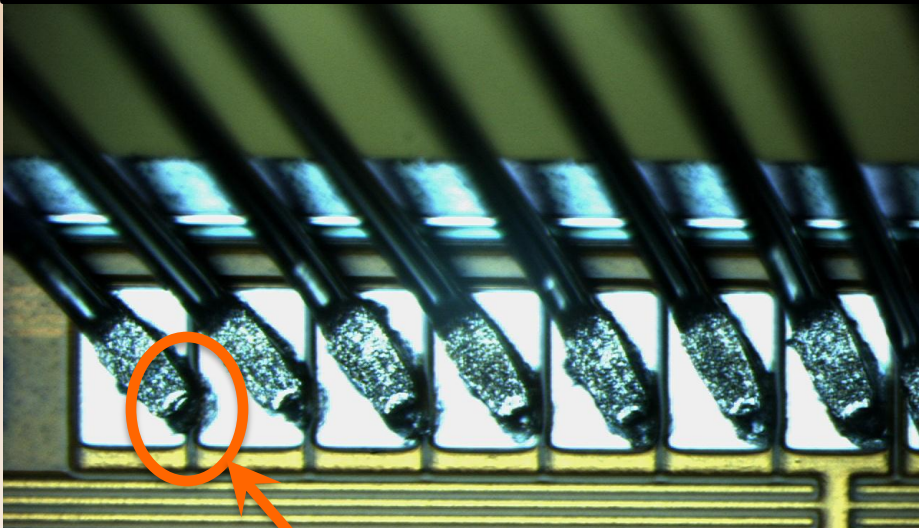
Examples of skew bonding problems on undersized or poorly designed pads

High risk of shorting adjacent pads, extremely accurate bond placement required.

Non-optimal bond pad design: Aluminium wedge wire bonding with standard 25 μ m wire requires a rectangular pad of at least 60 μ m x 150 μ m for best results. Even wider pad needed if skew bonding will be required.

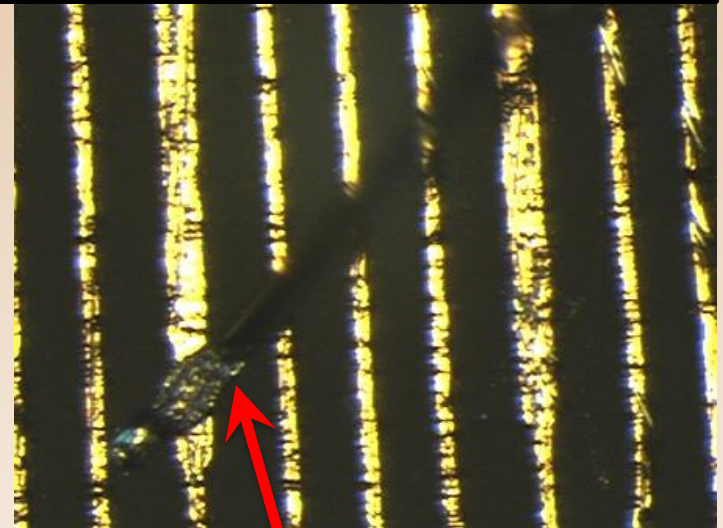
Reduced contact area and weakened heel (wire pushed over edge of pad by bond tool), risk of heel crack.

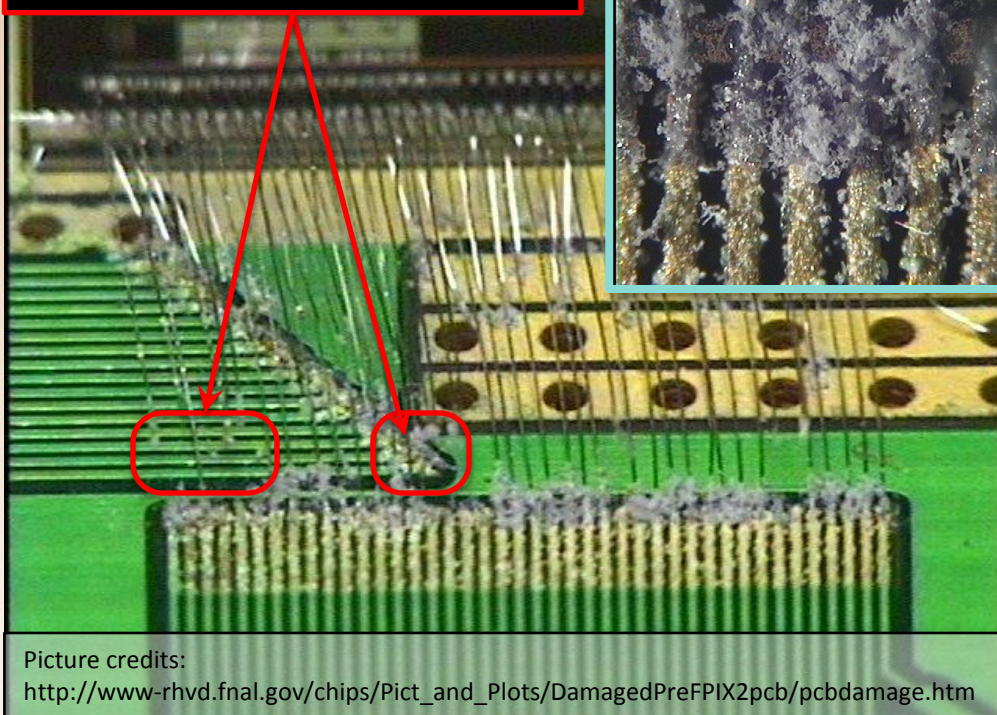
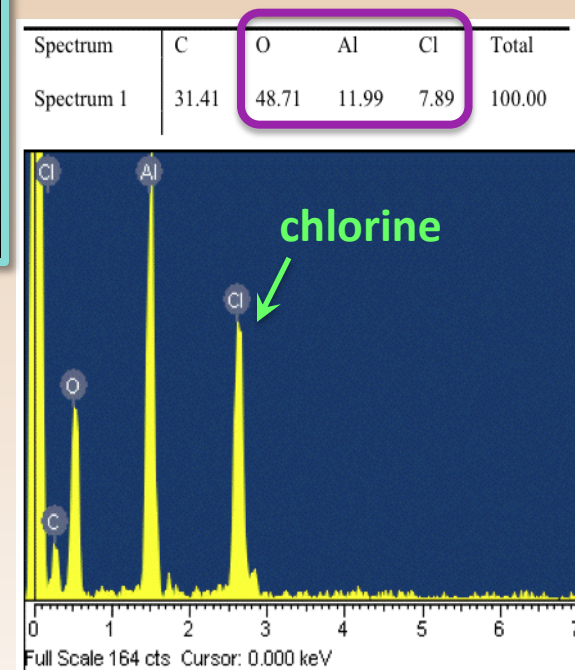
Contamination/corrosion: Bond pad and wire damage from foreign substances on surfaces. Can migrate long distances over surface with humidity or voltage. Worst case for aluminium wires is presence of chlorine and water, can totally convert Al to $\text{Al}(\text{OH})_3$ which is a white powder. **Solution: proper cleaning and verification.**

Wires in air, totally eaten through.

Although this example is from FNAL, we have seen this phenomenon in at least 4 CERN related silicon projects, including CMS and ATLAS.

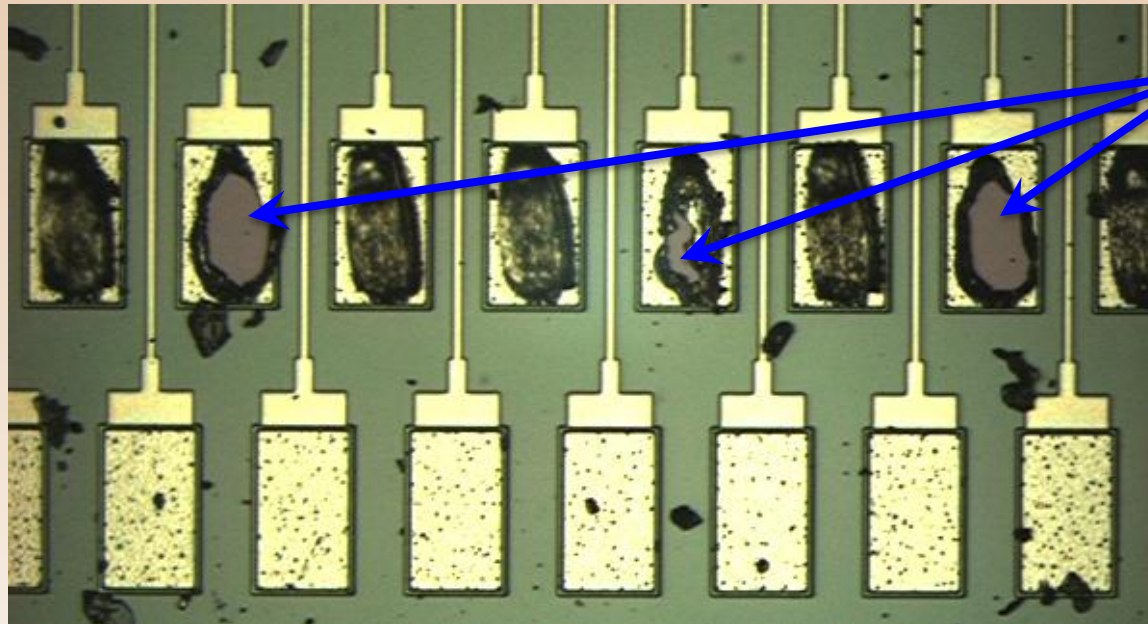
Improper metallization on Si, ceramic or glass: Metal layer adhesion failure, usually aluminum on silicon or glass (pitch adapter). Like cratering, but not the fault of the bonding machine. Metal layer lifts off of substrate with bond foot during bonding or sometime later. **Solution: solve adhesion problem with manufacturer (test pieces).**

Al on silicon adhesion failure during bonding

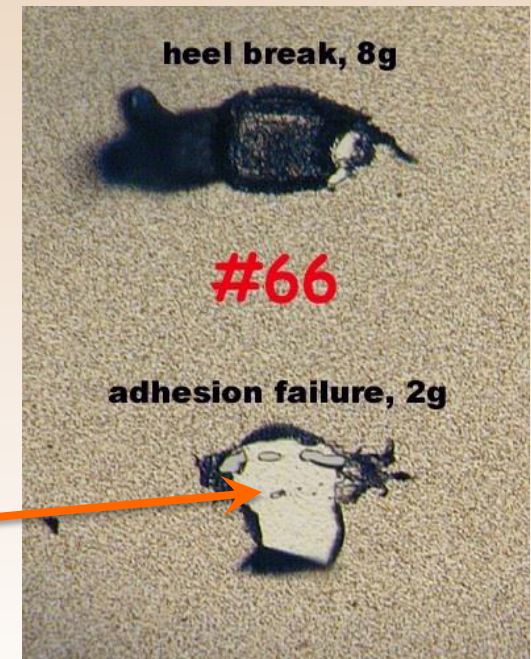
Pitch adapter pull test adhesion failure of 2nd Al layer (1st layer was probably overly oxidized).

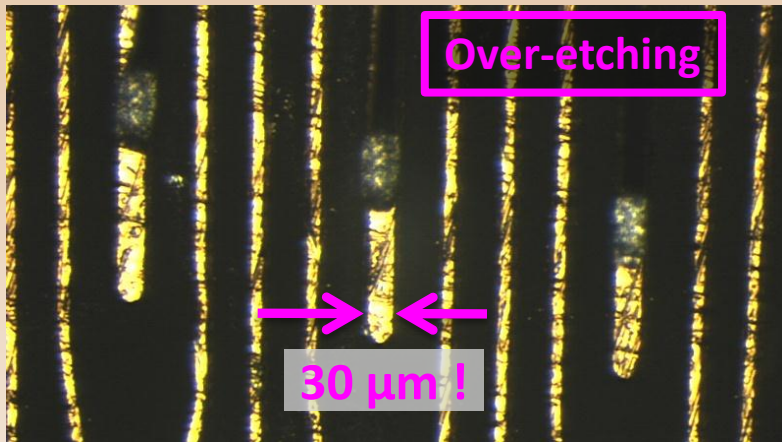
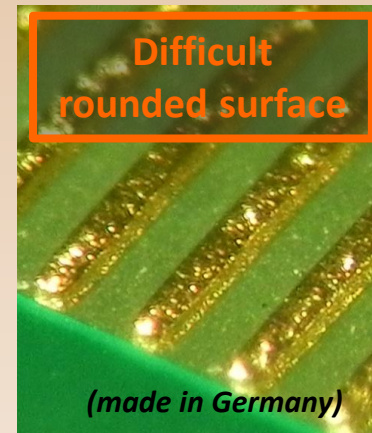
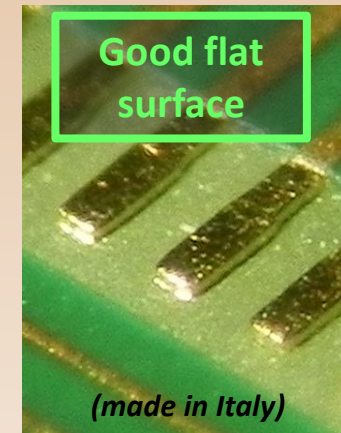
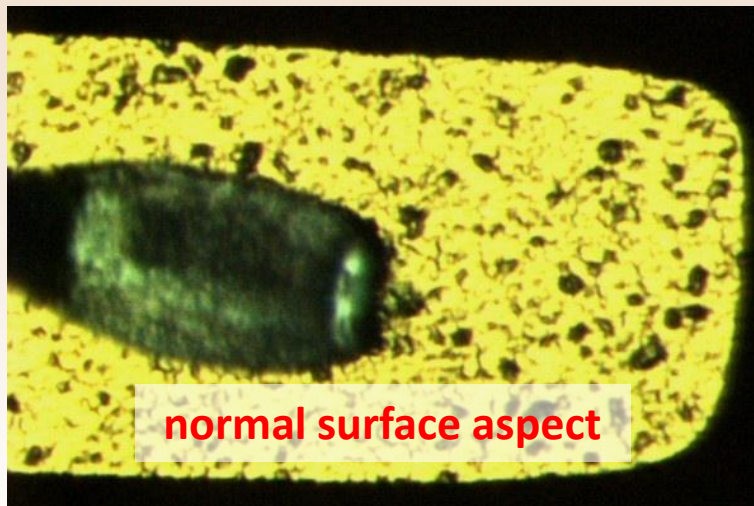
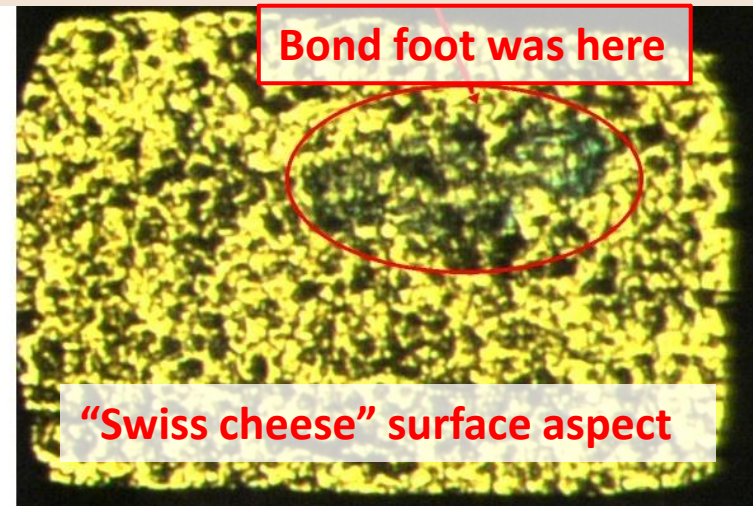
Improper metallization on PCB #1: Bond pads too narrow owing to over-etching, surface not flat, “bumpy”, or like “Swiss cheese”. Insufficient surface area of weld under bond foot leading to lifts during bonding or poor bond strength.

Solution: Put into specifications and reject non-conformity (or find a better company).

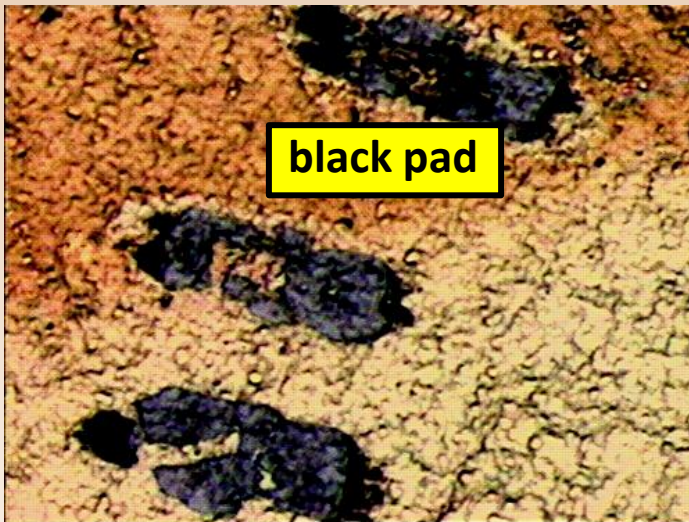
Improper metallization on PCB #2: “Black pad”, “purple plague”, metal migration, intermetallic voids, oxidation, etc. Believed to be from incorrect thicknesses, contamination of baths, poor choice of metals or process, ... **Solutions**: Thickness measurements, cross-sections, chemical analyses, spectroscopic analyses, bond pull testing, imposing high IPC standards may be required to avoid these problems, often occurring in the manufacturing process. Some require accelerated aging tests or current/voltage stress tests.

Black pad is severe oxidation of the nickel layer in Cu-Ni-Au PCB metallization. No weld is possible.

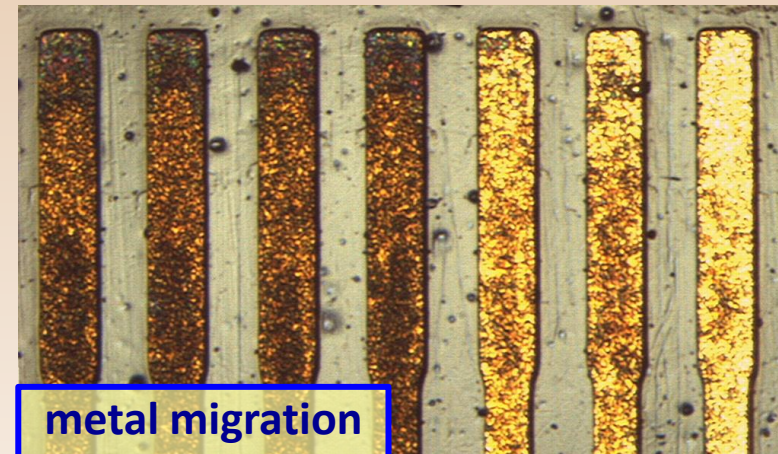
Metal migration is when metals diffuse through other metals, either thermally or electrically driven. Here Cu moved through the Ni and Au.

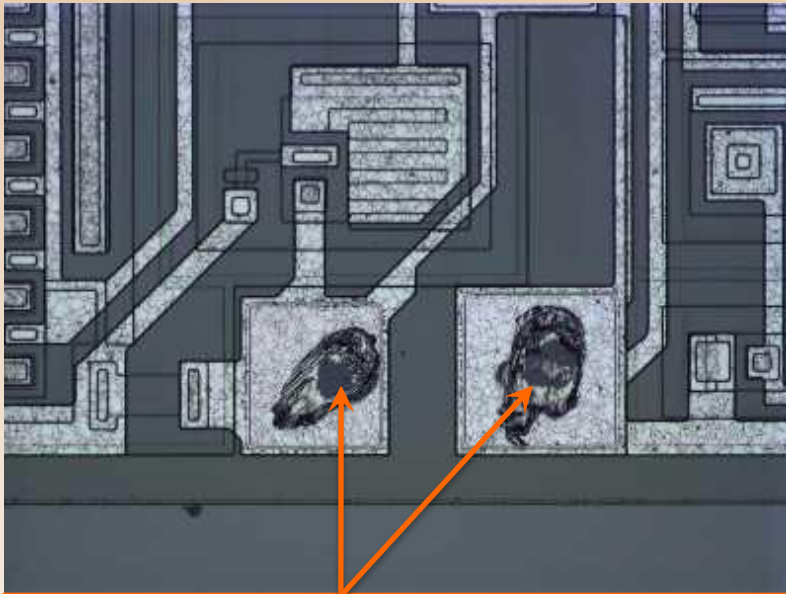
Damage to bond pads: More of an issue for gold ball bonding but probe damage can also degrade aluminium wedge wire bonding as well. Need enough Al on pad to make the weld!

Scratched through to the silicon in the uniform dark grey areas in center of the probe marks.

Solution: make the area for probing away from bonding or take great care using very small probe tip with a light contact .

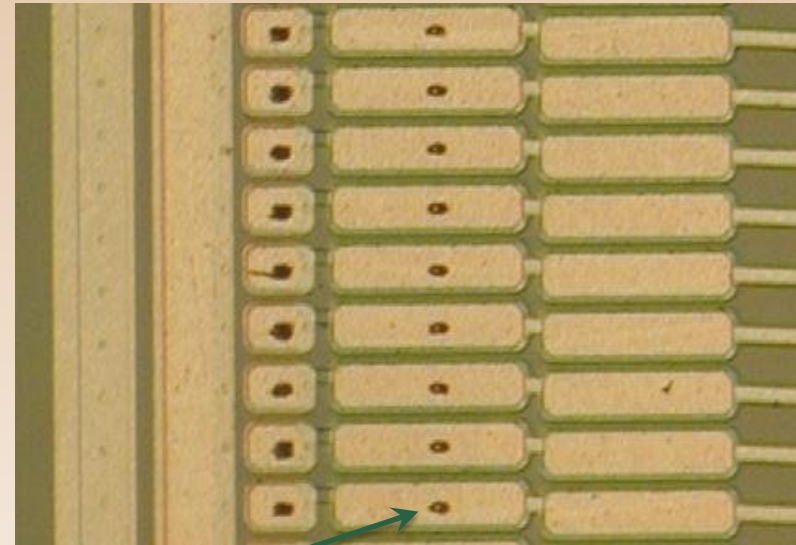
Nice small probe mark, should have been at the end of pad but plenty of space for bond foot.

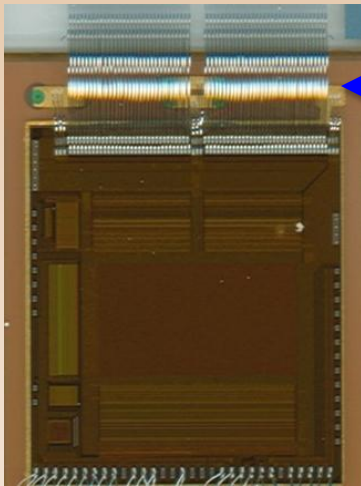
Most of the time: beautifully uniform set of 128 wires into a CMS tracker APV readout chip.

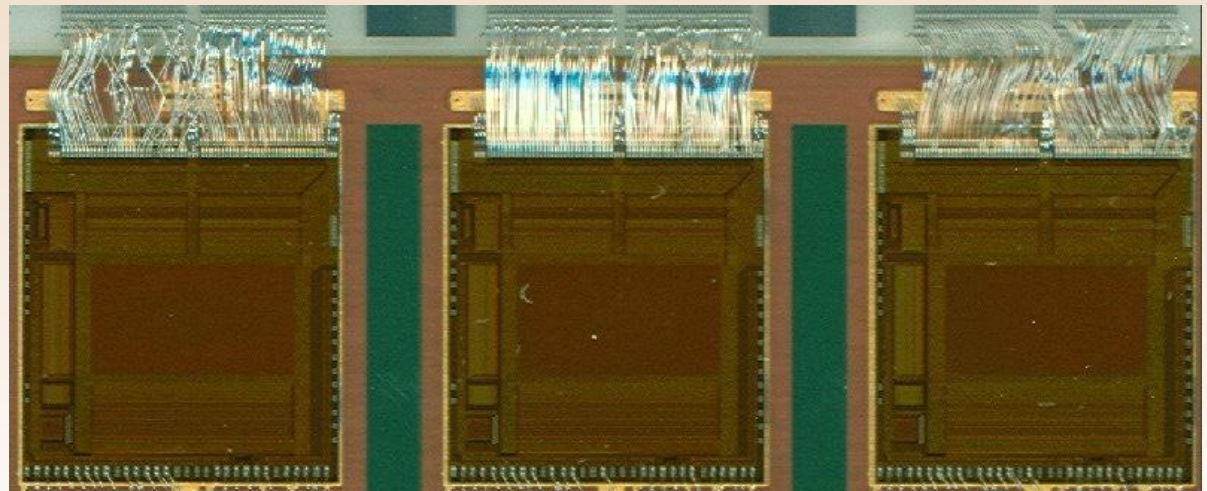
Broken or damaged wires: Usually coming from handling or transport. What passes through our lab is clearly mostly handling damage. Very easy to damage bond wires without even realizing it (fingers, clothes, tools).

Difficult installation access and clearances, module handling points close to bond wires and “operator error” resulted in almost 400 CMS tracker endcap modules coming to the CERN bond lab for wire damage repair, mostly minor. This one, however, was deemed “beyond repair” ...

Solution: better installation tooling, better training of personnel, encapsulation, ...

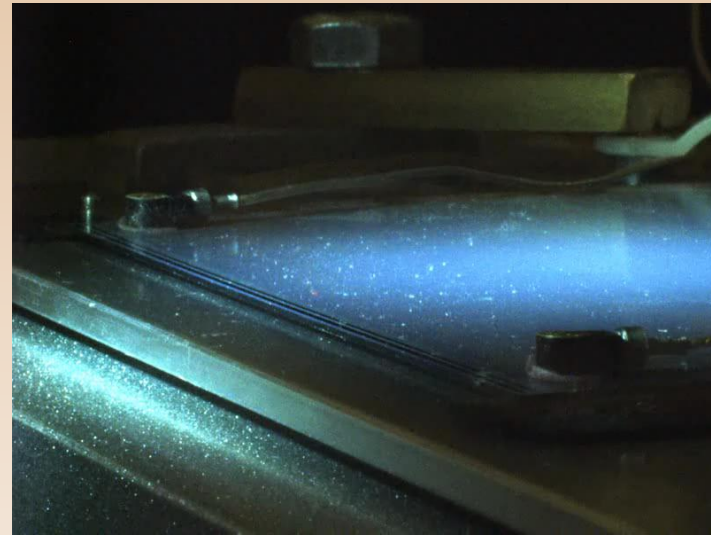
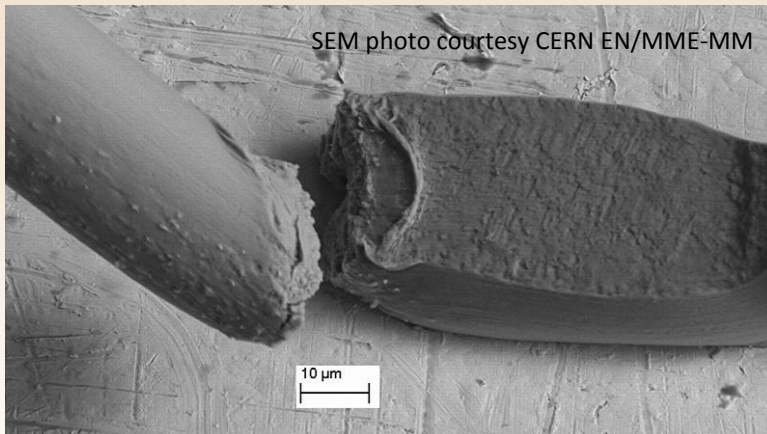
Broken or damaged wires: Transport was found to be responsible for early module bond wire damage. The culprit was large differential motion of components driven at a resonant frequency.

Vibration tester found resonant oscillation mode on a silicon module at 69 Hz. Typical transport frequency spectrum goes from 0 – 2 KHz.

Wires that are made to oscillate because the two feet move with respect to each other tend to break at the first bond heel. Metal fatigue causes heel crack.

CMS Solution: encapsulation with a silicone polymer or reinforcement of substrates.

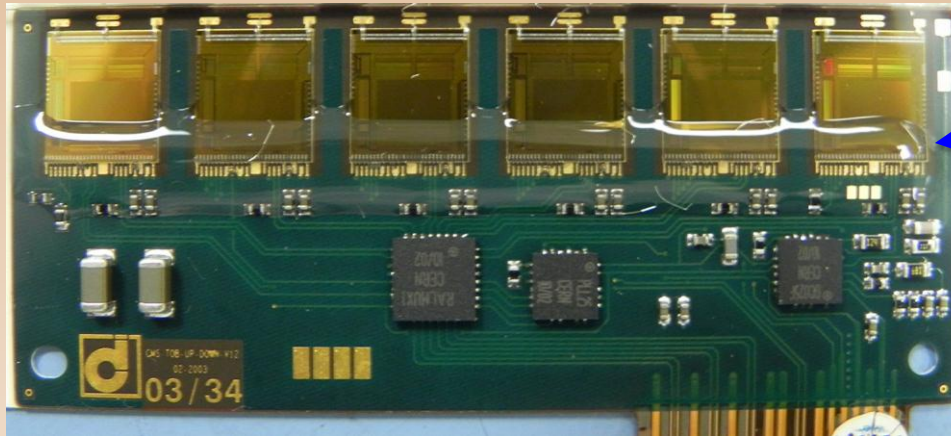
Broken or damaged wire protection by encapsulation

Clear silicone encapsulant, two component room temperature cure, very fluid before curing.

- 1) Encapsulant does not damage or break wires upon curing
- 2) Wires and encapsulant can survive thermal cycling of real environment
- 3) Can survive radiation
- 4) Proper filling of volume (no large voids)

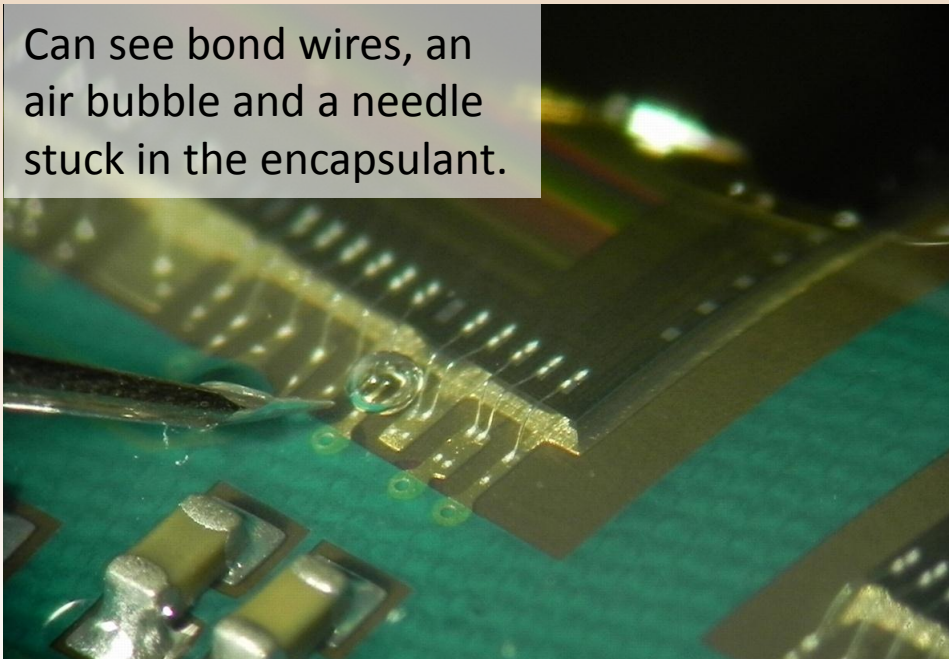
Can see bond wires, an air bubble and a needle stuck in the encapsulant.

Note: one loses reworkability

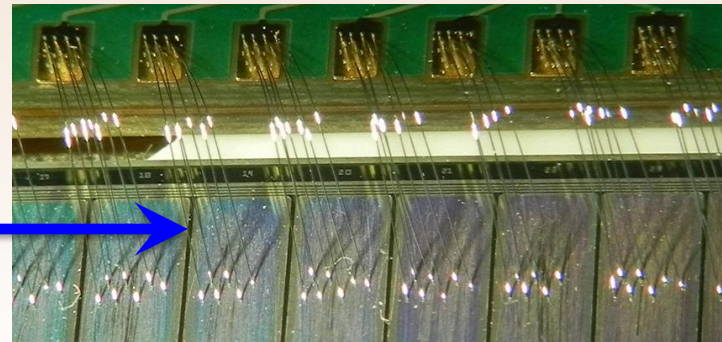
Only one needed but 7 wires bonded

- 7) Share information on wire bonding problems
- 8) Don't use wire bonding where a connector or soldering could be used
- 9) Redundancy is always good, add extra bond wires for critical connections

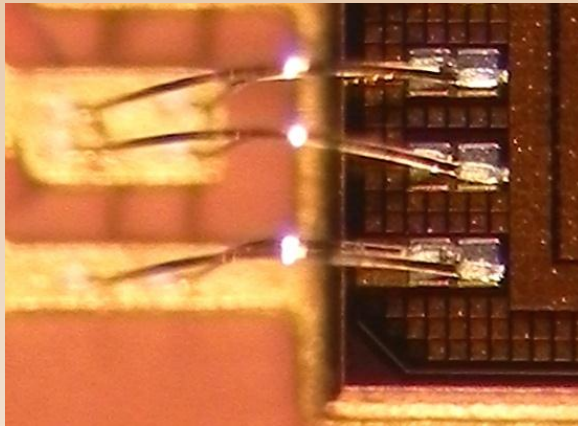
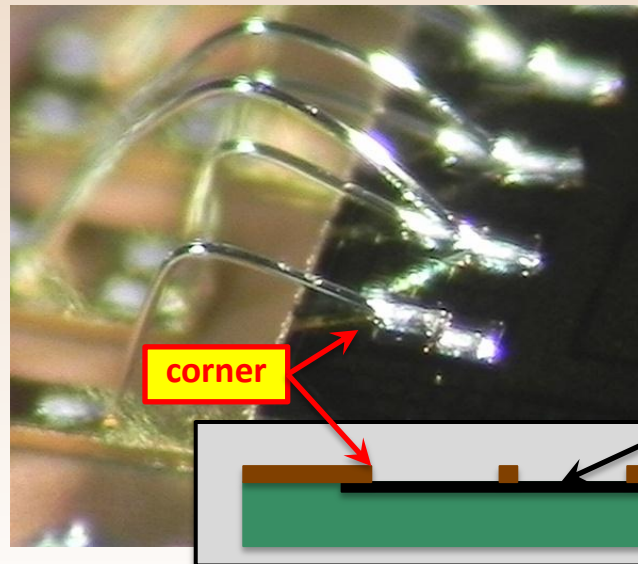
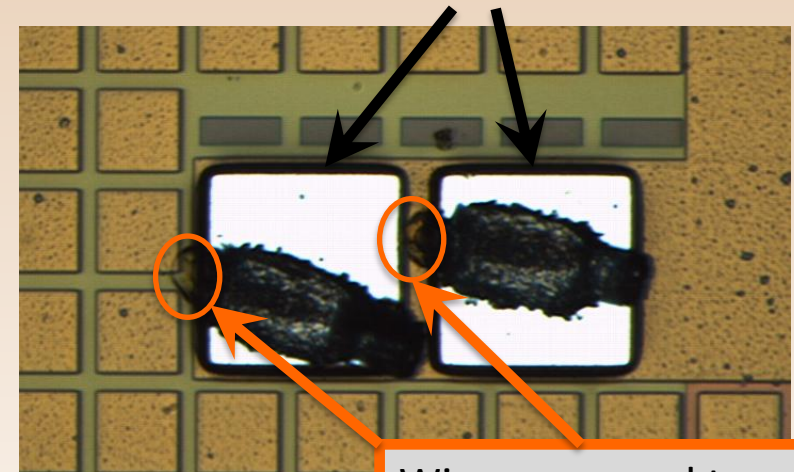
Non-optimal bond pad design: Too short pad dimensions and thick passivation window can lead to weakened or broken heels. This lead to 2g pull test failures in CMS tracker hybrids. **Solution**: care in foot placement and frequent pull testing.

Better: proper pad dimensions for Al wedge.

APV read-out chip, control bonds. Put 2 wires per signal for redundancy but pad should have been one large one not 2 small square ones.

Wires removed to show damage to passivation implying likelihood of damage to bond heel
