ATLAS Pixel

Interconnects Issues

Workshop on Quality
Issues in Current and
Future Silicon Detectors
03 Nov. 2011
CERN

D. Dobos
on behalf of
ATLAS Pixel

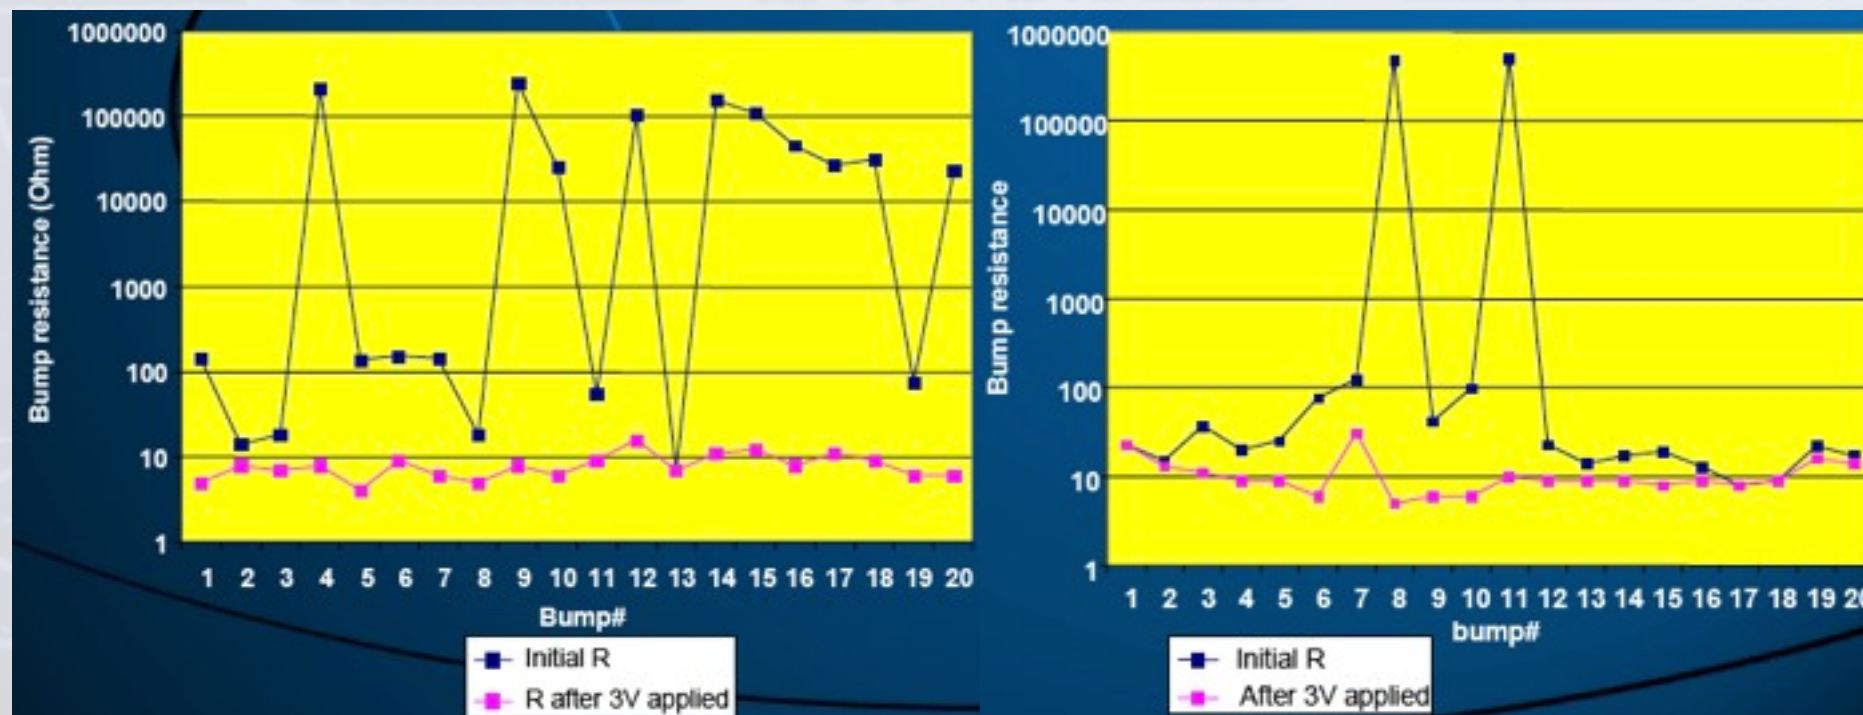
Advantage of indium bumps: lower flip-chip temperature

Significant difference is interconnection electrical resistance:

- Solder bumps have a constant resistance of about 0.5Ω
- Indium bumps resistance $\sim 10 \Omega$. Increase up to $500 \text{ k}\Omega$ observed on $\sim 10\%$ indium bumps. Caused by In_2O_3 oxidation layers on bumps - can be broken by applying a 3 V bias voltage to electronics.

Bump resistances have to be kept small to avoid a significant contribution to the FE preamplifier noise.

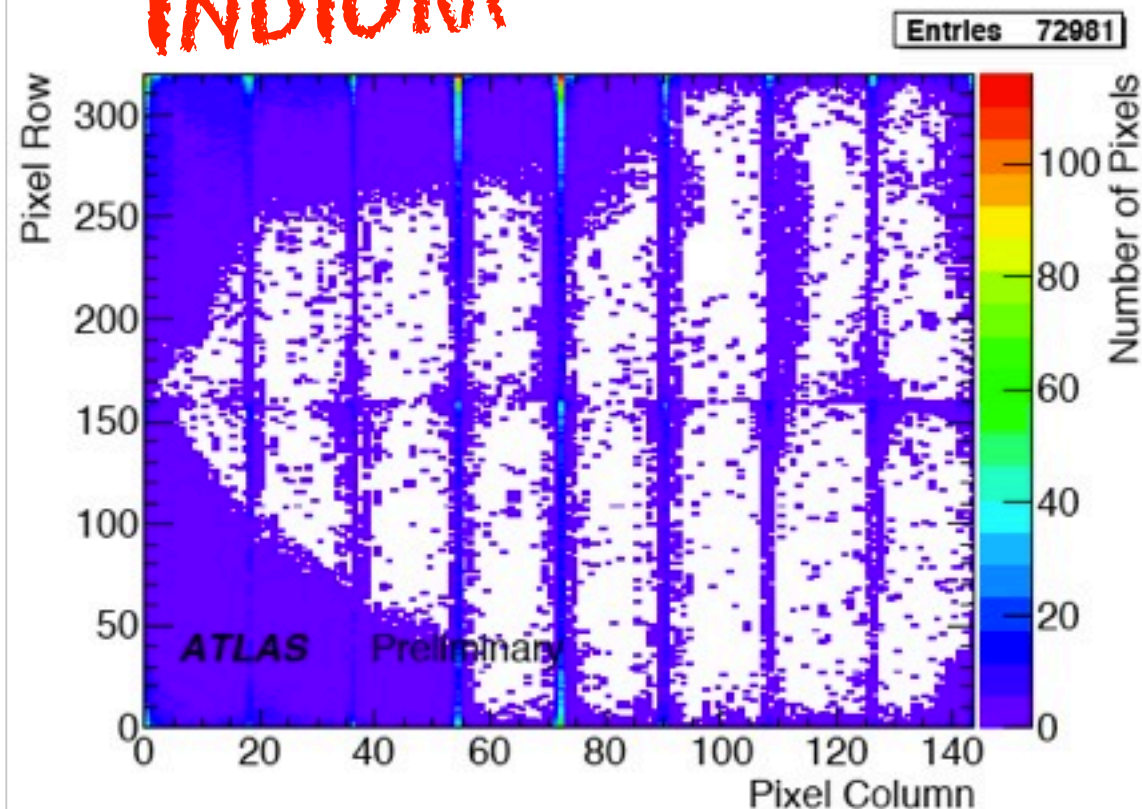
INDIUM

- Used crosstalk scan (4 ke⁻ threshold 200 ke⁻ injection)
- Sensor crosstalk 3.5%, low cross-talk in electronics (shielding)
- Analogue and threshold scan (noise: 160e⁻ -> 120e⁻) verification
- 76980 disconnected pixels (0.1%) in 1697 modules
- 94.8% of total disconnected bumps are Indium type bumps
- Larger connected areas are from few badly damaged modules

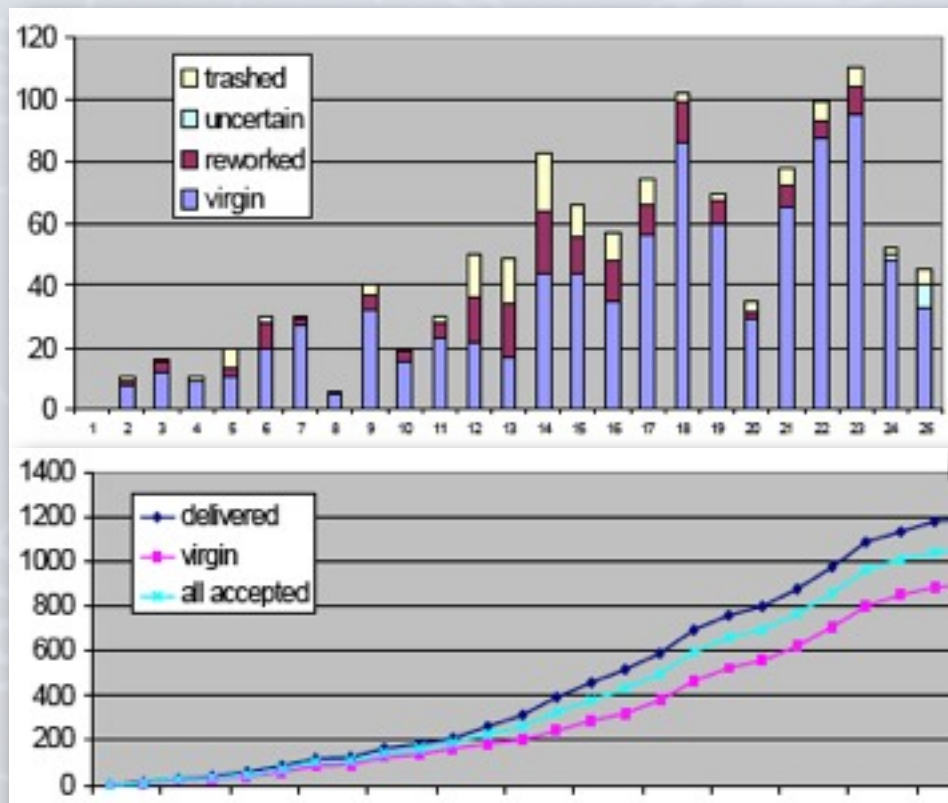
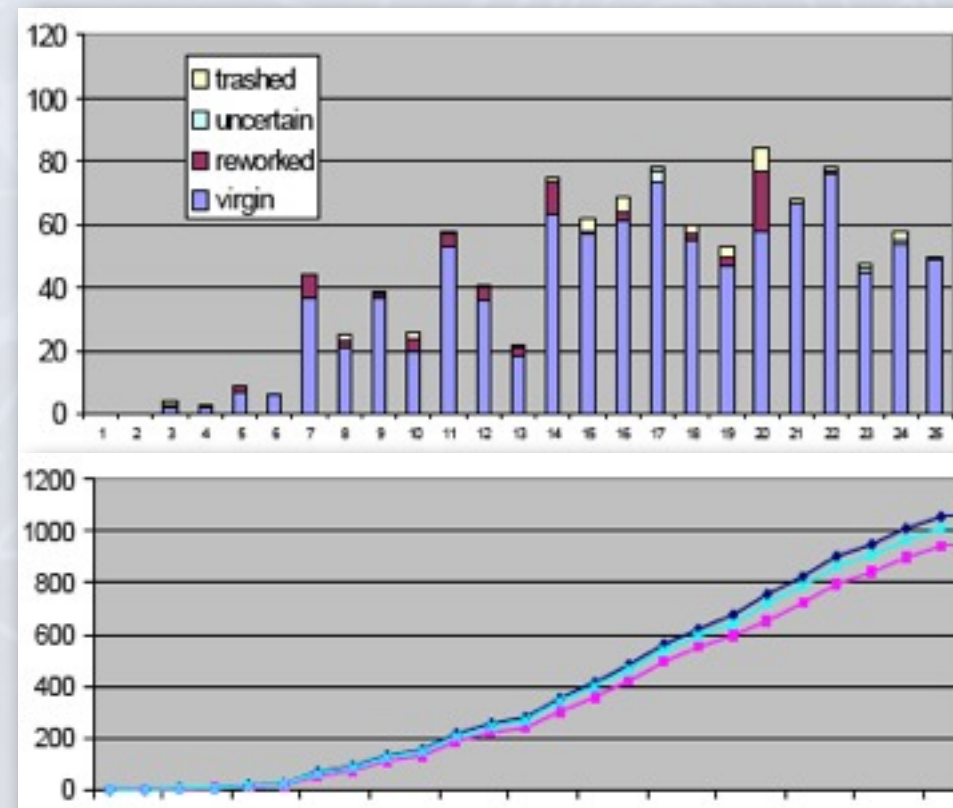
Production yield and timelines of 2576 modules:

Indium bumps:

- OK: 89%
- Virgin OK: 74%
- Reworked: 13%
- Failed: 11%

Solder bumps:

- OK: 97%
- Virgin OK: 87%
- Reworked: 7% + 3% internal
- Failed: 3%

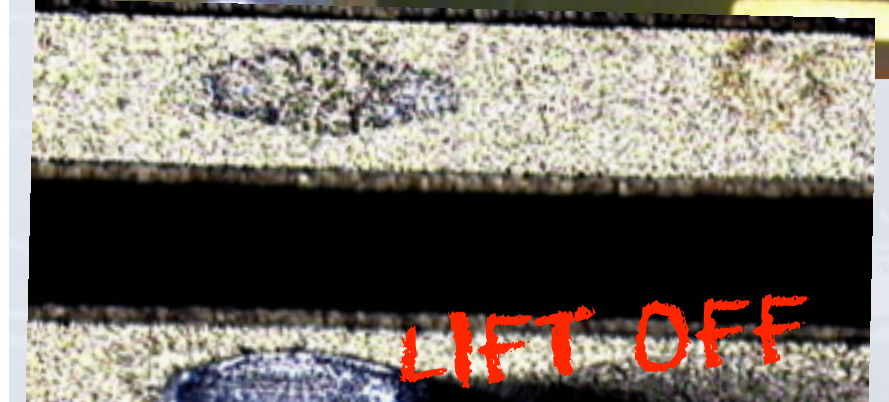
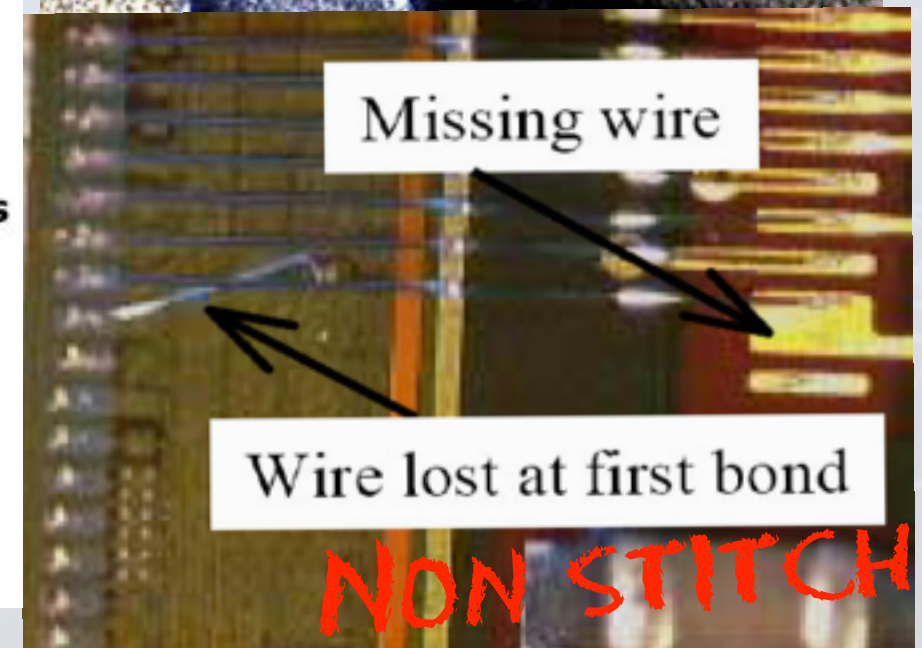
Wirebond **PULL & POKE** Quality Assurance

PULL FORCES
