# Mechanical Tests of the 3D-printed W prototype

CERN, January 2025

# W Absorbers for the LHCb ECAL

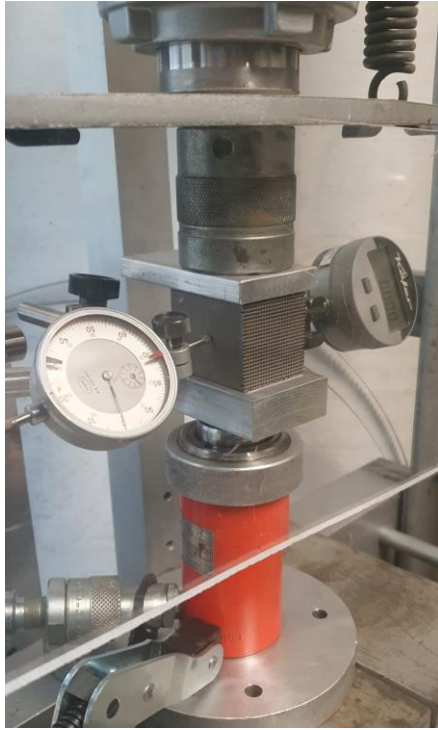
# Test Setup

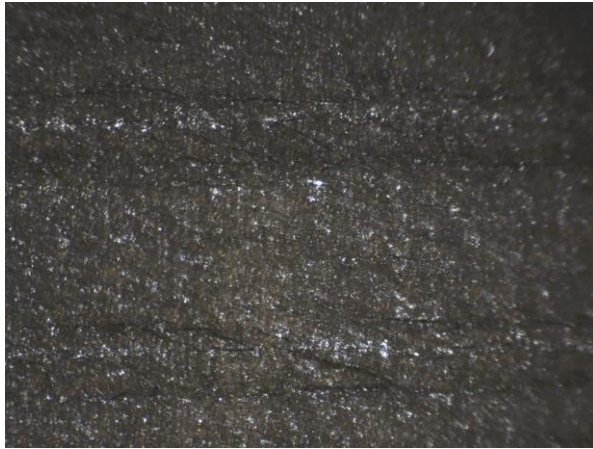
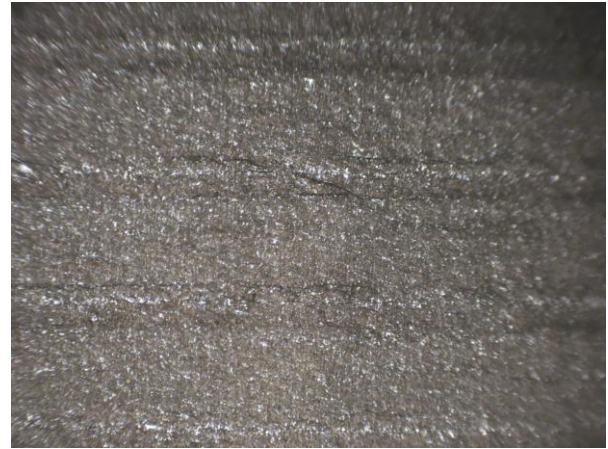
- ♦ Absorbers in delivery conditions shown below
- ♦ Cracks appear on the entire outside surface of the absorbers

- ♦ Load endured by the absorber exceeds the expected load
- ♦ Nominal stress is far below the compression test result of additive manufactured, cylindrical test specimens (165 MPa vs. ~800 MPa)
- ♦ Why does the absorber fail the way it does?
- ♦ What causes the surface cracks in the absorbers? How can they be prevented?
- ♦ Where should we move from here? (long term test, precise test with strain measurement, ...)
