# Design of a New Switching Power Supply for the ATLAS TileCal Front-End Electronics

*TWEPP 2012*

*Gary Drake*

*Argonne National Laboratory, USA*

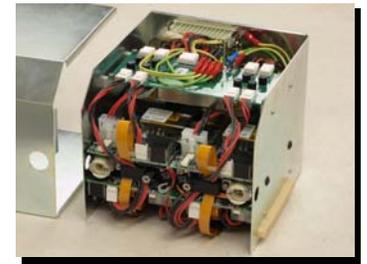
Picture by Ivan Hruska

Range of Voltages: 5:1  
Range of Currents: 62:1

⇒ One Basic Brick Design  
Different Component Values

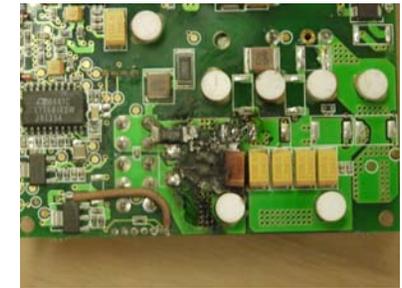
Burned capacitors

- Produced in 2005
- Installed on detector in 2006-2007
- Performance & reliability concerns developed:
  - Board fabrication problems
  - Assembly & soldering problems
  - Substantial rework
  - Stability problems
  - Spontaneous tripping on detector → Noise
  - Hard failures on detector - ~6-10 per year
  - Later – tripping correlated with beam →

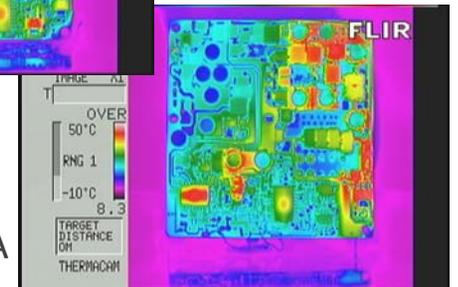
**New Version**

- +5MB @ 13A

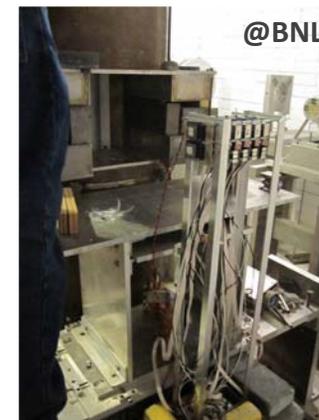
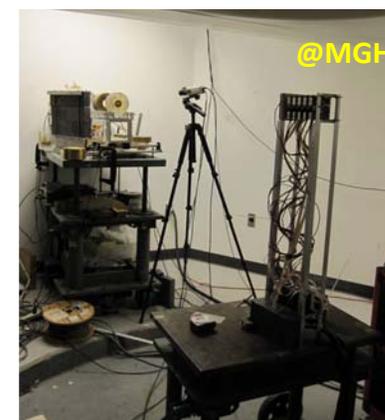
- **Results:**

- Photons: Slow degradation; No failures
- Neutrons: Slow degradation, No failures
- *Protons: Found Single Event Upset with controller chip*
- *Protons: Energy scan found dependence on energy (SEUs not seen before in tests at 60 MeV)*

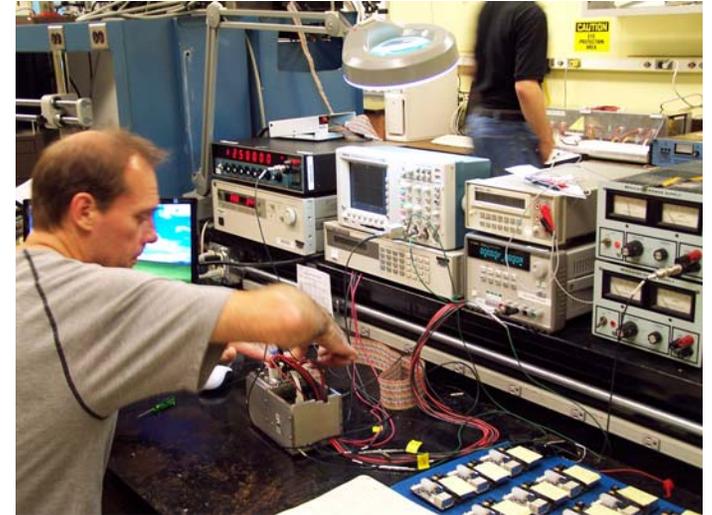
- Delivered 40 boxes to CERN **Boxes 6-45**
  - Installed on detector
  - → Total of 40 boxes on detector
  - ⇒ *1 trip on detector to date → ~240 days*

- V7.5.1 – January, 2012-present, Quantity 2080 bricks
  - We are in production now, nearly complete
  - ⇒ *Will install remaining supplies during 2013 shutdown*
