The Advanced Photon Source 352-MHz RF Systems

(...... A Case for Solid State?)

Doug Horan APS RF Group CWRF2012 May 8-11, 2012

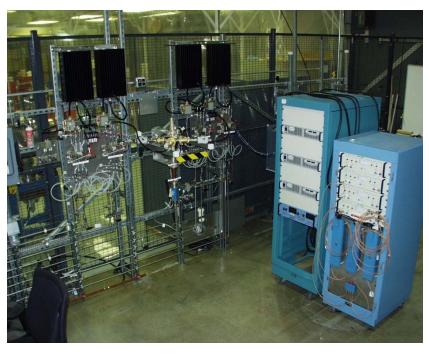
APS 352-MHz 4kW Demonstration

Produced 3.45kW CW

Demonstrated advantage of drain voltage control to improve efficiency at intermediate power ranges:

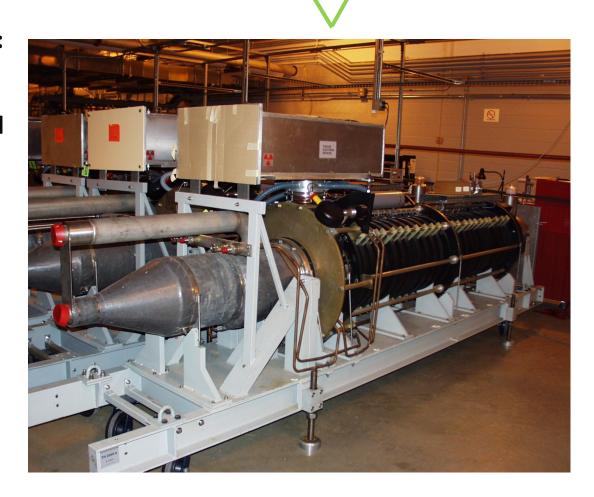
352-MHz/1MW CW Klystron Availability?

- Only one supplier remains: Thales
- Cost per unit has increased≈ 300% since 1992
- The number of sockets worldwide for these klystrons is shrinking (12?.....15?) How long will they be available?
- Other capable suppliers exist, but NRE would be significant

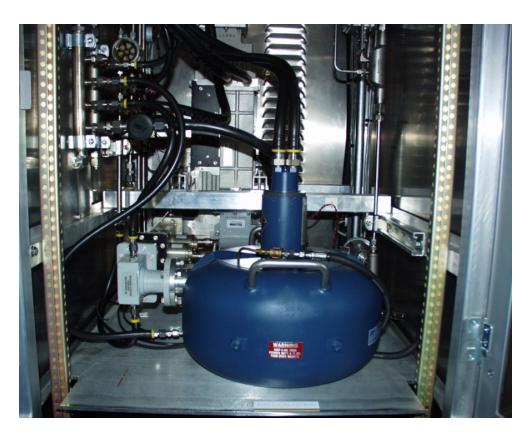
L-3 2.815GHz/5kW CW Klystron

- 1-5/8" EIA coaxial output
- Permanent magnet focus
- Mod-anode gun, but will be operated in diode mode
- Requires 12kV @ 1.295A
- RF gain ~ 42dB
- Efficiency not so hot (≈ 32%), but no focus supplies needed
- Stable operation to full power

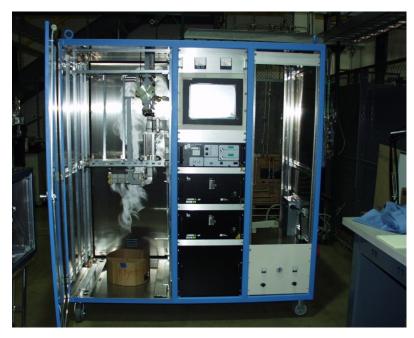
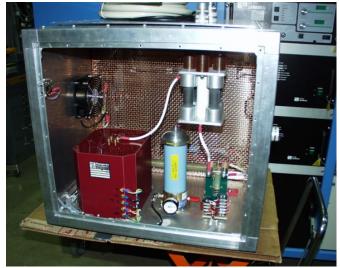
SPX-0 2.815GHz/5kW CW Amplifier System

- Utilizes L-3 L4442 PM-focus klystron
- 50kW output isolator and RF load
- Includes waveguide shutters between klystron and isolator input port
- Ultra-low ripple HVPS for minimal phase and amplitude noise on output

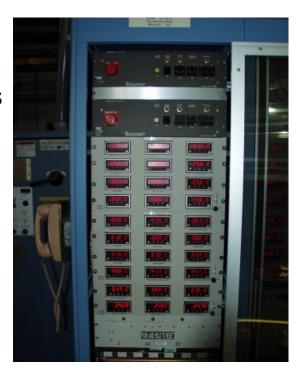
ORIGINAL INTERLOCK SYSTEM AT SECTOR 36 CAVITY LOCATION

- Replacement of all original process meter relay logic rf interlock systems with PLC's was completed
 - → Simplified system wiring, reducing intermittents
 - → Eliminated process meters and associated failures
- Only two rf system trips attributed to PLC interlock systems since 2005!
- Eliminated at least 2-3 trips/year from old interlock systems

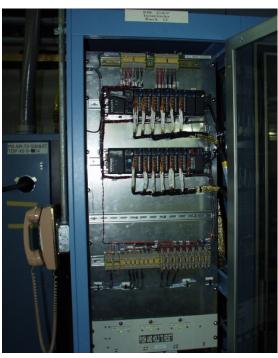
PLC INTERLOCK SYSTEM
INSTALLATION AT SAME LOCATION

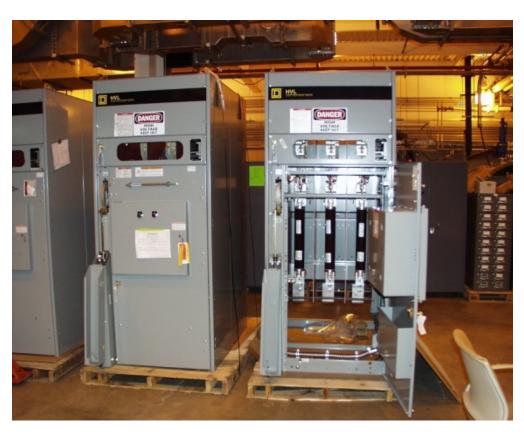
NEW 13.2kV SWITCHES BEING PREPARED FOR INSTALLATION

- Original switch would fail and stick in open or closed position
- Typically 2-4 failures per year
- Significant downtime to make repairs
- No failures with new switch!
- See Gian Trento talk

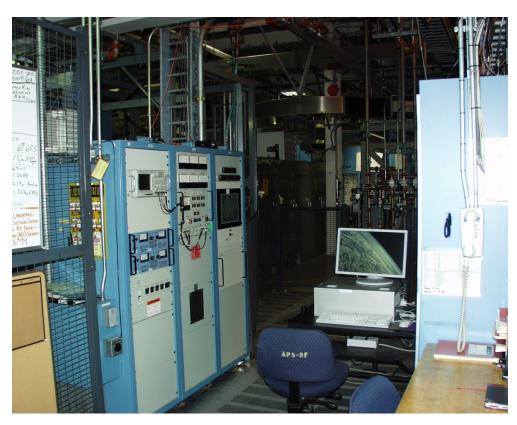
RF1 HIGH VOLTAGE POWER SUPPLY CONTROL RACKS

- Tests on T-R set oil to detect arcing
- See Gian Trento talk

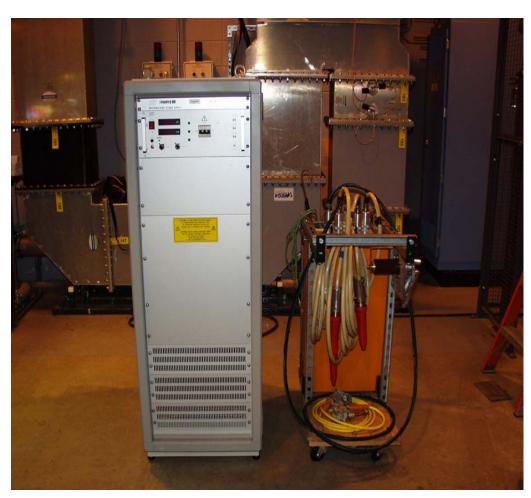
125kV/10mA SPOTKNOCKING POWER SUPPLY WITH PANTAK CABLE SET AND HIGH VOLTAGE JUNCTION BOX

- Typically caused by barium deposition over time
- Causes random crowbar trips
- All klystrons have developed this problem to some degree
- "Spotknocking" the klystron gun is very effective
- Extends useful life of older klystrons
- A spotknocking power supply system is essential to maintain system reliability

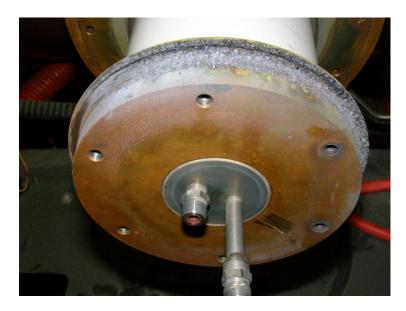
Booster Input Coupler -- Waveguide Transition Arcing

- Arcing damage caused by degraded rf contact with waveguide transition matching post
- Coupler had to be replaced after 17 years of service!
- Same problem seen on one other coupler, but not as bad; coupler contacts will be cleaned and a new matching post will be installed
- One coupler will be disassembled for inspection every shutdown from now on
