LHC High-Power RF System Performance 2011

Erk Jensen, Olivier Brunner,
Nikolai Schwerg and Daniel Valuch
on behalf of the RF Team

CWRF 2012, Port Jefferson, LHC RF

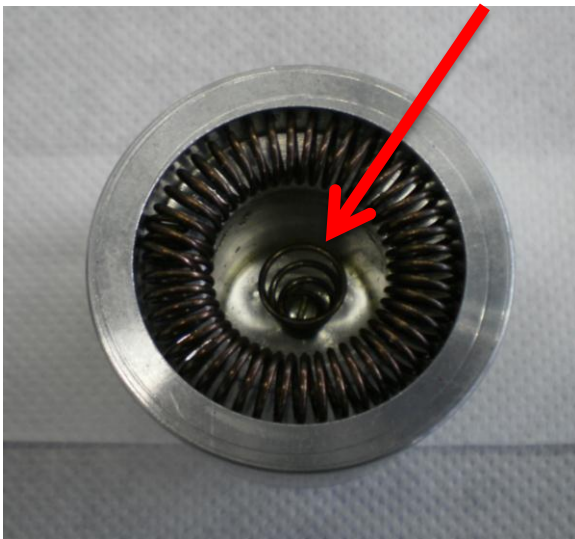
Klystron HV Connectors

- Spring contacts degrade (black deposit)
- Contacts needed to be cleaned repeatedly
- New connector design without springs, but special contacts (Multi-Contact) installed
