Review of vacuum activities. PS Complex - Shutdown 2011 – 2012

Paul Demarest – TE-VSC-IVM

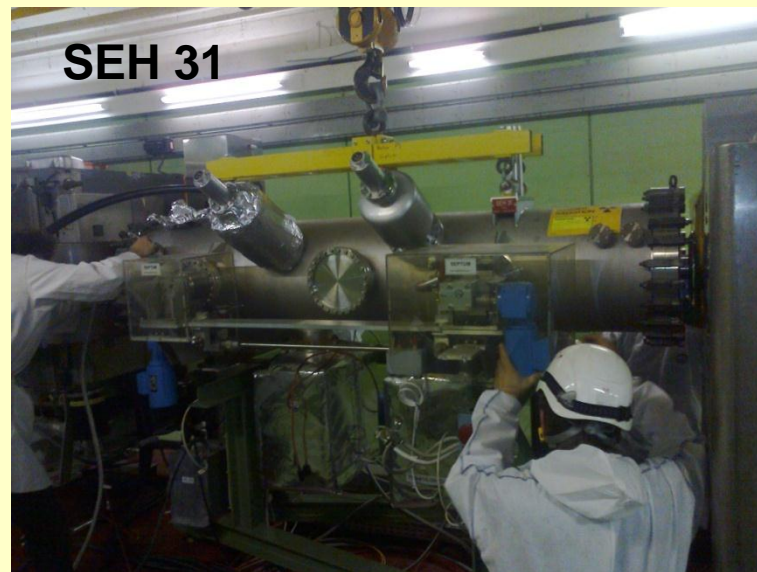
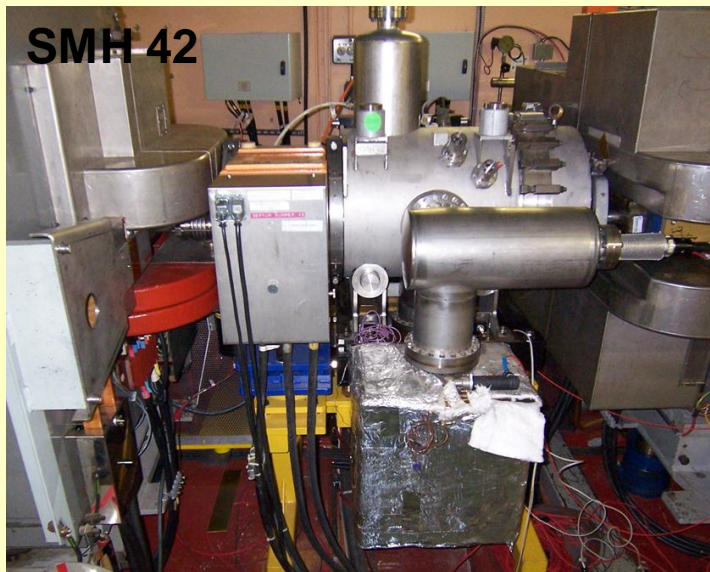
Pulsed systems – Finite number of pulses before fatigue sets in leading to failure.

Removed septa refurbished ready for installation at a later date.

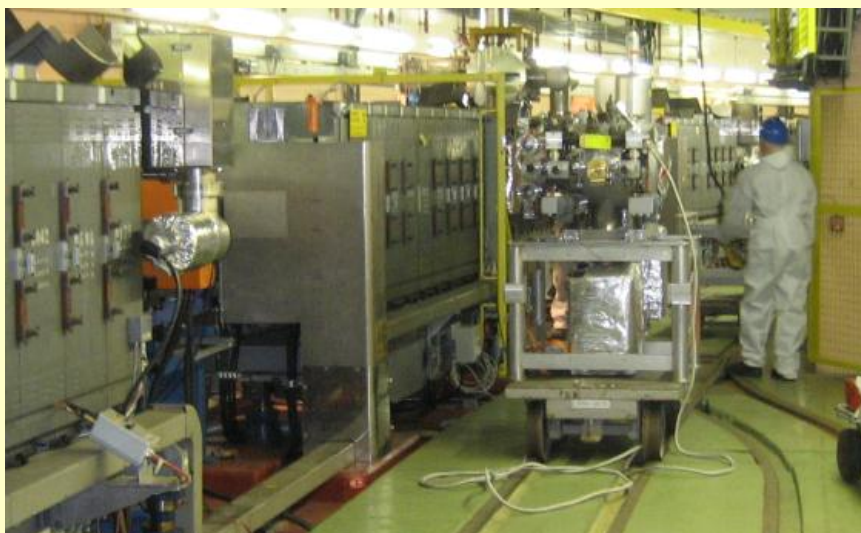
Work and dose planning - PE.SMH16 exchange 01/2012														
Description: Preventive removal of SMH16.2 and reinstallation of spare SMH16.3 in PS SS16														
										Working time (man.hours)	Effective dose (µSv/h)	Collective dose (man.µSv)

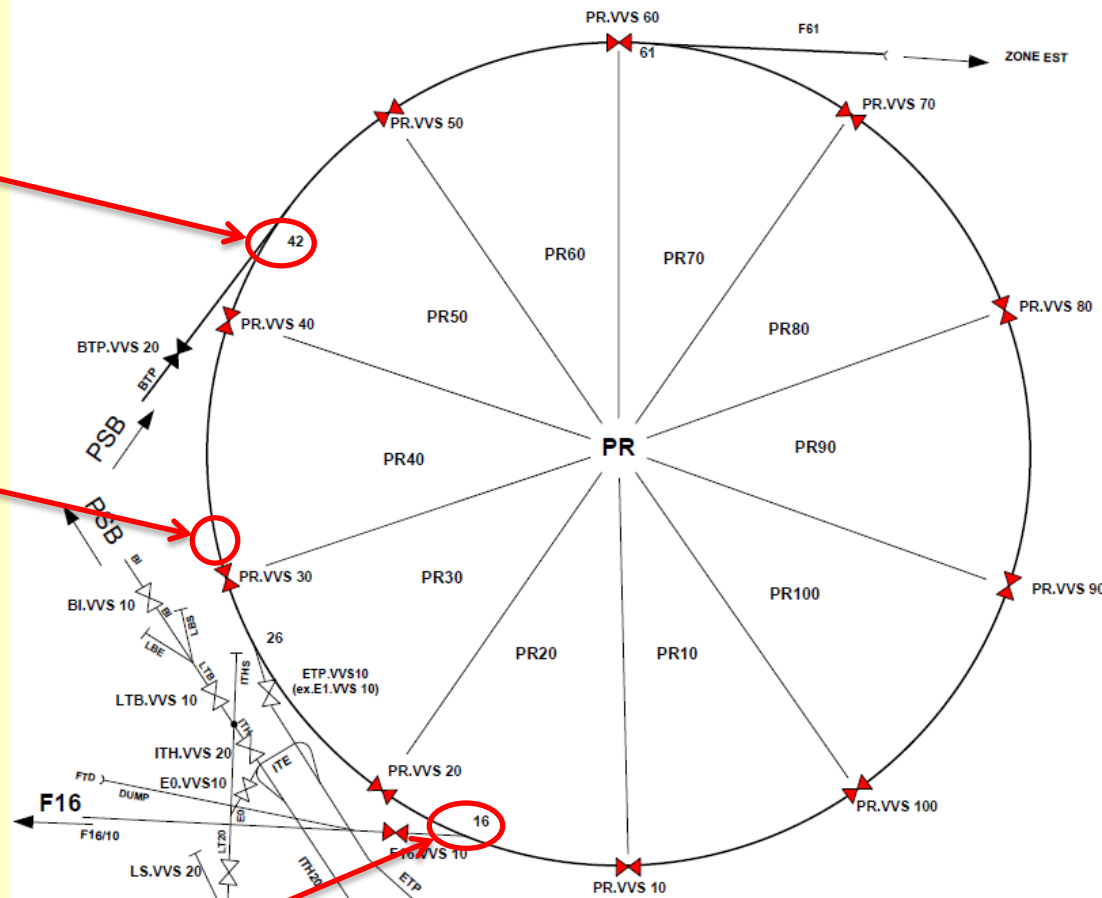
Preparation for ejection
by SMH 16

Ejection to SPS, AD and n-Tof via TT2

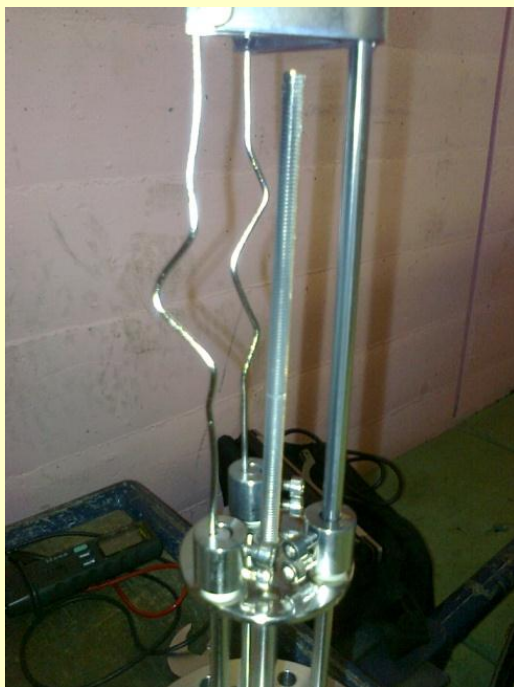
FWS - Provides information on beam profile and position
 Replaced - FWS.54, 64, 65 & 85
 Modified design: Larger aperture to avoid contact with the beam and a more robust mechanism.

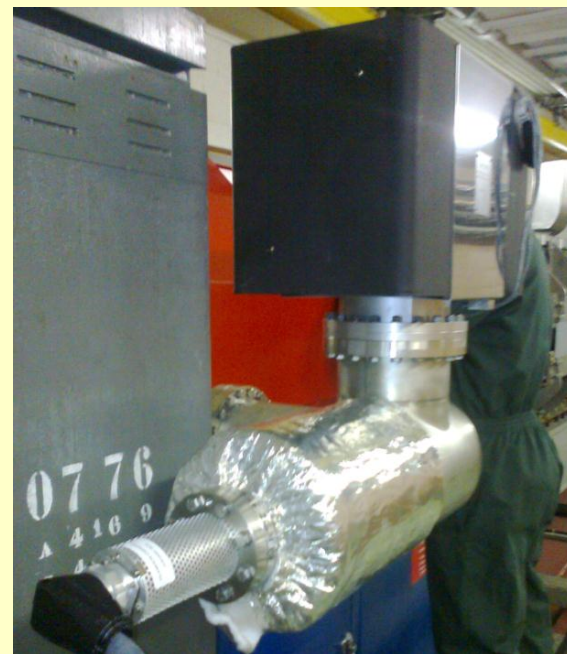
Replacement of Sublimator Filaments.
Replaced on sectors 20, 40, 50 & 100 opened during the shutdown.
Total of 44 sublimators replaced.

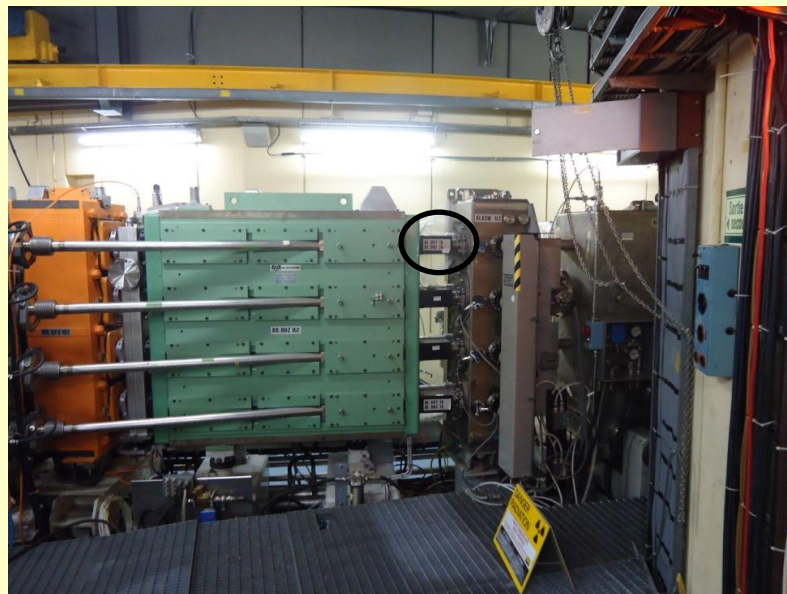
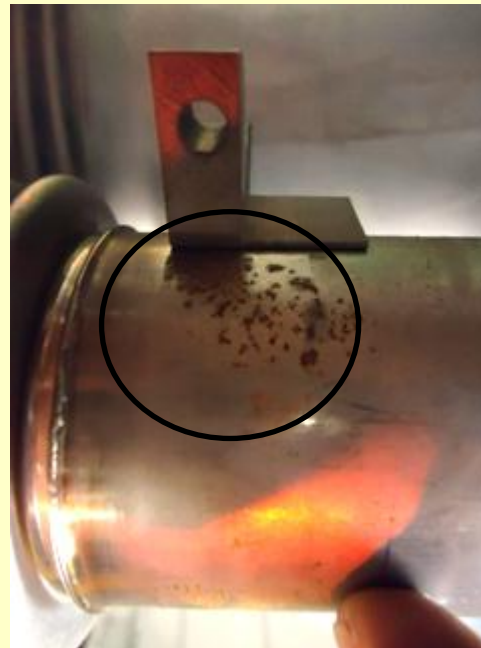
- July 2011 - Leak developed on one of the four injection chambers – Temporary repair with vac seal.
- Due to corrosion on the stainless steel chamber, the result of chemical reaction with PVC clamp used for mounting corrector magnets.
- All four chambers replaced - Evidence of corrosion on all chambers.
- Magnet re-shimmed by MCN to prevent any movement and fatigue of the coils during pulsing.
- Replacement magnet clamps now manufactured from charged epoxy resin.

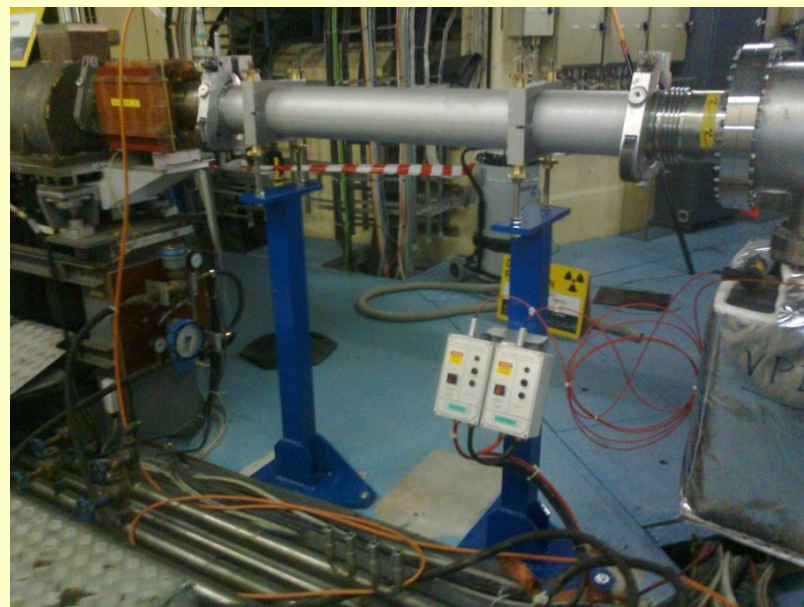
The BI.DIS magnet was removed and replaced with a plain vacuum chamber.

No longer required as now ions are generated at Linac 3 and LEIR.

This magnet was used when ions were fed to the PS via Linac 2 & the booster.

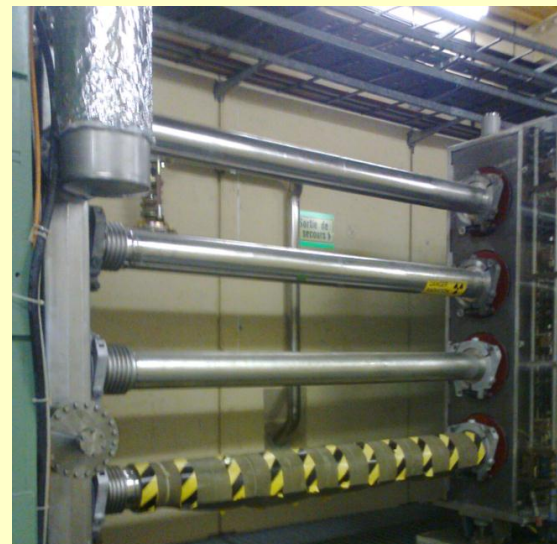
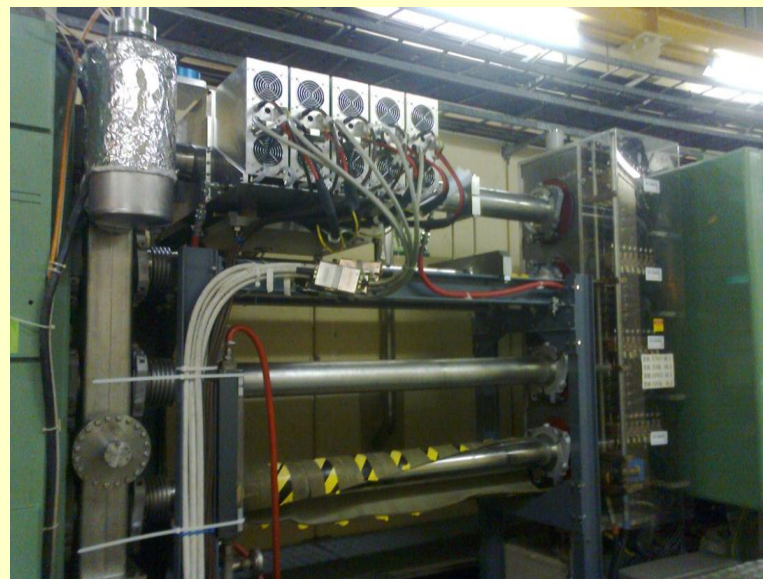
Experimental RF cavity installed in BR20.
 Replacing a vacuum chamber in Sector 6L1.
 On one ring only.
 Installed for testing with the view of replacing
 the existing RF cavity system in the future.
 Only to be tested during non-experimental beam
 time.

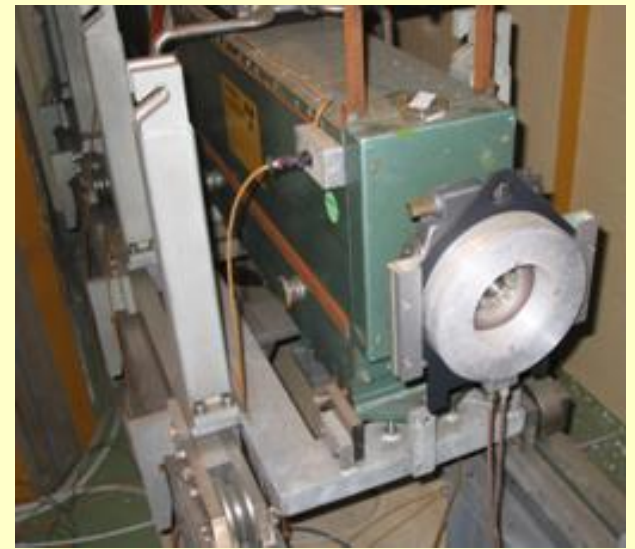
Replacement of FTA Vacuum window AD target area.

Following a leak detection on the FTA line of TT2 a leak of 4.0×10^{-7} mbar.l/sec was detected on the window.

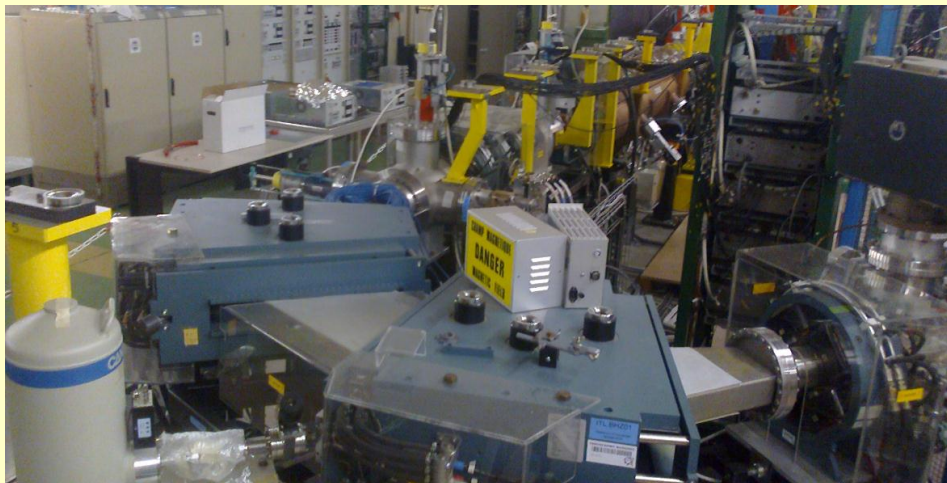
Inspection and cleaning of the ITL bending chamber.

Evidence of dust particles but no obvious damage to the inside of chamber.
 Cleaning required to reduce the possibility of damaging pumps and instruments.
 Carried out with vacuum cleaner in conjunction with endoscope camera.

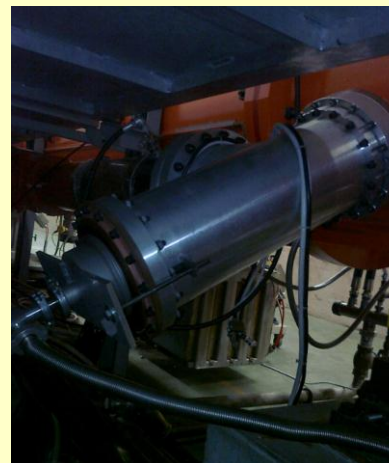
RF feeder loop – Tank 2
Bell installed – Rotary Pump

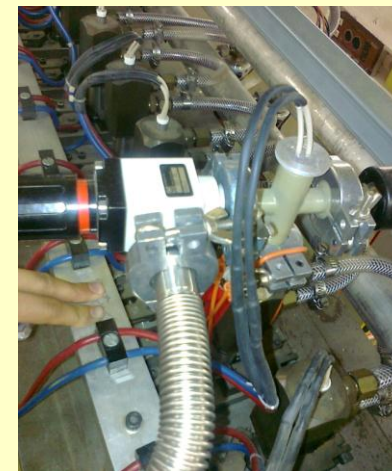
Drift-tube 11 – Tank 1
Cooling line - Scroll Pump
