The CMS Tracker End Caps integration

Gaëlle Boudoul

(Institut de Physique Nucléaire de Lyon /CERN)

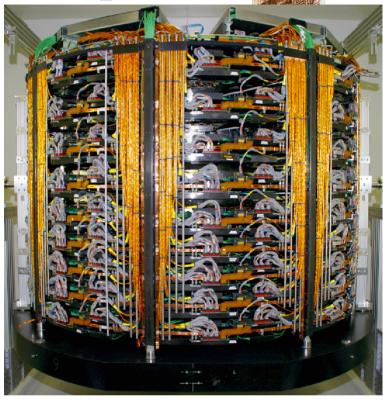
The CMS Tracker End Caps

- •8 petals mounted on each side of the carbon fiber disks, 9 disks per end cap
- Both mechanical structures built by Aachen C1B, precision (CERN photogrammetry) $< 200 \mu m$
- All optical ribbons integrated (Karlsruhe)
- Design and installation of the services (Lyon)
- One end cap ("TEC+": +z direction) integrated in AachenC 1B
- Second end cap integrated at CERN by Lyon group

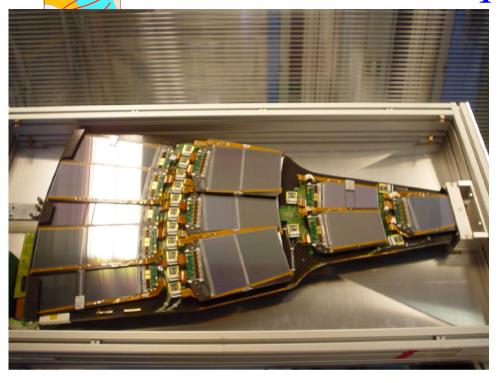
Petal qualification

- "Burn-in" of components & connections at level of petal
- 6 cooling cycles between room temp. and
- $-20^{\circ}\text{C} \rightarrow 3 \text{ days in total}$
- In-depth qualification of petals
- Grading
- Quality of petals produced is very good:
 1-3 % of bad strips

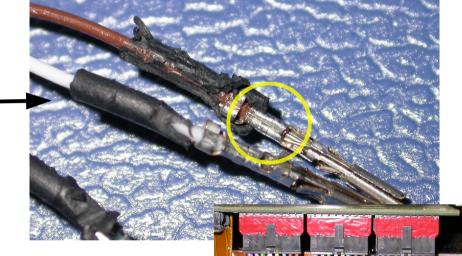
Optical inspection: bad crimp contacts

- insulation material below conductor crimp

- automatic stripping/crimping of thin rad hard wires problematic

crimp connecti

⇒ all connectors to be exchanged (26 000 contacts)

- company produces new pigtails (thicker wires, better QA)
- splice crimp connection to cable proven to work well

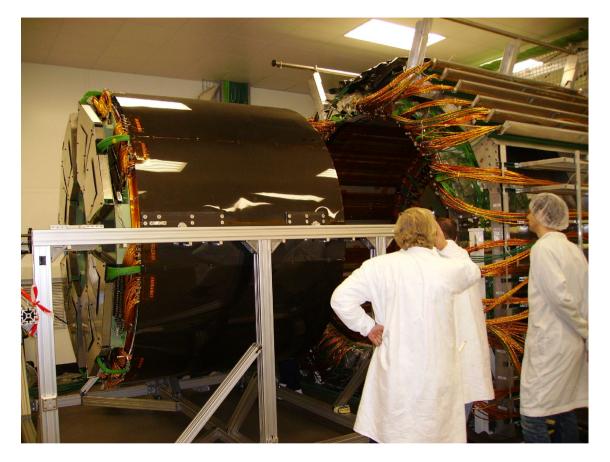
Insertion of the TEC- inside the tracker tuber

A slice of the tracker containing approximately 10% of readout channels has been operated to test system performance, and was commissioned using cosmic triggers.
