Design and Production of the LHCb Silicon Tracker

Ralf Bernhard
University of Freiburg

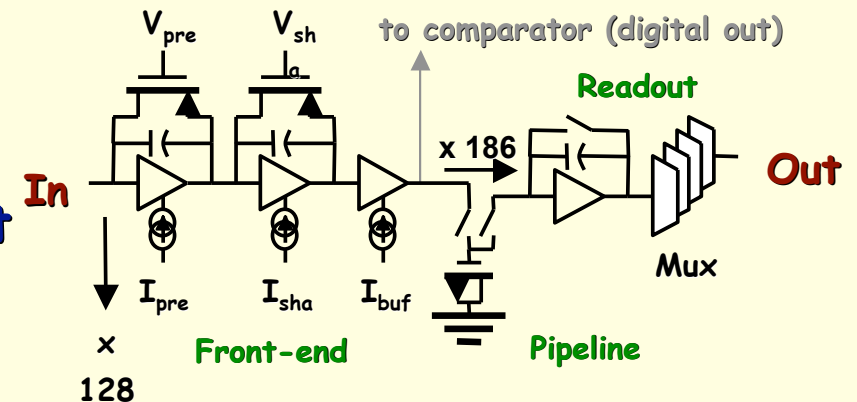
"Beetle" front-end readout chip:

- radiation-hard design in $0.25 \mu\text{m}$ CMOS
- analog pipeline, multiplexed analog readout
- adjustable shaping time of $\sim 25 \text{ ns}$

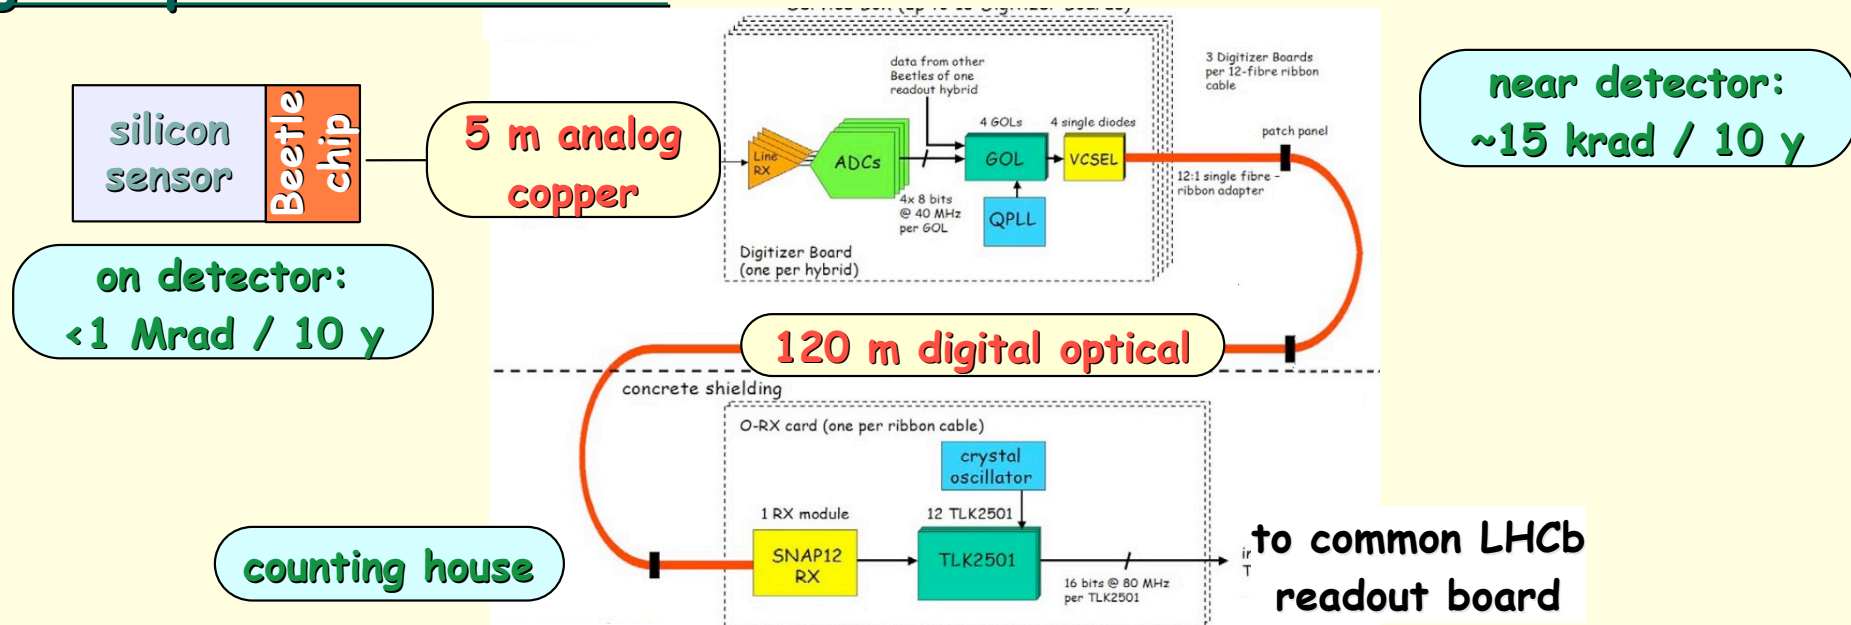
Digital optical readout link:

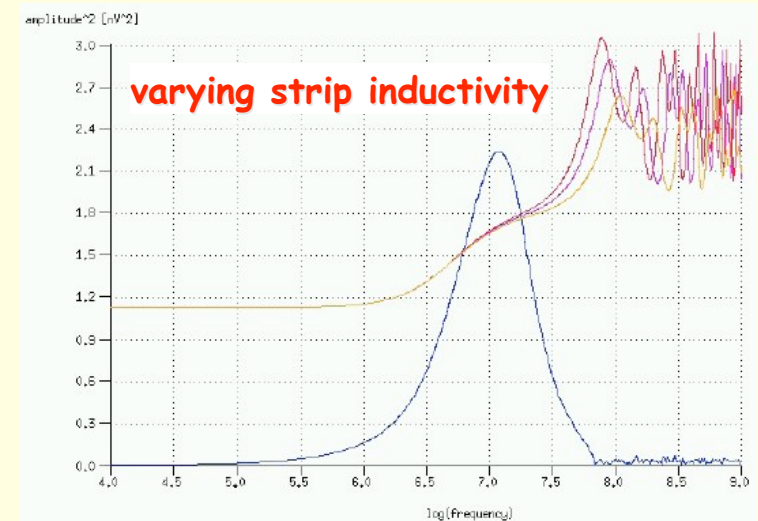
Noise proportional to detector capacitance:

- observed no significant noise contribution from strip resistance (up to 33 cm strip length)
- confirmed by SPICE simulation of r/o strips (as LCR network) and Beetle front-end amplifier
- careful: convolution of detector noise spectrum with frequency response function of amplifier

Also: no deterioration of signal integrity due to the Kapton interconnects

- behave just as an additional capacitive load
- again, confirmed in the SPICE simulation

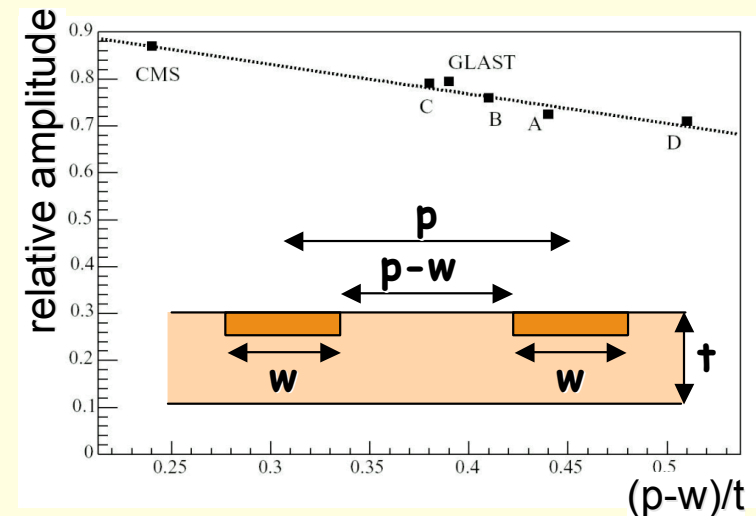
Significant loss of CCE in between readout strips:

- observed on all tested detectors
- not an artefact from clustering
- size of charge loss is independent of strip length, overbiasing, shaping time
- but seems to depend roughly linearly on the ratio (pitch-width) / thickness
- attributed to charge trapping at silicon bulk - oxide interface in between the strip implants
- unfortunately never found the time to do a proper simulation ...

sensor thicknesses chosen such that
 $S/N > 12$ in between strips

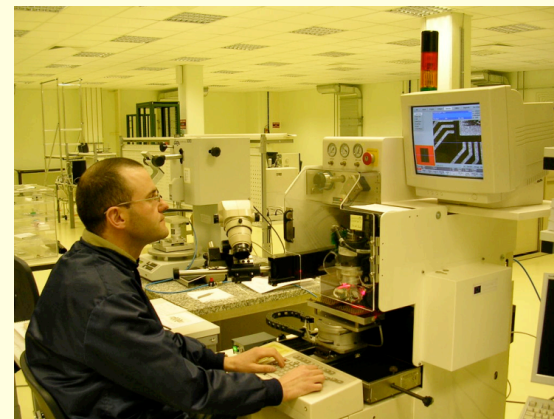
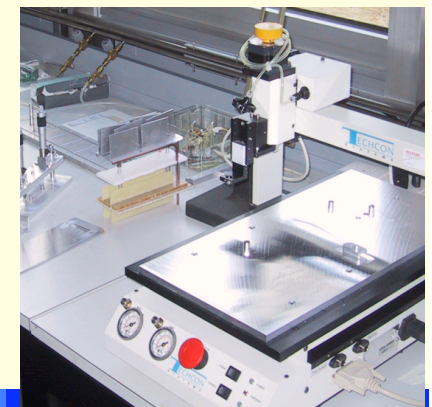
IT Module Production

Main production steps:

- position hybrid & pitch adaptor, glue them onto the sandwich support
- r/o functionality test
- position and glue silicon sensor(s)
- measure sensor alignment
- bond hybrid and pitch adaptor, bond bias and GND to the sensor(s)
- r/o functionality and HV test
- bond all readout strips
- 48h burn-in test:
 - 34 temperature cycles between $+40^{\circ}\text{C}$ and -5°C
 - detectors continuously biased at 500 V
 - readout tests at different temperatures

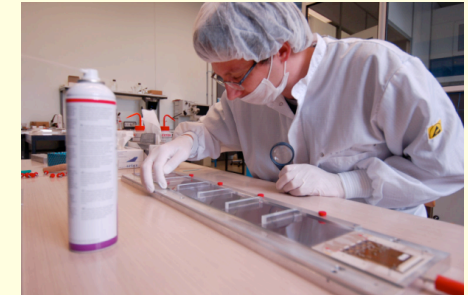
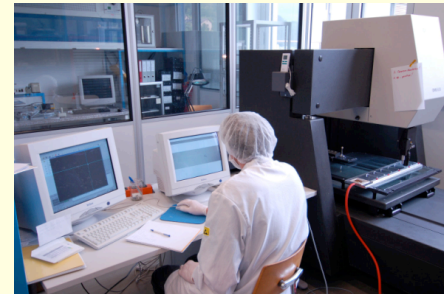
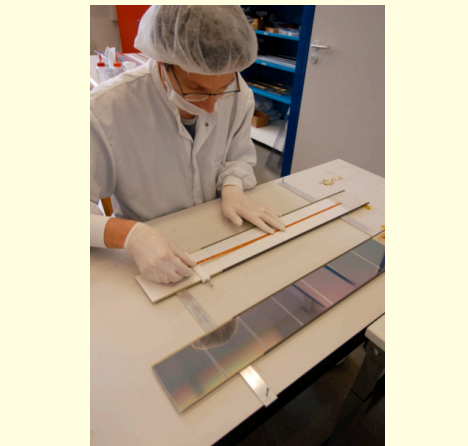
Trigger Tracker Production

"Stage I" production steps:

- place seven sensors and lower hybrid (use sensor edges for positioning)
- measure and correct alignment (CMM)
- glue support rails along the edges
- measure final sensor alignment
- glue bias voltage cable along back of module, connect GND and bias voltage (soldering / bonding)
- bond sensors and pitch adaptor
- 36 h burn-in test:
 - several temperature cycles between 25°C and 5°C
 - detectors biased at 500 V, currents monitored
 - IV curves and readout tests at different temperatures

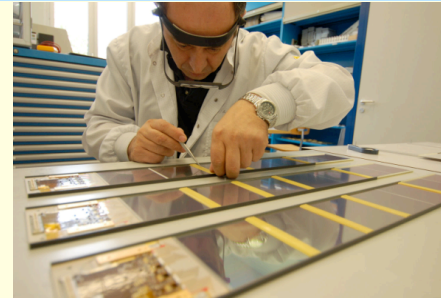
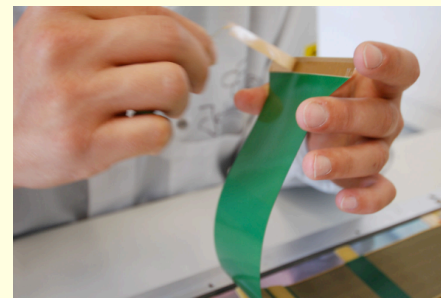
Trigger Tracker Production

"Stage II" production steps:

- glue Kevlar protection caps over bonds
- assemble, bond and mount Kapton interconnect cable and upper hybrid onto the detector module
- solder GND connections to lower hybrid
- 36h burn-in test

"Stage III" production steps:

- for "4-2-1" modules repeat stage-II steps for the 3rd readout sector
- 36h burn-in test

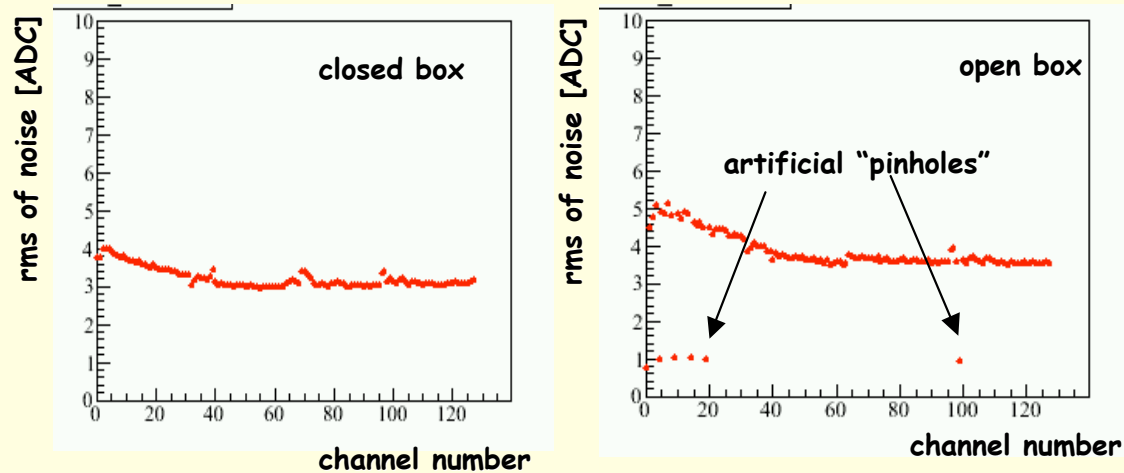
Burn-In Tests

Thermal cycling with readout tests at different temperatures

- pedestal and noise measurements
- pulse-shape and charge-collection scans
 - IR laser to inject signals in sensors (TT)
 - internal test pulse on Beetle chip (TT and IT)
- identify bad strips (open, short, pinhole) from analysis of noise and test-pulse data

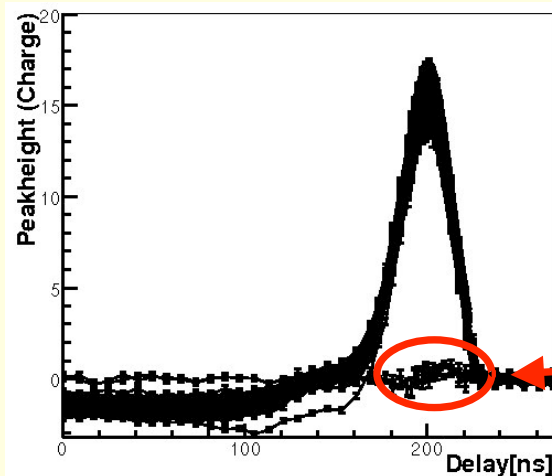
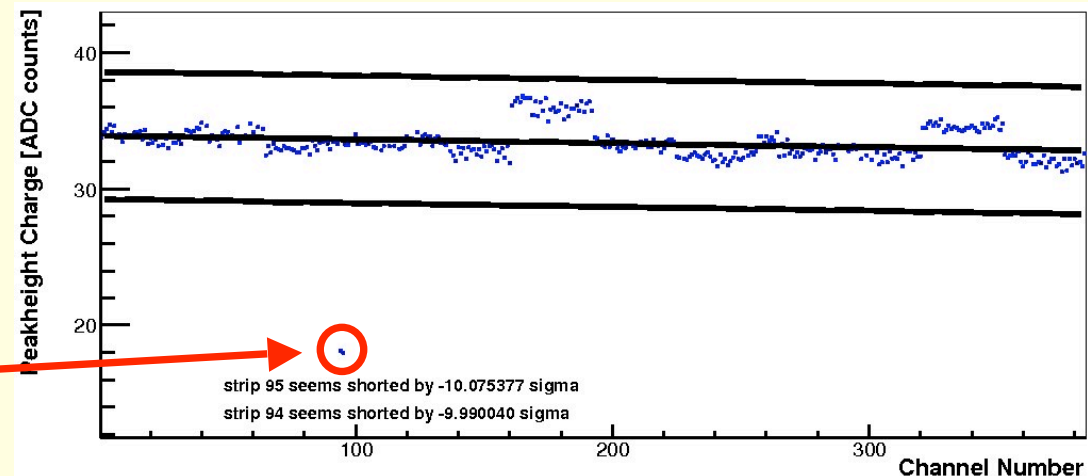
Burn-In Tests

Thermal cycling with readout tests at different temperatures

- pedestal and noise measurements
- pulse-shape and charge-collection scans
 - IR laser to inject signals in sensors (TT)
 - internal test pulse on Beetle chip (TT and IT)
- identify bad strips (open, short, pinhole)
from analysis of noise and test-pulse data

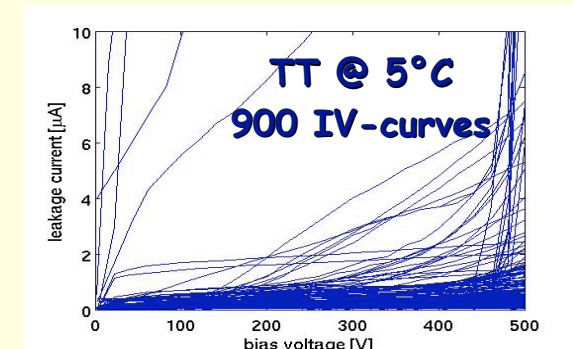
Module Quality

- 147 modules produced (= 15% spares)
- three modules “lost” during production
- three modules had to go through “major” repair cycle (e.g. replace sensor)
- found 109 bad strips out of ~ 158 k tested
- leakage currents typically < 500 nA per sensor

- currently ~ 300 modules produced (384) and fully tested
- some 15 of these show unstable HV behaviour between 350 V and 500 V, under investigation
- fraction of bad strips $\ll 1\%$
- leakage currents typically < 400 nA per sensor

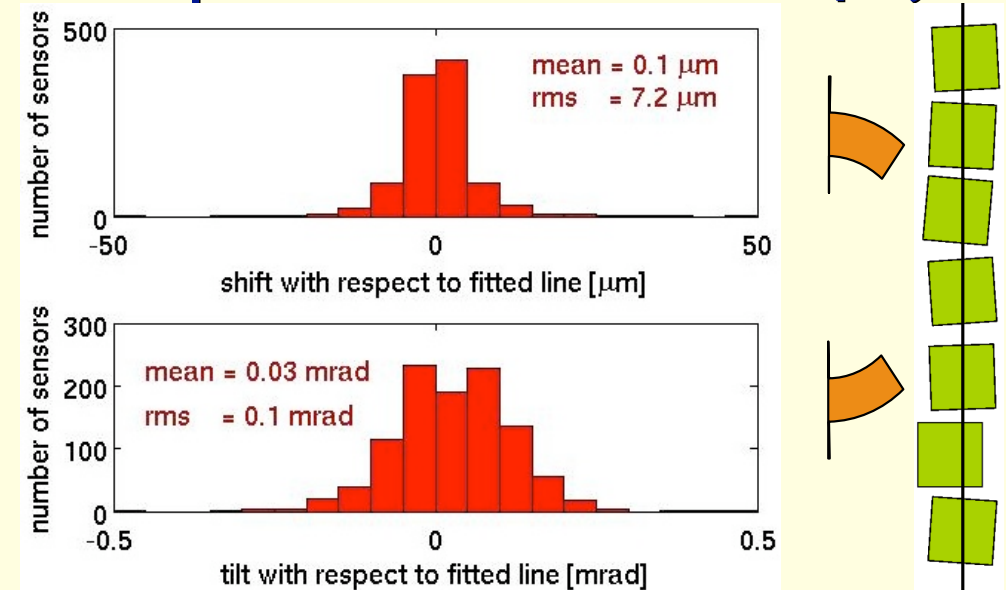
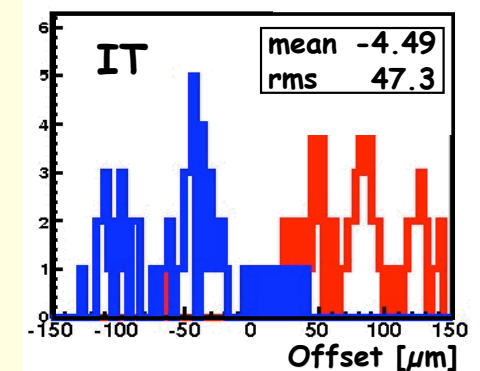
Module Quality

Positioning precision (benchmark: expected spatial resolution of $\sim 50 \mu\text{m}$)

- excellent relative positioning of the sensors on a module
- each module can be treated as one unit in software alignment, no need to align individual sensors
- positioning of sensors on supports worse than what we had hoped for (for IT, not measured for TT)
- mainly due to worse than expected tolerances on production templates
- no problem: software alignment of individual modules was always foreseen

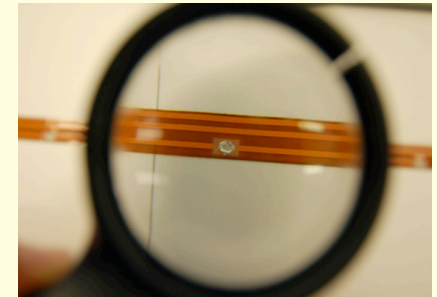
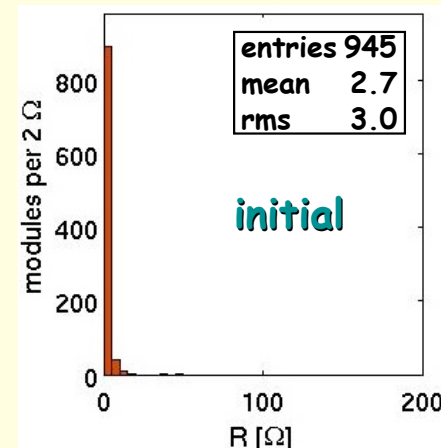
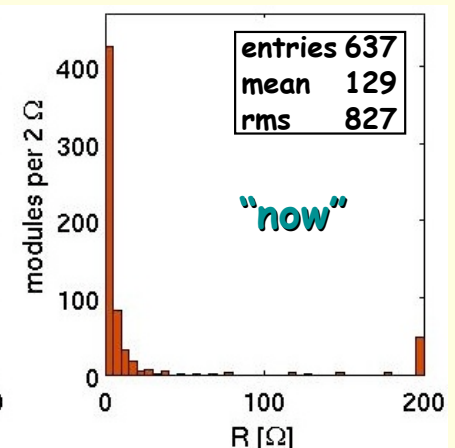
Silver Glue

Silver glue on aluminium is a bad idea (similar effects reported by CMS)

- TT: use Kapton cable to connect bias voltage to sensor backplane
- electrical connection initially done with silver glue
 - TT9-75: Elecolit 340 (one-component "silver paint")
 - TT76-155: Elecolit 325 (two-component epoxy)
- measured resistance of all connections
 - shortly after module production
 - again after a few weeks / months
- find significant increase of resistance
 - for both types of silver glue
 - typically a few hundred Ohms now
- added bond connections on all sensors to avoid long-term problems
- also: some GND connections on IT done with silver glue -> add bond wires

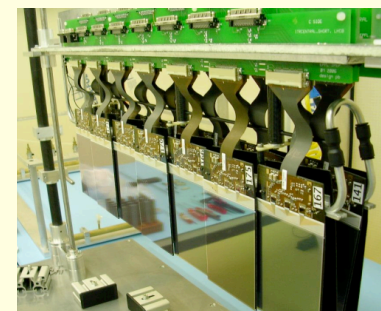
IT (12 individual detector boxes):

- first box assembled and being debugged
- commissioning of each box in the lab
 - installation of first box foreseen for July
