Lessons from the CMS TOB Mechanics

Forum on Tracking Detector Mechanics

3-4 July 2012, CERN

**Antti Onnela
CERN – PH/DT**

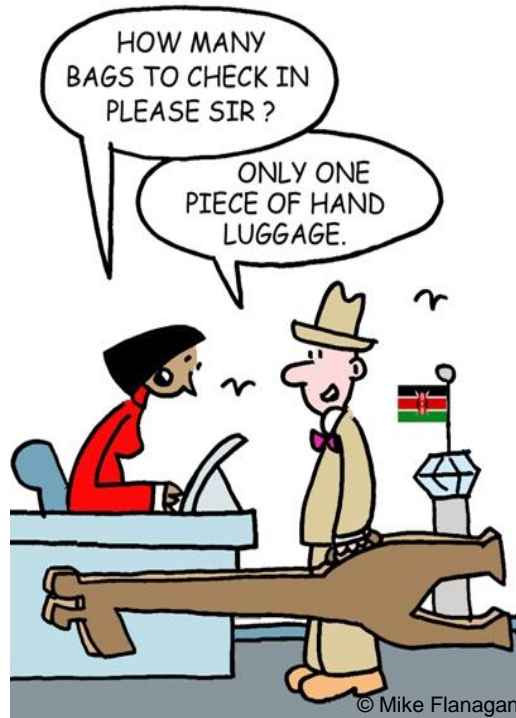
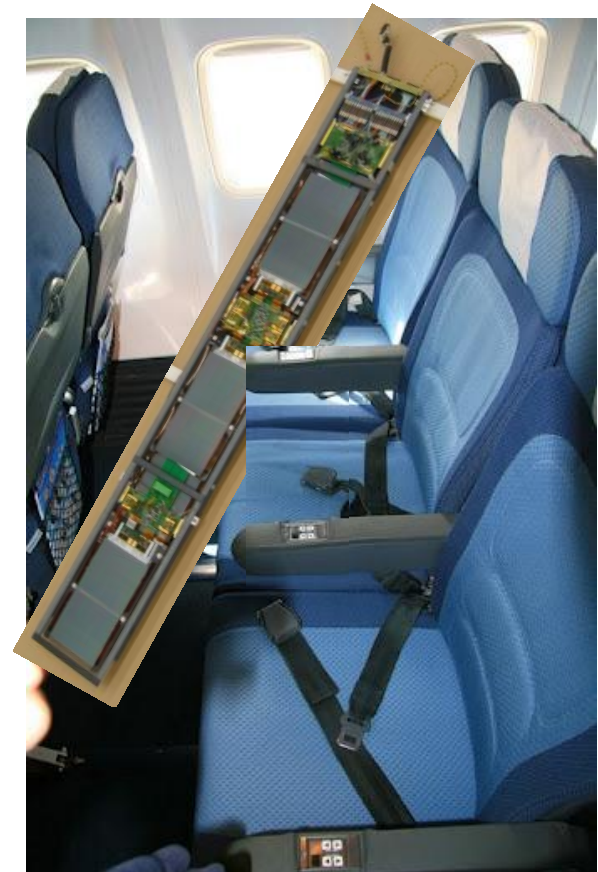
Transport methods

- One option was to profit from the dense personnel traffic between Fermilab, Santa Barbara and CERN.
 - Hand-luggage (very limited in space + mass)
 - Luggage (not the safest option...)
 - Buy a 2nd passenger seat (sounds safe, but...)

First ideas were proposed in the good old times.
Then we got September 11th 2001, and never tested all these...

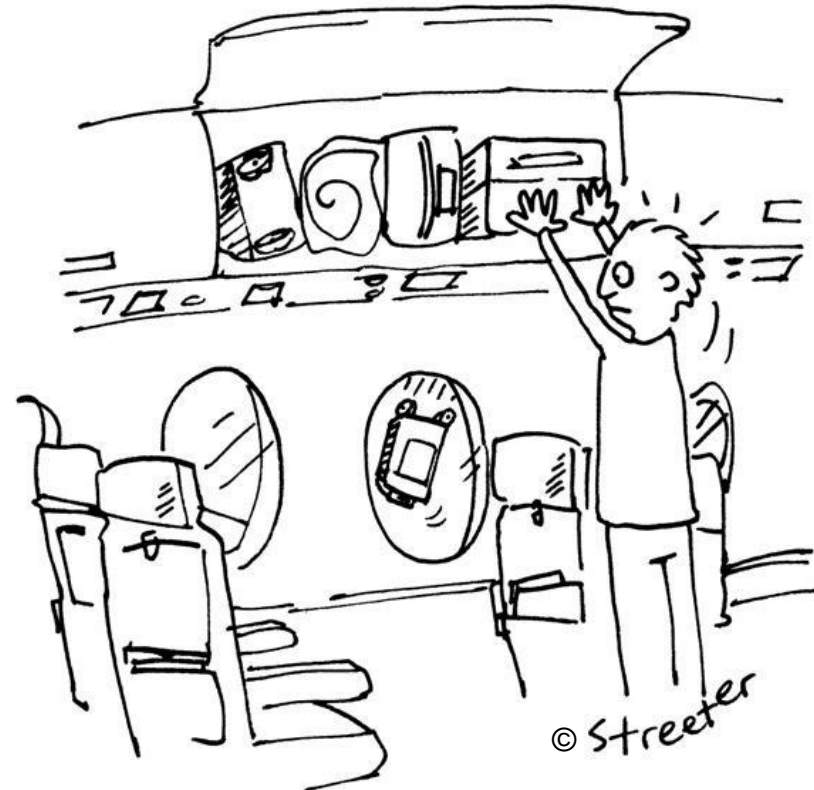
Broken bond-wires

- First pre-series TOB modules were transported as hand-luggage (considered safest method!) and some via freight. The result was *a major shock*: Hundreds of **bond-wires were broken** in the modules in both transports!

- ‘Everything’ was suspected, including shocks by bad handling. The module production responsible did not believe this to be the reason in the hand-luggage case (he did the transport himself...).

- Suspects for the bond breakage:
 - Bad bond welds
 - Shocks
 - Vibration
 - Thermal effects (did not seem likely)
 - Other ?

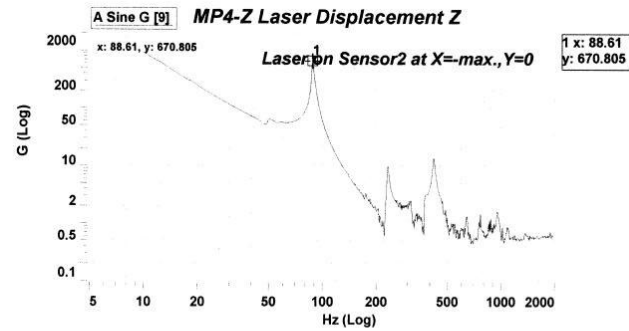
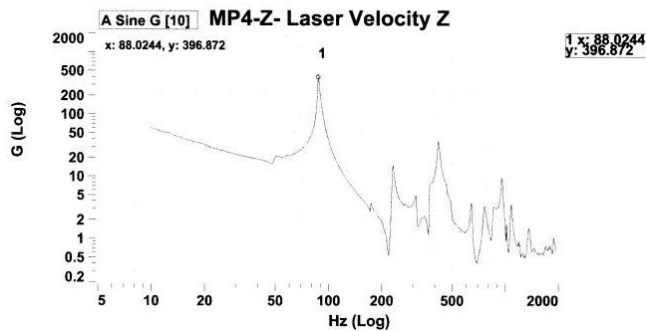
Test 1: Search for resonance frequencies

- Low acceleration sine sweeps, 0.1 and 0.5 g :
 - First resonance frequency 88 Hz, cantilever mode of sensor 2.
 - Second resonance frequency 220-240 Hz, most likely a transversal flexing of the sensors (and electronics?)
- Same results for all modules, reinforced and non-reinforced
- **No bonds broken, even at resonance.**

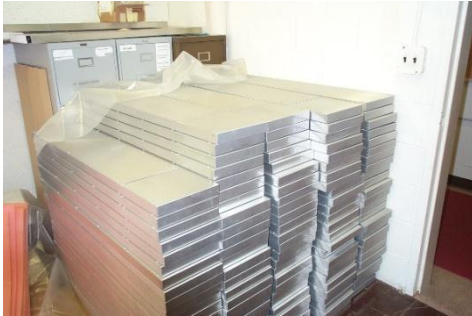
Rod transport boxes

- Sheet aluminum, very rigid with lid
- Rod clamped at 6 locations, butted at the end
- Two-piece lid allows for operation while still in box
- 215 fabricated

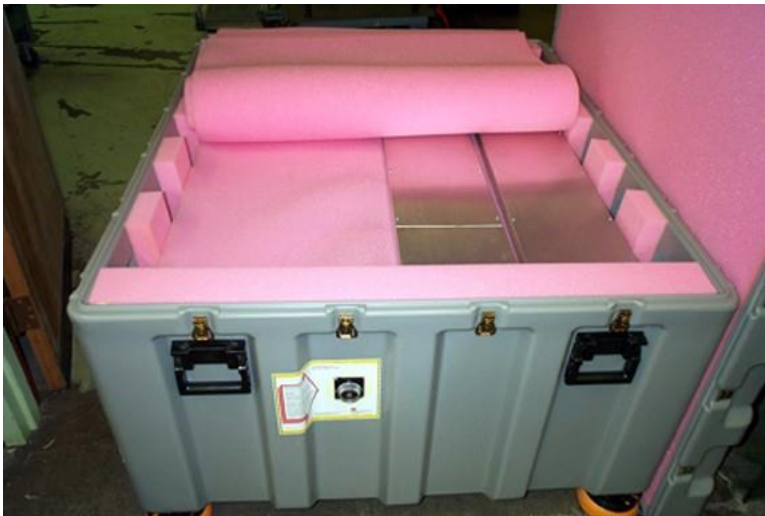
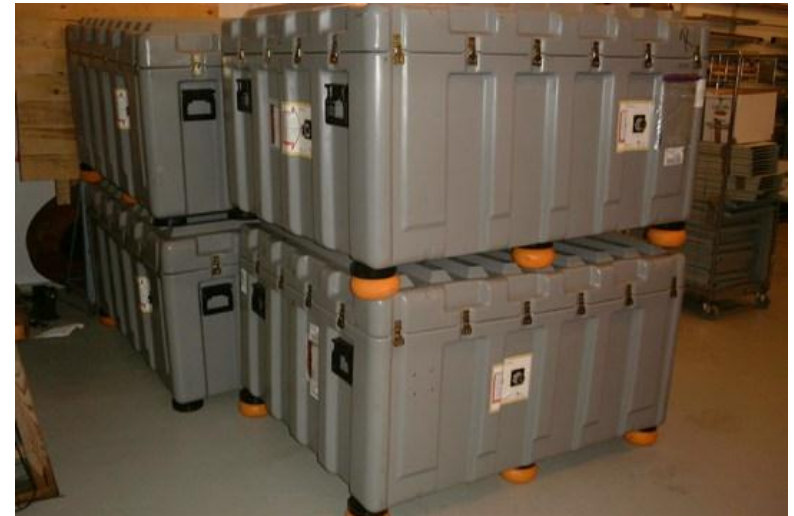
Rod transportation crates

- Hardigg AL5545-2305AC transport crates
- 6 inches of made-to-fit closed-cell antistatic polyurethane foam on inside top and bottom of crate, 2.5 on the sides
- Exterior toroidal cushions as feet of crate

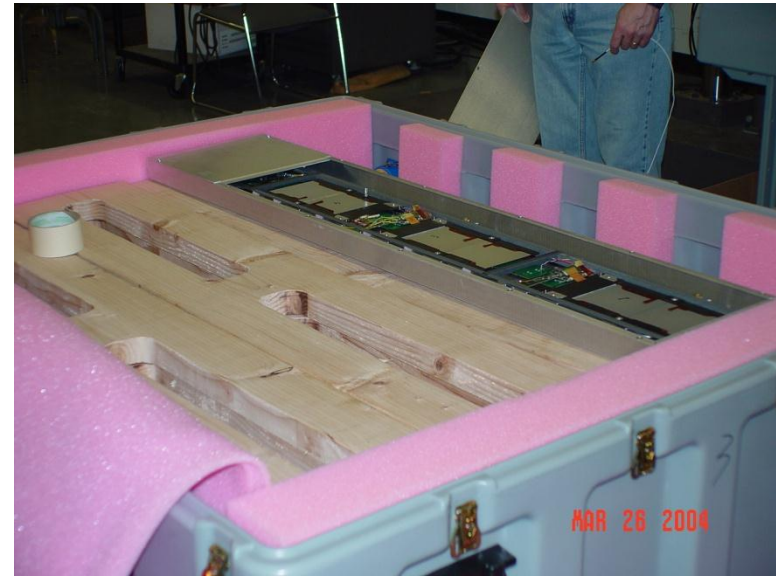
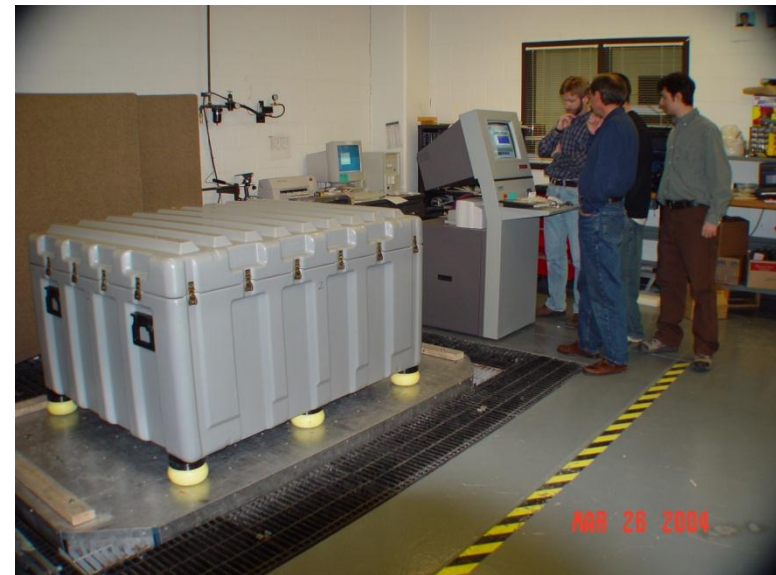
Testing

- With 100 g shocks on the crate the Rod had max acceleration <30 g and vibrated with ~ 30 μm amplitude.
- The drop and vibration tests showed that the Rods and Modules were robust and well protected by the transport boxes and crate.

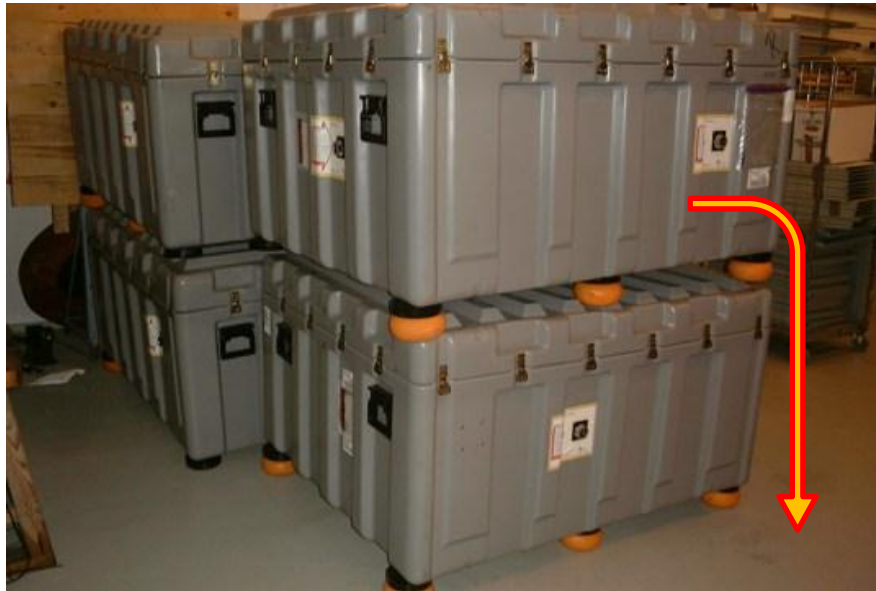
Transports during Production phase

- Several major shocks on the Transport crate were recorded
 - One event was beyond the 100 g limit of the accelerometer.
 - Several events between 10 g (our alarm limit) and 80 g.
- In the 80 – 100+ g events the crate has probably fallen from ~ 1 m height.
 - The loaded crates were labelled 'DO NOT STACK', but...

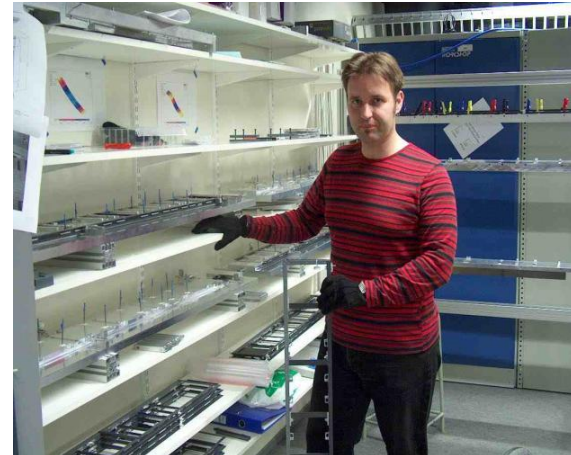
Rod frame supports the modules and the services

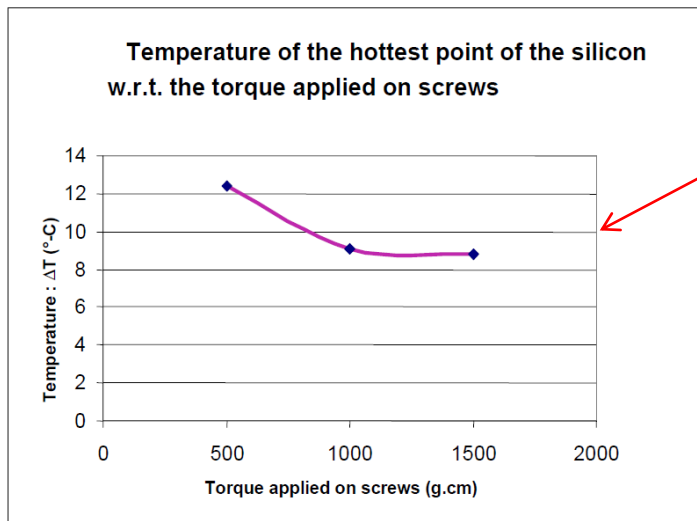
Module support / cooling contacts

ΔT of max 10°C between silicon and coolant allowed

- Double-sided module with caps
- Screws fixing module on the blocks
- 1000 g.cm seems to be adequate (quite tightened)

The module support / cooling contact pieces must be precisely located:

1. For module positioning
2. For tight thermal contact (no gaps)
3. Avoid breaking module when tightened

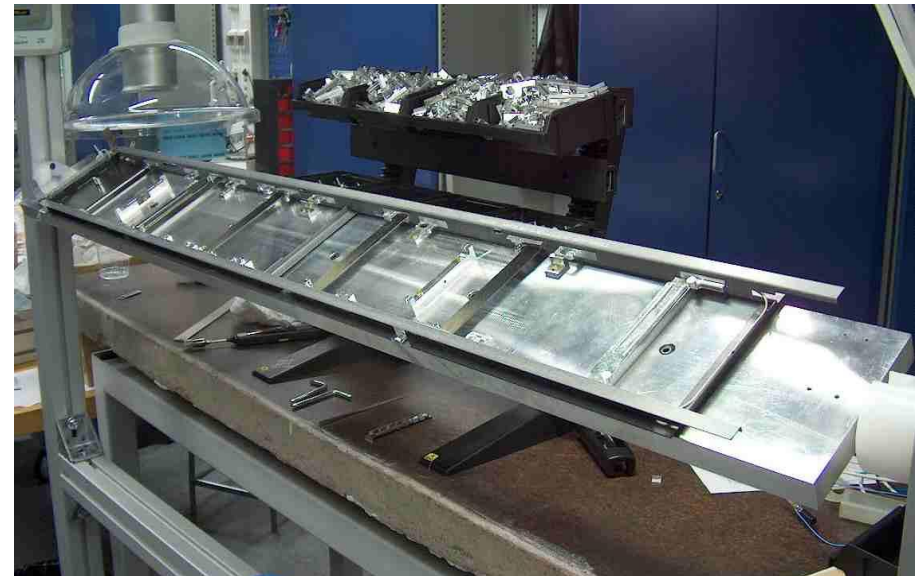
1. Components placed stress-free on an accurate gluing jig
2. Capillary glue (Araldite 2020) added + room-temperature cure

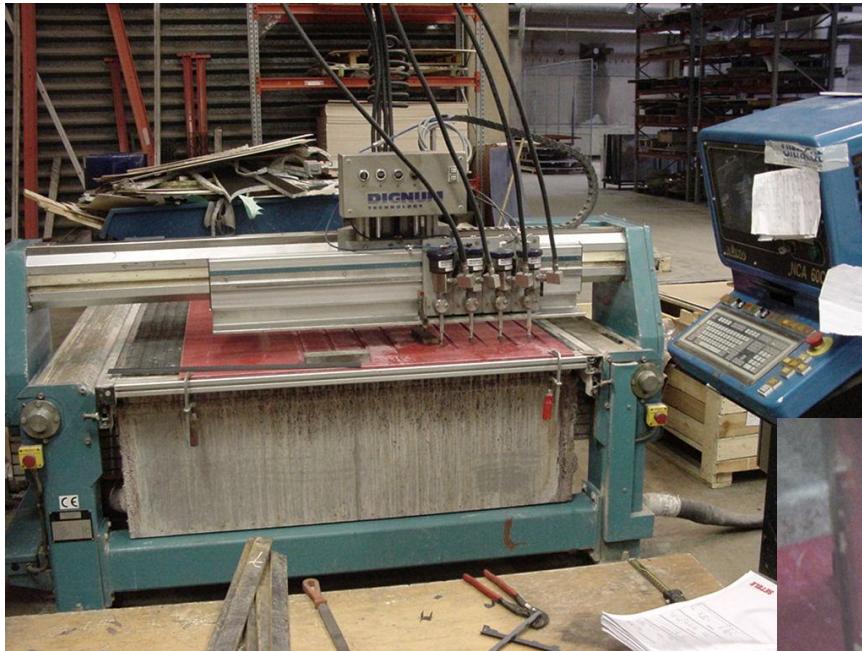
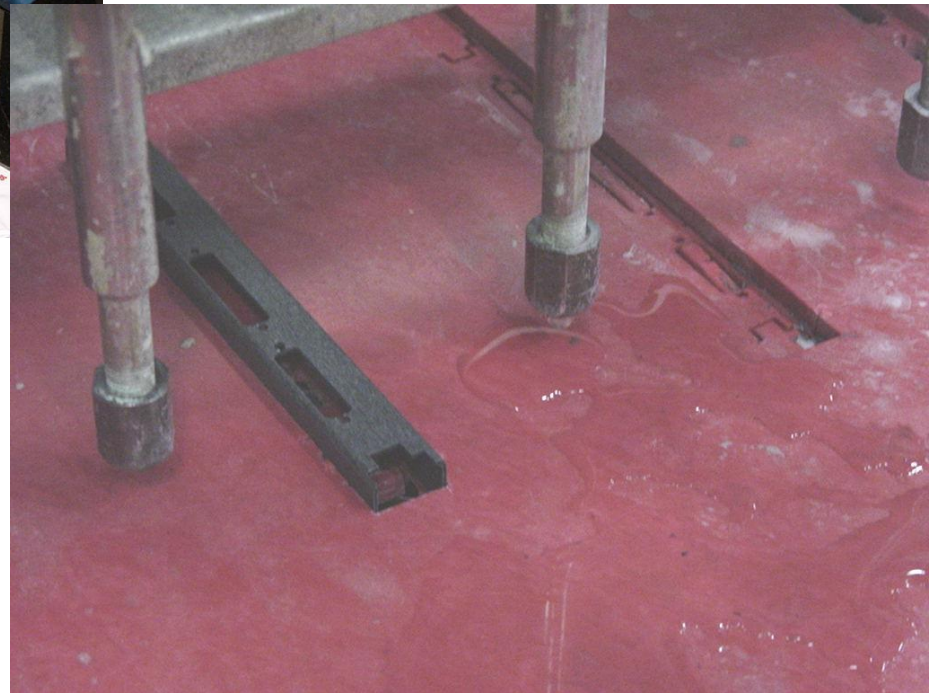
Industrial production of components

Water-jet cutting worked excellently,
even for thin C-shape profiles

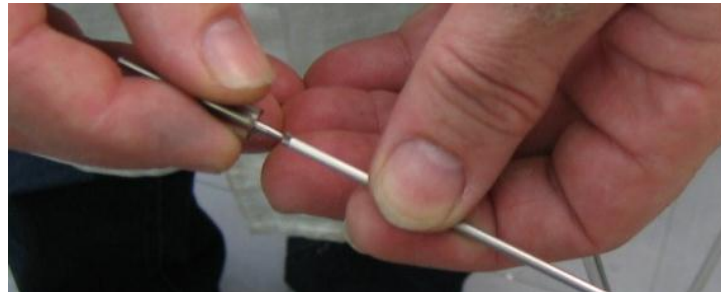
Cooling pipes in CuNi with soft soldered joints

A test-set of soldered connections.
Leak-tightness tested to 15 bar pressure,
and thermal cycling down to -196°C .

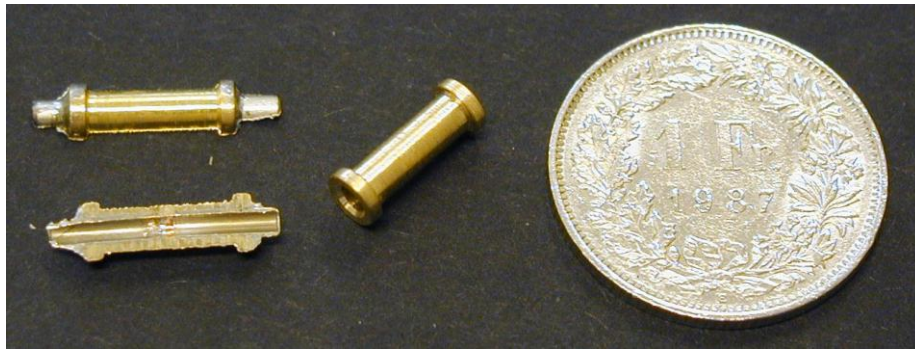
Copper-nickel 70/30 pipes and brass connection pieces
Soldered with eutectic Sn62% - Pb36% - Ag2% with rosin flux (ERSIN 362)

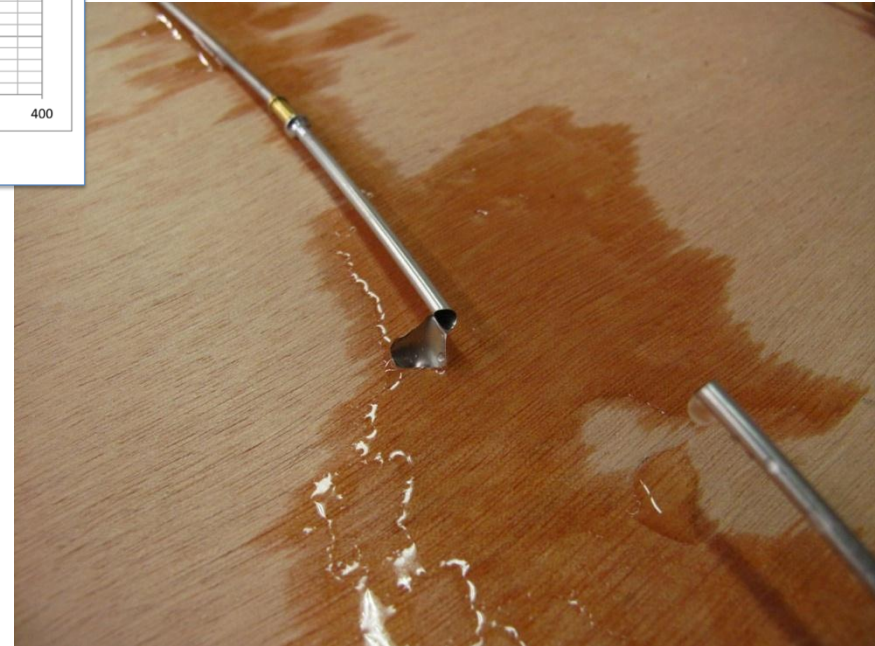
However, in the production some years ago...

“Bubble test” of bent and soldered rod pipes
with water and 20 bar (not 200 bar) air
→ **850 pipes tested, 10% of them leaked !**
All leaks in the pipe wall (well known problem also in Atlas...)

Fortunately, only $\sim 1\%$ of pipes found now leaking, even if tighter test and rods gone through all production chain, thermal cycling, transports, etc. These leaks were repaired by soldering, to be fully He leak-tight.

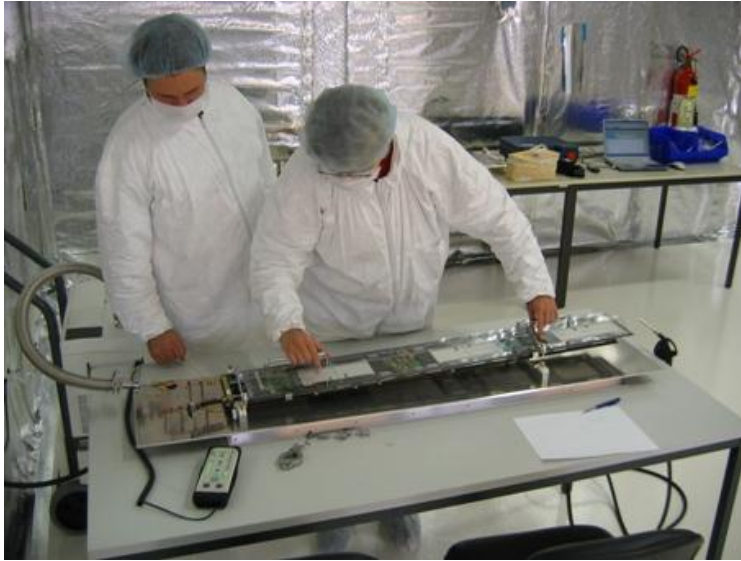
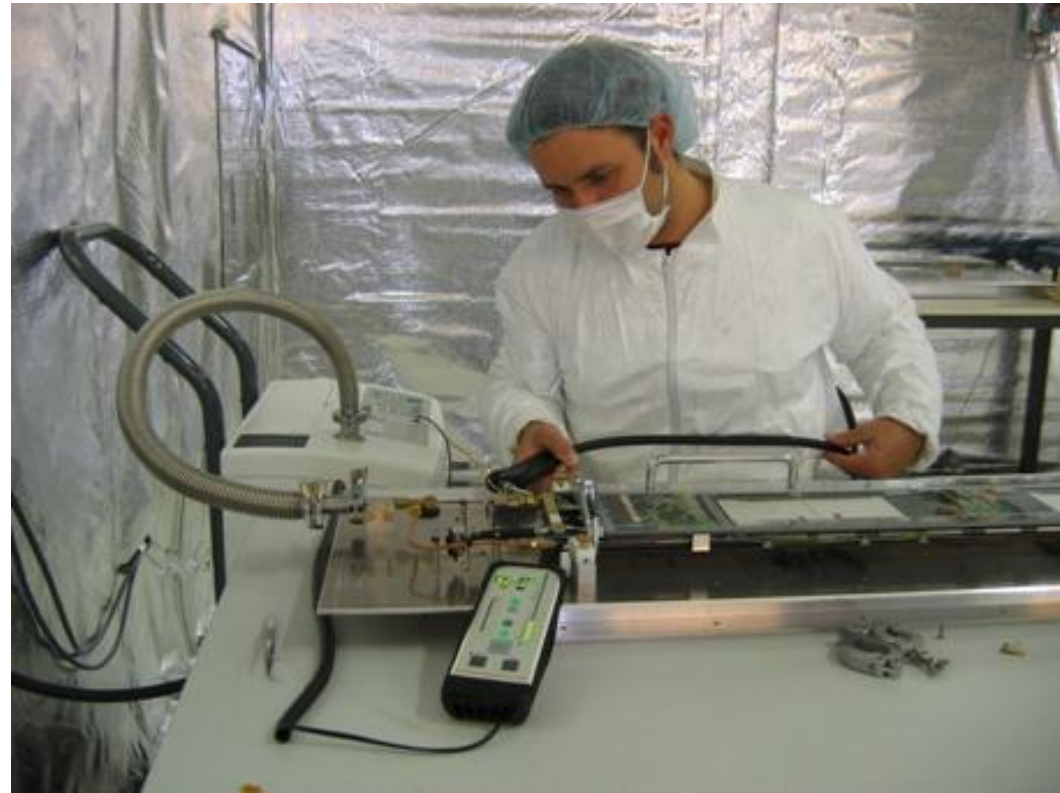
Leak testing of completed Rods

Helium leak-detection, test in vacuum mode.

Alarm limit 10^{-8} mbarl/s (bubble-test at best $\sim 10^{-5}$ mbarl/s).

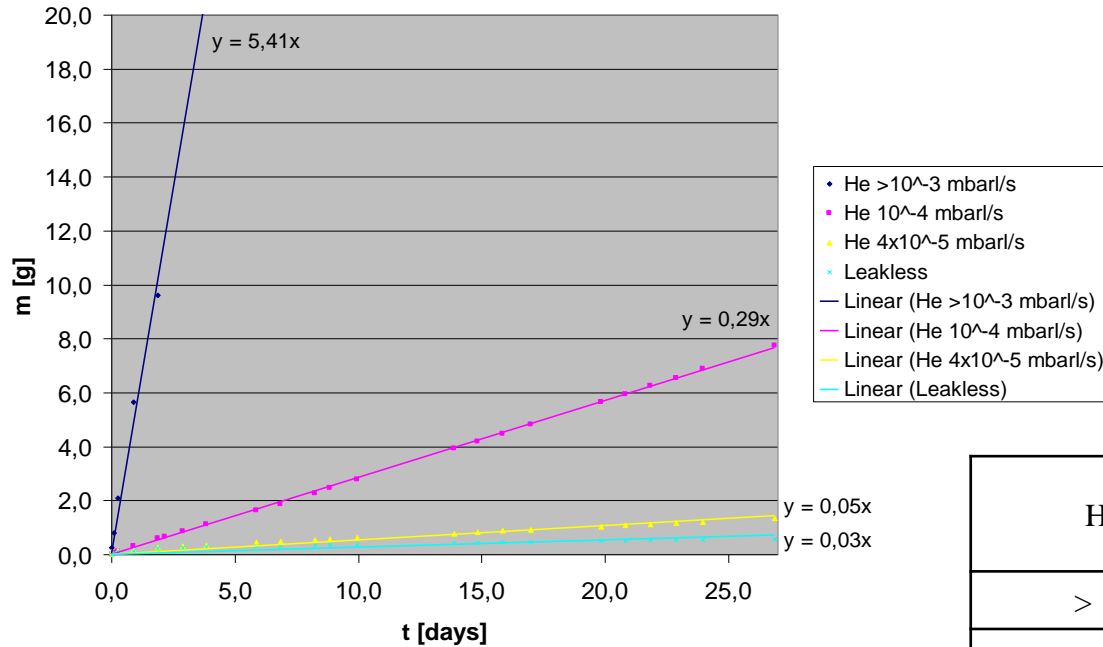
Leak He vs. PF-5060

He leak size	Loss of PF-5060	
	[g/a]	[ml/a]
$> 10^{-3}$ mbarl/s	1870	1113
10^{-4} mbarl/s	105	63
4×10^{-5} mbarl/s	18	11
$< 10^{-10}$ mbarl/s	8	5

Bubble-test can spot leaks down to 10^{-5} mbarl/s of He, i.e. to ~ 10 g/a of the final fluid PF-5060.

With He testing (1000-100'000x more sensitive) drop to insignificant leak levels for fluid loss.
