T2K Muon Monitor

Takahiro Hiraki
for the T2K Collaboration
(Kyoto University)
Nov 7, 2012

Purpose of muon monitor (MUMON)

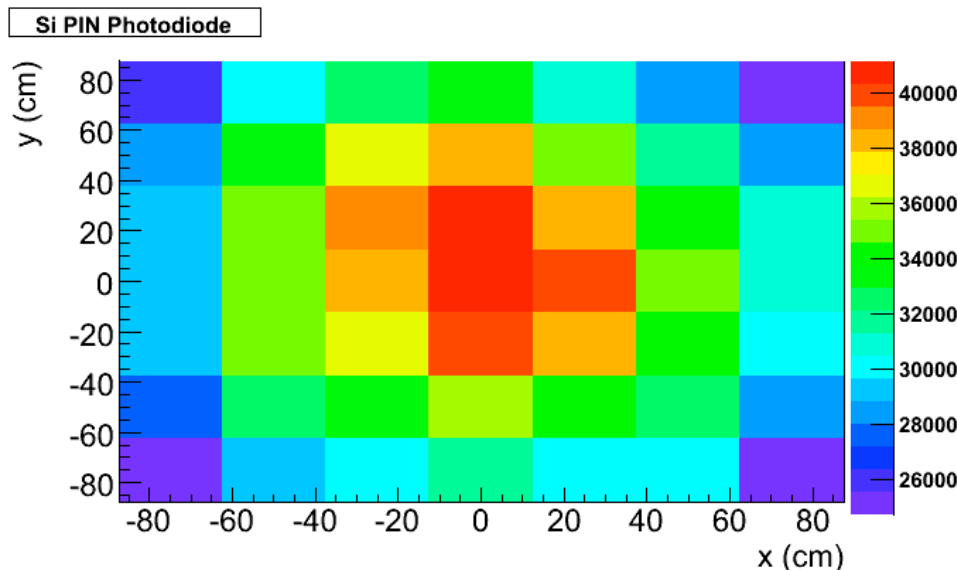
Two-dimensional profile at MUMON (MC)

- take data of collected charge in each channel
- make 2D histogram by filling each collected charge
- Fit histogram by 2D gaussian function
- get profile center(RMS<1cm) and muonintensity(RMS/Mean <1%)

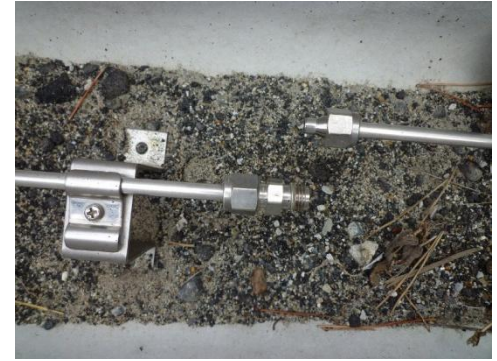
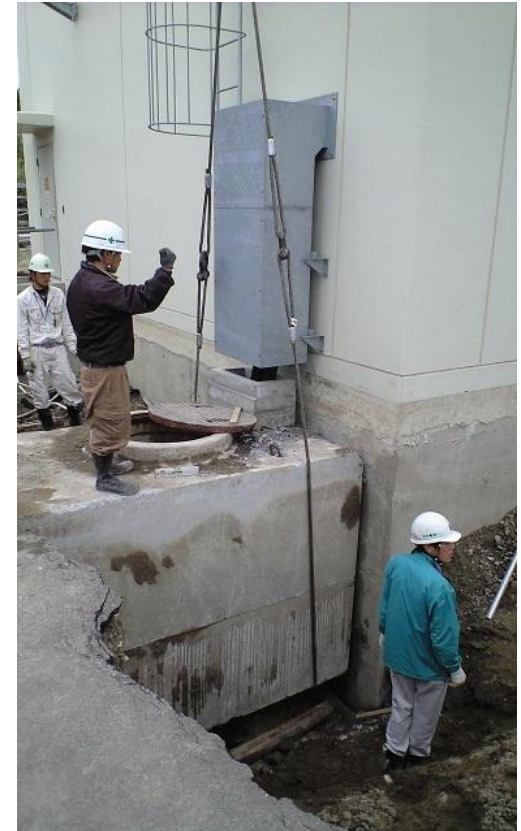
earthquake damage

- Fortunately, all detectors and most of cables and gas pipes were not damaged.
- MUMON survey has been done.
→ Please see Ishii-san's slide.
- Data after the earthquake has been taken same as before the earthquake.
- Beam profiles are consistent with past data.

- MUMON has two independent detectors, Si PIN photodiode and Ionization chamber.
- Damage by the earthquake was not critical.
- MUMON has been stable and had good data taking.
- Linearity and radiation resistivity of Si become issue at high intensity.
- We are studying diamond detector as a candidate of alternate detector in future.

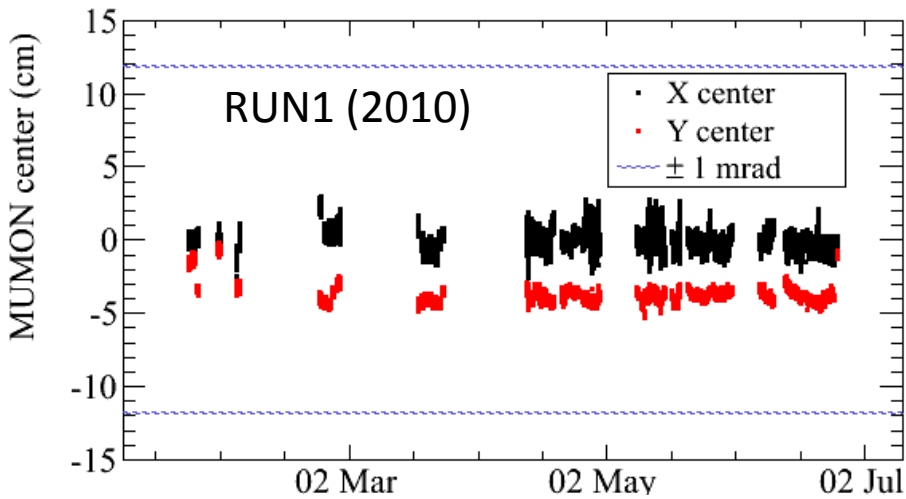
beam center stability

obtained by fitting the profile of Si detectors

Beam direction has been well-controlled so far.

(We want to control |beam center| < 1 mrad (11.8 cm at MUMON))

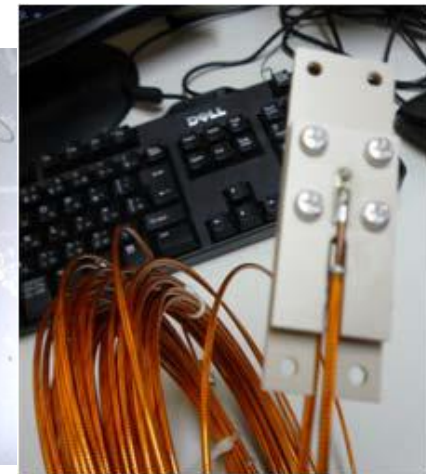
package

HV:200V

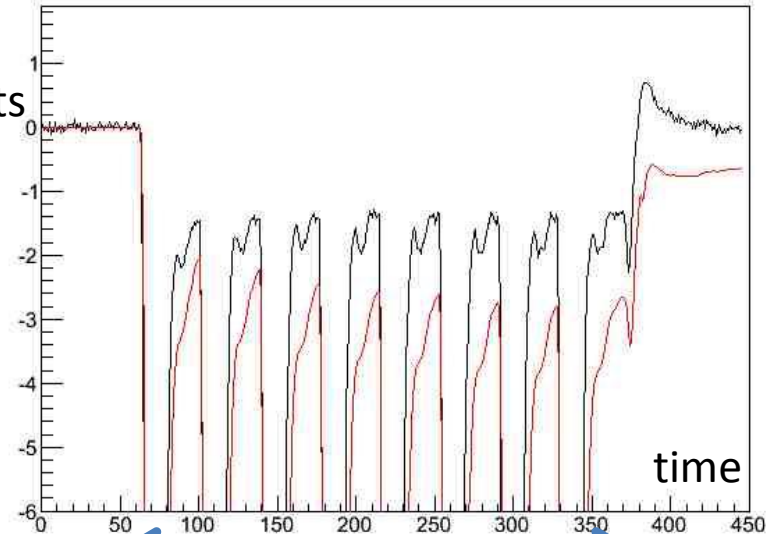
waveform

black:diamond

red:Si

normalized by collected charge

- Incomplete drift of carriers causes pile-up effect.
- Pile-up effect in diamond is smaller than in Si due to fast drift mobility.

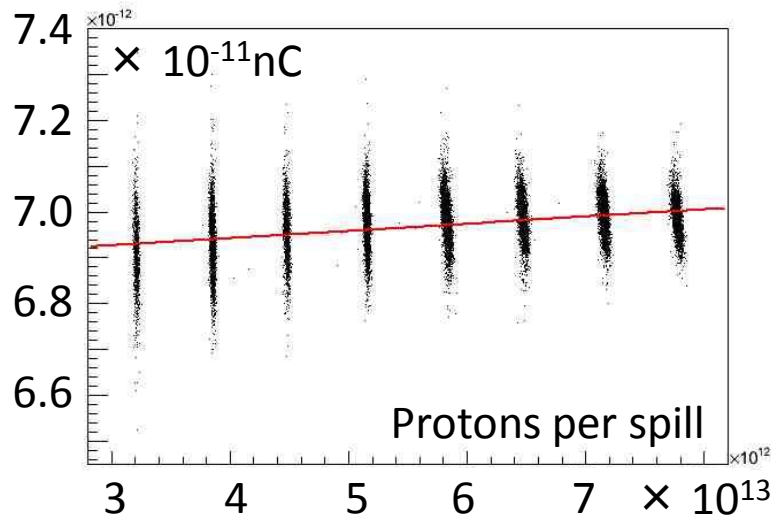
Diamond

Charge/Protons per spill

- Better linearity than Si

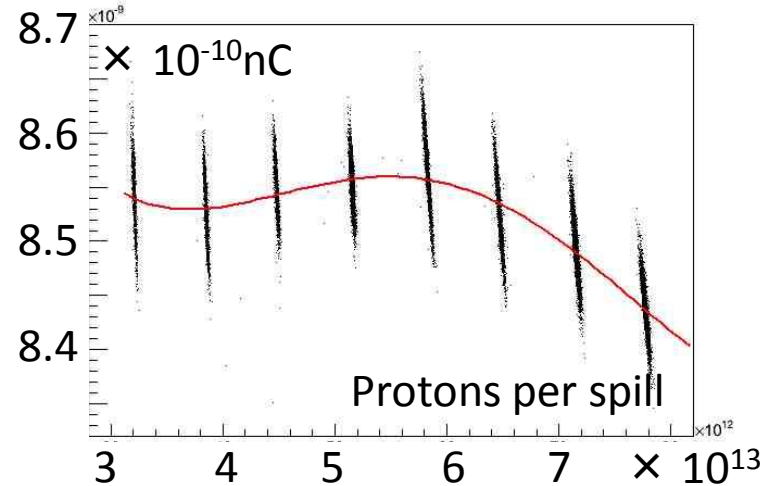
Si (center)

Charge/Protons per spill

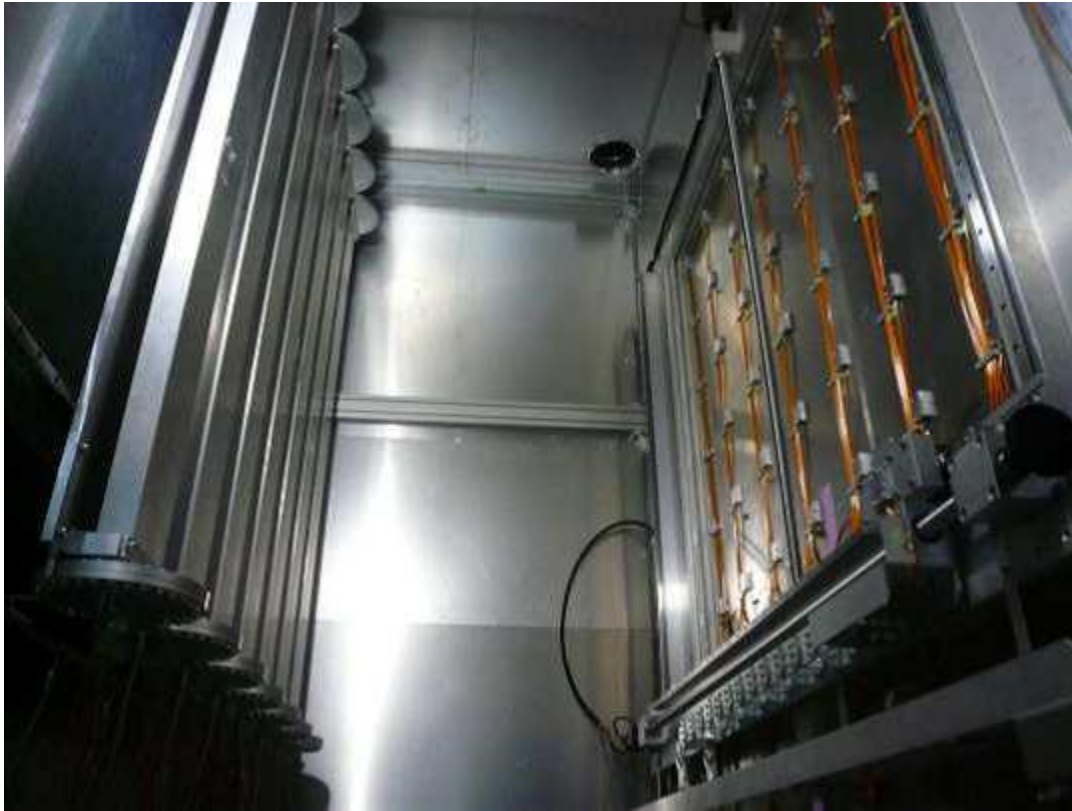
picture

Ionization Chamber

SI PIN photodiode

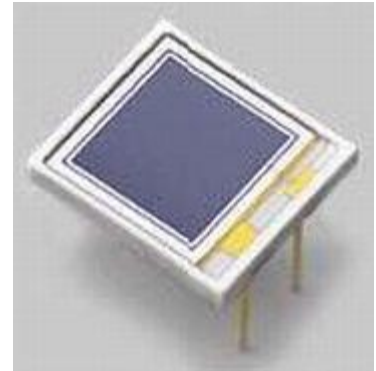
Silicon PIN photodiode

- HAMAMATSU S3590-08
 - Active area: 10mm × 10mm
 - thickness: 0.3mm
 - HV: 80V
-
- not tolerant of the severe radiation
 - lifetime: ~1month with the 0.75MW proton beam
 - Packages were designed so that replacement can be quickly done

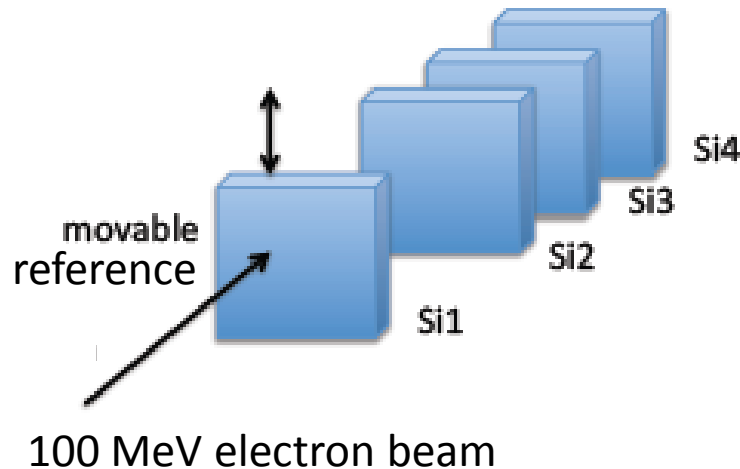
Estimation of Lifetime of Si

- Radiation damage test was conducted using 100 MeV electron linac at Uji (Kyoto) in 2009.
- From the result of the test, we set 1.0×10^{14} electrons/cm² as the limit.

- In the T2K experiment, main component of radiation at MUMON is muon.
- So, we estimated limit for T2K beam using NIEL scaling (the dose of some particles can be replaced with that of 1 MeV neutrons).
→ **8.1×10^{20} POT (250kA)**
- Delivered POT so far is 3.0×10^{20} POT (Good Spill).
- Our target for next run is 8.0×10^{20} POT.
→ **Better to replace current Si detectors.**

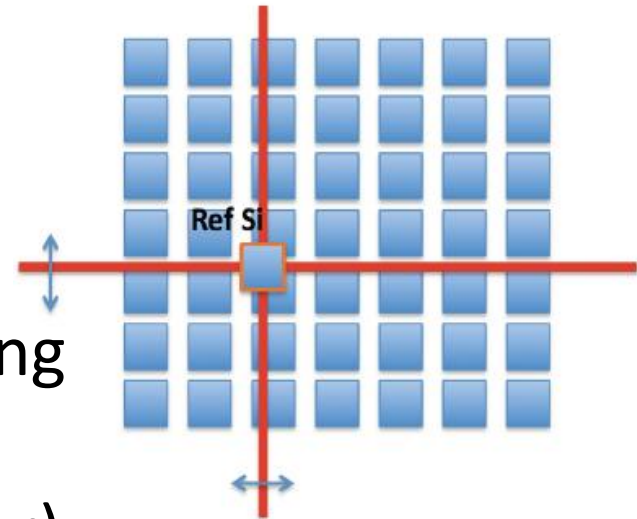
Replacement of Si

- Calibration for all channels has been done by comparing with the reference movable Si.
- So, this reference Si sensor will be left for reproducibility check.
- Radiation damage of reference Si detector will not exceed the limit until next summary because It is always evacuated to the bottom position during data taking.
(~70% intensity compared to the center)

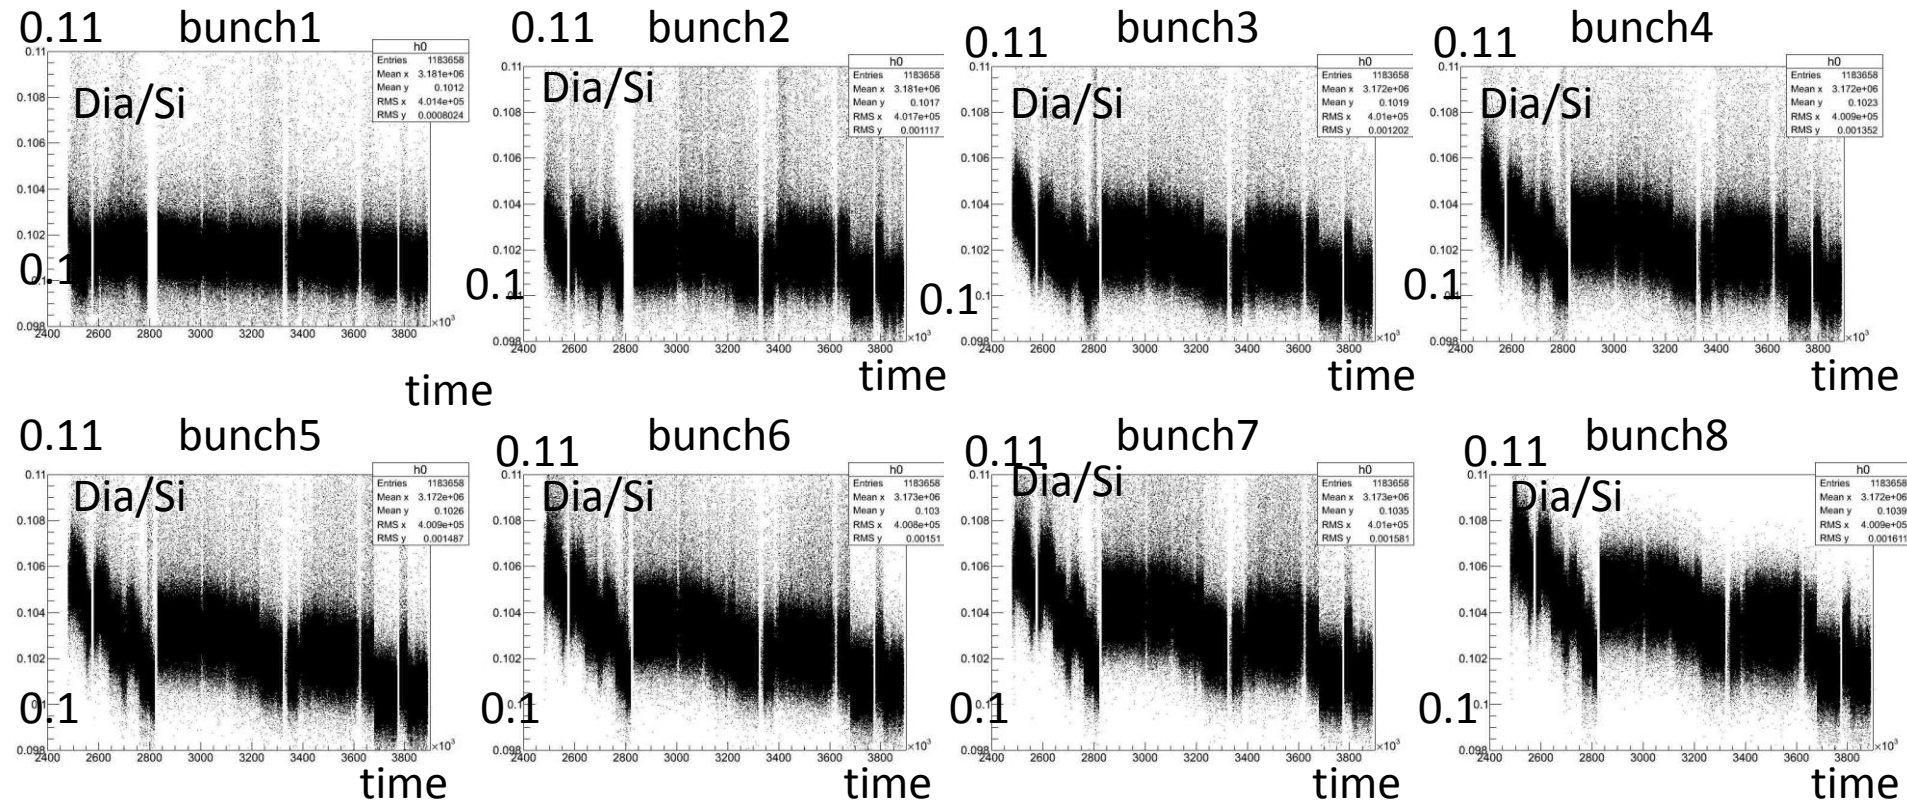
Dia /Si ratio time dependence

Dia charge/Si charge is stable at 1st bunch

Protons per spill dependence becomes larger in latter bunches

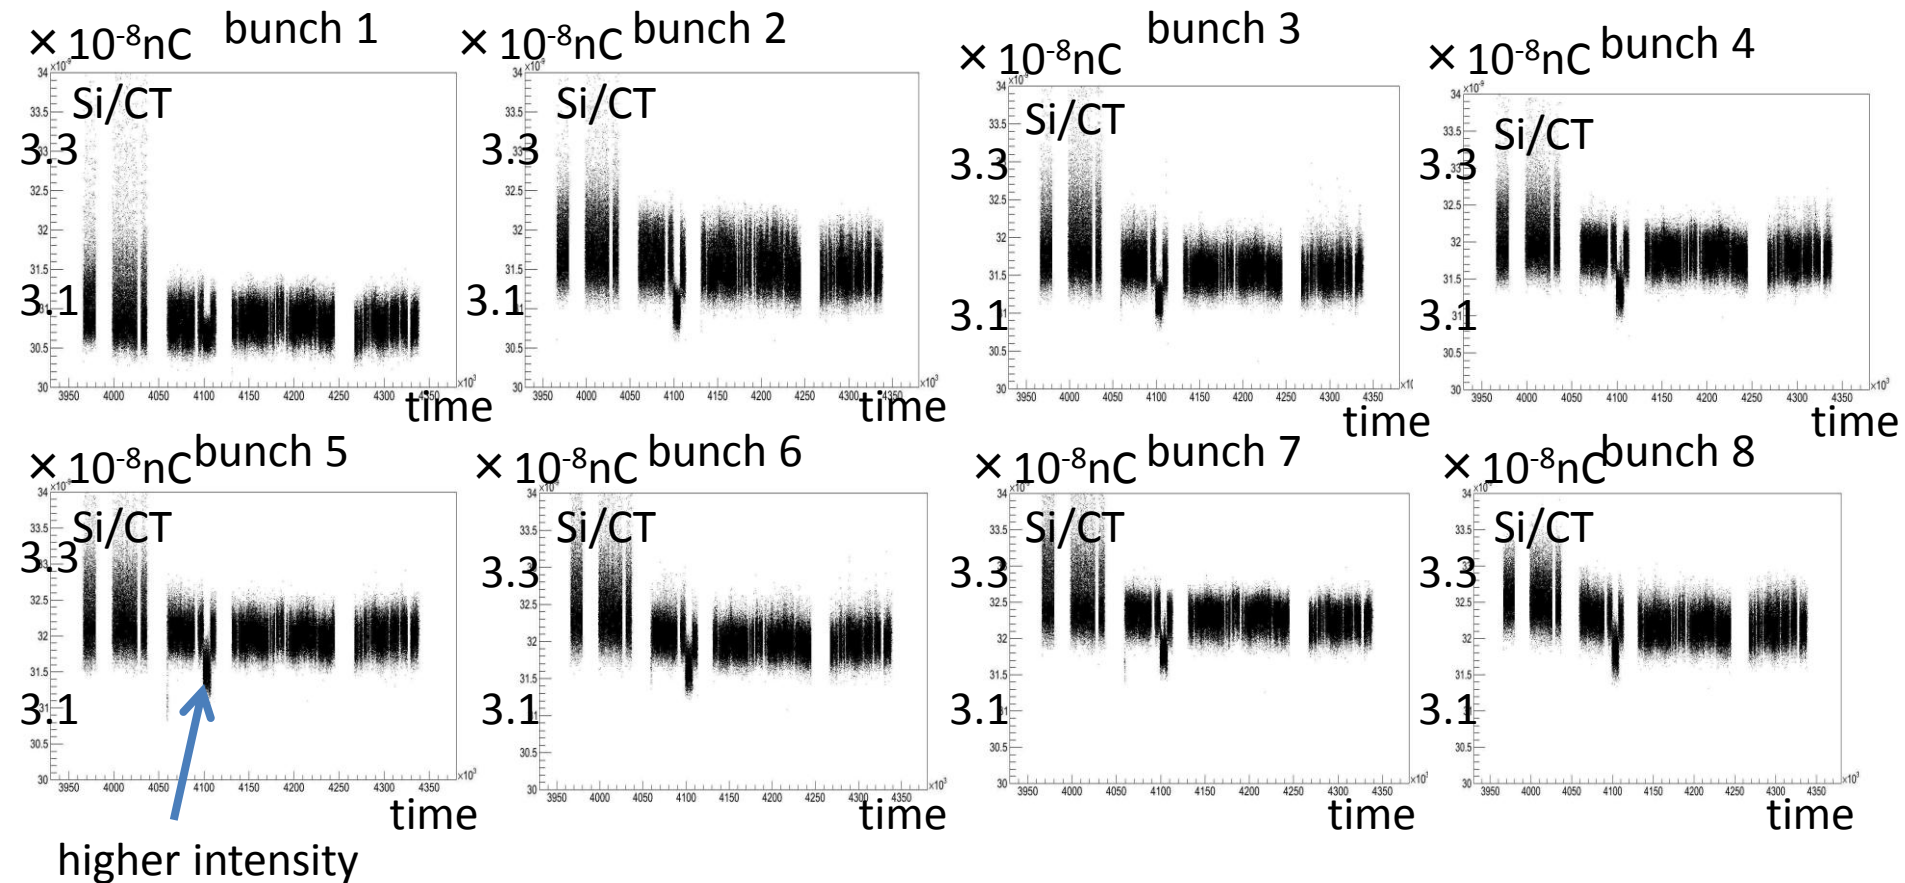
Si total charge/Protons per spill

Charge collection decrease is seen from 2nd bunch.

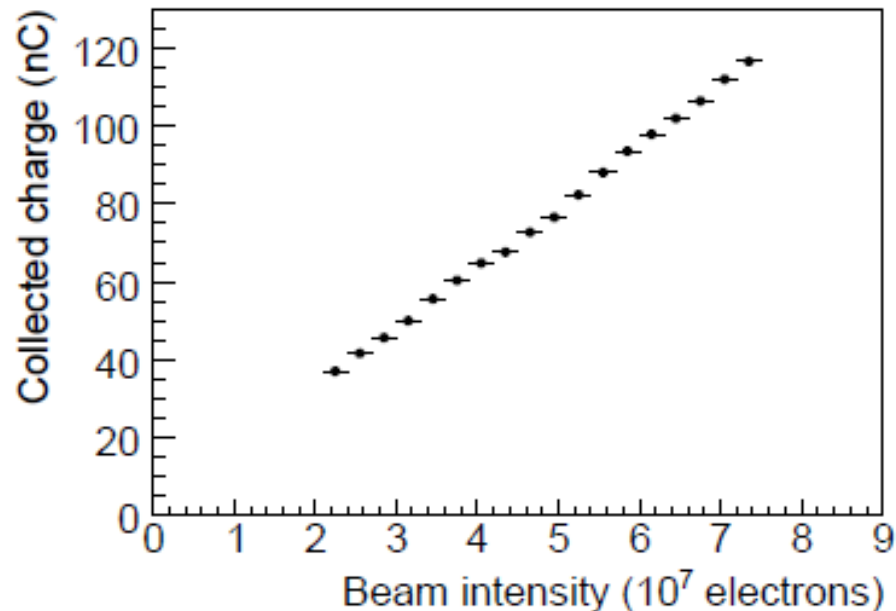
- Non-linearity has not observed in past beam test using electron beam in which electrons per time was not so strong.
