NuMI Operation Summary: 2005-2012

Sam Childress - Fermilab

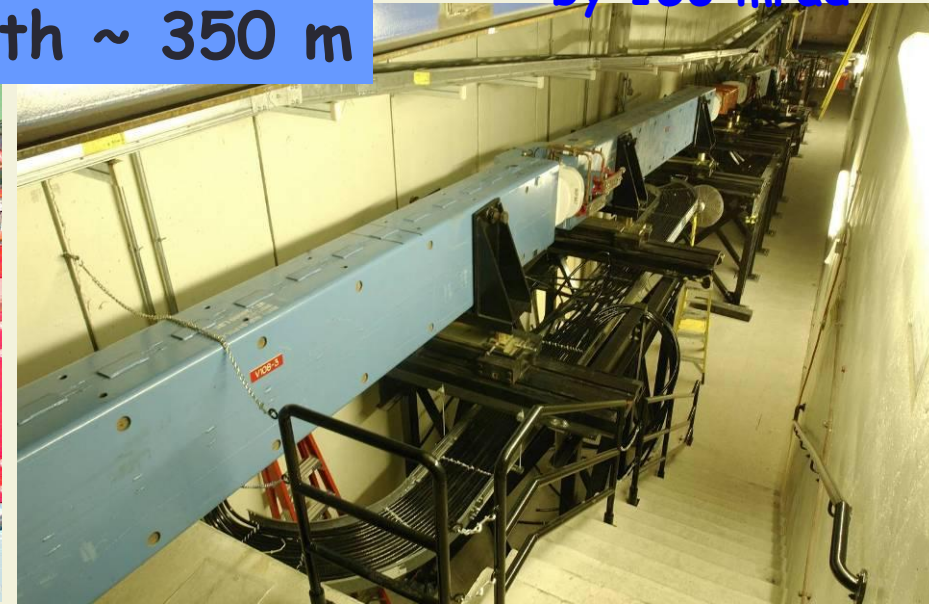
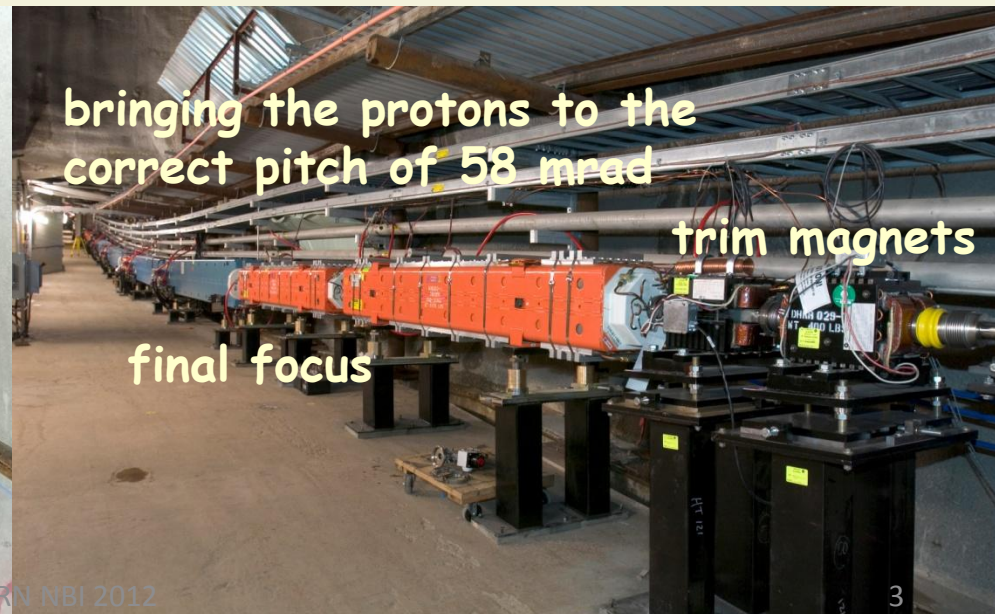
Primary Proton Line

bending down
by 156 mrad

Total length ~ 350 m

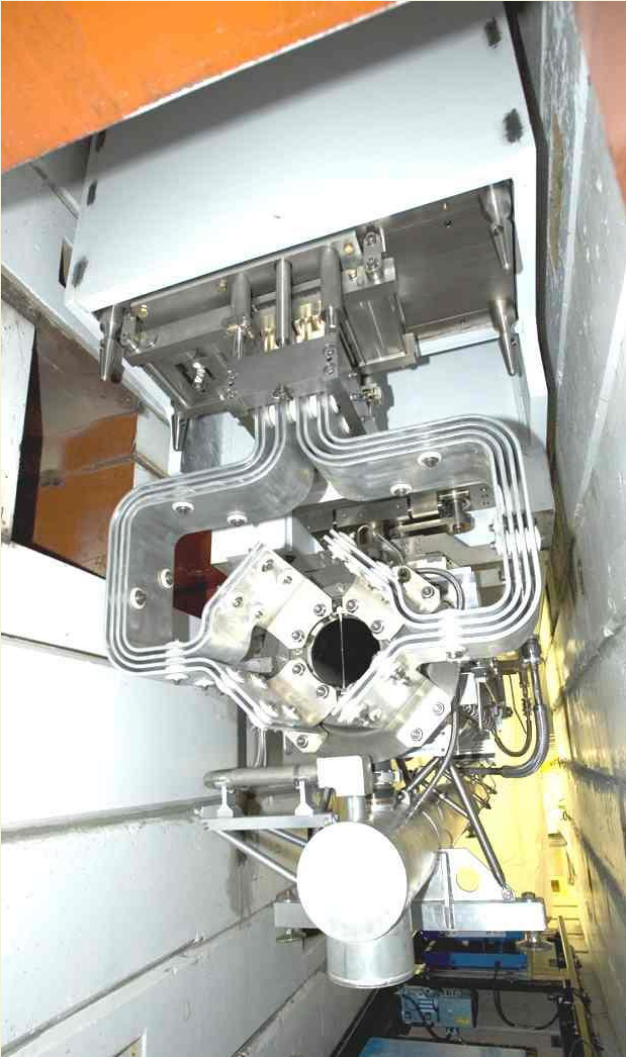
Horn System – 2 Horns

(Shown in work cell, hanging from support module)

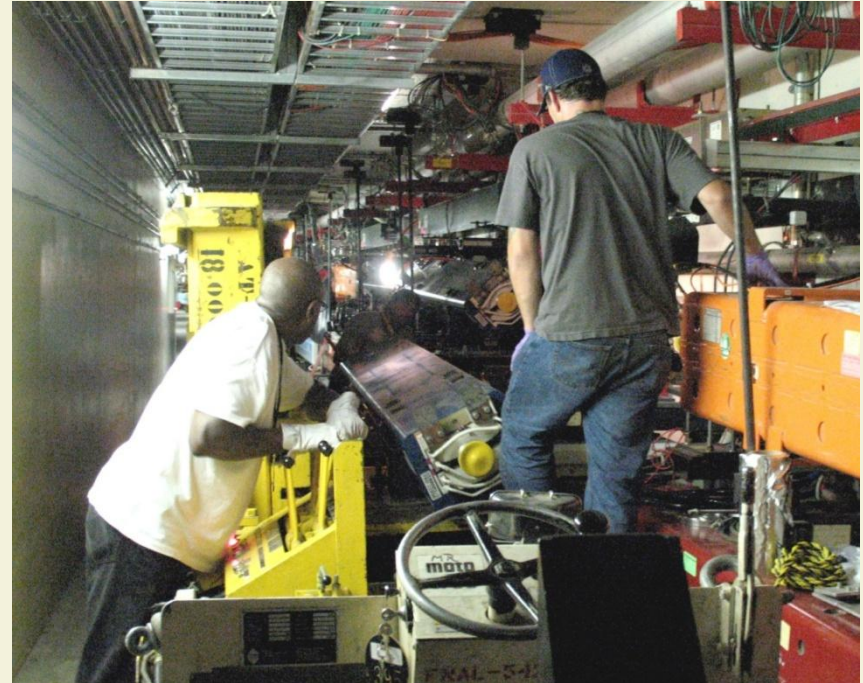
Replacing a primary beam 3 meter
dipole. Ceramic isolator water leak.

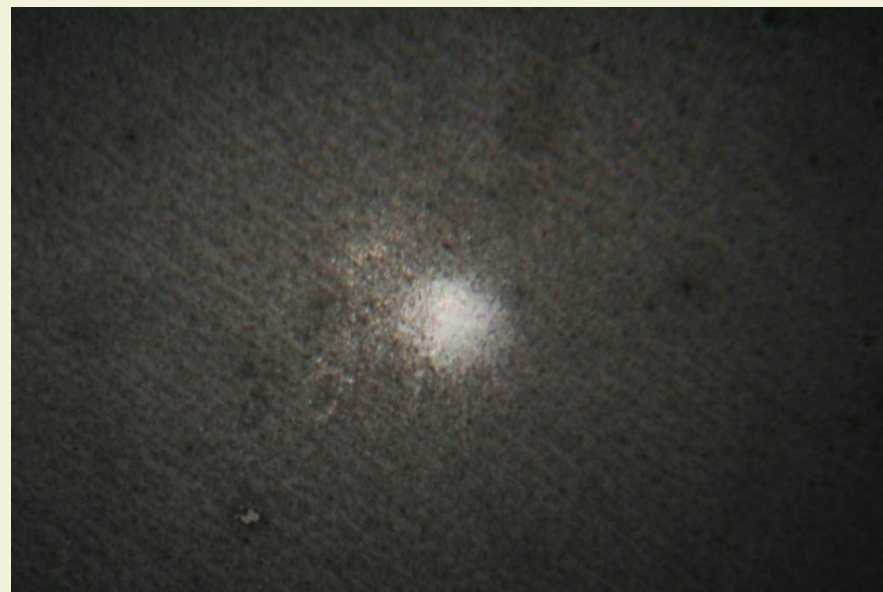
Decay window inspection shows oxidation beam profile. Change from vacuum to He in decay to mitigate pressure on window.

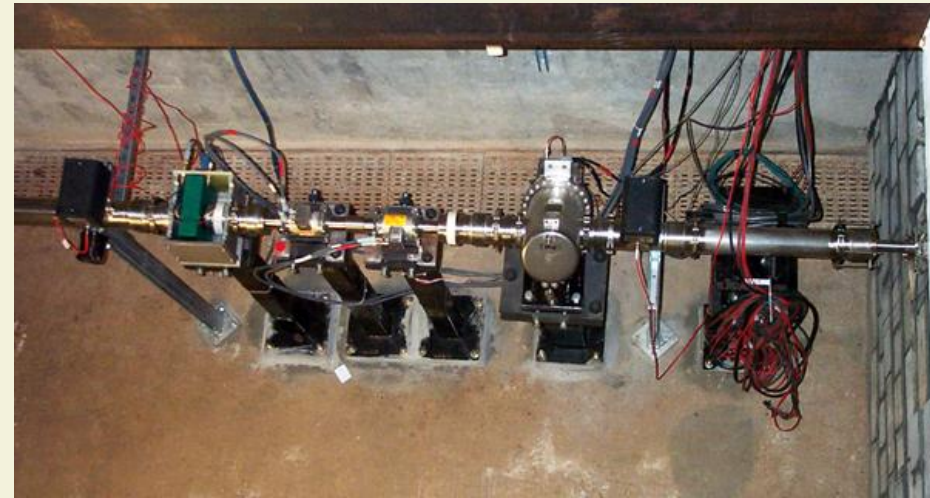
Water backup in PB
Pretarget tunnel.

- Nov – Dec: Replace Horn 2; strip-line failure
- May – PB tunnel flood due to blockage under target hall.
- June – Change target NT02 to NT03. Graphite “depletion”
- June – Add dehumidification to Beam Dump region.

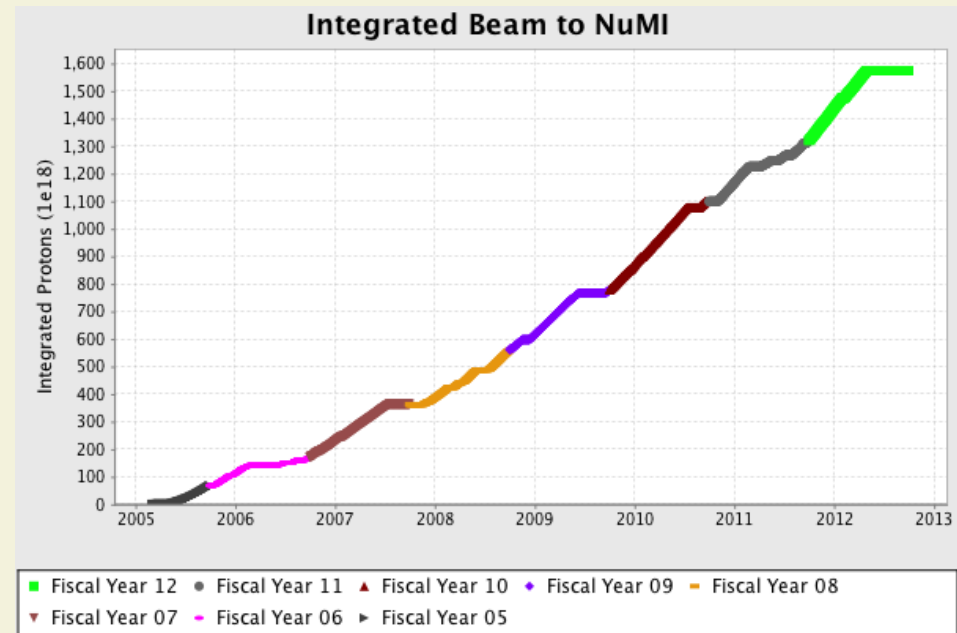
NuMI Downtime Summary

- Primary Beam ~ 1%
- Neutrino beam ~ 13%
- Accelerator (including scheduled M&D) ~ 13%

- **Fraction up since May 2005 ~ 73%**
