T2K Beam Operation Summary

(earthquake recovery and beamline survey)

NBI 2012

Earthquake damage and recovery

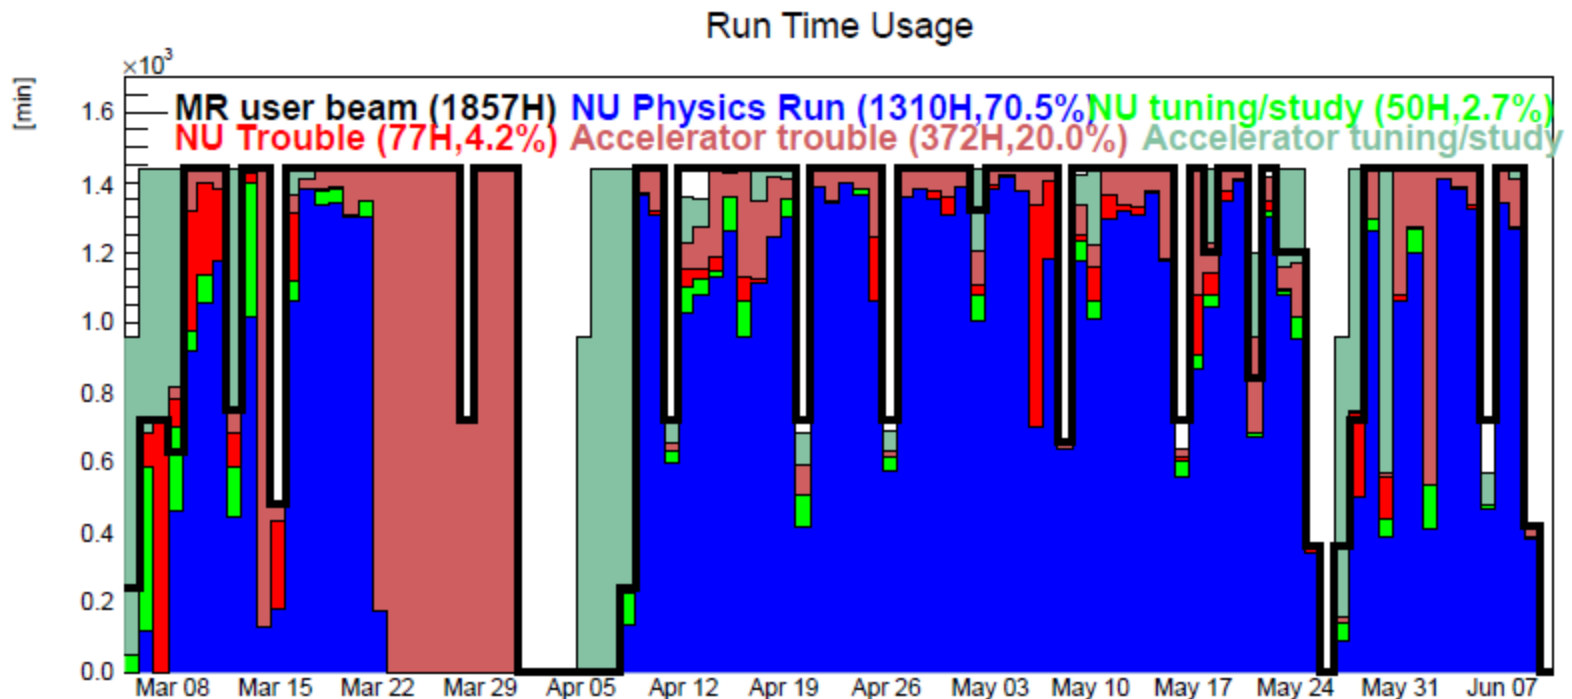
Summary of beam operation in Spring 2012

- Allocated beam to MR user : 1853hrs~80% of total time 97days
- Running efficiency : ~70%=physics run(1310h)/allocated(1853h)
- Acc. trouble ~20% : LINAC klystron PS down, MR injection kicker down, MR BM down, FX kicker down, high radiation in MR machine room limited the beam power
- Nu trouble ~4.2% : horn PS down, cryo. of magnet stopped due to a thunder storm, horn cooling water's quality deteriorated due to air contamination and intense beam → performed ion exchange of the cooling water

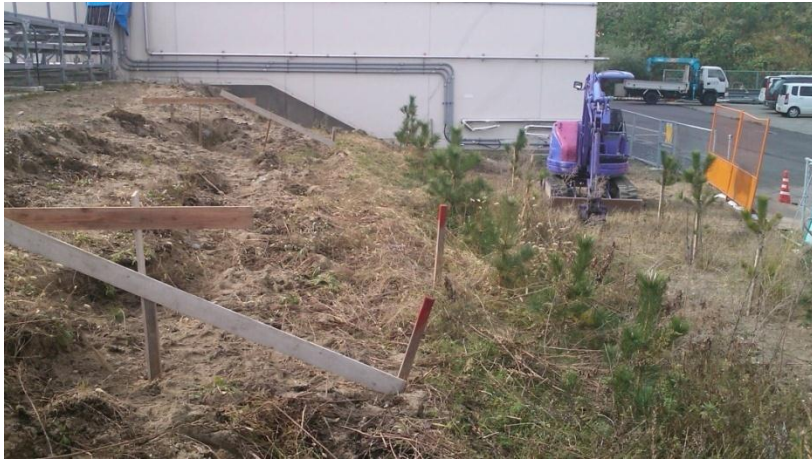
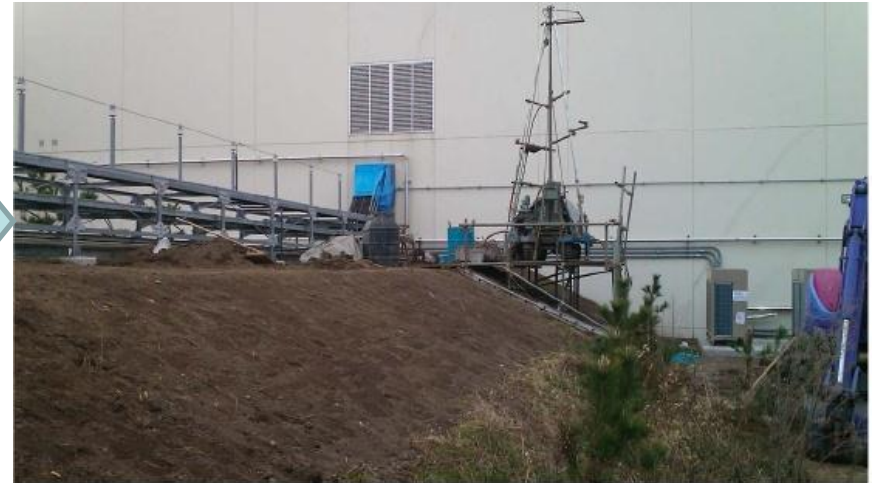
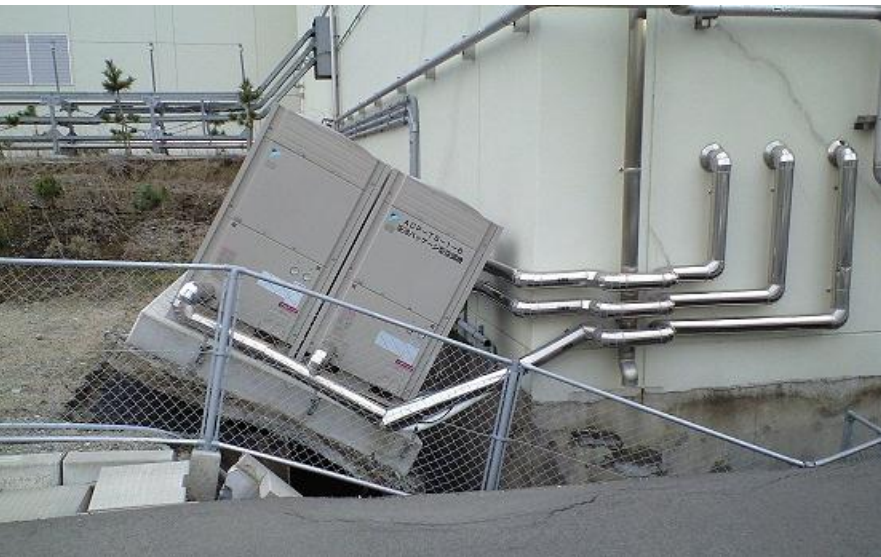
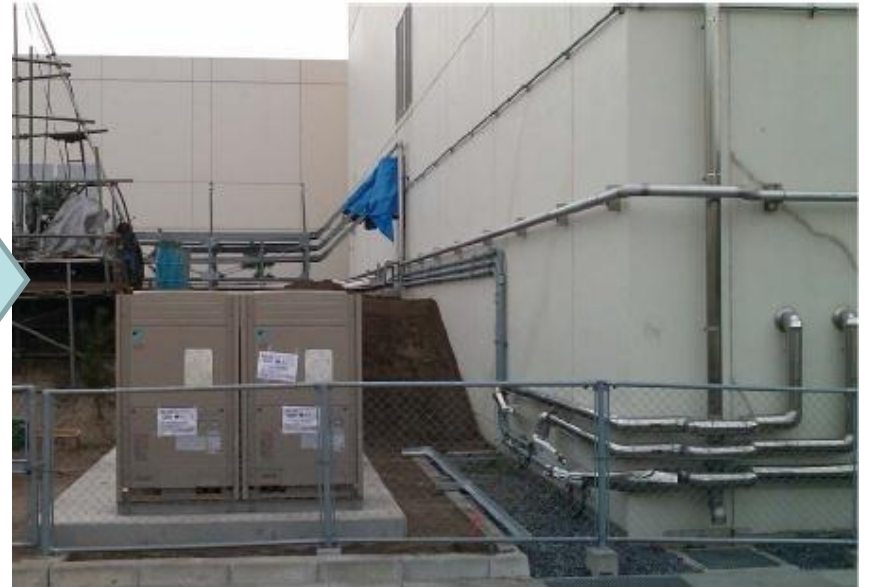
Recovery around Target Station

- The earthquake occurred on Mar. 11, 2011
- Large displacement everywhere in J-PARC
 - Beam-line components were displaced
- Ground collapse at some places
- Cracks in buildings and tunnels
 - Cracks in the MR tunnel resulted in a water leak and some of cables and monitors were submerged
- Electricity, network, cranes, air conditioning, ventilation, cooling water and drainage stopped or got damaged
- Everything necessary for beam operation were recovered before the scheduled beam on Dec. 24, 2011

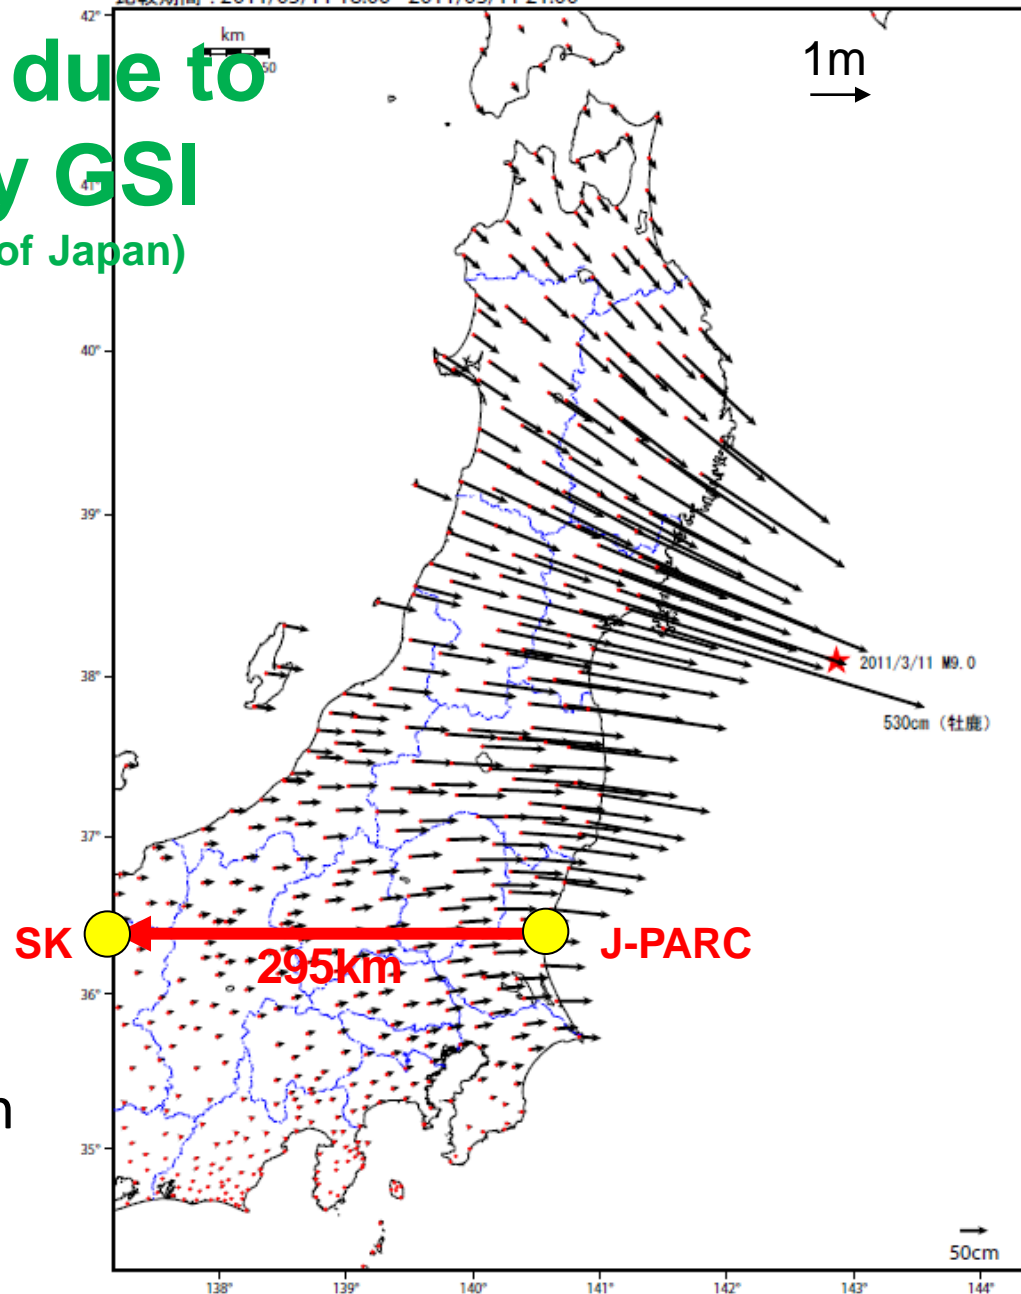
Displacement data due to the earthquake by GSI

Most concern was the direction and baseline change.

We performed a long-baseline GPS survey.

Direction change < 0.001 mrad

Distance change = +0.9m

Effect of these changes on the oscillation analysis is negligible.

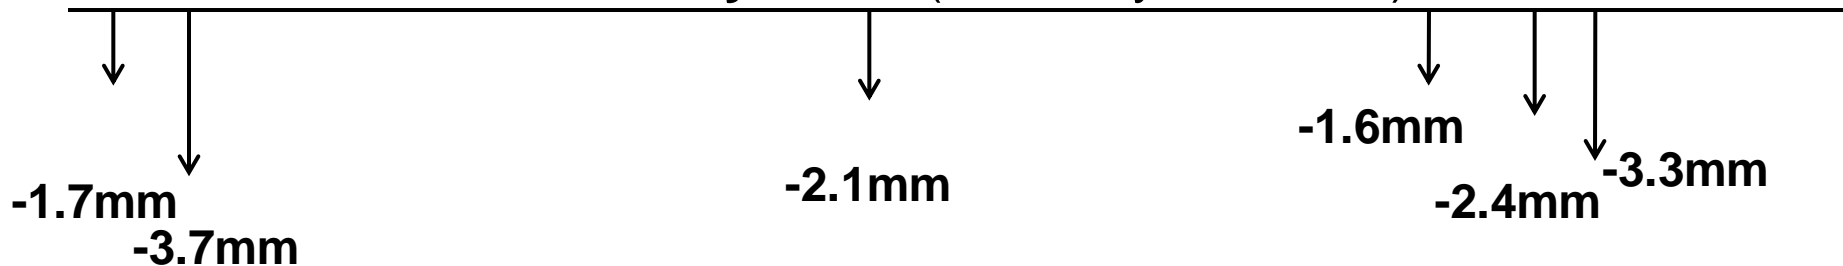
Level-survey result (accuracy is $\pm 1\text{mm}$)

Relative alignment is OK for the experiment

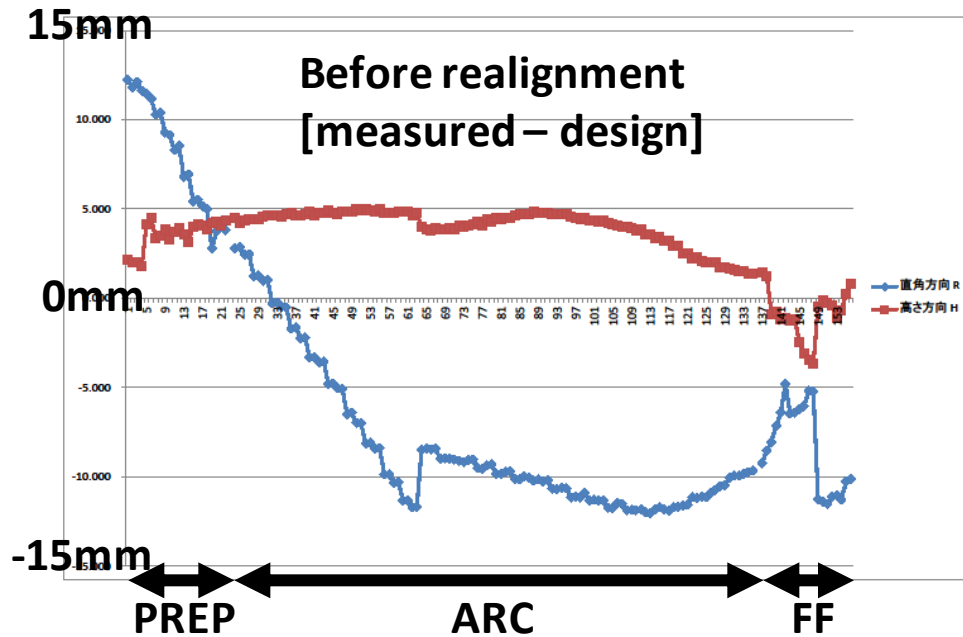
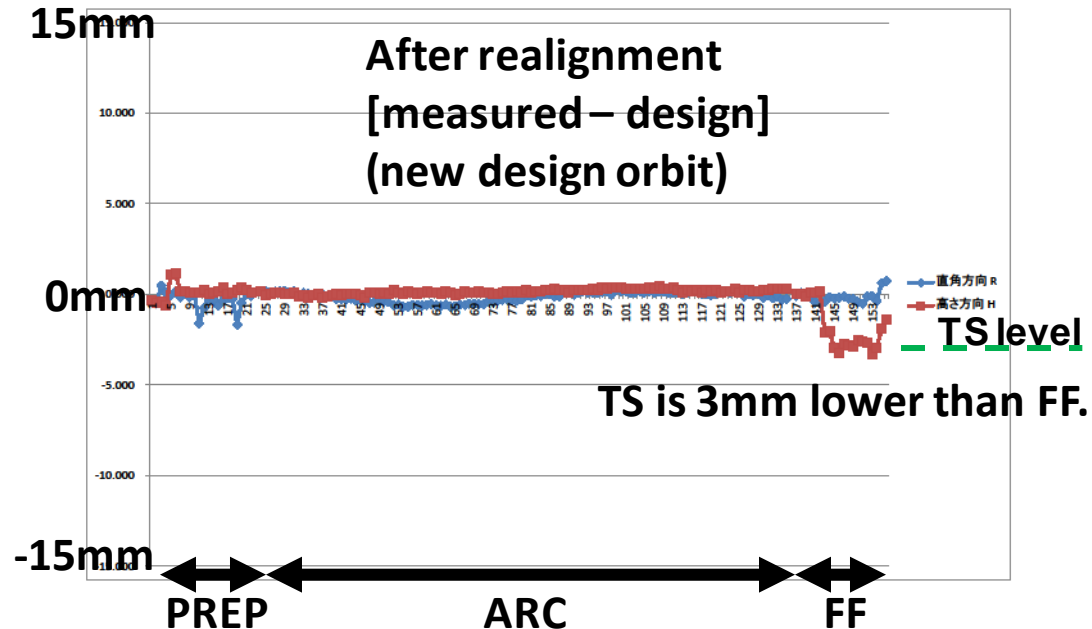
Primary-beamline magnets were realigned

--- ΔR :horizontal direction
--- ΔH :height

Realignment was done based on the May 2011 survey results. The beam orbit was also redesigned.

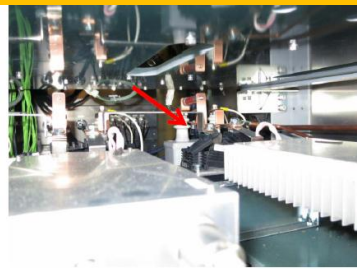
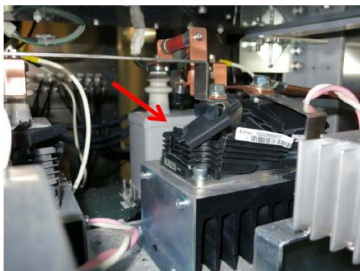
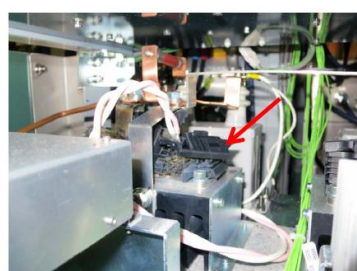
Broken IGBTs

- On Dec. 22, during final operation test, horn power supply was broken
- Several IGBTs to switch charging capacitors were burst
- We changed to the old power supply, which had been used for K2K and at beginning of T2K
