Improved Operation of ISAC RFQ

TRIUMF, CANADA

Improvements of RFQ Operation

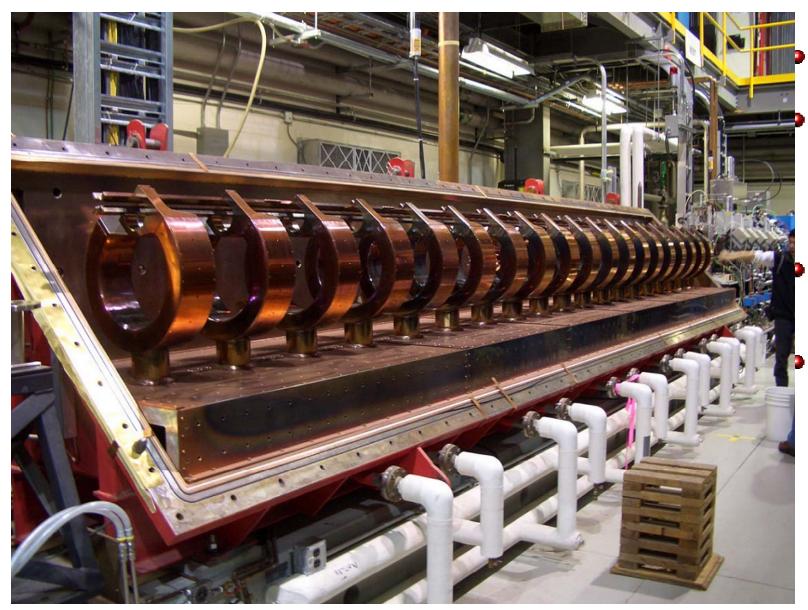
35 MHz CW mode Vane-shaped rods, 19 rings space 40 cm apart, 8m long Max. intervane voltage is 74 KV accelerates ions A/q up to 30 from 2KeV/u ~ 150 KeV/u

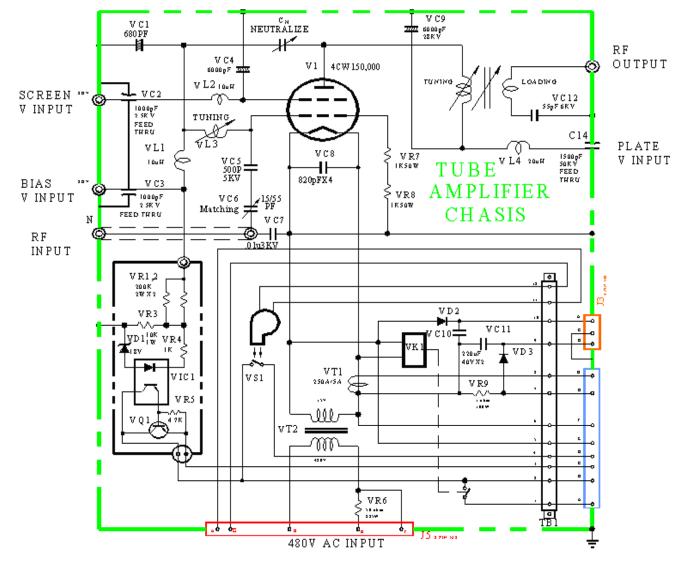
RFQ Power Amplifier Schematic

- 4CW150,000 Tetrode Gain=23dB
- Grounded cathode, grid driving, solid state driver power: 400 W, and 1000W in pulse conditioning

•
$$V_{-Plt} = 17 \text{ KV},$$

$I_{-Plt} = 16 \text{ A};$
 $V_{-scrn} = 1000 \text{ V};$
 $V_{-Bias} = -450 \text{ V};$
 $V_{-Filament} = 12.5 \text{ V},$
 $I_{-Filament} = 210 \text{ A}$

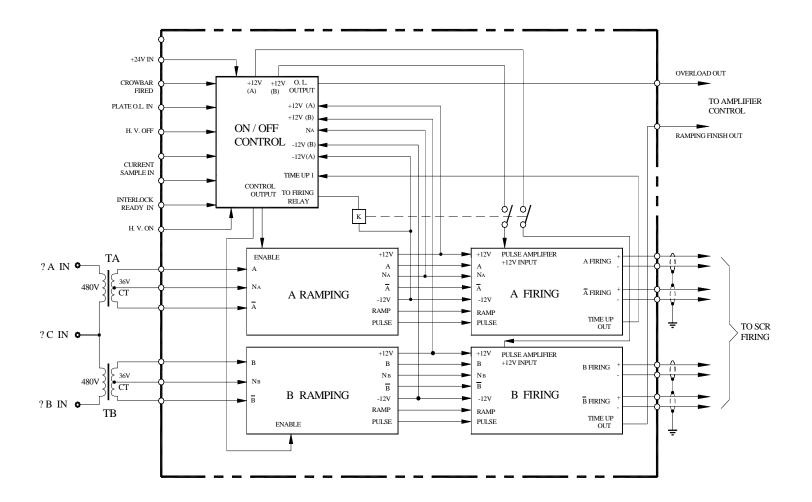
H-V SOFT START BLOCK DIAGRAM

- Implementation of new ramping circuit for smooth start up of the H-V power supply (hard start in original design)
- Reduced inrush current (limit setting @ 400 A) while turn on the plate voltage (hard start inrush current > 8000 amperes)
- Slow voltage rise to prevent high inrush currents and very fast cut off (8 ms compared to 24 ms in the mechanical switch)
- Mechanic switcher reliable now (once failure)
- Much less trips for switch gear (very tough for operations before). Turn off H-V, keep mechanic switcher on while overload

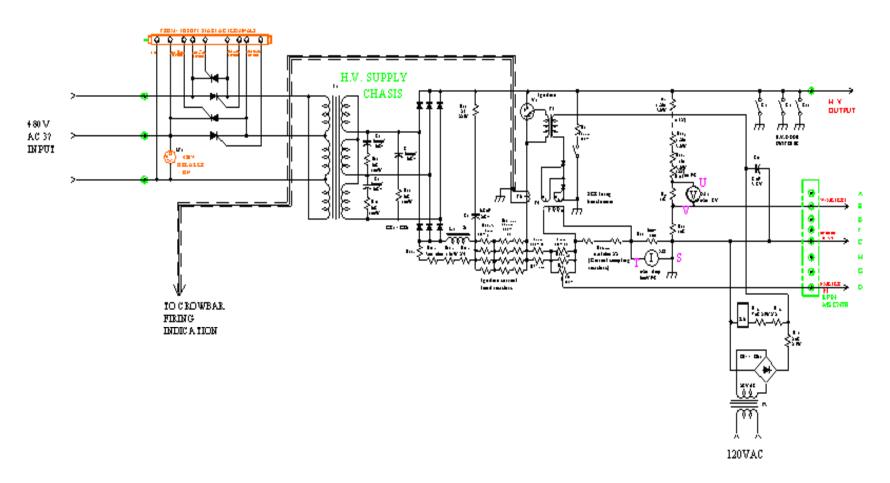
H-V Crowbar Circuit Schematic

- Frequently failures of the spark gap (PerkinElmer's Mini-Triggered Spark Gaps model GP-486) brought RFQ a lot beam down time. Last one worked deficiency only a year
- 30 Joules dump to the spark gap while crowbar fired, that caused it fails often
- A new SCRs trigger circuit and home made transformer to replace the original spark gap (model GP-486 and its matched trigger transformer TR-2189). SCRs can take over 1000 Joules
- Interference to GP-486, but not to SCRs circuits (less crowbar firing now while in pulse high power conditioning).

- Two SCRs (in series) in crowbar fire circuit works reliable over 1 year,
- Most time of the year working at Max. A/q (26~30),
- Much less crowbar happened (from rf interference).

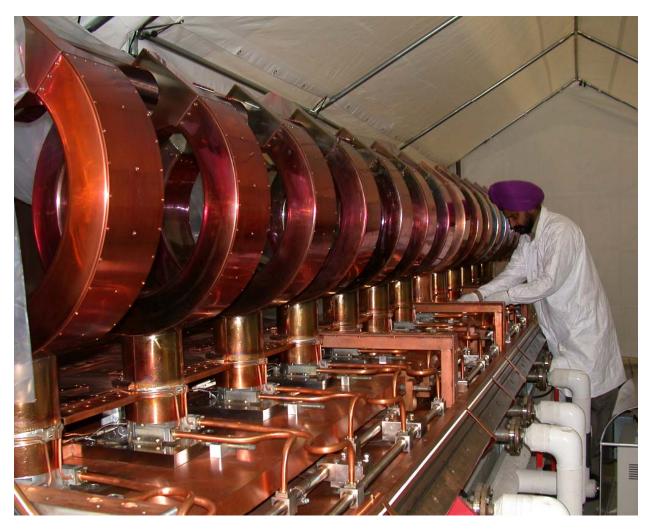
RFQ leaks localization and repairing

- 3 leaking circuits found, Removed RFQ lid
- RFQ was covered for dusty free
- All 6 shrouds were removed to localize the exact leak spots.

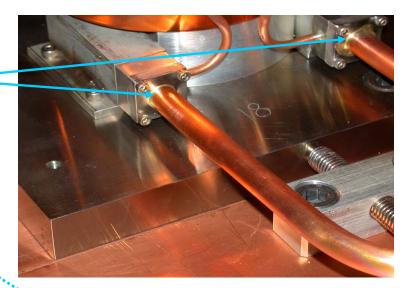
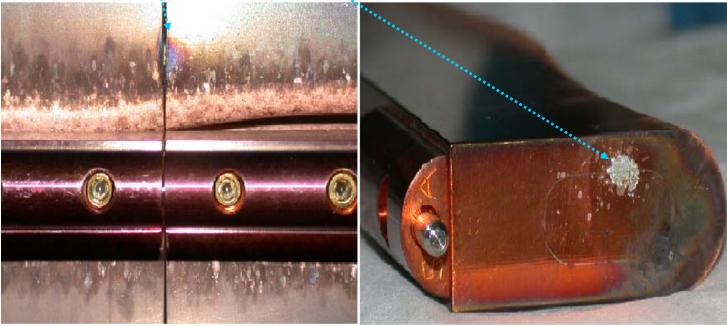
Electrode and Brazed joints leaks

- leaks at cooling supply and return brazed joints (in 5 the detachable lines)
- Leak in electrode

The water leaks due to manufacturing issues (aggressive soldering flux)

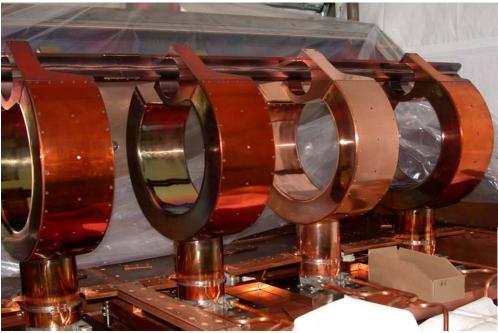
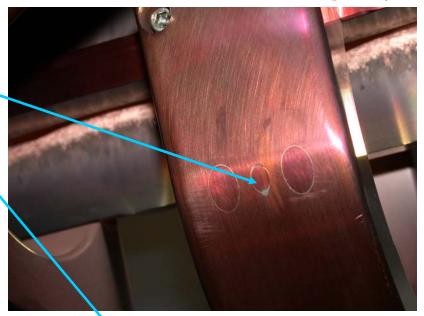
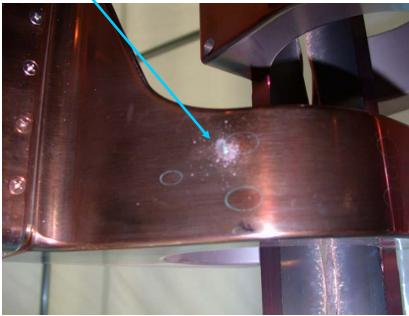
Rings #8 and #18 replaced

- Plugs at the claws leaking in rings #8 & #18
- Two new rings replaced

All leaks are associated with manufacturing process deficiencies (aggressive soldering flux had been eliminated from manufacturing in 2002

One new ring installed

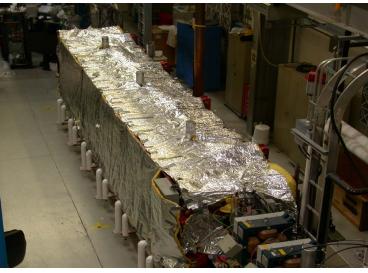
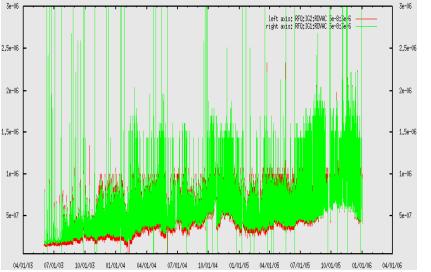
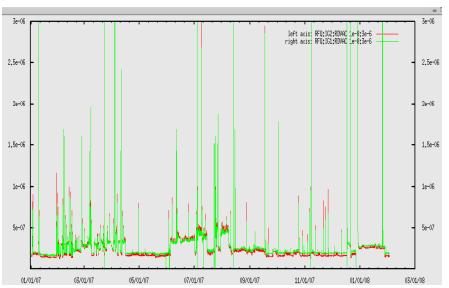
Vacuum improvement after leak repairing

Baking RFQ at 65 degrees for 60 hr.s

- All Turbo pumps were equipped with protective RF shield
- Installed extra cryo-pump
- Baking RFQ over weekend
- Vacuum pressure 1.8x 10⁻⁷ Torr
 Max. voltage after rf conditioning (now 1.5 x 10⁻⁷ Torr)

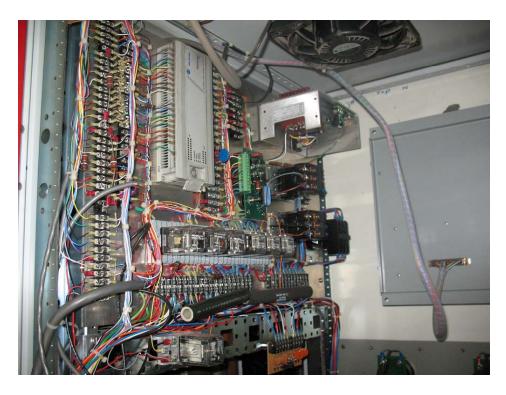
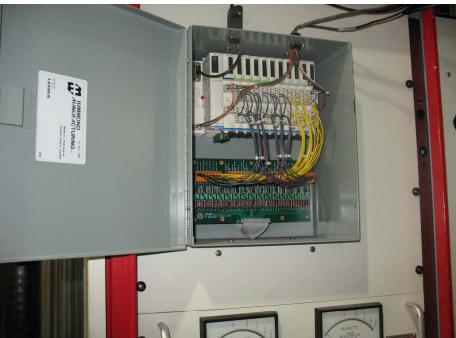
RFQ Amplifier Remote Control

- Upgrading the PLC for the amplifier control
- Various signals of PA/RF preparing and re-wiring
- New PLC code and EPICS for RFQ remote control being done

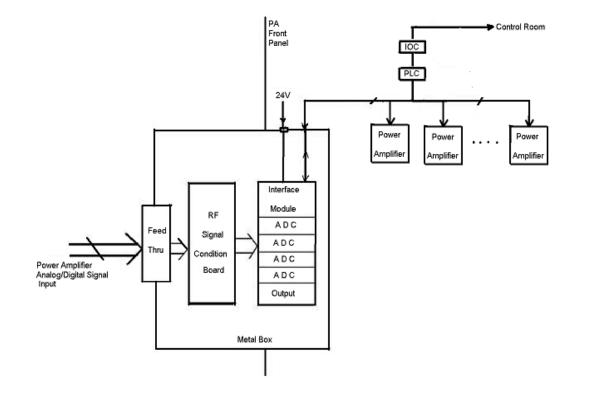
Power Amplifier Control Block Diagram

- All ISAC-I power amplifiers share one PLC
- About 30 signals in each amplifier
- Each amplifier uses 4 ADC, one interface module and one signal condition board

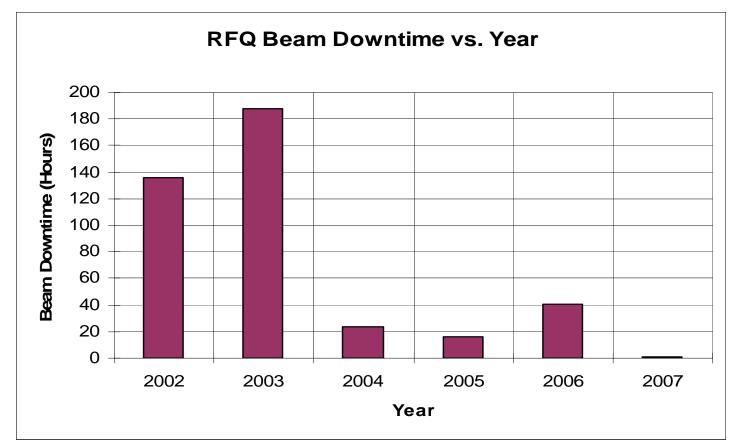
RFQ Beam Down Time Statistic

- Beams with max. mass were accelerated late in 2006 (2007)
- Spark gaps failed and replaced by SCRs at beginning of 2007
