## The ATLAS barrel and end-cap SCT commissioning at CERN

A. Clark, SCT subsystem, ATLAS Collaboration  
6th "Hiroshima" Symposium, Carmel, 11-15 September, 2006

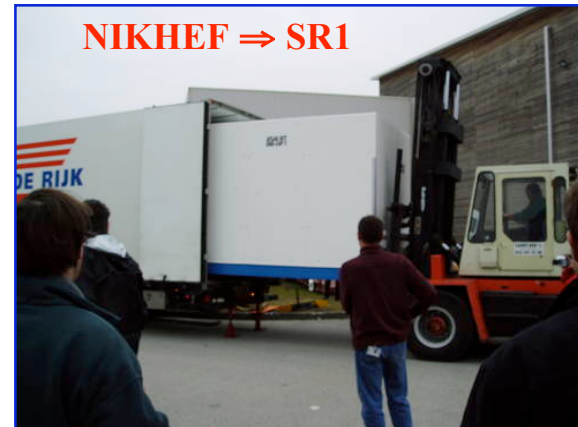
**Transport - lesson - outstanding success**

- a) Environment controlled, air-sprung
- b) Spring suspension, nested containers
- c) Monitor  $x, y$  &  $z$  acceleration, temp, RH%, pressure

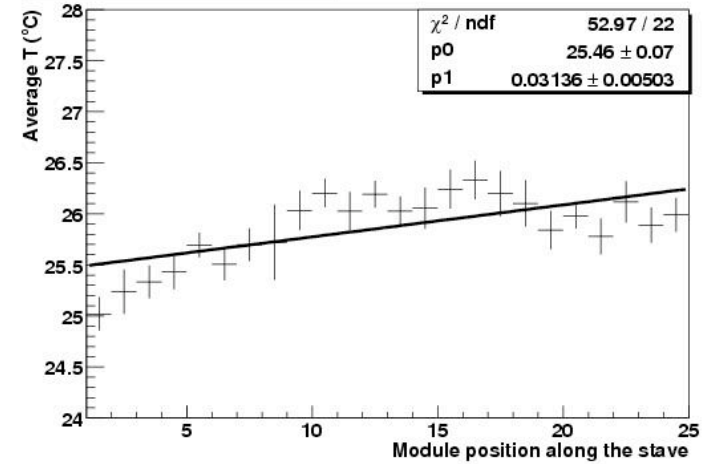
Temperature Profile for B3

B3 temperature profile along stave from entry to exit averaged over all staves.

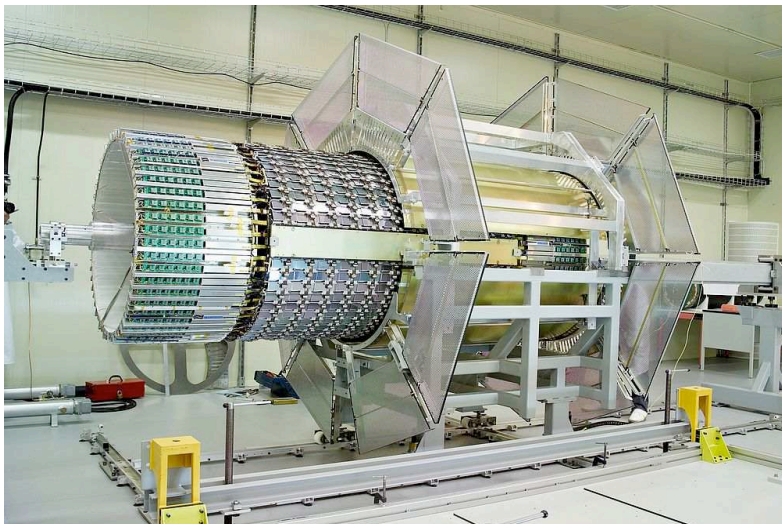
**B6 ⇒ thermal enclosure - 22.7.05**

**B5 ⇒ B6 + thermal enclosure - 12.8.05**

**B4 ⇒ B5 + B6 + thermal enclosure - 06.9.05**

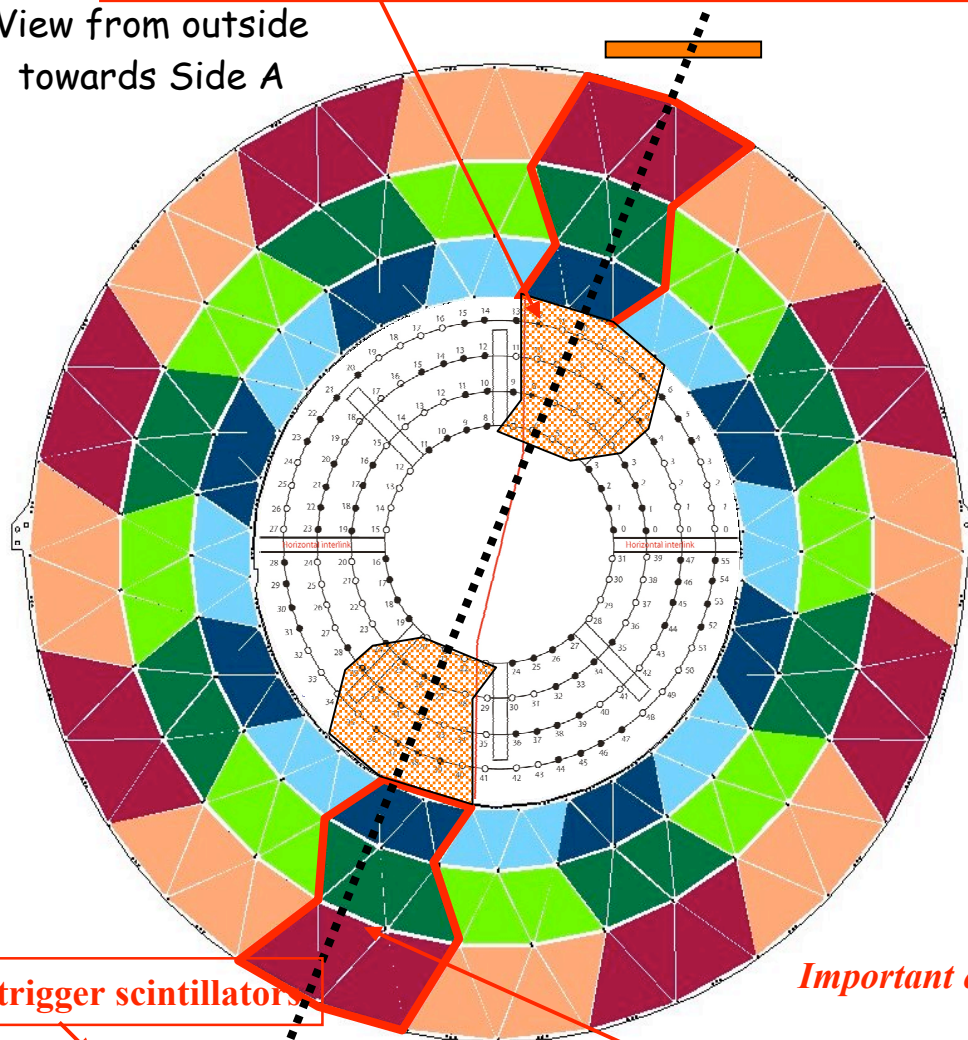
View from outside  
towards Side A

**SCT (468 modules) - readout 12 ROD, 1 TIM, 1 LIP**

**3 trigger scintillators**

**TRT - 2 x ~ 6600 channels (1/8 TRT) 9 ROD readouts**

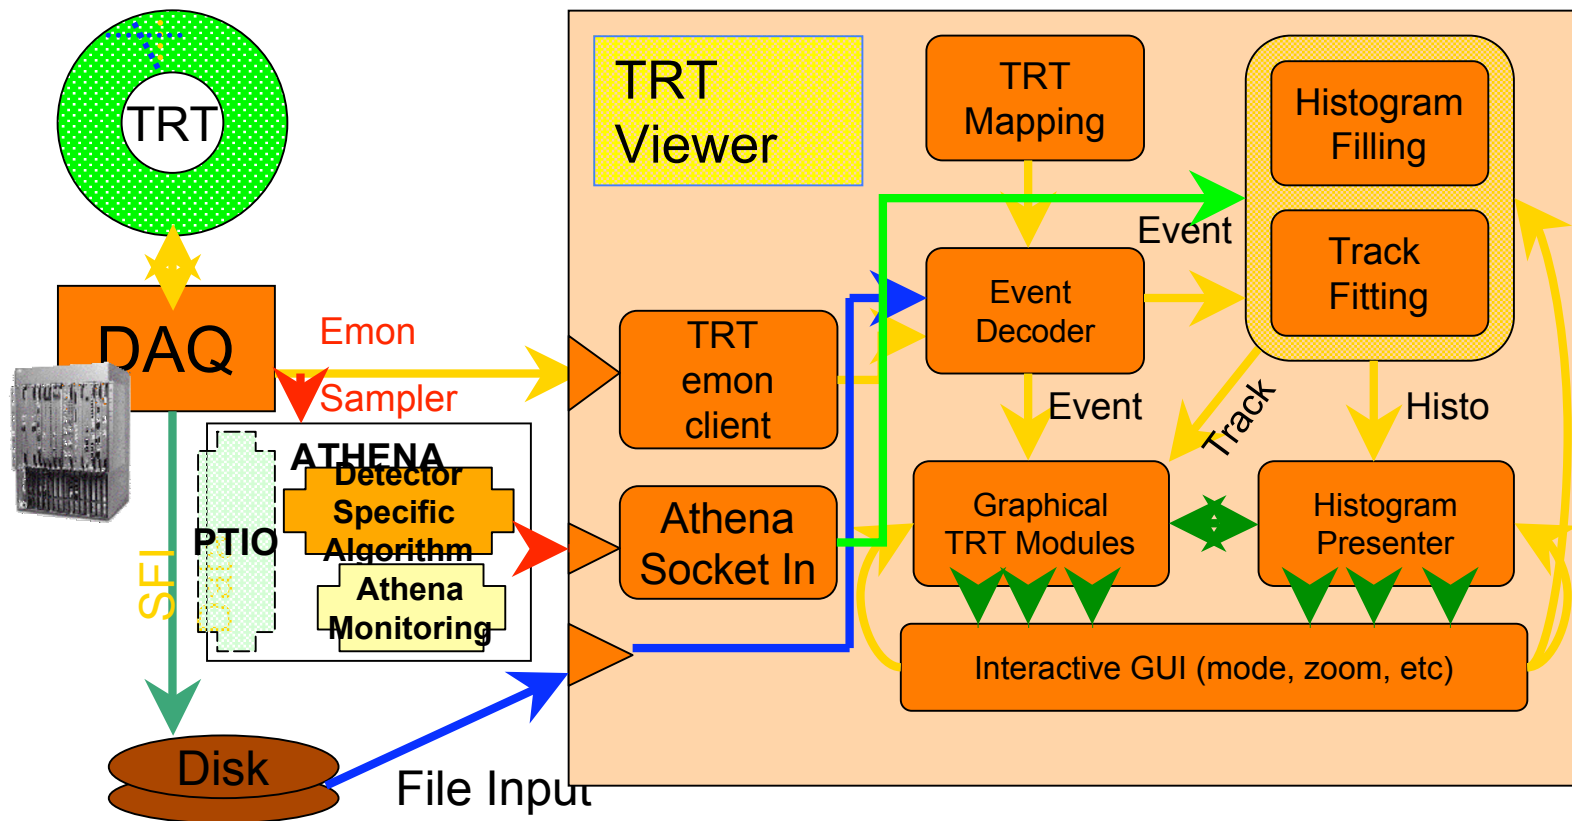
- Detector specific histograms +
- 1) monitor synchronization of LVL1 and BC IDs of different detectors
  - 2) monitor hits for any track collection, calculate residuals etc
  - 3) monitors matching of TRT and SCT segments

Developed for TRT, SCT also inserted

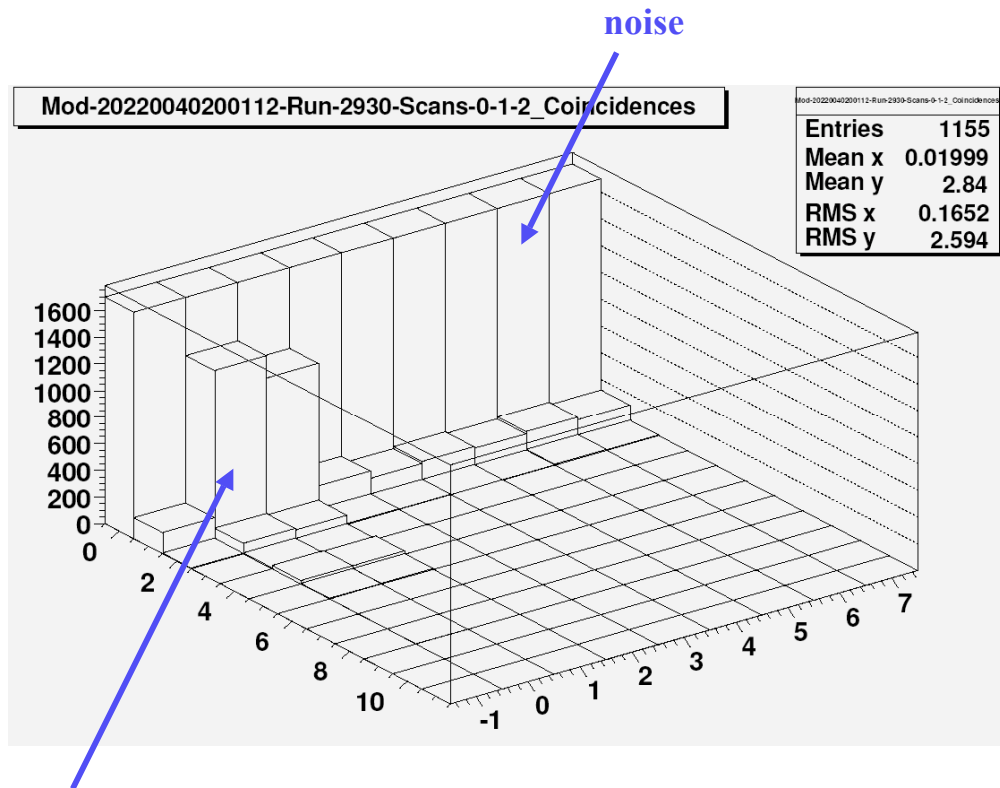
Timing coincidence  
between module sides  
for each module  
(BOC Tx coarse scan (32 bcos))

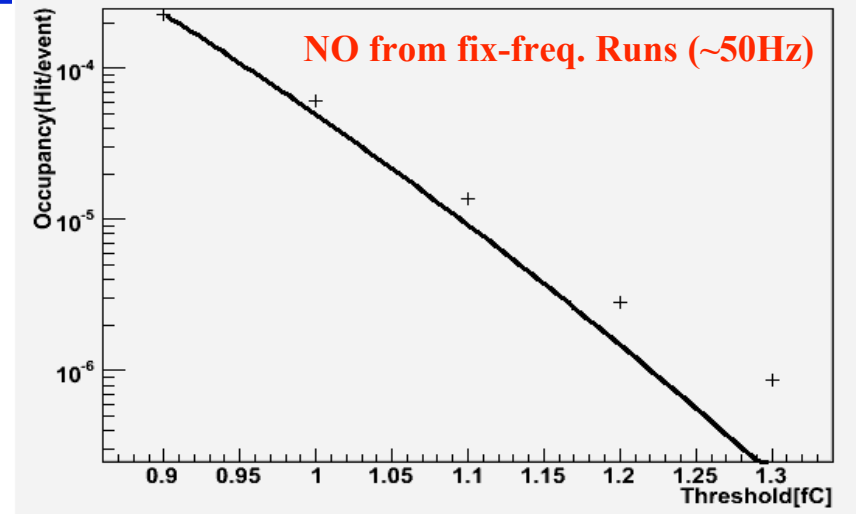
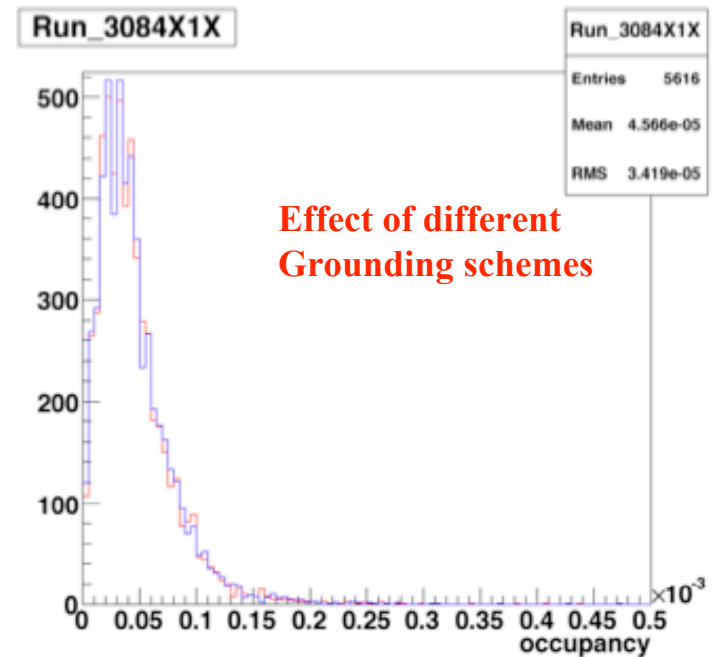
- First full test after 4-barrel assembly
- Number of extra defects found in tested sectors):
  - 4 interrupted LMT lines - repaired
  - 3 of 468 modules with opto anomalies (redundancy, no channels lost)
  - 2 non-readable FE chips (dead Vcsel?)
- **Functional channels ~ 99.8% (+0.03%)**
- Noise threshold and occupancy scans made:
  - with/without TRT
  - as function of trigger rate
  - with/without cooling and heaters
  - with different grounding schemes
  - effect of noise in adjacent time slots
  - Possible common mode effects
- **No evidence of increased noise in any tests**

Run 3102	Top	Bot
B3	$4.56e-5$	$4.14e-5$
B4	$3.41e-5$	$4.03e-5$
B5	$4.17e-5$	$4.27e-5$
B6	$6.63e-5$	$4.95e-5$

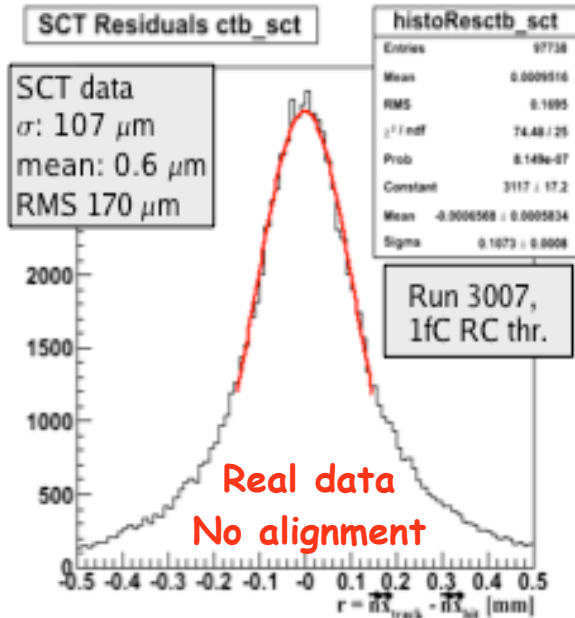
- Perfect alignment:  $\mu \sim 0 \mu\text{m} \Rightarrow \sigma = 55 \mu\text{m}$

modules: 100  $\mu\text{m}$  ( $r\phi$ ,  $z$ ), 500  $\mu\text{m}$   
 Barrels: 100  $\mu\text{m}$  ( $r\phi$ ,  $z$  and  $R$ )

- Overall efficiency > 99% (in spec)
- Resolution better than obtained with the expected level of misalignment
- Alignment studies ongoing - promising results
