Search for Location of Enhanced Field Emission

Y. Higashi, KEK

International Workshop on Vacuum Arcs,
October 1-4, 2012, Albuquerque, USA

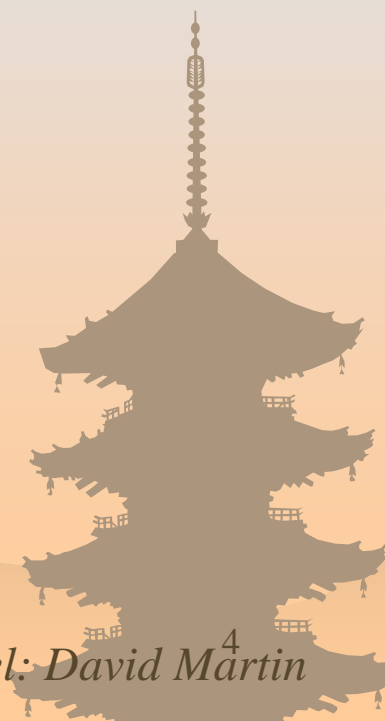
1C-SW-A3.75-T2.6-Cu

Single-Cell SW Structure for High Gradient Test

High shunt impedance structures, $a/\lambda=0.143$

*Solid Model: David Martin*⁴

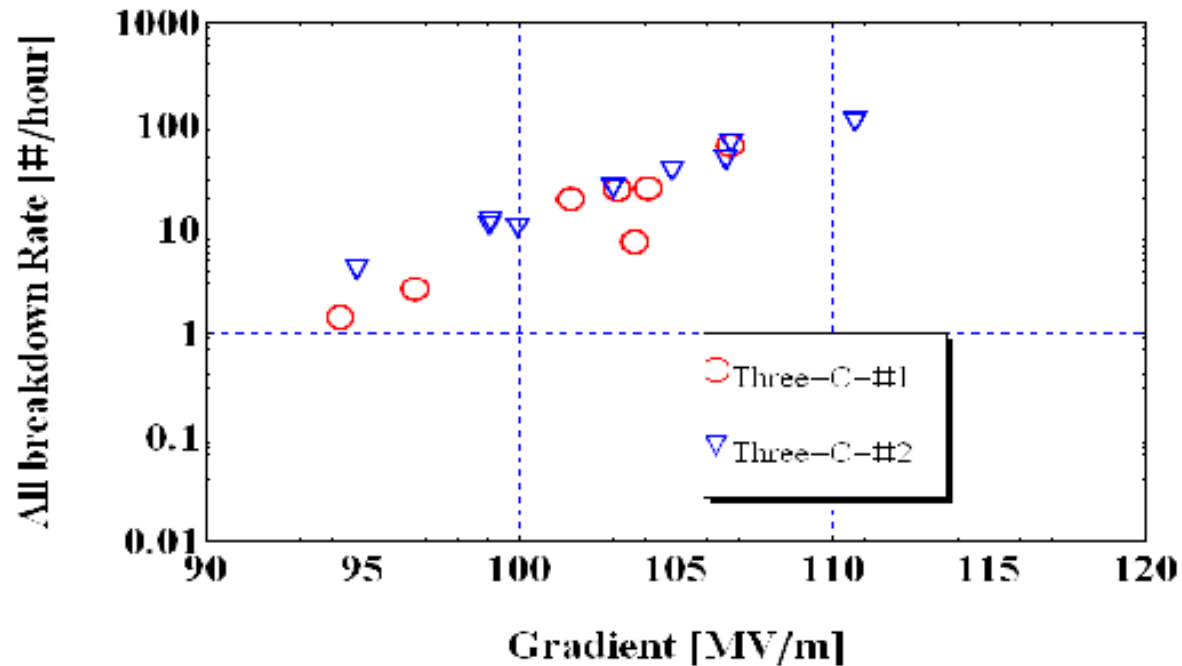
Two structured #1 processed normally and #2 processed similar to superconducting accelerator structures

The near perfect surface processing affected only the processing time. The second structure processed to maximum gradient in a few minutes vs few hours for the normally processed structure.

- ❁ The nearly perfect surface processing affected **only processing time**. Ultra-clean structures conditioned faster than the normally processed structure.

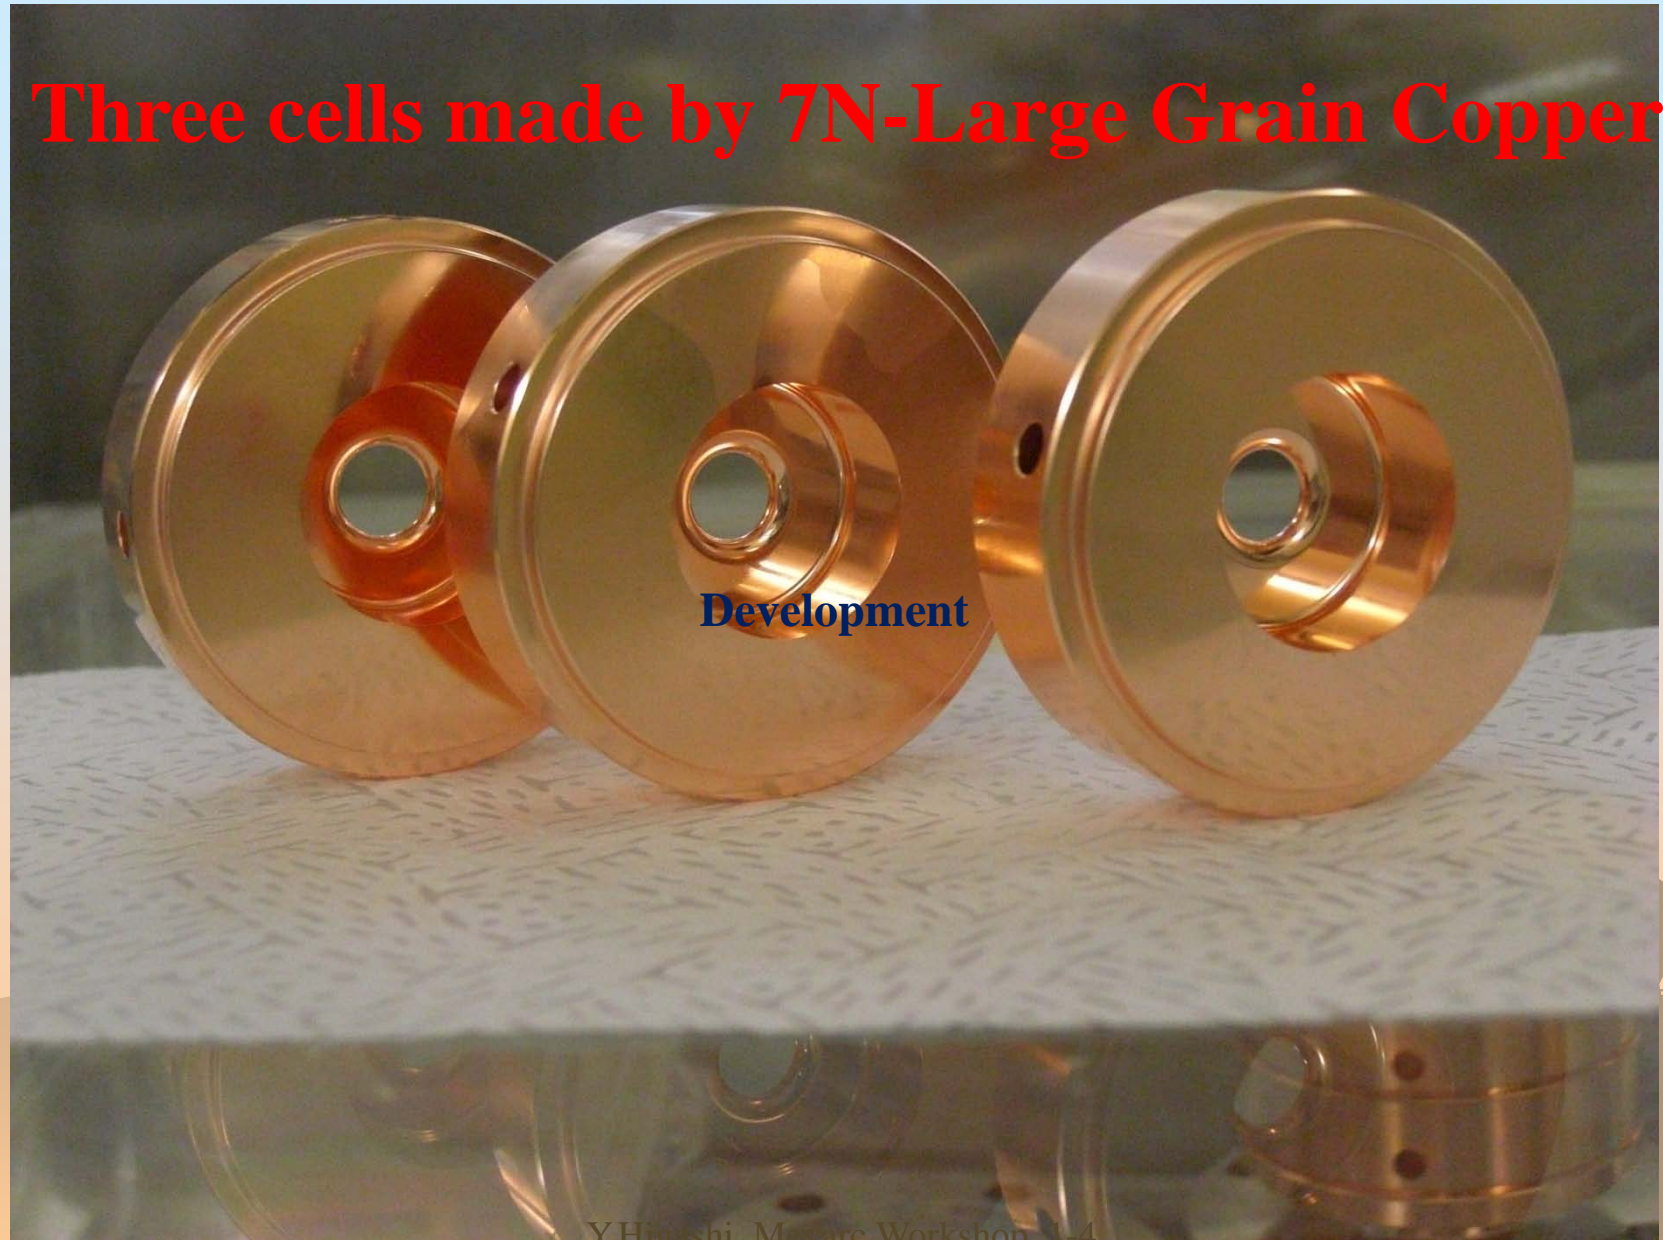
Three cells made by 7N-Large Grain Copper

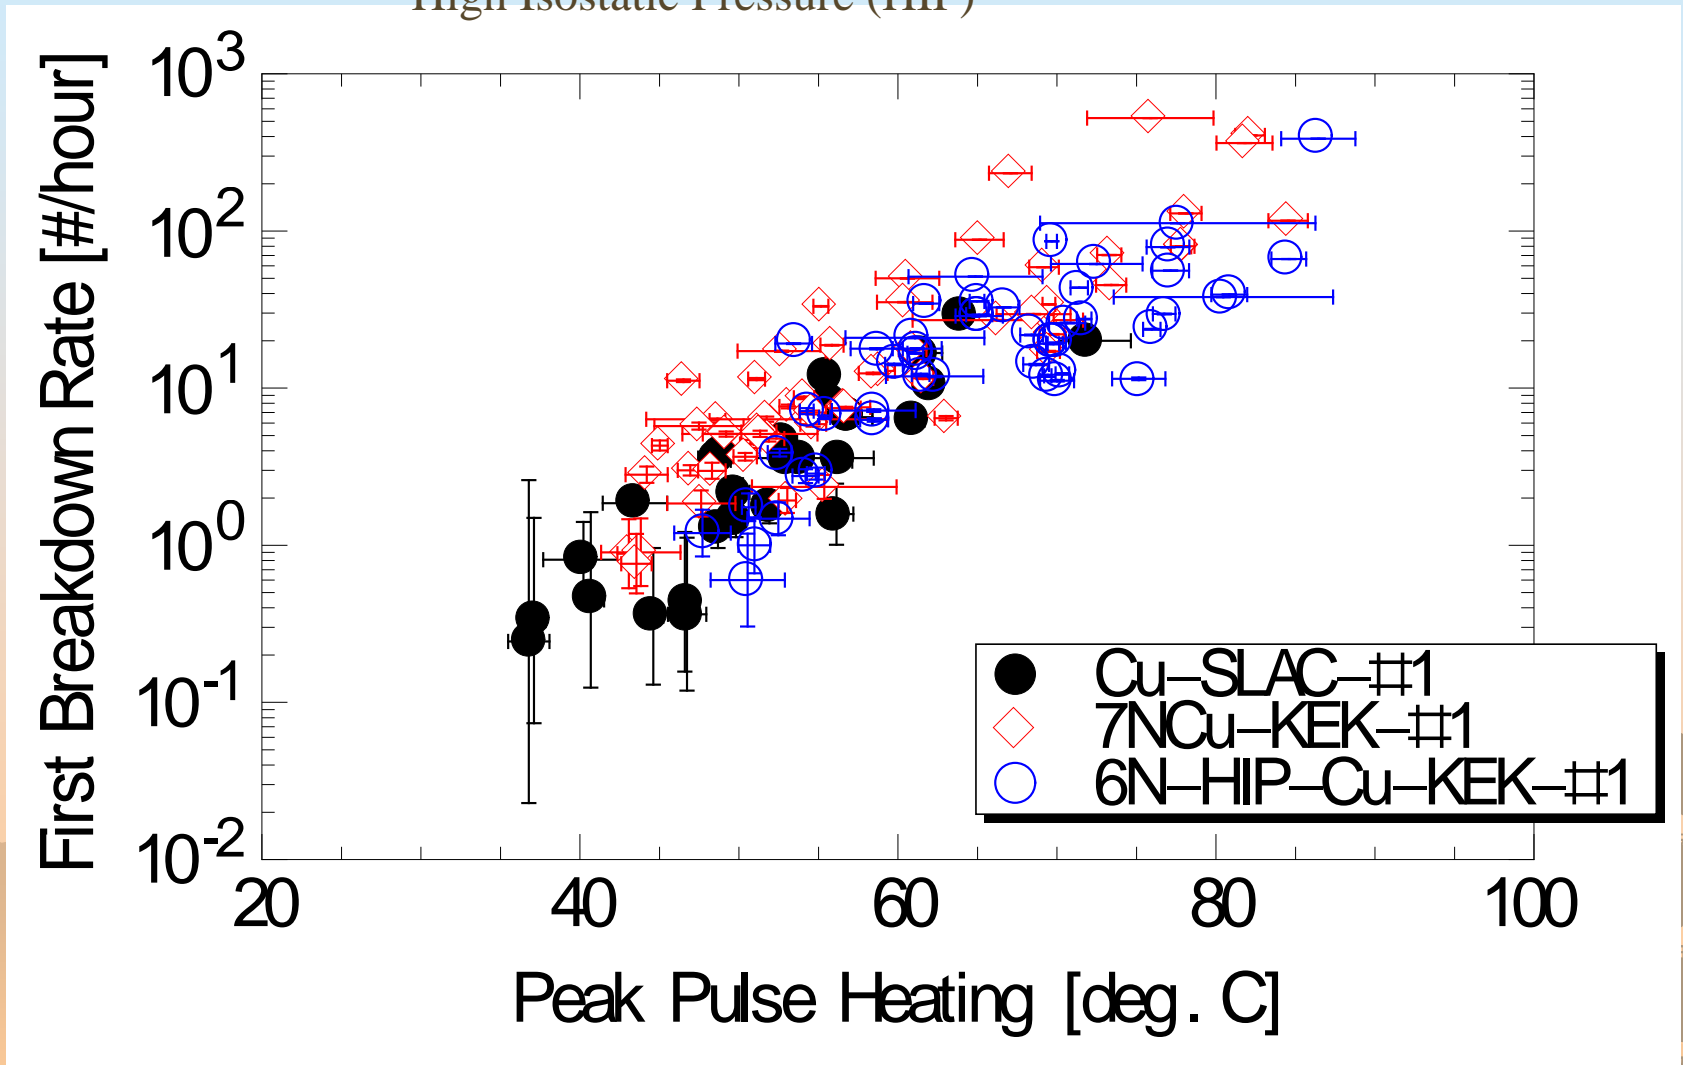
Breakdown rate vs. pulse heating for three A3.75-T2.6 copper structures, one OFC copper, 6N copper treated with HIP, and 7N large grain copper

High Isostatic Pressure (HIP)

- ❁ We compared breakdown rate for three A3.75-T2.6 copper structures, one OFC copper, 6N copper treated with HIP, and 7N large grain copper. But rf breakdown performance **was almost same**.

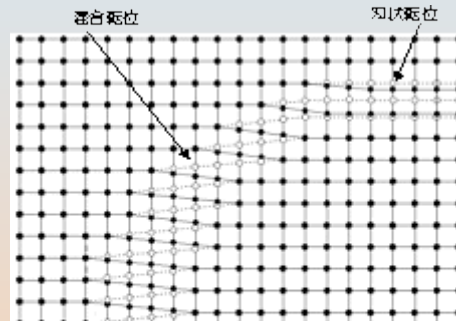
正常な箇所より間隔が広い
正常な箇所より間隔が狭い
転位の芯、中心

Crystal defect density almost the same in 4N, 6N, and 7N copper:

- Dislocation density seems to be $10^6 \sim 10^8 \text{ cm/cm}^3$ even with annealing.
- Distance to dislocation is approximately $1 \sim 10 \mu\text{m}$

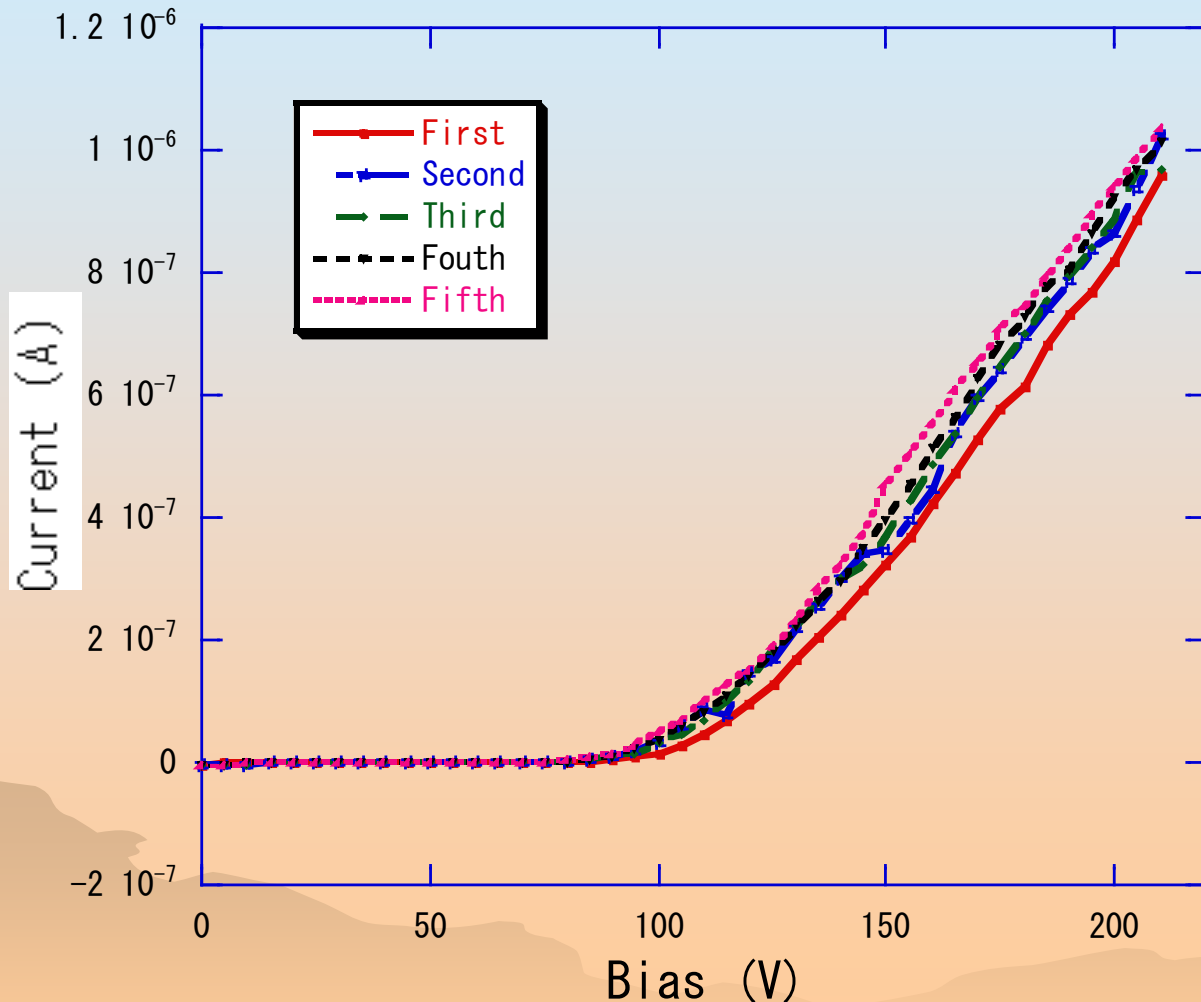
Fowler-Nordheim plots at 35 arbitrary points

Each of the 7 frame includes data for 5 different locations

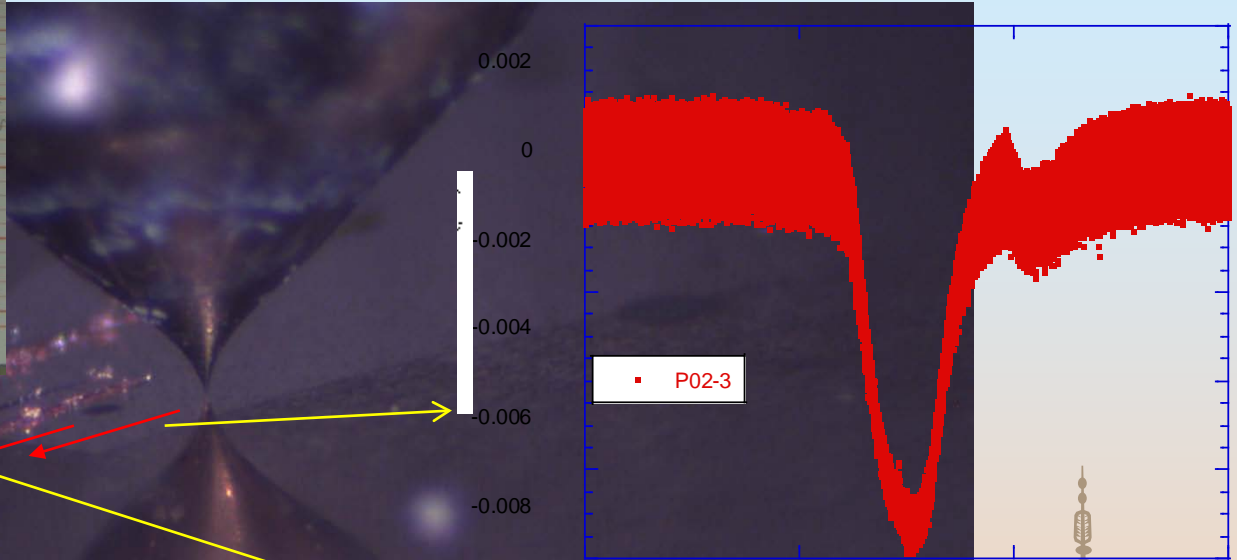
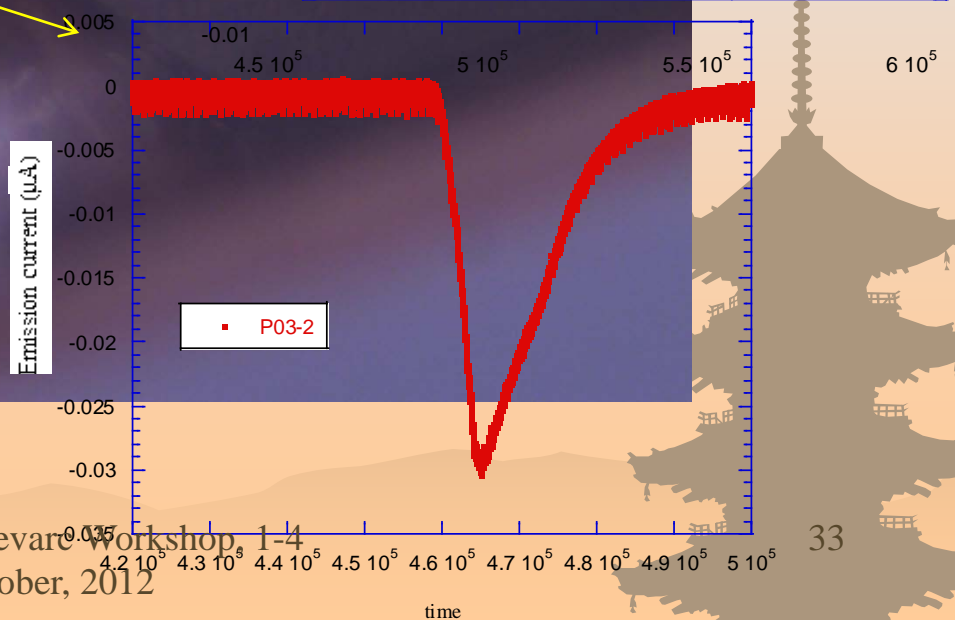
Enhancement of field emission on a grain boundary

- ❁ We observed enhancement of field emission on a grain boundary of the ultra-pure 7N-LG copper
- ❁ We were able to reproducibly measure enhancement points on surface of standard copper

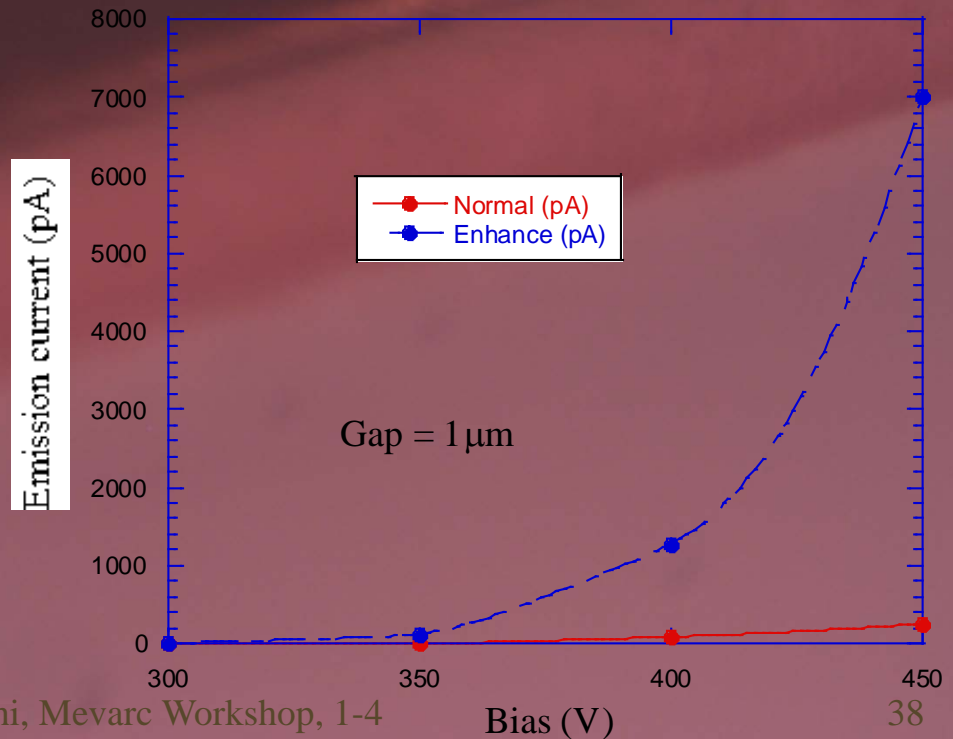
Comparison of currents from enhanced and "base" field emission
