Progress on the Low Resistance Strip Sensors and Slim Edges Combined RD50 Experiment

CNM (Barcelona), SCIPP (Santa Cruz), IFIC (Valencia)

June 4th, 2013

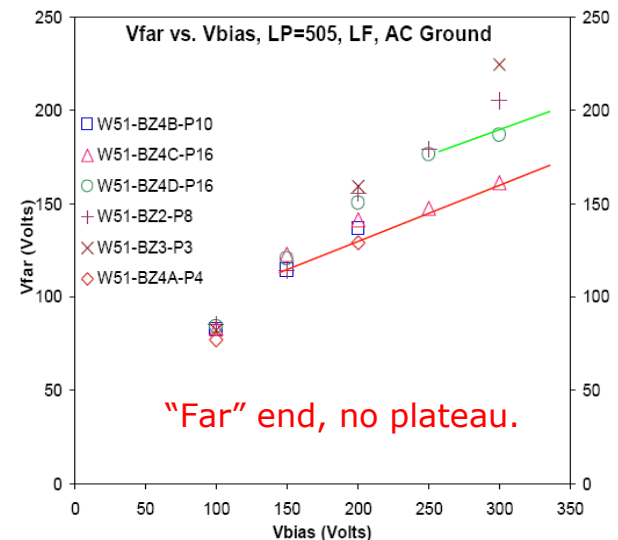
- In the scenario of a beam loss there is a large charge deposition in the sensor bulk and coupling capacitors can get damaged.
- Punch-Through Protection (PTP) structures used at strip end to develop low impedance to the bias line and evacuate the charge.
- Placement of the resistor between the implant and bias rail (“transistor effect”).
- Measurements with a large charge injected by a laser pulse showed that the strips can still be damaged.
- The **implant resistance** effectively isolates the “far” end of the strip from the PTP structure leading to the large voltages

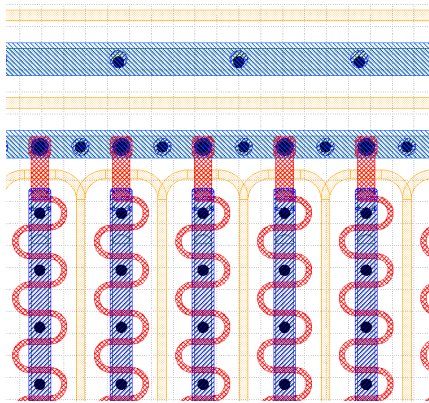
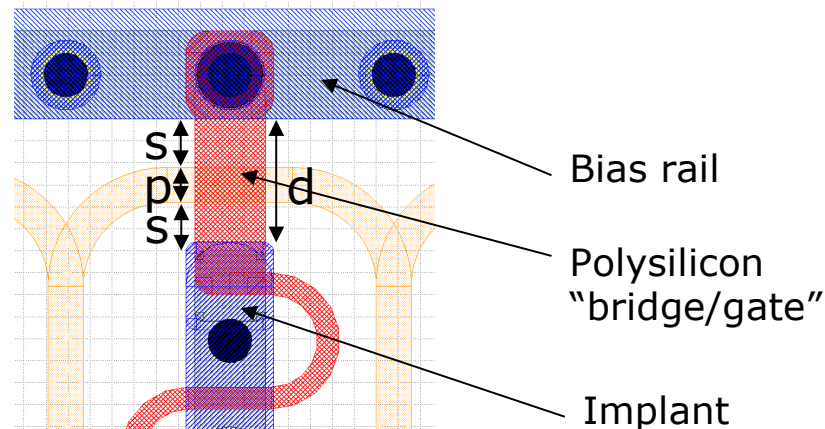
- Reduce implant distance to bias ring to favor punch-through effect at low voltages
 - ❑ Not tried before at CNM
 - ❑ Very dependent on surface effects (difficult to simulate)
- Poly resistor between the implant and bias rail (“transistor effect”)
- Compromise between Punch-Through effect and early breakdown
- Design of experiments varying $p, s \rightarrow d$

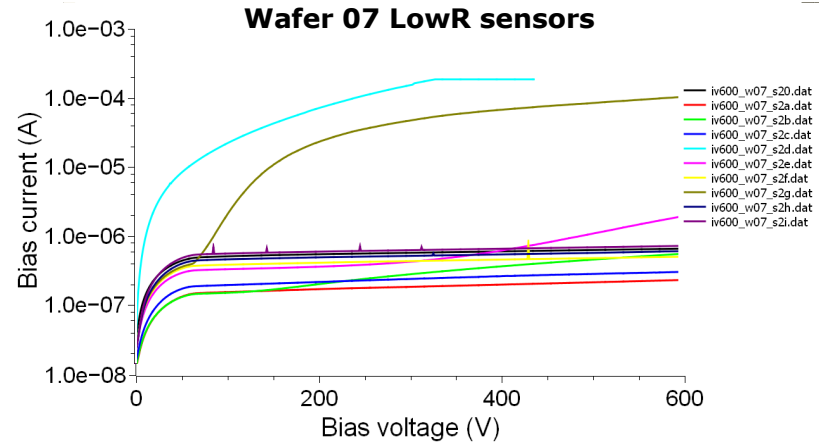
- For IV measurements, sensors were biased from 0 V to 600 V in 1 V steps. Current compliance equal to 200 μ A was set.
- Both standard and LowR sensor show similar behavior.

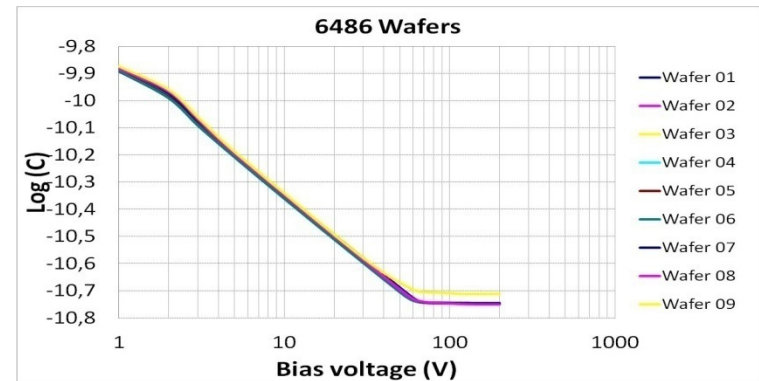
- For CV measurements, pad diodes placed on the wafer were biased from 0 V to 200 V in 1 V steps.
- A probe contacted to the active area and connected to a LCR meter (500 mV @ 10 KHz) to obtain the capacitance.

$$V_{FD} = 61,5 \text{ V} \pm 2 \text{ V}$$

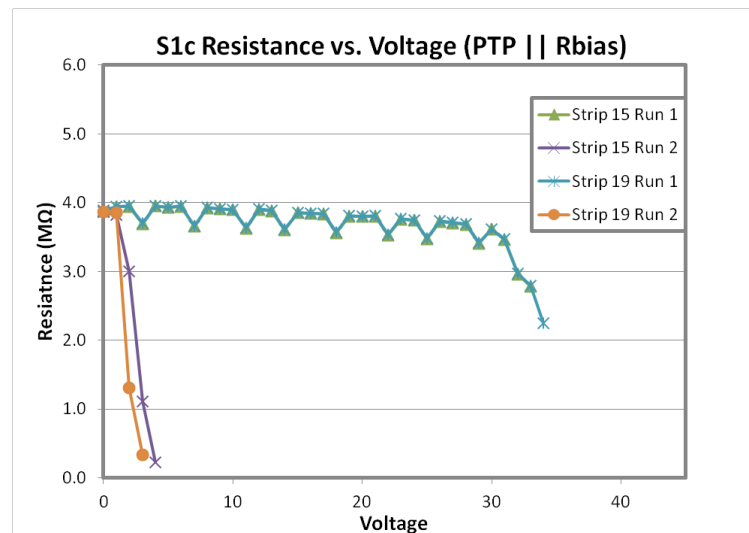
- S1a (16 μm PTP distance) was chosen for the first test.
- The 1st measurement has some scatter, but 2nd and 3rd strips are very consistent, with the transition voltage of about 35 V. In all 3 cases the 2nd run had vastly different transition voltage.
- S1c (20 μm PTP distance) chosen s1c for the 2nd test.
- This test is also different in how the voltage was removed after the scan. During the 1st scan, we cut-off the voltage supply abruptly (a standard procedure). Thinking that this might cause problems, we removed the voltage gradually after the scan, at the rate of 1V/sec.

- The transition voltage indicated in the 2nd test is at about the same value of 35 V. This indicates that the transition is due to oxide breaking rather than the PTP turn-on.

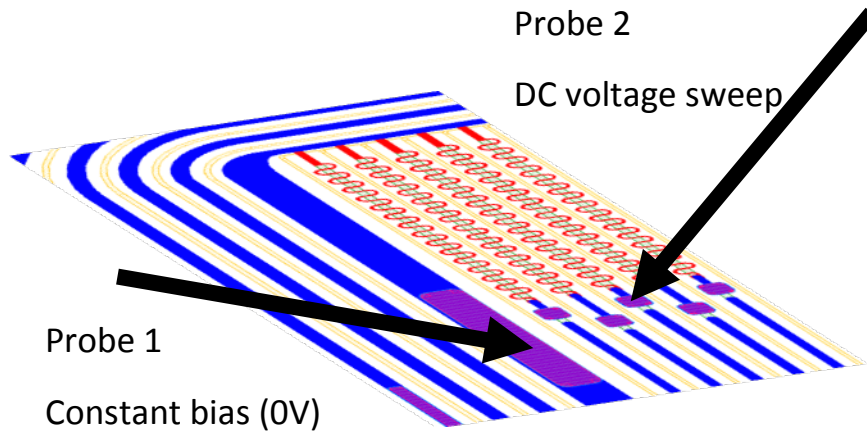
- Equipment setup

- Room temperature $\approx 22\text{ }^{\circ}\text{C}$
- N_2 flow over wafer to remove moisture.

- Constant bias:
 $V_{\text{chuck}} = -100\text{ V}$
 $V_{\text{bias}} = 0\text{ V}$
 Measure bias leakage current
 (200 μA compliance)

- DC voltage sweep:
 $V_{\text{dc}} = 0\text{ V to } 50\text{ V}$
 0,5 V steps
 Measure leakage current at
 DC pad (200 μA compliance)

- $V_{\text{test}} = V_{\text{dc}} - V_{\text{bias}}$
 $R_{\text{eff}} = \Delta V_{\text{test}} / \Delta I_{\text{dc}}$
 $|I_{\text{dc}}| \approx |I_{\text{bias}}|$

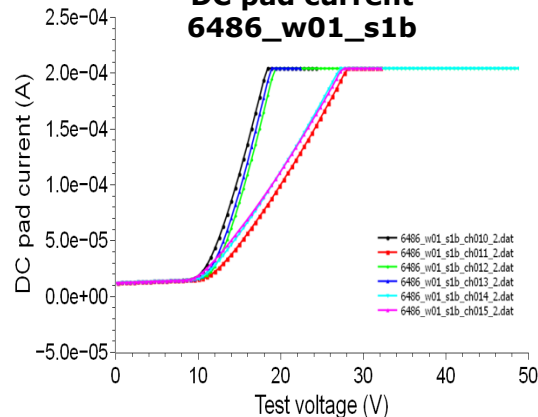
**DC pad current
6486_w01_s1b**

Second measurement

- Breakdown is observed systematically.
- Second (and more) measurement shows it is a non reversible effect.

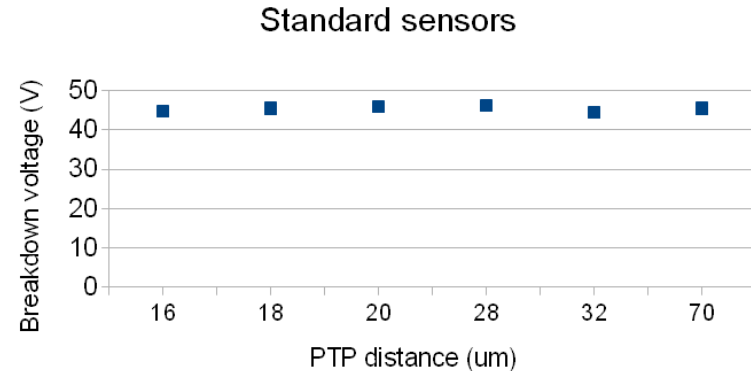
- High currents are not generated in the PTP zone, but in the thin thermal grown oxide.
- Breakdown occurs between strip implant and Polysilicion bias resistor.
- Breakdown is independent of PTP structure geometry, but dependent of oxide thickness.
