# Results from the commissioning of the ATLAS Pixel Detector

Lucia Masetti - Physikalisches Institut Uni Bonn  
for the ATLAS Pixel Collaboration

17 September 2008  
TWEPP 2008 - Naxos, Greece

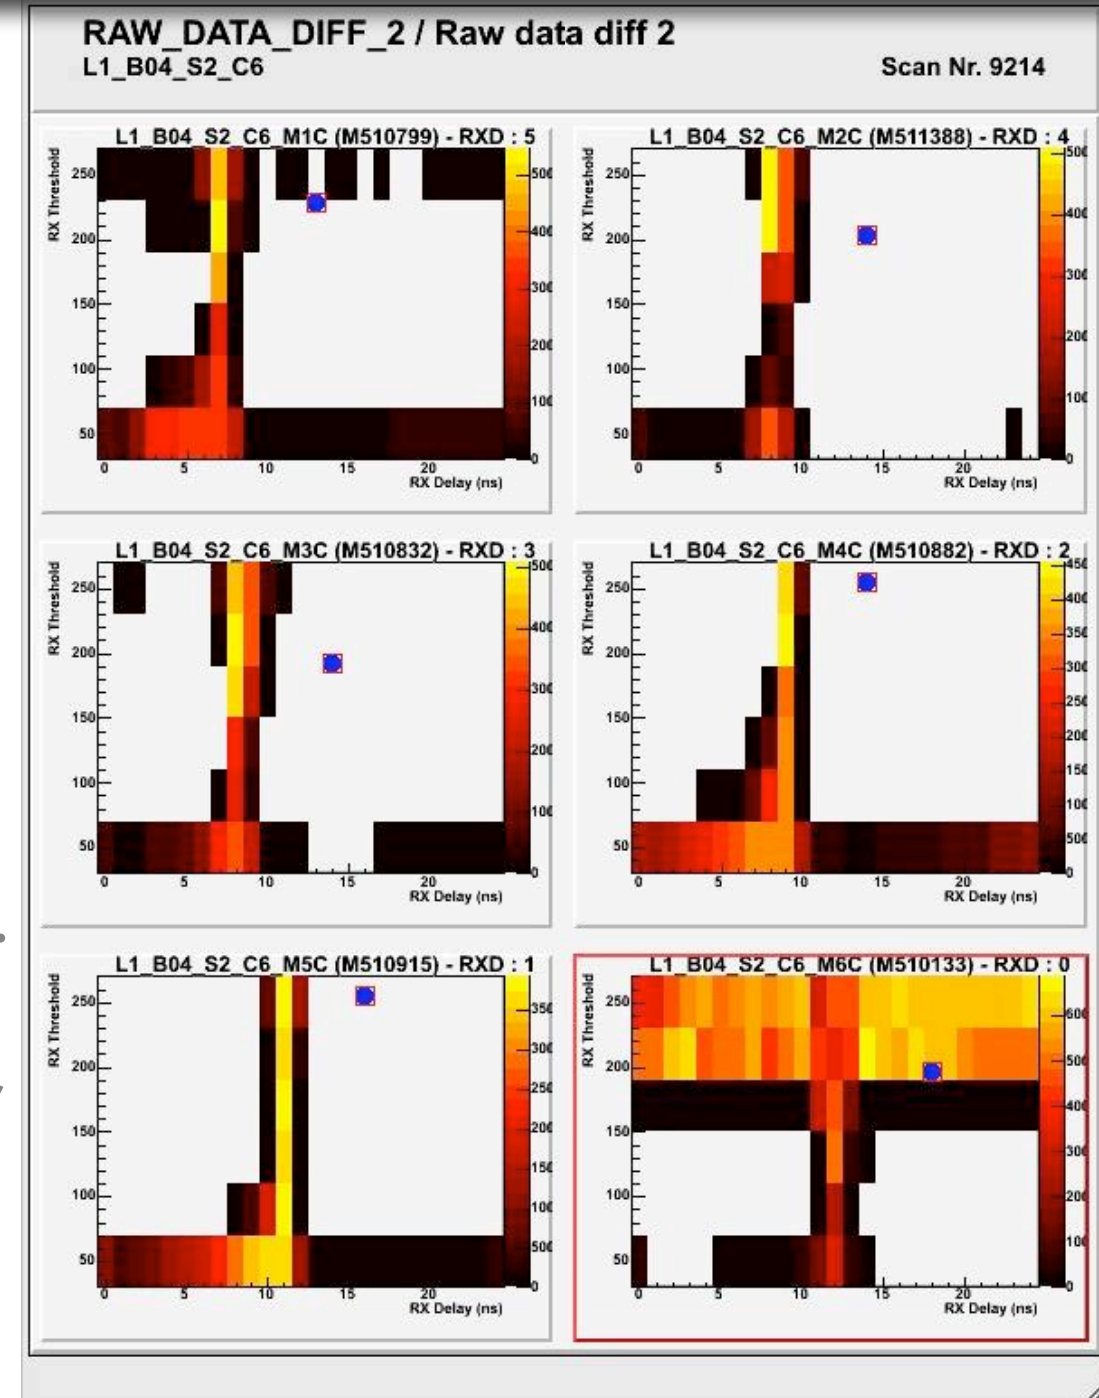
# Optolink tuning problems

Optoboards  
at 10°C

Different data  
patterns  
give different  
optimal  
threshold/  
phase settings.  
Can only tune  
with the faster  
one (left)

- Modules operate at  $-2$  to  $4^{\circ}\text{C}$ , too cold for stable operation of optoboards
- **Heaters** can keep optoboards at room temperature
- Tried to run at  $10^{\circ}\text{C}$  to preserve laser channels from dying
- **Optolinks could only be tuned at  $20^{\circ}\text{C}$** , that was finally chosen as the operating temperature
- On **August 28th** the whole detector could be turned on and **1662/1744 modules** could be further tested (communication ok)

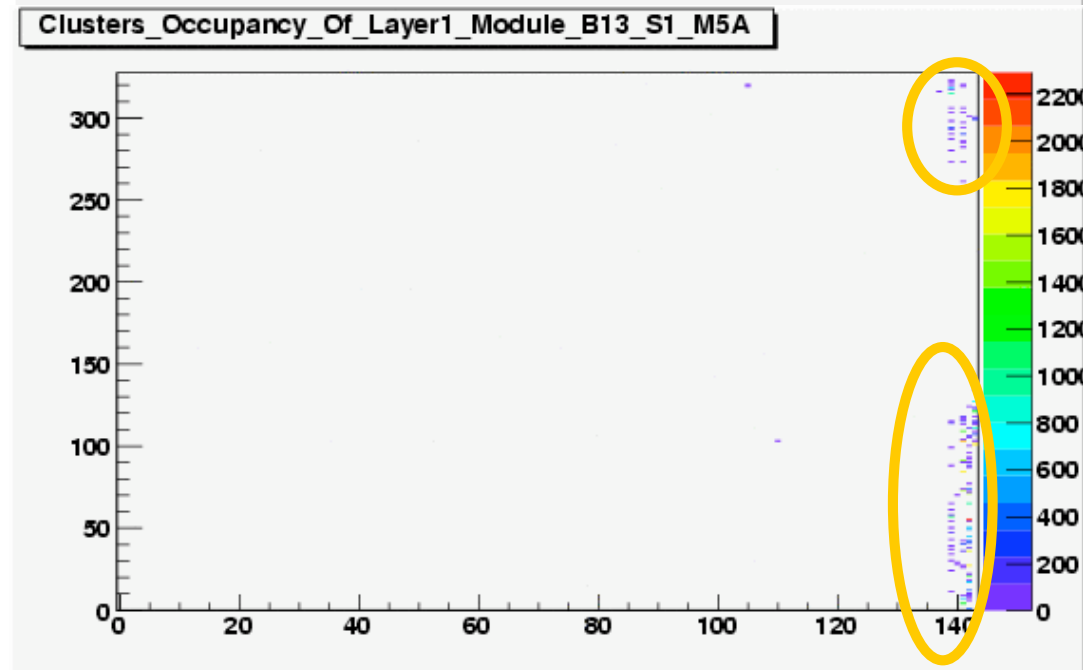
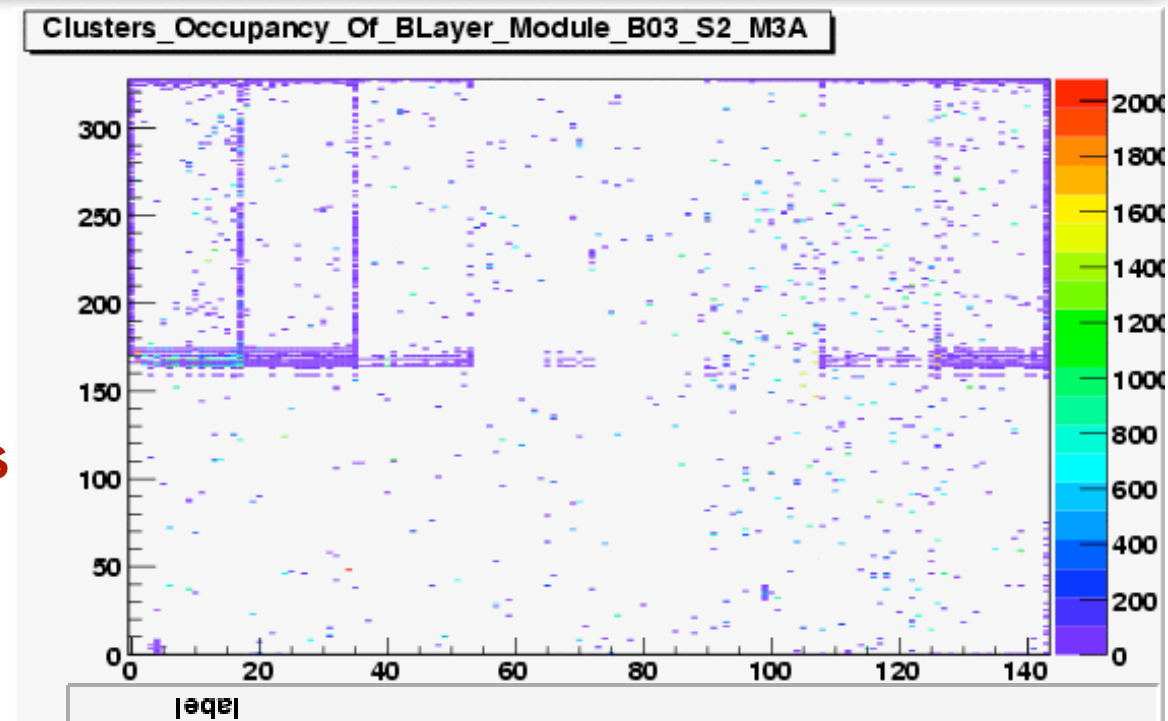
# Modules without HV

Most clusters  
from single  
noisy modules

Good  
agreement  
between noise  
data and  
threshold  
scan
