# CMS Tracker, ECAL and Pixel Optical Cabling Experience

Poster: “CMS Tracker, ECAL and Pixel Optical Cabling: Installation and Performance verification”, TWEPP, Sept. 2008

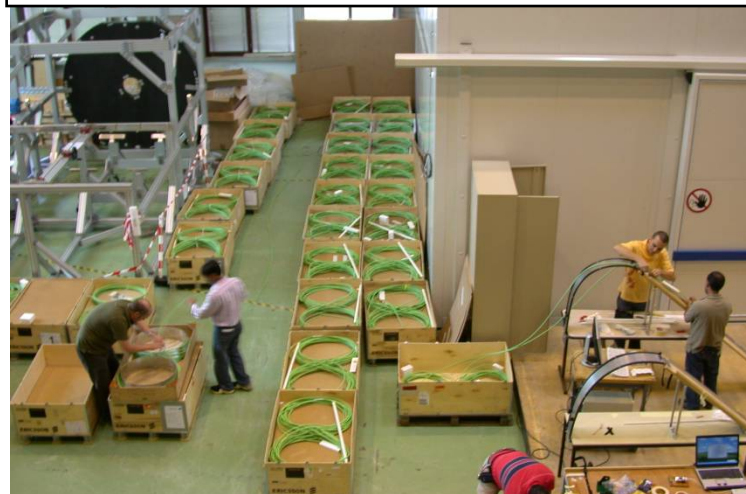
### Cable Preparation (Apr. 2007 – Oct. 2007)

Cables assigned to specific path,  
protected and packed for P5

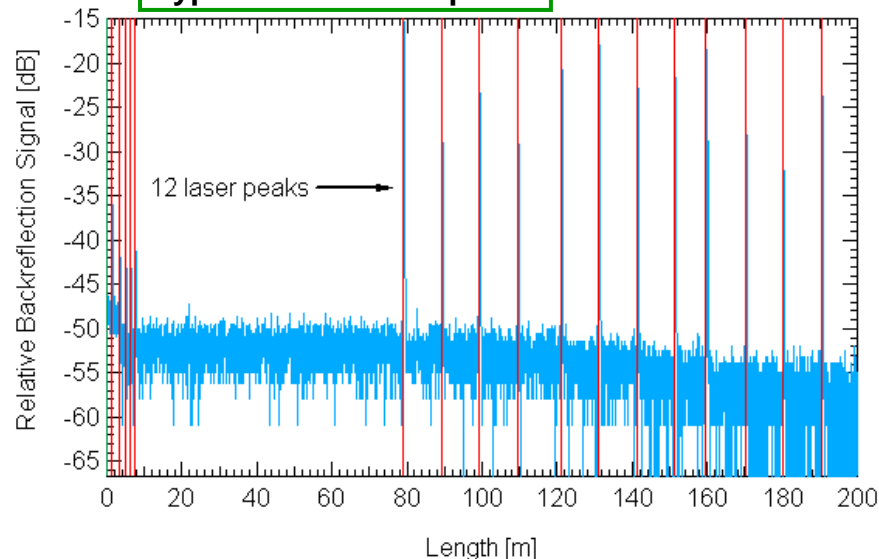
Typical when MFS and MU are visible

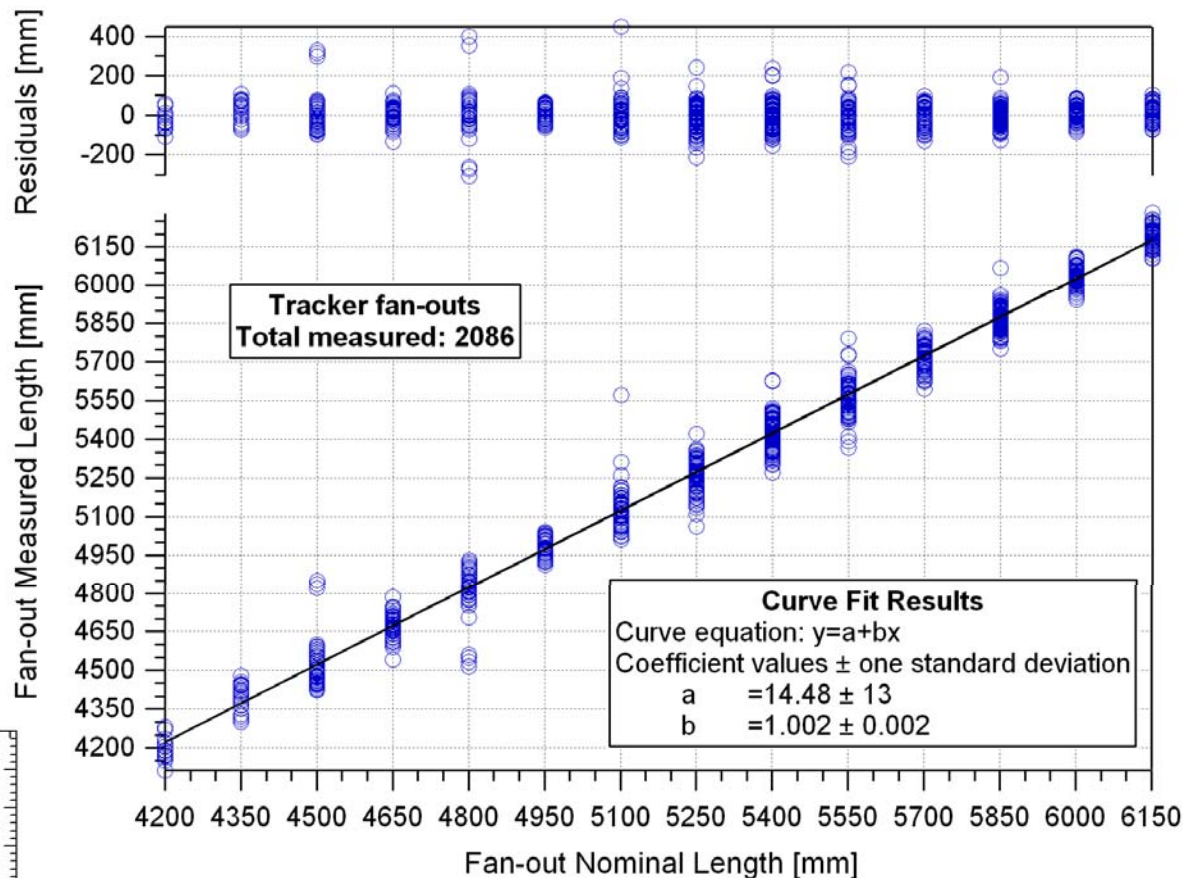
# Example of measured lengths: fan-outs

MU visible  $\Rightarrow$  measure of fan-out and pigtail lengths

**Cabling map validated!**
