CM 35 RF Session Summary

Kevin Ronald for
The MICE RF Group

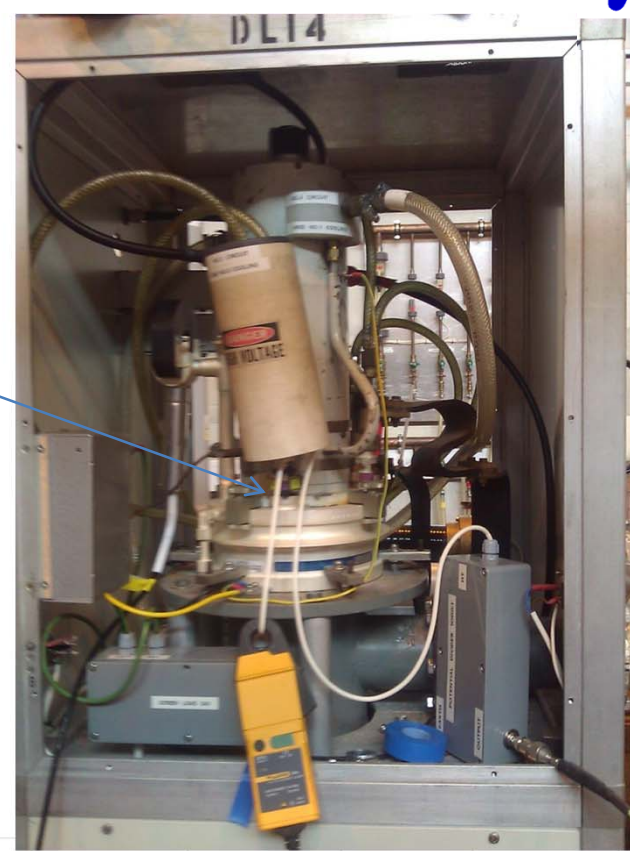
New tetrode tube in DL test amplifier number 1

- Tube needed to be conditioned after spending 3 years on shelf
- Input matching required careful tuning as new valve presents different RF load eventually this was optimised at around 20dB
- After 20 hours running, with a lot of adjustments to amplifier and electrical parameters, system is stable and predictable with linear response
- Still some issues with screen power supply to sort out – loading of screen is moving with beam current and output loading

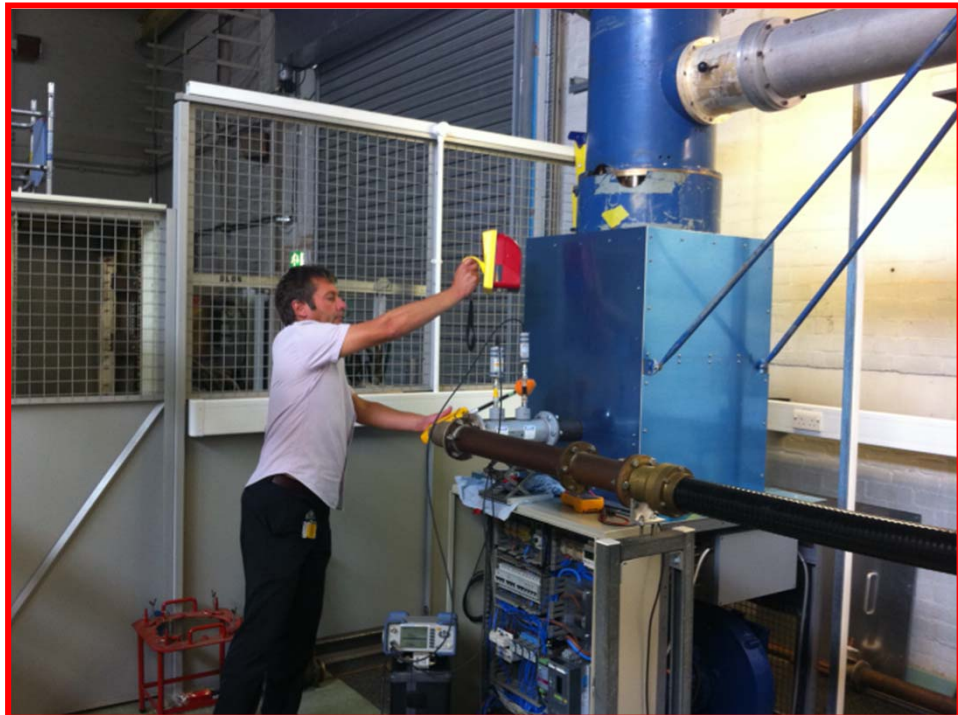
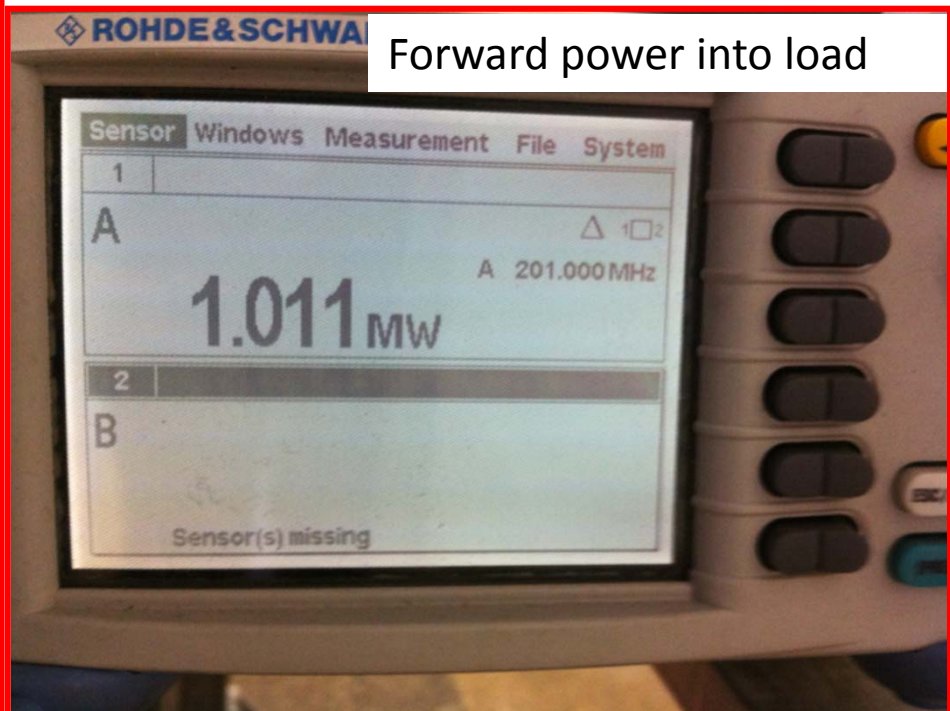
RF and power supply testing

- Operation at 1.2MW with good conversion efficiency and gain
- Overload of power supply resistors during a crowbar caused system stop, replaced with higher power units, testing underway, but now problematic – repeated crowbar events

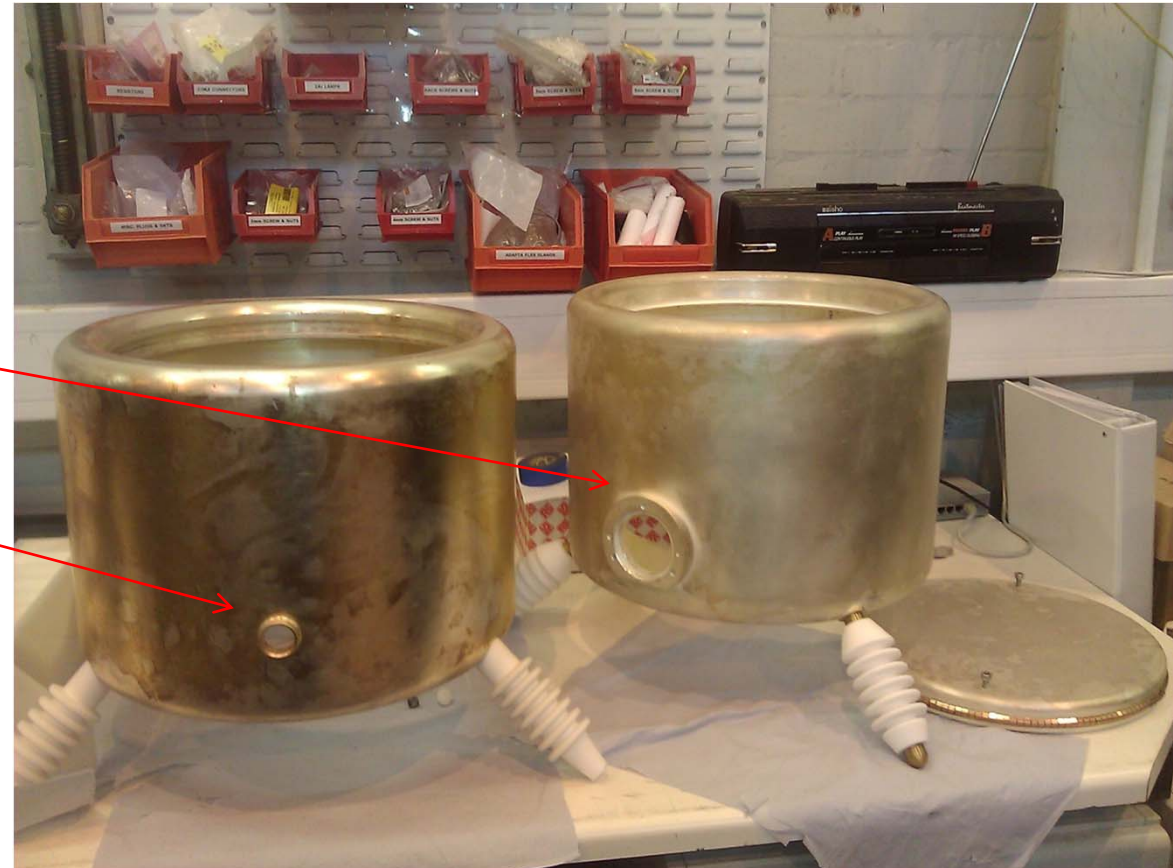
- HT top box is where high voltage is applied to the anode
- Water coolant is supplied to the valve using insulating glass rods
- On the original LBNL amplifier, coolant passed out of the system as steam
- CERN HT top box with ability to pass both coolant flow and return pipes, which is why it was used
- Original LBNL HT top box with small inlet for only one coolant pipe
- HT box to tube interface is slightly different and is where fault is created
- LBNL HT top box is being converted to two water pipes and with correct spacing should remove issue that created arcing

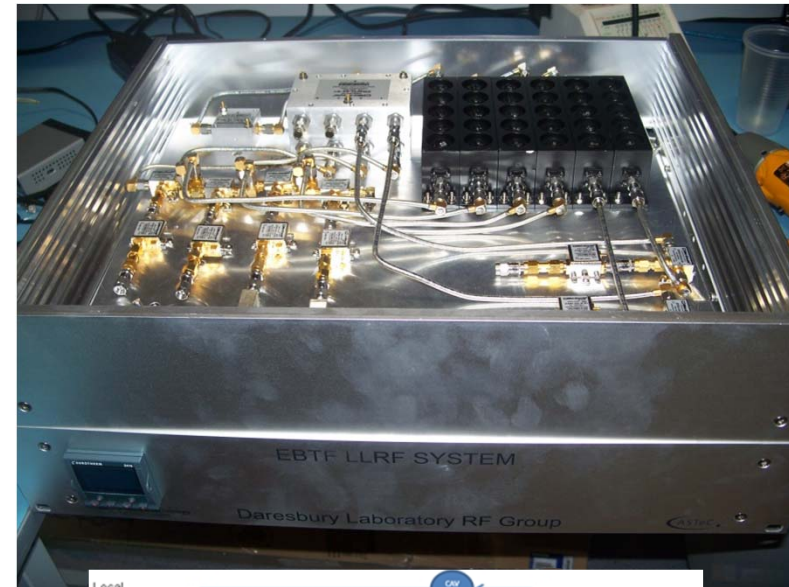
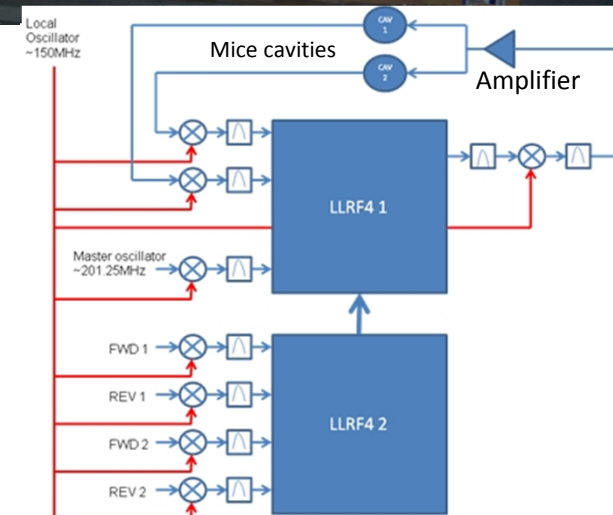
Digital low level RF Control

- To **control** and regulate cavity amplitude and phase angle during the RF pulse
- DL able to build up hardware ~ 3months
- Systems in use already with EPICS control, feedback, feedforward, resonance control etc
- Ramped pulse structure to limit reflected power tested on bench with 1.3GHz cavity

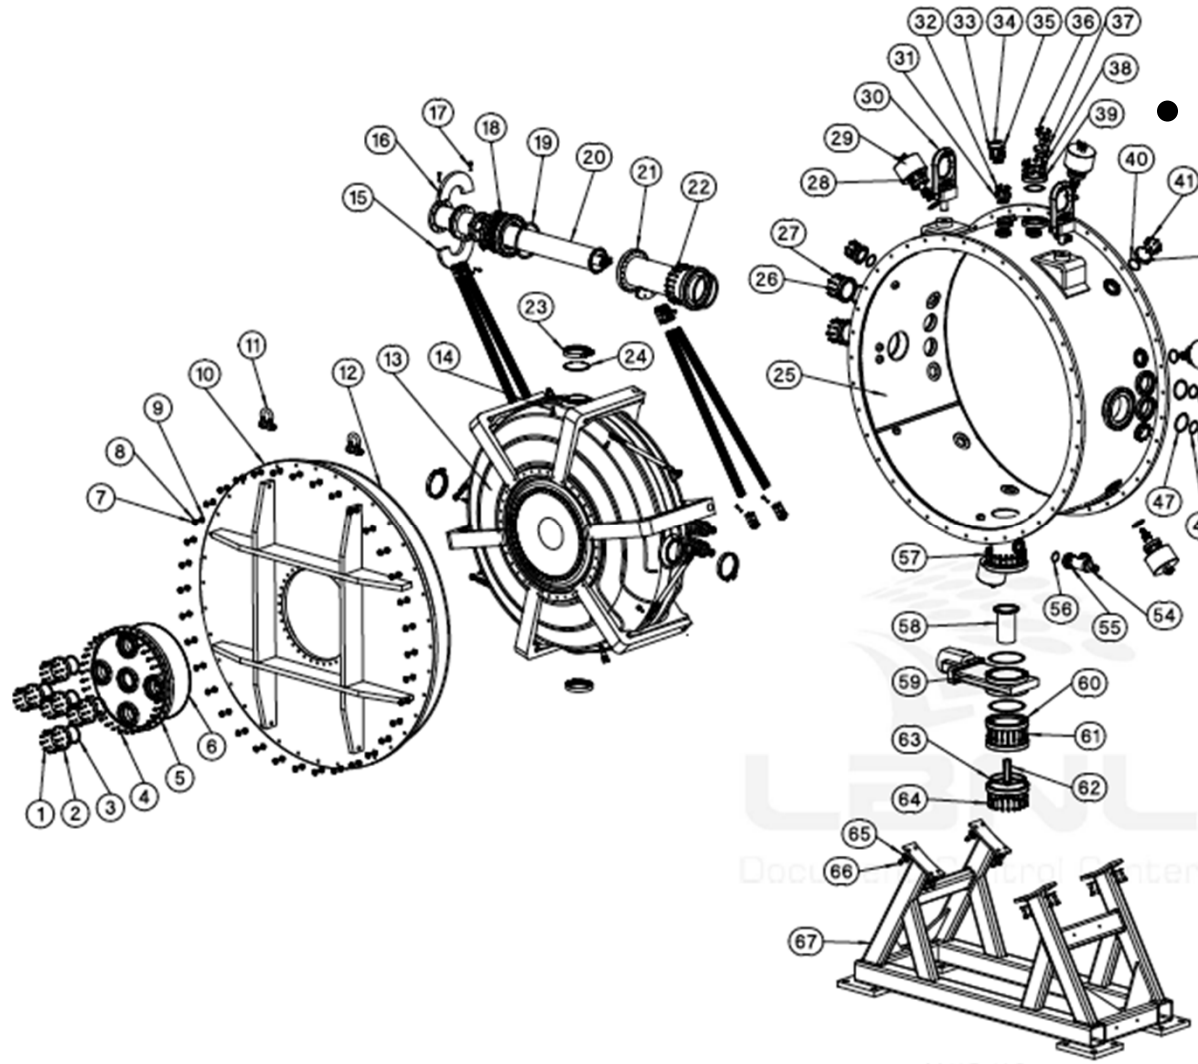
Cavities

- Cavity dimensions mechanically measured
- First cavity electropolished
 - 9 cavities to be polished imminently
- Beryllium windows fabricated
- New coupler design nearing fabrication
- After polishing, cavities subject to RF measurement and tuning
- Single cavity test stand completed at MTA
 - First cavity moved to FermiLab for testing
 - Awaiting couplers, other components in place at FermiLab
 - Apr 2013 planned for tests
 - In fringing magnetic field, up to 1T
- Automated actuator driver to tune cavity being developed
 - Will interface to LLRF

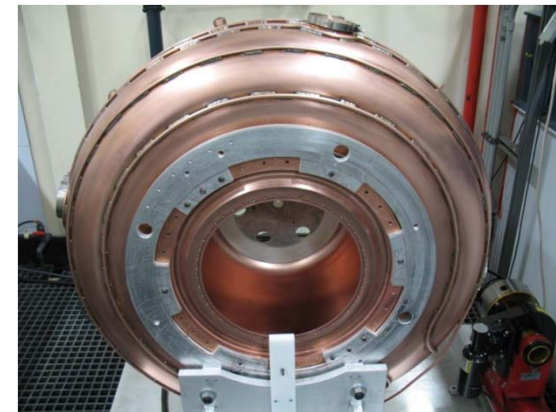
- MICE cavity in vacuum vessel for MTA test
- Components
 - 1st MICE cavity EP'ed and now at Fermilab
 - Be windows ready
 - Tuner forks built
 - Ready for fabrication of new couplers

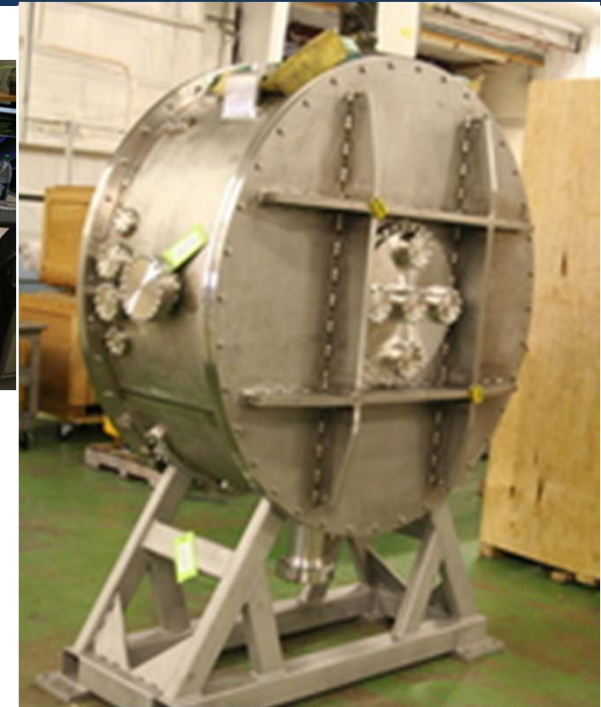
- **Assembly/integration**
 - Cavity and vessel at Lab-6
 - Clean room prepared
 - Plan in place for handling and transport (R. Schultz, J. Volk)
 - Assembly fixture designed (A. DeMello)
 - Tuner control bench tested (P. Hanlet)
- **Expect operation Summer 2013**
 - beam test also under consideration
- **Ultimately will be tested with the first Coupling Coil Magnet**
 - Requires 6-month MTA shutdown
