Update on Actel FPGA Radiation Test (Round 3)

Marina Artuso, Erika Cowan, Bin Gui,
Dylan Hsu, Ray Mountain, JC Wang
Syracuse University

LHCb Upgrade Electronics Meeting
Feb 14, 2013

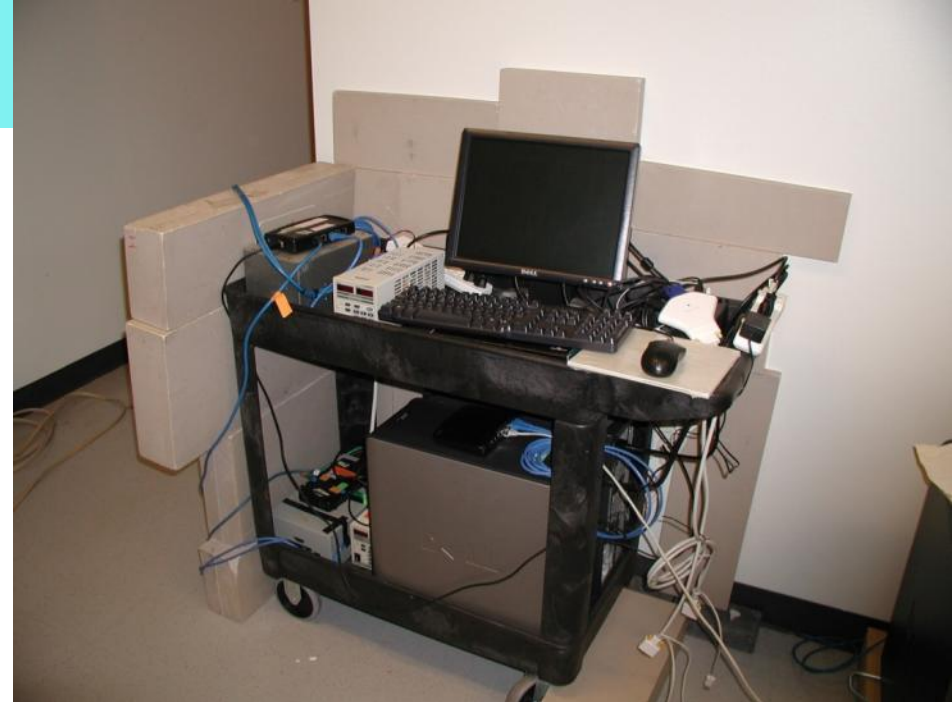
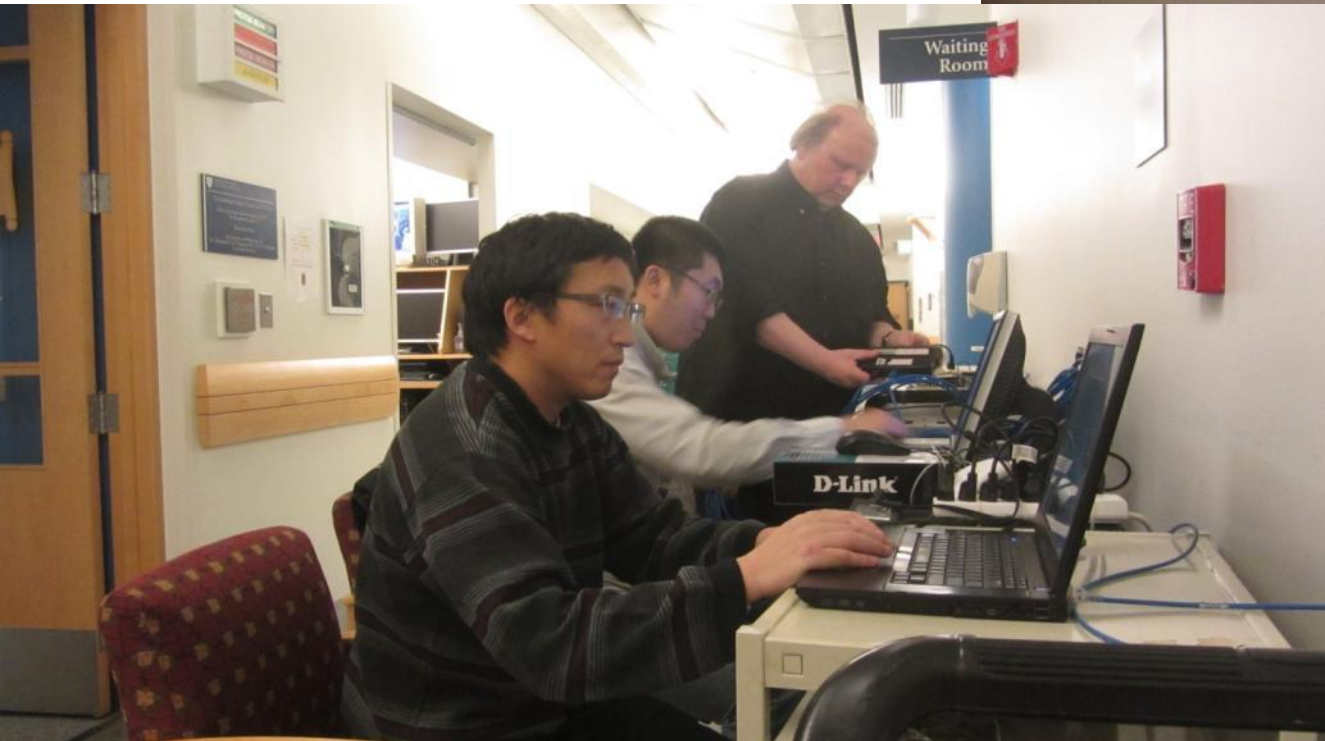
Near station

2 x PC run labview DAQ
2 x TNG 5 provide communication between PC & FPGA, and current measurements.

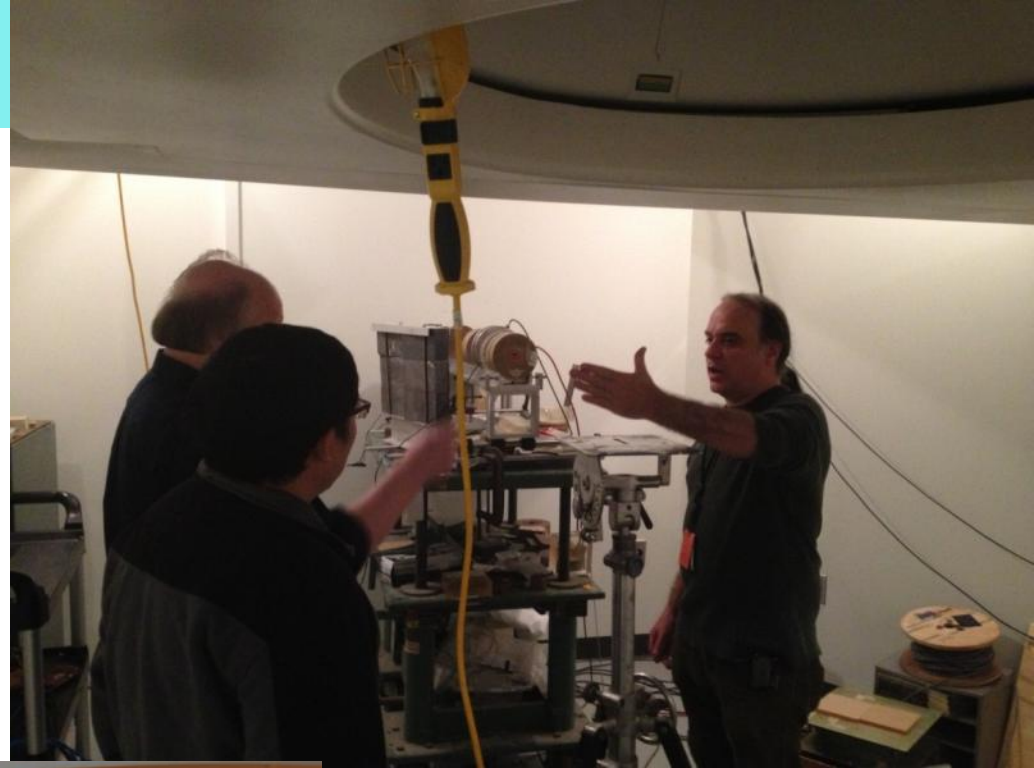
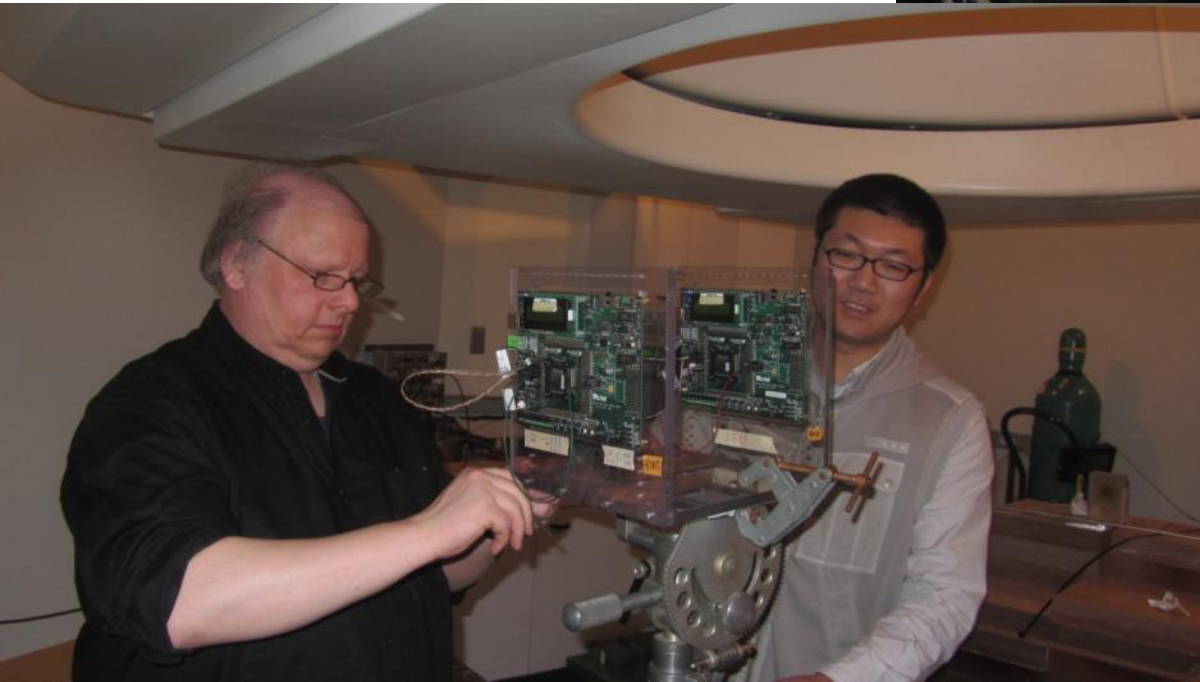
Far station

Laptop PCs to control near station DAQ PCs via a local network.

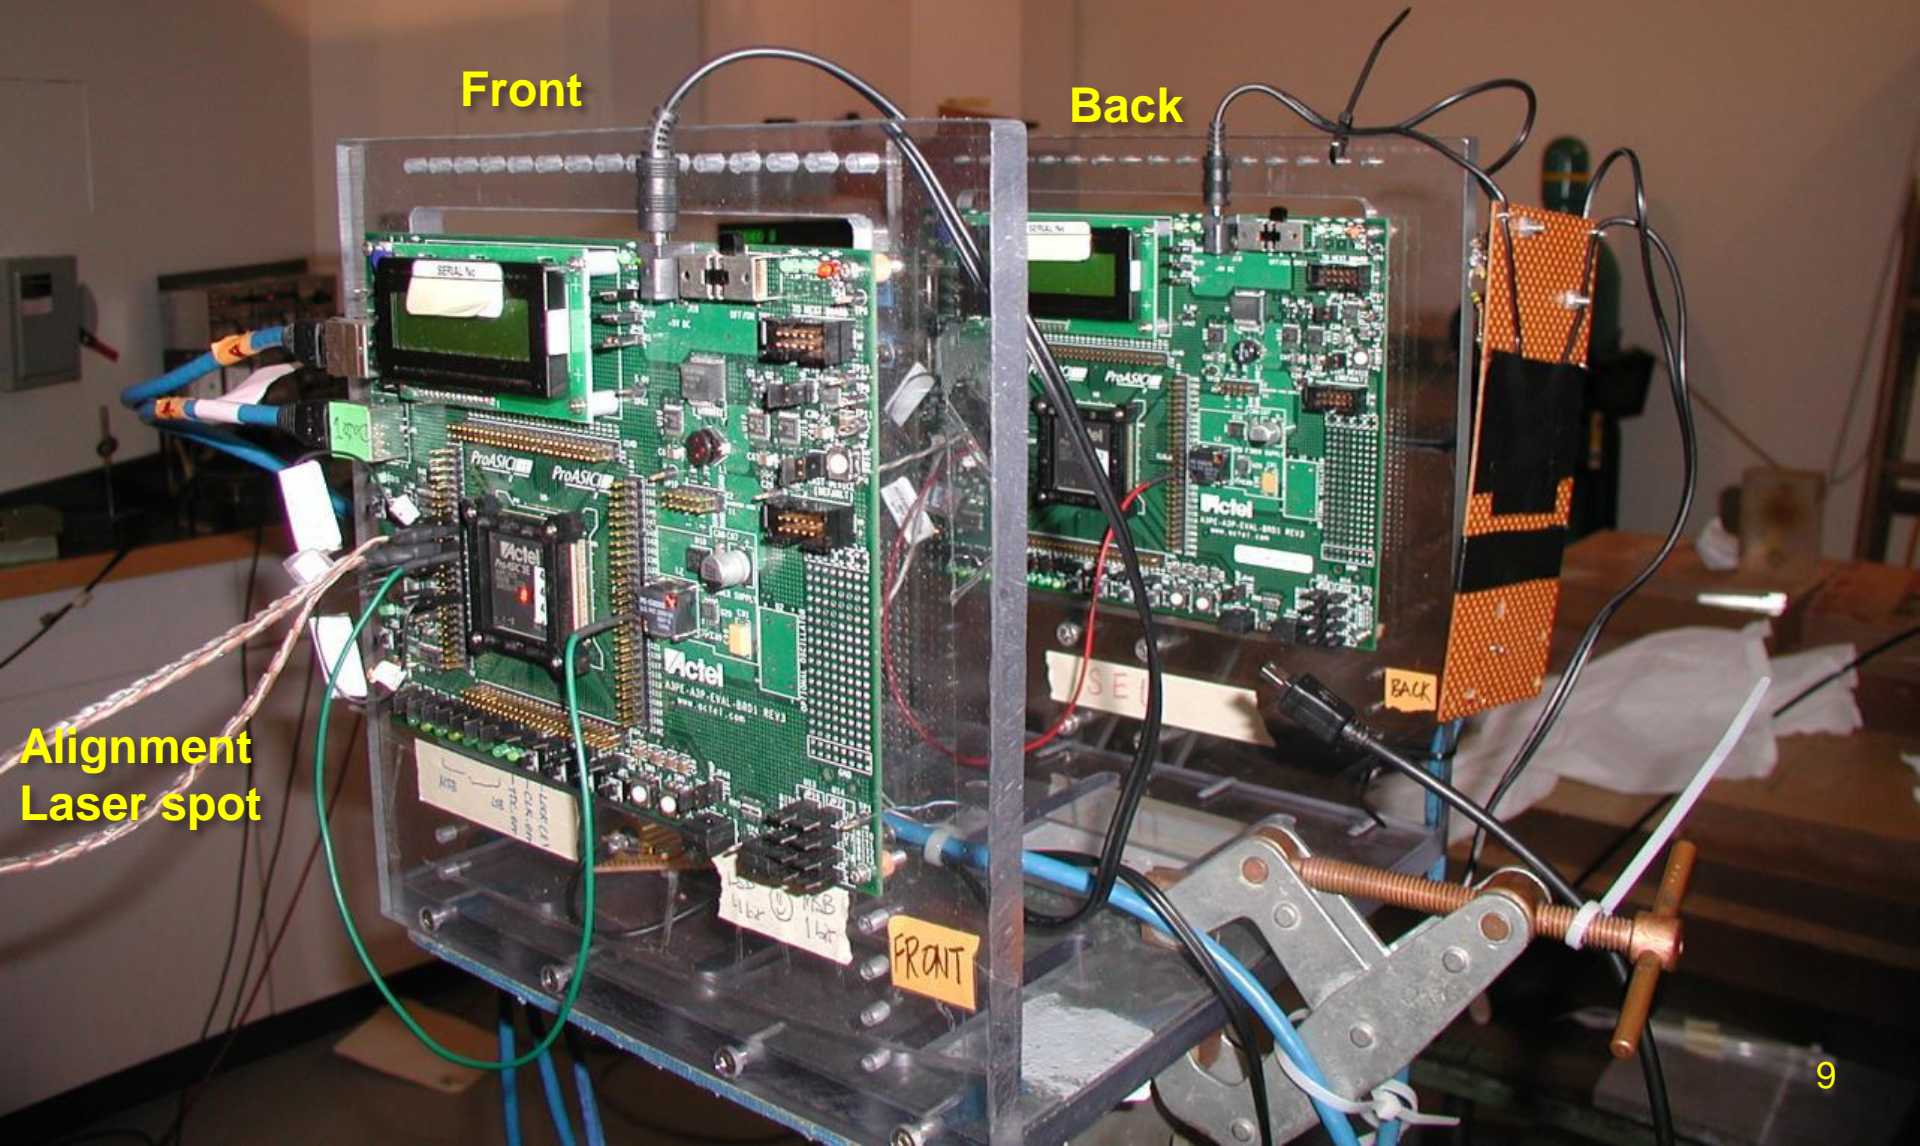
FPGA Board

Aperture
Ø12.7 mm

Ion Chamber

p Beam

Adjustable
mechanics

Front

Back

Alignment
Laser spot

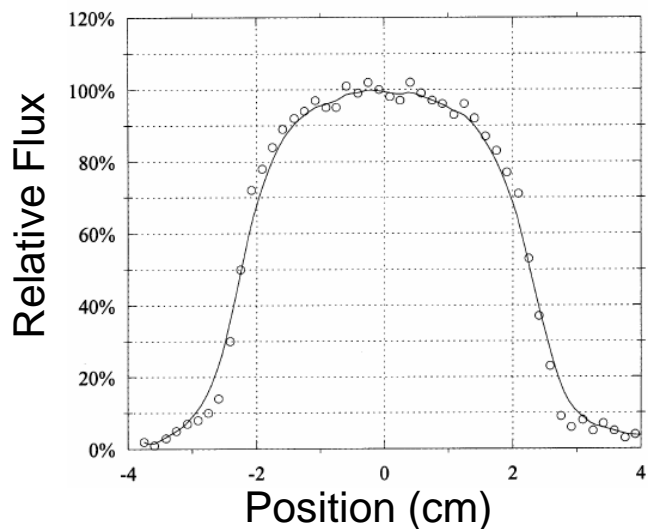
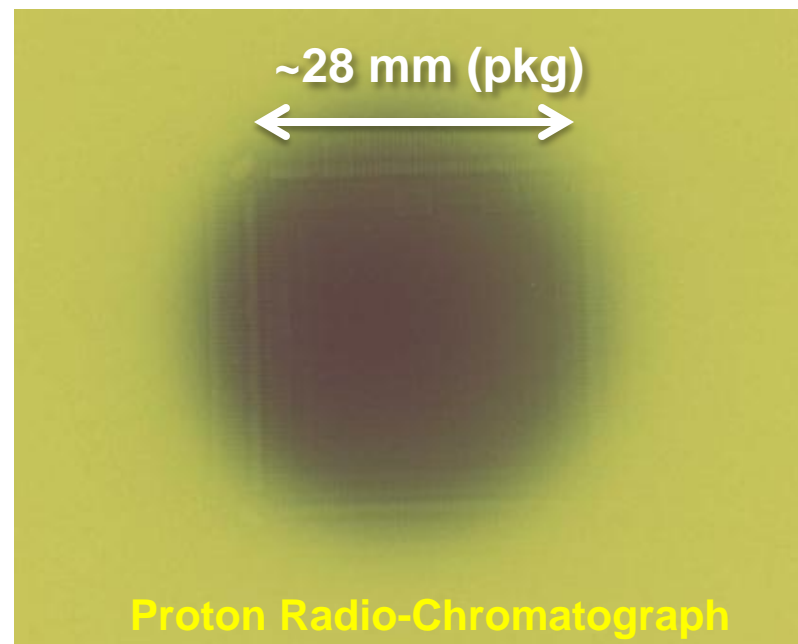
- ❖ With one Pb foil scattering. Beam energy 226 MeV.
- ❖ Particle flux uniformity is better than 10% in a 10 mm diameter. The size is ideal for our FPGA tests (dice size: $7.9 \times 7.7 \text{ mm}^2$).
- ❖ Beam is centered on FPGAs, aligned with laser spot.
- ❖ We test 2 FPGAs at a time. The downstream (back) FPGA receives ~ 68% radiation dose comparing to the upstream (front) one.

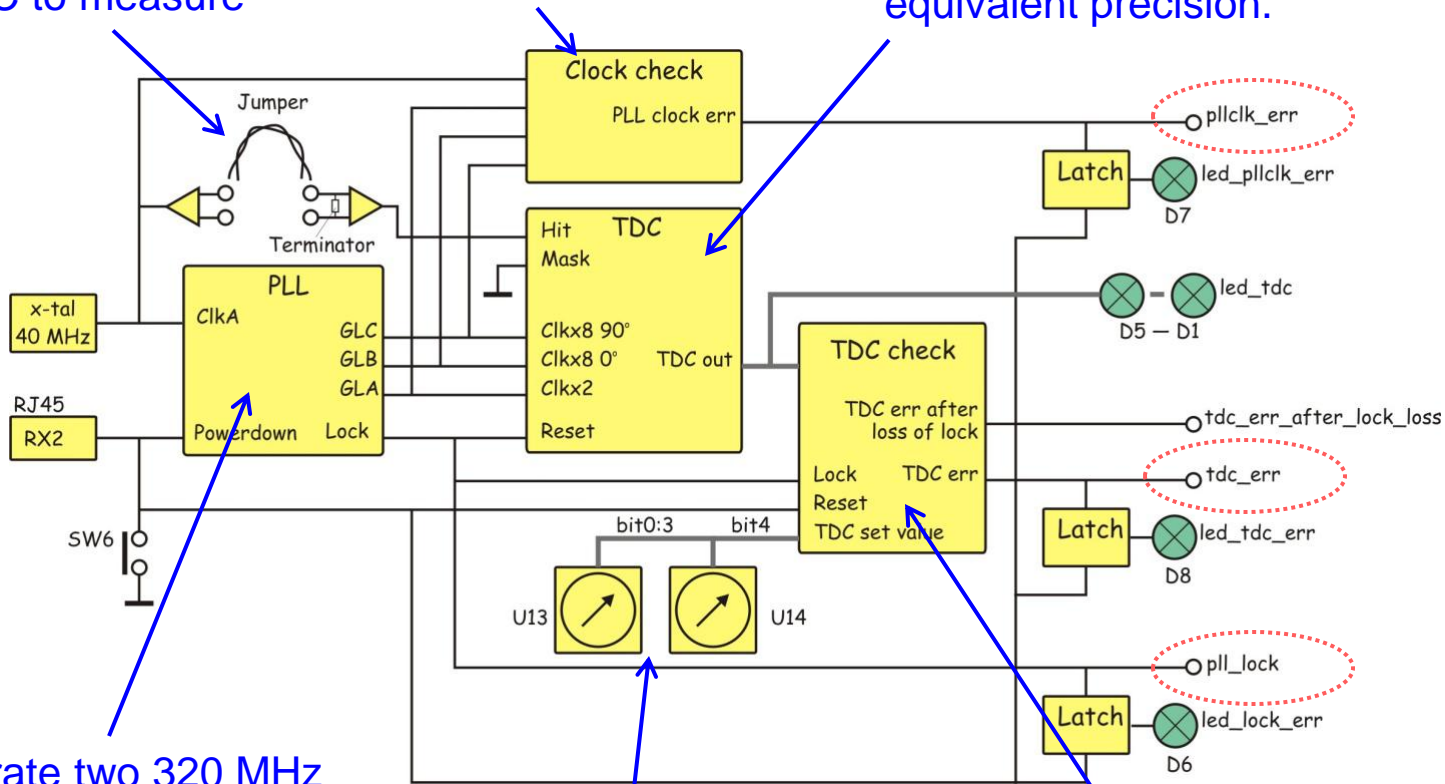
PLL Test Setup

Twisted pair cable provides delay for TDC to measure

Check if frequencies of produced clocks are correct

Measure 40 MHz time signal, with 1280 MHz equivalent precision.

Generate two 320 MHz and one 80 MHz clocks of fixed phases,

Set a 5-bit number for comparator to check against measured TDC.

Check if measured TDC value agrees with U13/14.

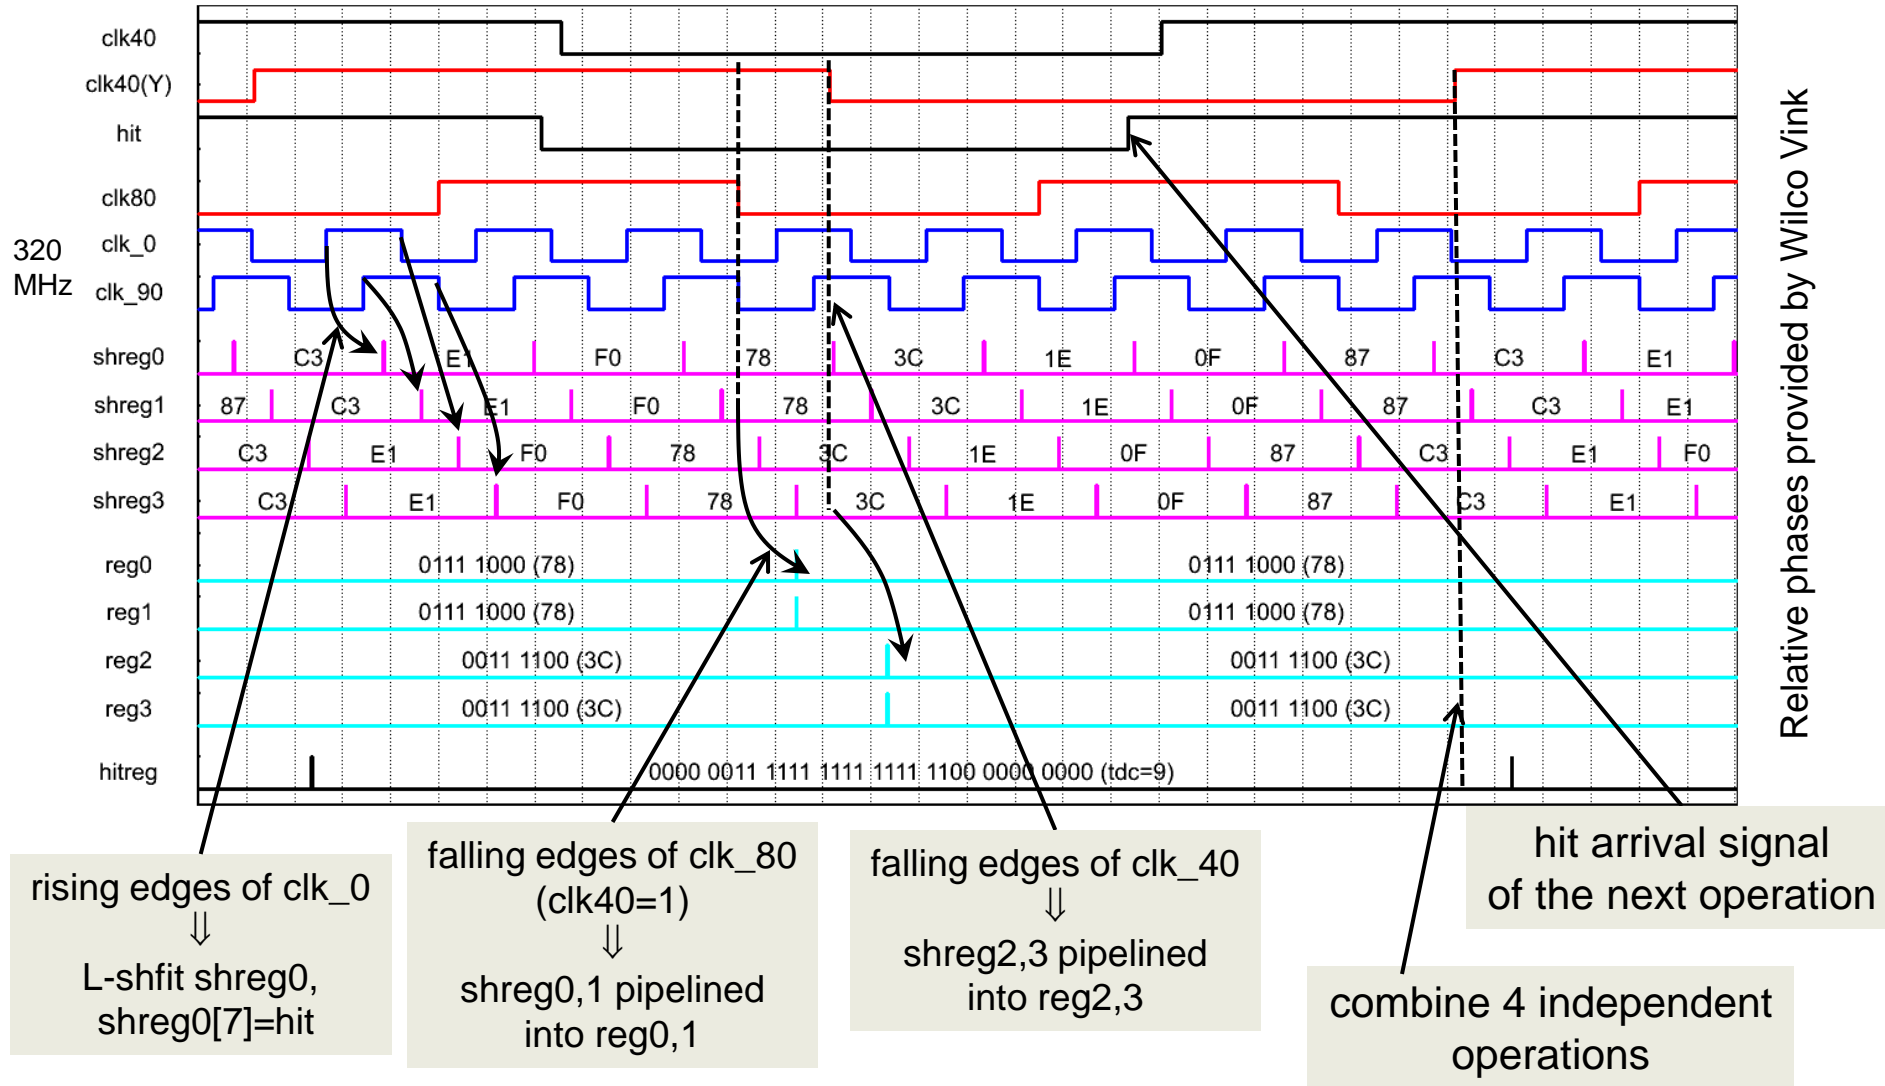
TDC Logic & Time Diagram

Relative phases provided by Wilco Vink

Setups at NIKHEF & Syracuse both work with this version of firmware.

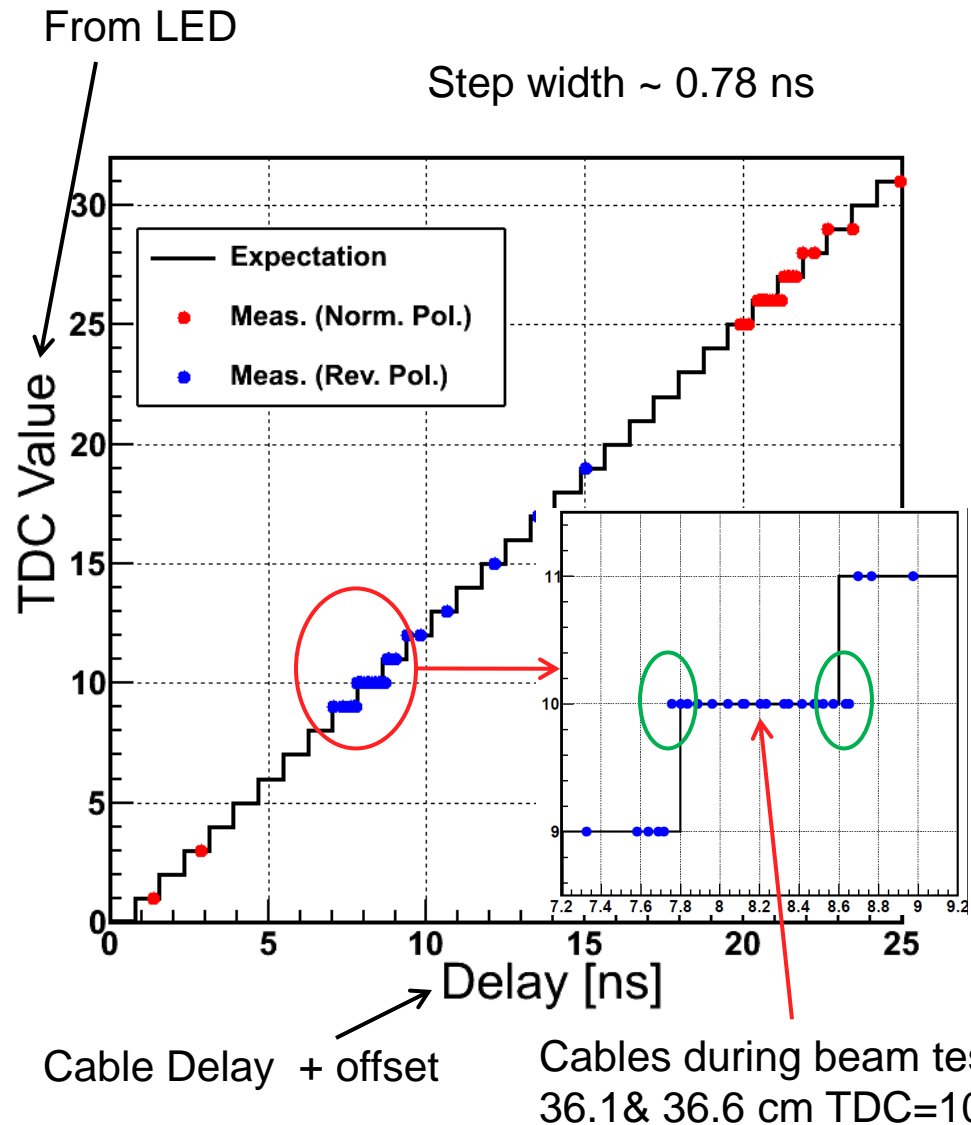
- TDC value vs delay follows an expected step structure.
- We made a bunch of twisted cables with length varying between 15 to 150 cm.
- Delay cables are connected in normal or reversed polarities. The net effect is 12.5ns extra (less) delay if the signal is perfectly 50% duty.
- We use cable delay plus an offset as the total delay. The offset reflects contributions from gates & traces. It is obtained to align the points to the steps, and is slightly chip dependent.
- Points at step edges may be at transition of two TDC values and is difficult to determine from LED. This is better studied with large statistics of TDC-error counts.
- Cable delay will be better calibrated.

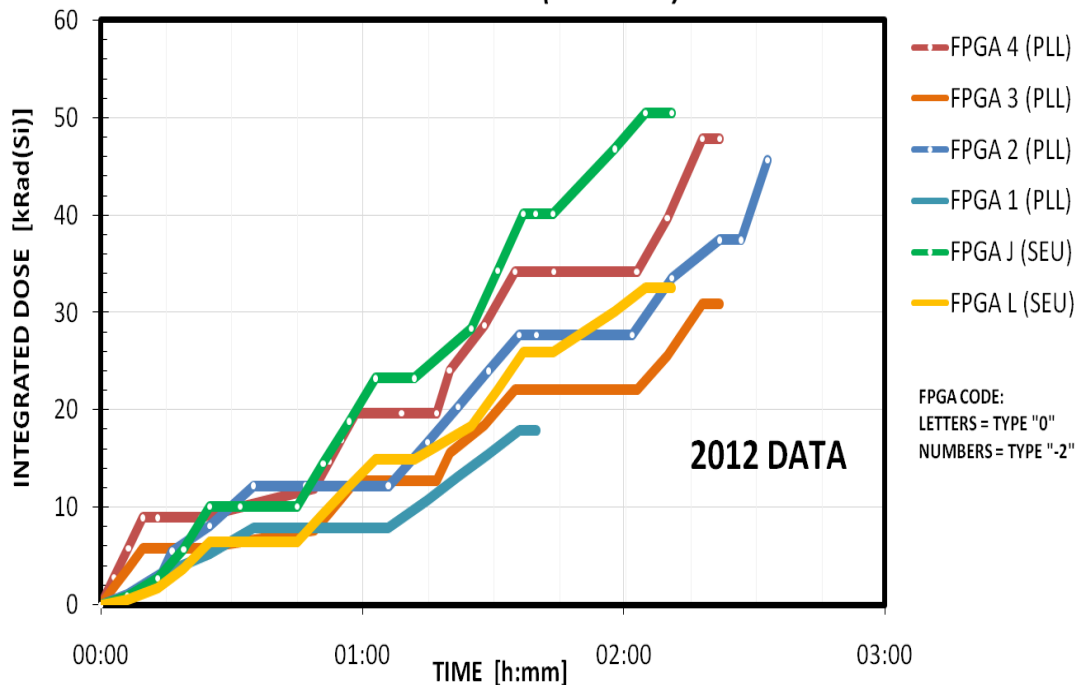
EXPOSURE PROFILE (ROUND 3)

Chips are tested in pairs

FPGA 4 (front) & FPGA 3 (back).

FPGA 2 (front) & FPGA 1 (back).

FPGA J (front) & FPGA L (back).

The radiation dose a downstream (back) FPGA receives is ~68% that of its upstream partner.

All FPGAs receives 30 kRad or more, except for FPGA 1 that we intentionally removed for other test.

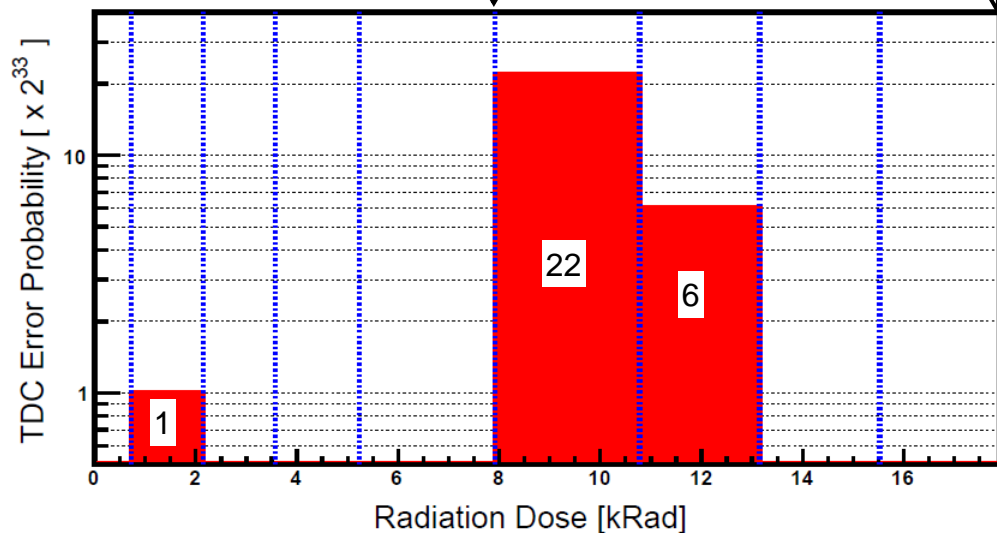
Programmer was disconnected from boards during beam time.

Blue lines separate runs.

The TDC errors for each run can be at any time.

Verification	OK
Verification	failed
Reconfiguration	failed x3
Verification	failed
Power cycle	
Reconnect programmer	
Verification	failed
Change programmer	
Power cycle	
Verification	failed x2
Reconfiguration	failed

Verification	OK
Reconfiguration	OK
Verification	OK

After 17.9 kRad, FPGA 1 is taken out.

We want to keep it alive to compare transition curves before & after irradiation.

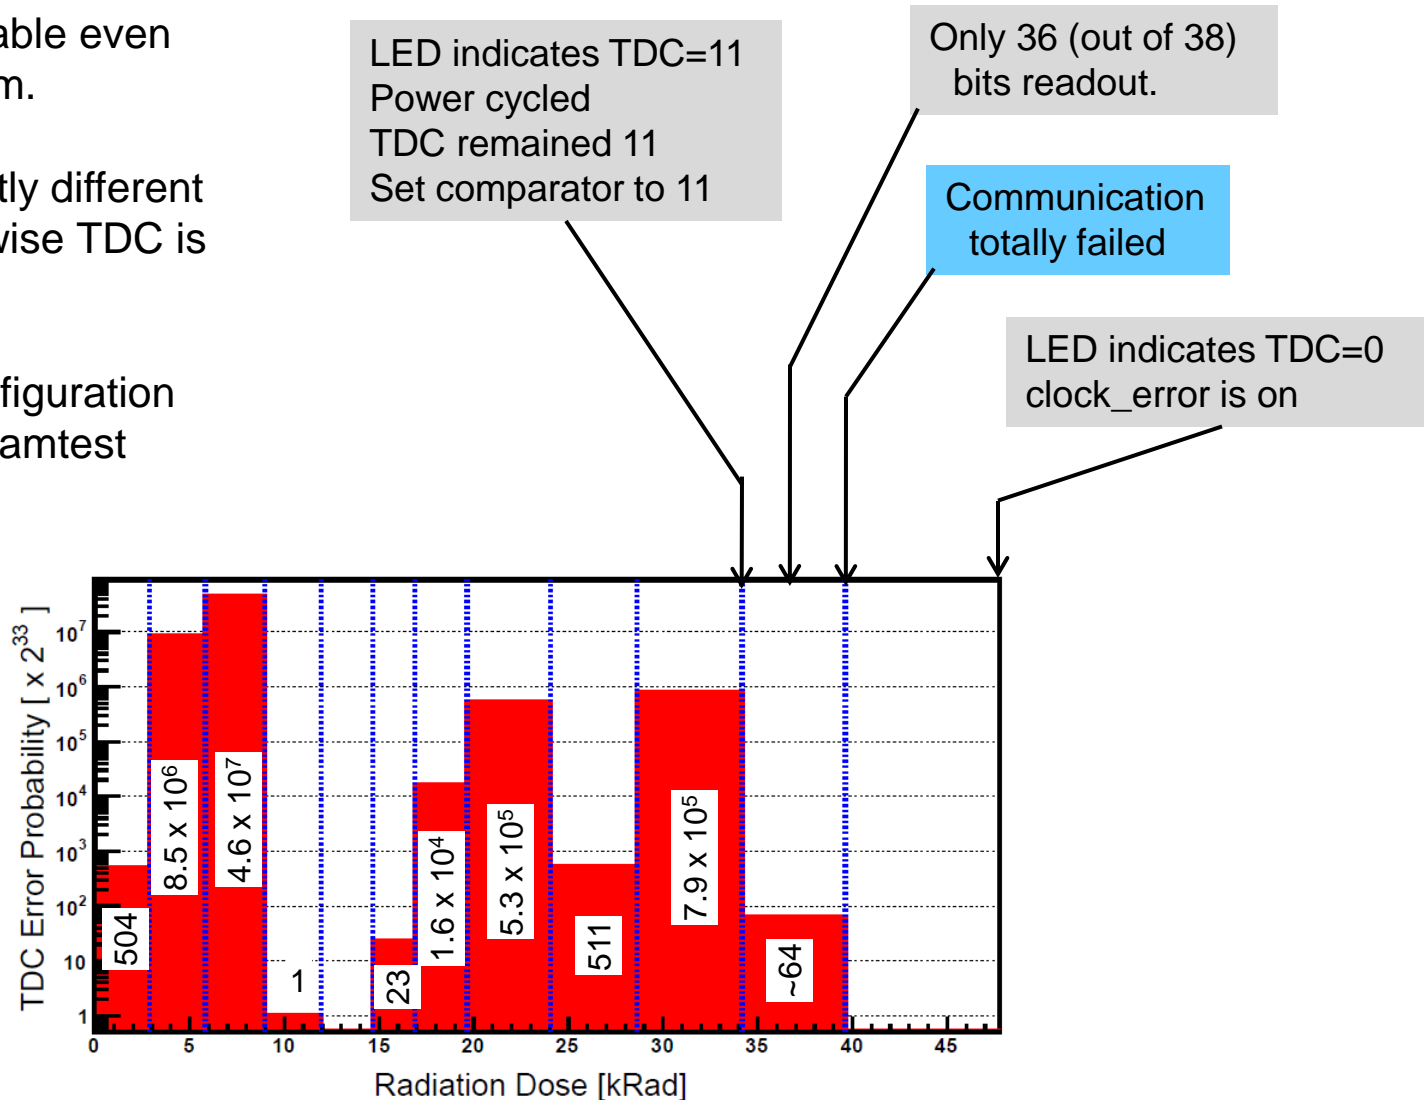
FPGA 4 was not stable even before the test beam.

Its firmware is slightly different from others. Otherwise TDC is non-linear.

Verification & reconfiguration failed before the beamtest started.

FPGA 4 received 47.8 kRad

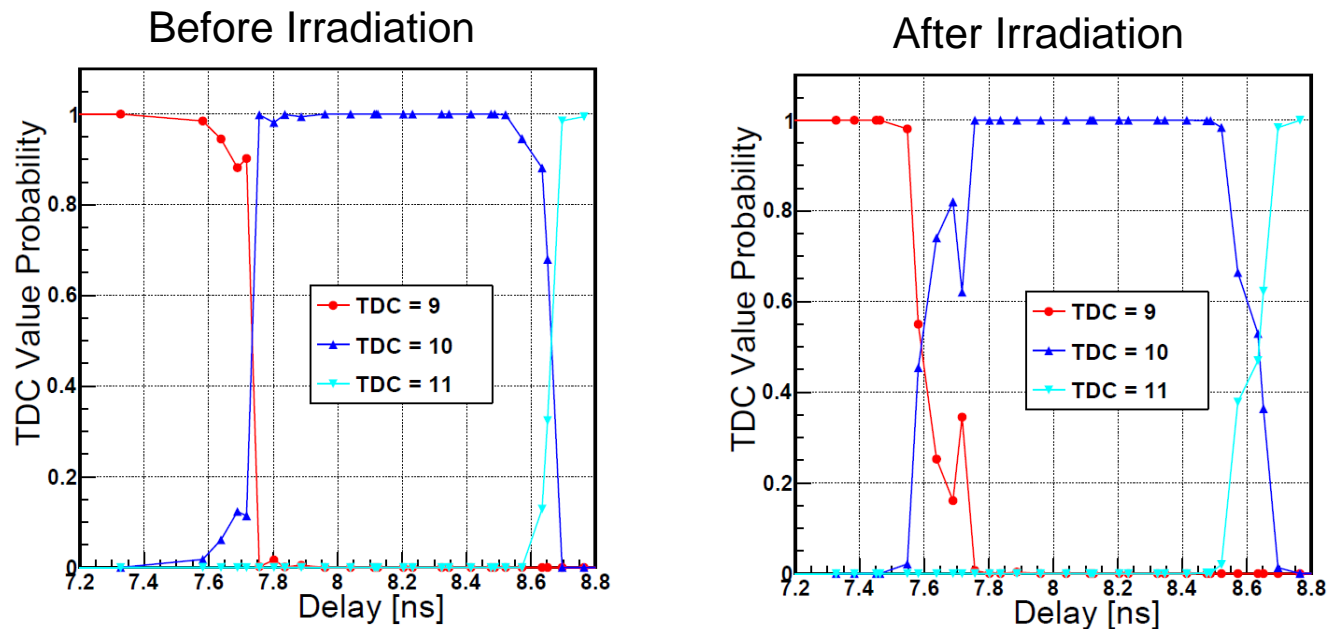
- We measure TDC value probability vs delay curves.
- After irradiation the transition areas are wider than before. The center might also shifted.
- The cable delays are calculated from their physical lengths of twisted pairs, which are expected to be not precise.
- We tried to calibrate the cable delay with electronics signals to the precision of a few 10 ps. The outcome is not great.

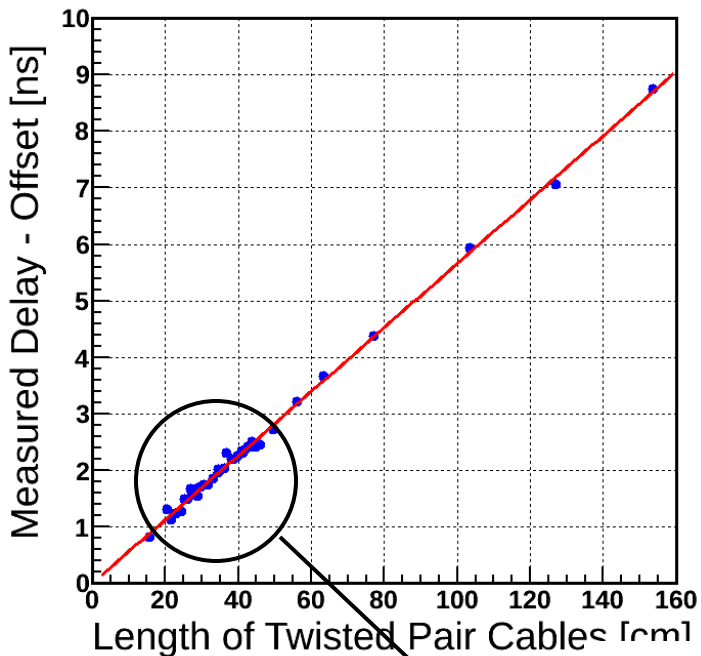
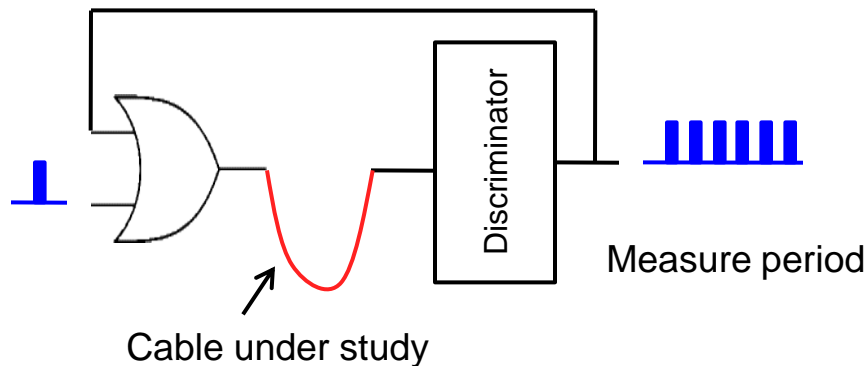
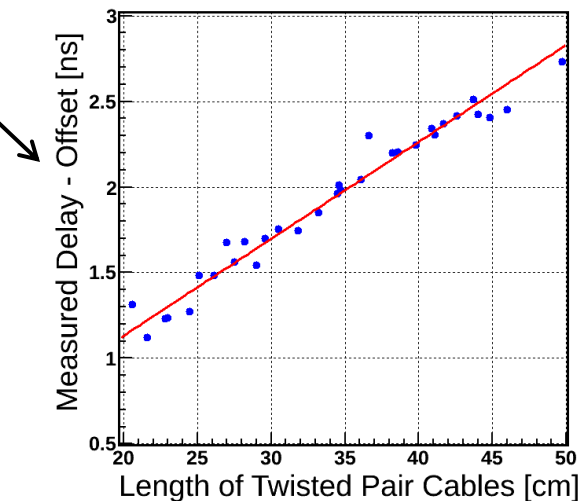
Calibration of Cable Delay

R. Kiesler *et al*, NIM 56 (1967) 357.

The measurement is stable to the precision $< 10\text{ps}$.

However, the difference with length measurement may be too big.

We may have a way to refine these measurement. Suggestions are welcomed.
