**CNGS Run 2007
and
Ensuring Safe and Reliable
Operation of CNGS as of 2008**

Edda Gschwendtner

CNGS Secondary Beam Working Group

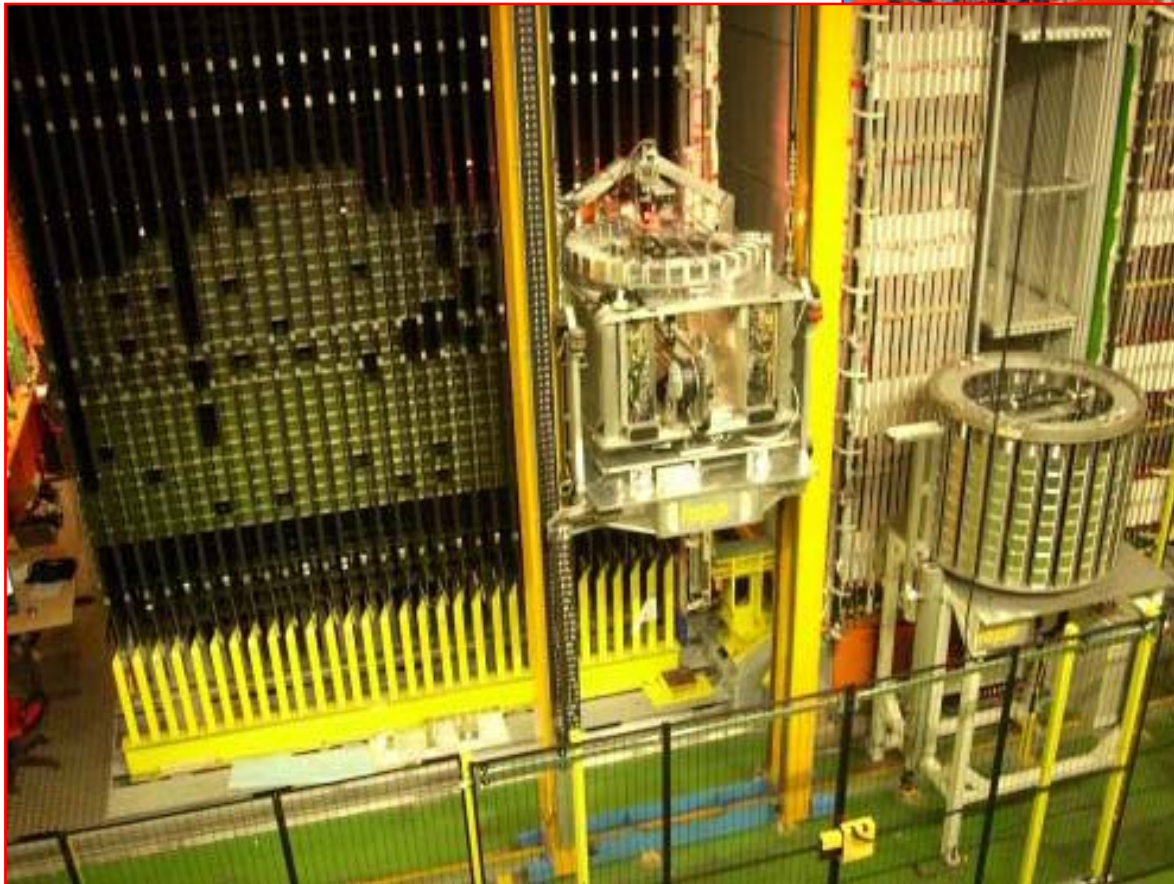
BAM in *Dark*
5 Piling/Pressing stations
1 Wrapping station

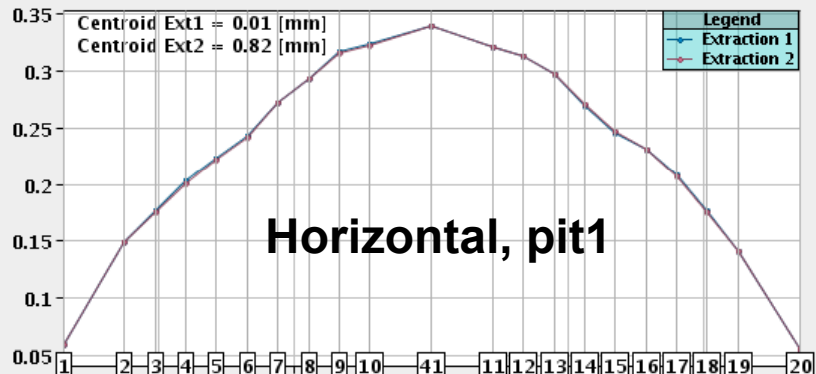
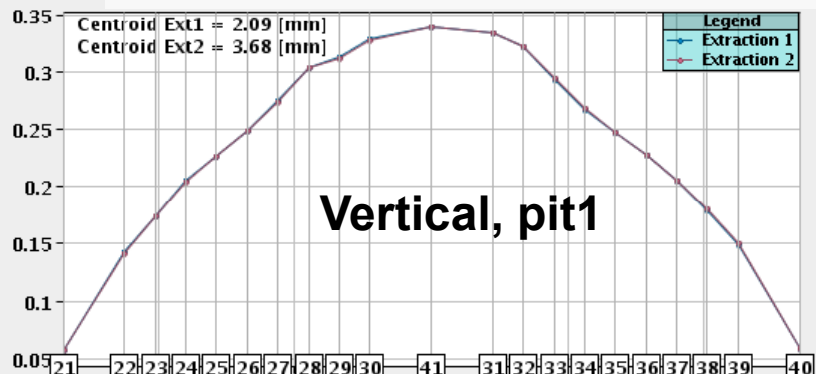
Pit 1

• Pit 1: sensitive to target vs horn alignment

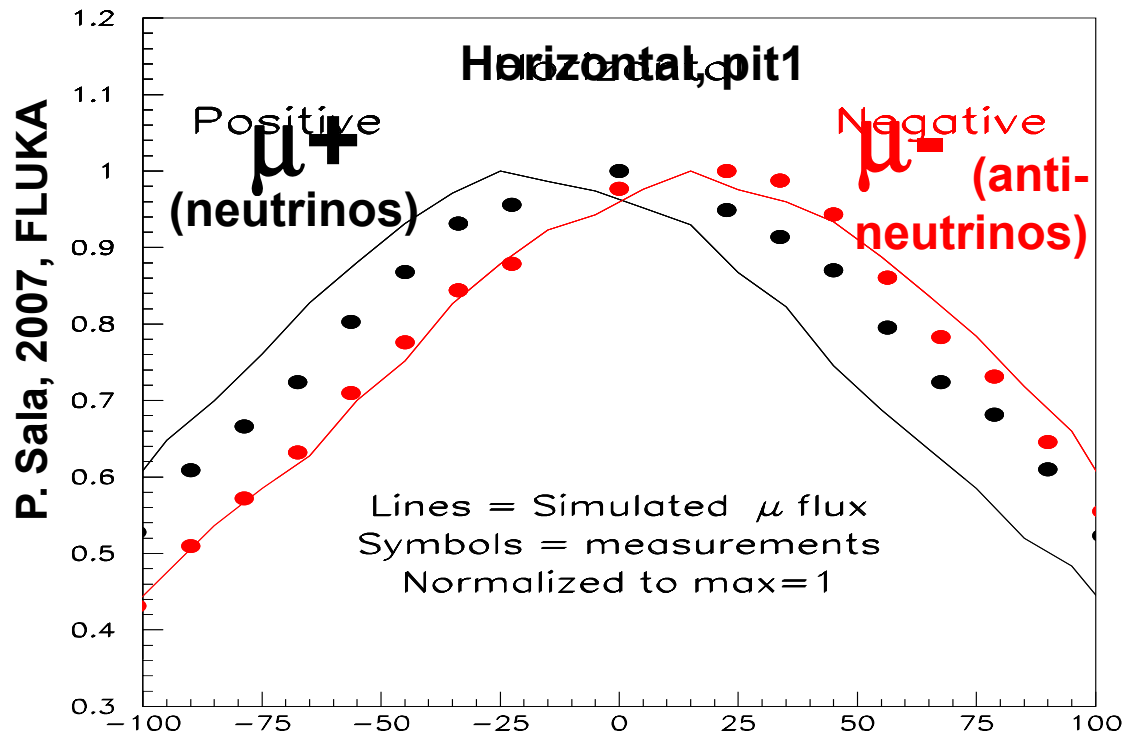
Neutrino/Antineutrino Behavior

Comparison of measurements with first preliminary simulations:

- Earth magnetic field: 0.4 Gauss
- Shielding of iron wall of decay tube not yet included!
- deflection is bigger in simulations

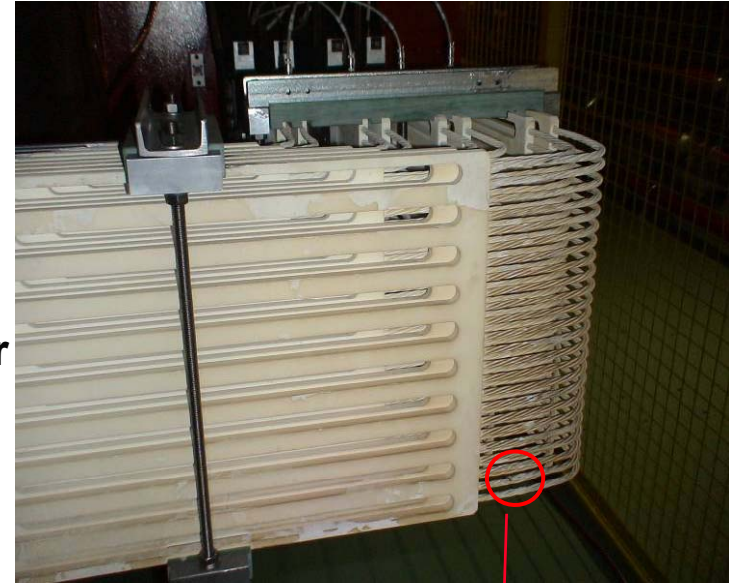
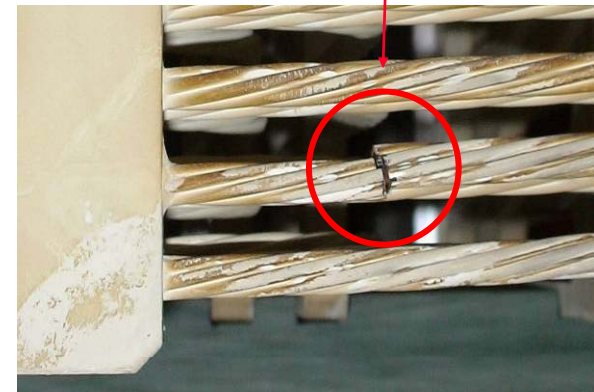
Discovered on Reflector
August 2007

Twisted & brazed
cables, Ag-Cu.
Fatigue (pulses) on
strands plus force from
thermal expansion
stripline caused **cracks**
& fatigue failure.

- **Successful Repair and Modification of the Horn and Reflector in 2007**
(As a consequence of a water leak in the reflector cooling circuit in 2006)
 - **Restart of the CNGS facility as scheduled on 17 September 2007 for six weeks**
- **CNGS beam performance: very good**
 - In total: $8.5 \cdot 10^{17}$ protons on target
 - **38 OPERA events in bricks**
 - **More than 400 events from interactions outside OPERA detector**
- **Failures in the ventilation system due to radiation effects in electronic**
 - **Consequences on**
 - safety of installed equipment – possible temperature rise
 - access system – switch between beam and access mode
 - **Stop of CNGS beam 5 days ahead of time**
- **Other issue: Broken cable in one of the flexible junctions in the reflector striplines**

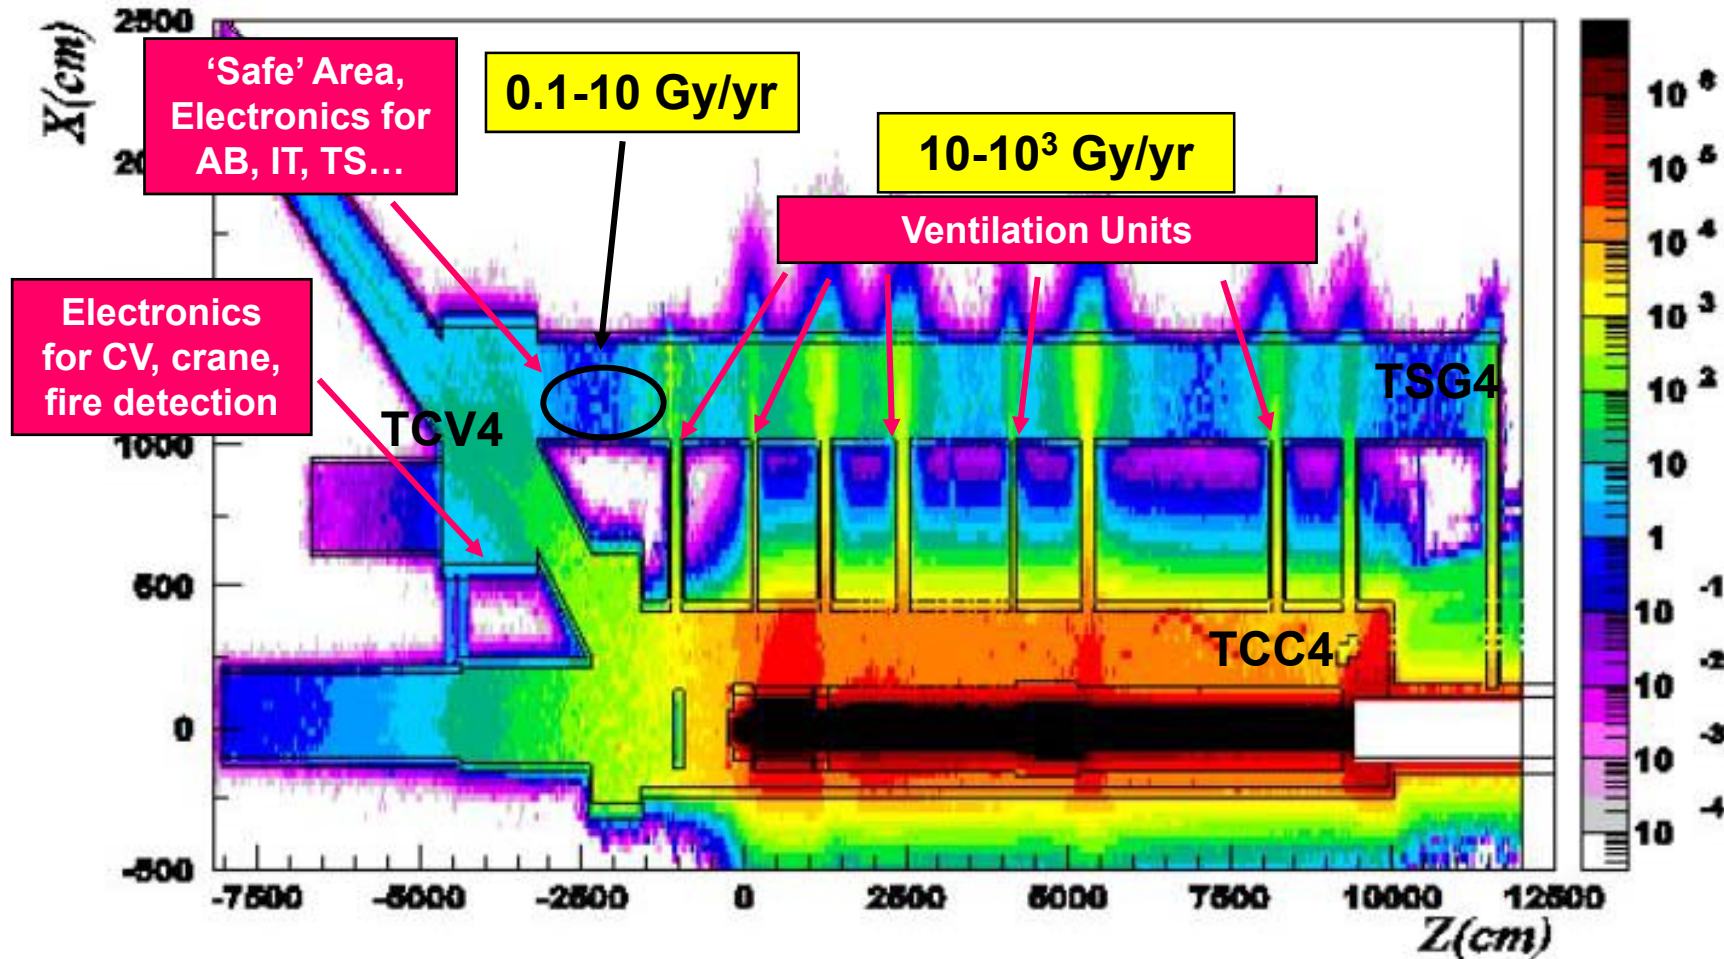
Present Situation: Expected Dose Levels

Gy/yr for a nominal CNGS year of $4.5 \cdot 10^{19}$ pot

Commercial electronics typically does not fail below 10 Gy

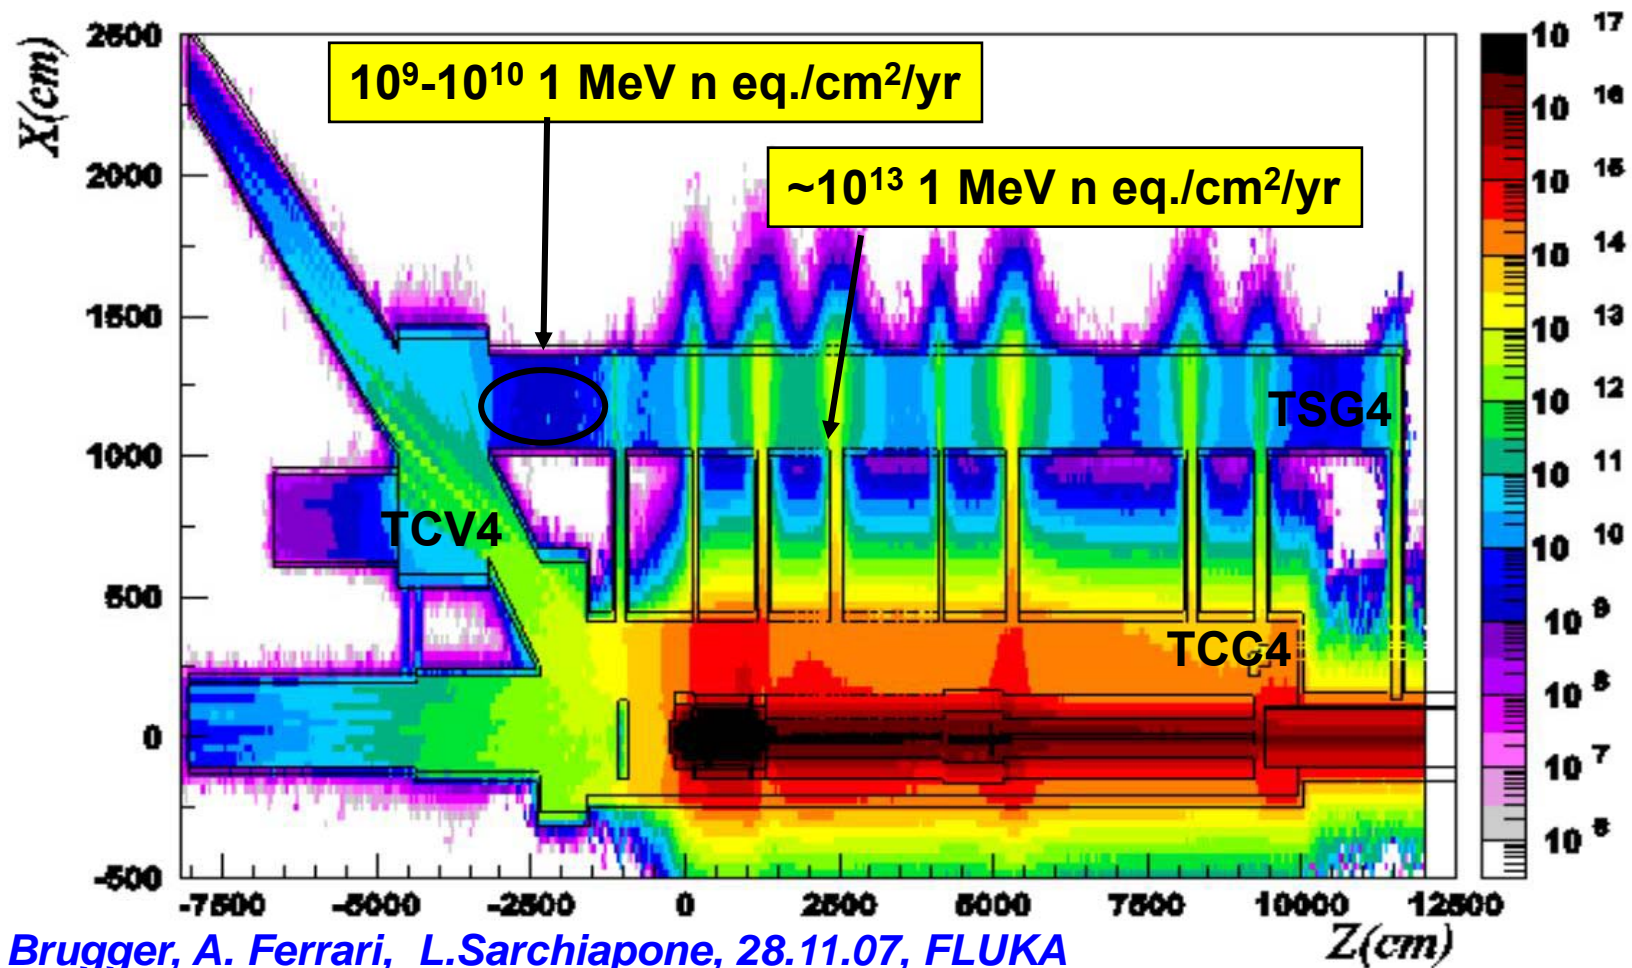
Expected Neutron Fluence

1 MeV eq. neutron fluence ($\text{cm}^{-2} \text{yr}^{-1}$) for a nominal CNGS year of $4.5 \cdot 10^{19}$ pot
