A new vendor for high volume production of silicon particle detectors

With results from the first prototype batch

Marko Dragicevic (HEPHY Vienna)

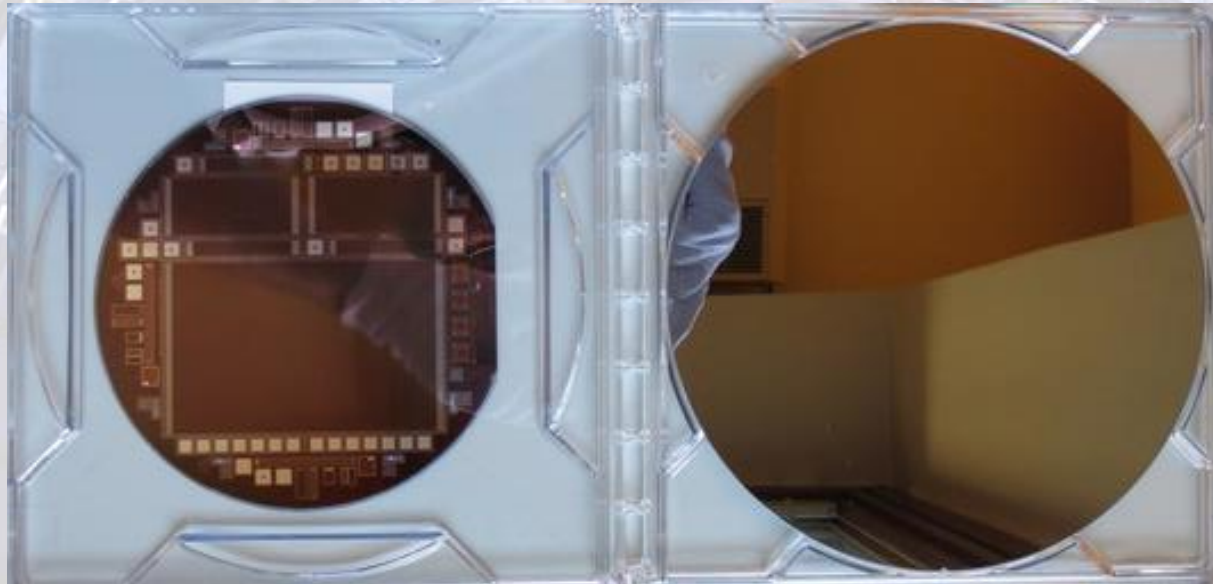
Wafer Size: 6" \rightarrow 8"

- Diameter: 150 mm
- Clearance: \sim 5 mm
- Area: 15,394 mm²
- Diameter: 200 mm
- Clearance: \sim 5 mm
- Area: 28,353 mm²

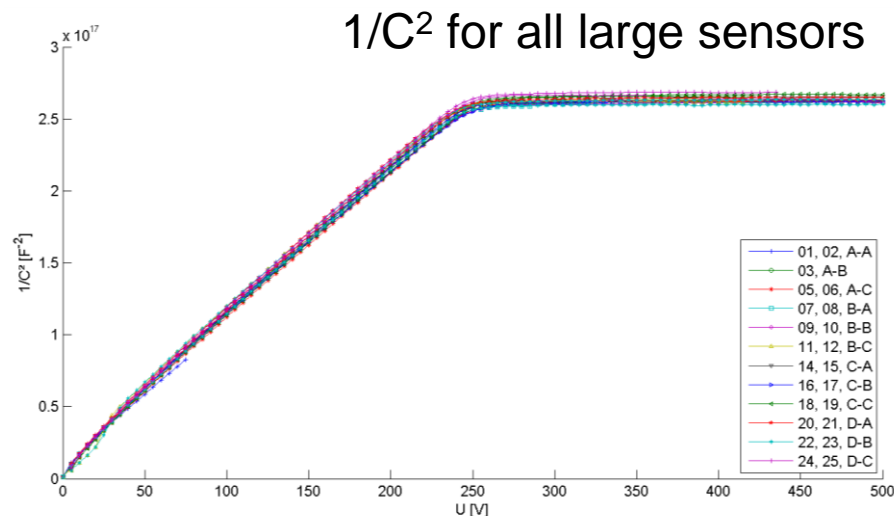
CV-Curves

- Uniform for all sensors on all wafers
- Depletion voltage well defined ≈ 240 V
 - Corresponds to 1.2 k Ω cm and matches specs of bulk material

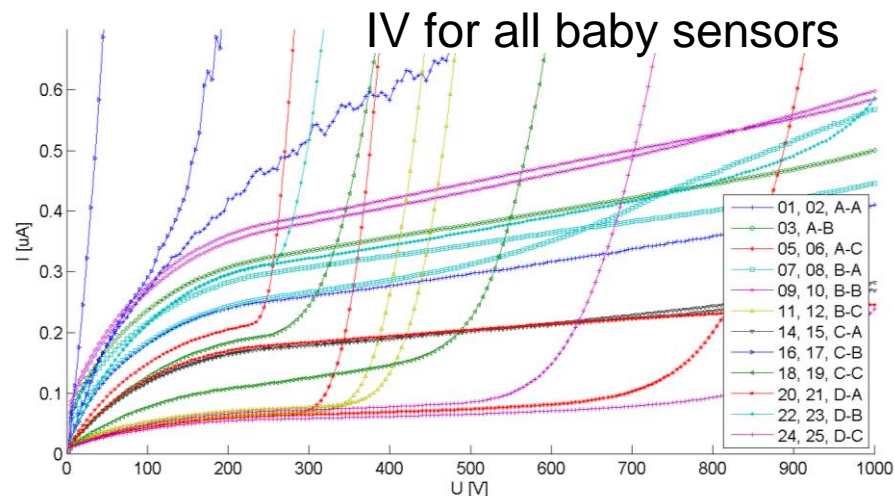
IV-Curves

- Many sensors are stable up to 1000 V
- Some sensors with very low leakage current but early breakdown
 - Different treatment of the backside n+ implant

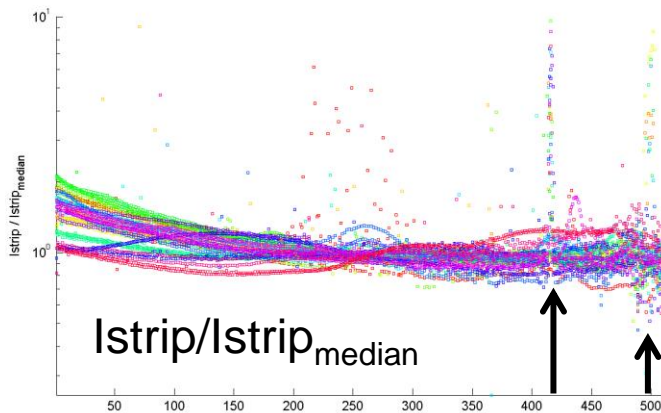
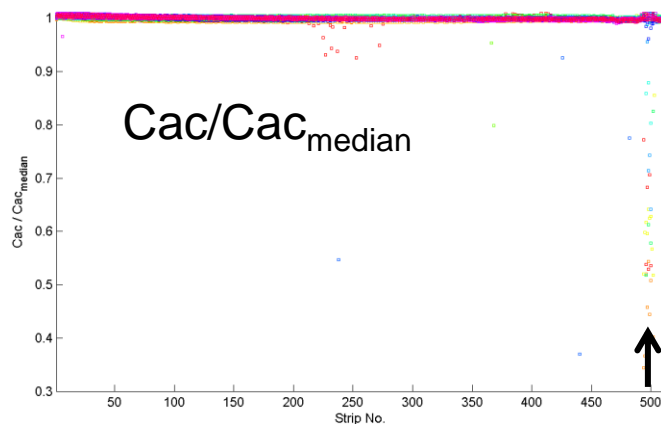
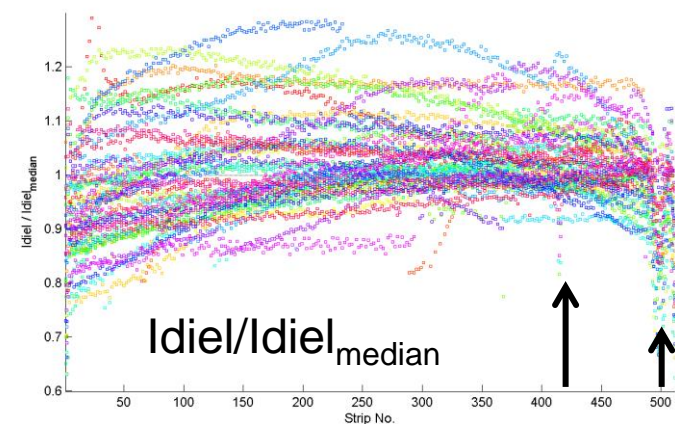
Accumulation of „Bad Strips“ (Large)

- Accumulation of anomalous strips around strip no. 416 and 500

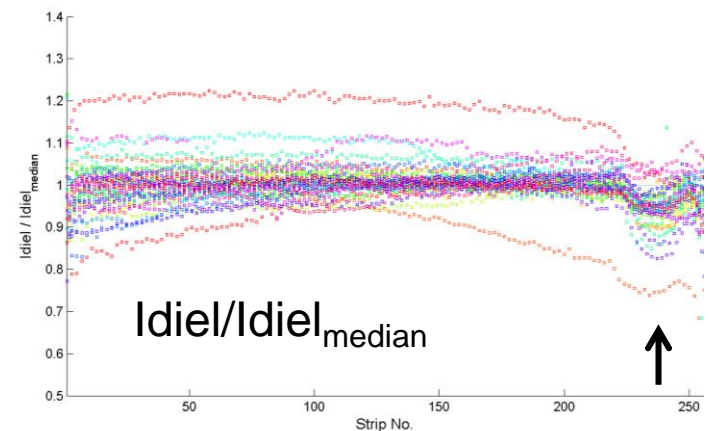
Accumulation of „Bad Strips“ (Baby)

- Accumulation of anomalous strips around strip no. 222-248

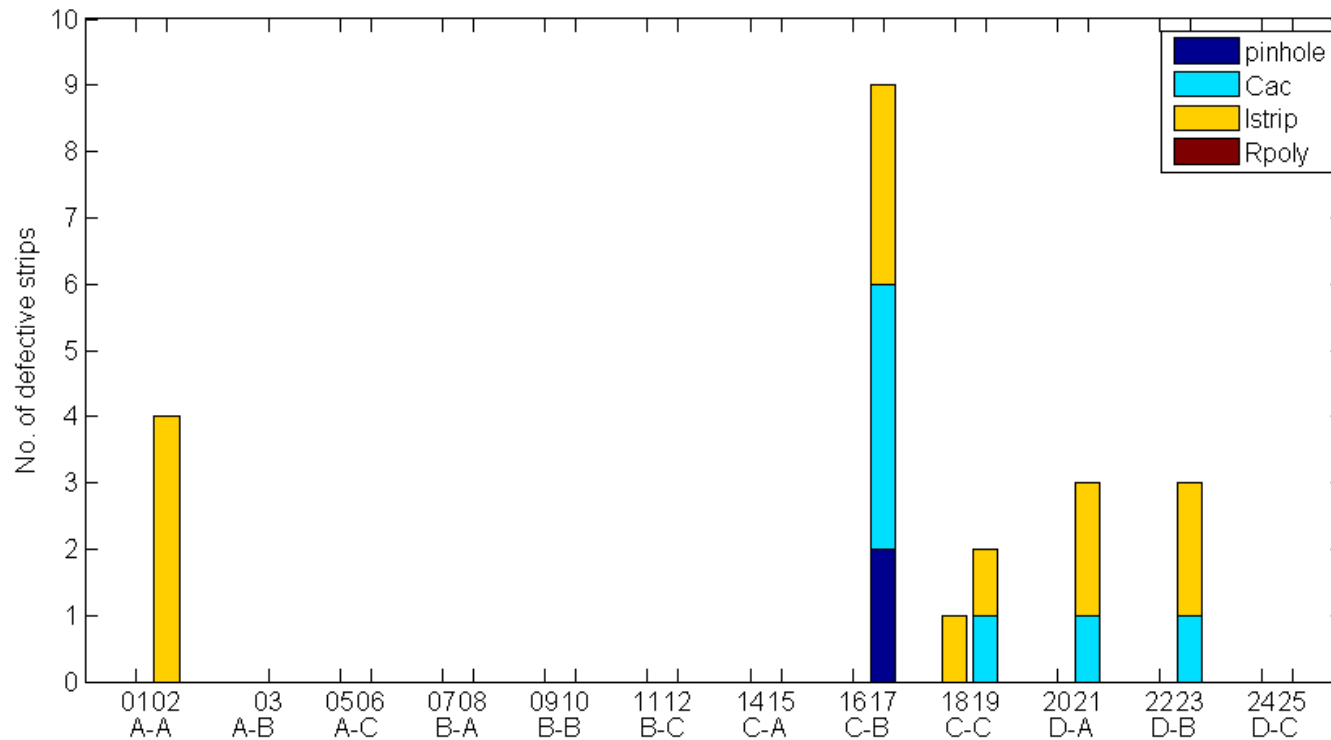
Strip Scan (Baby)

No. of faulty strips ignoring strips from “*bad strip area*” 222-248:

- Overall only 22 faulty strips remain

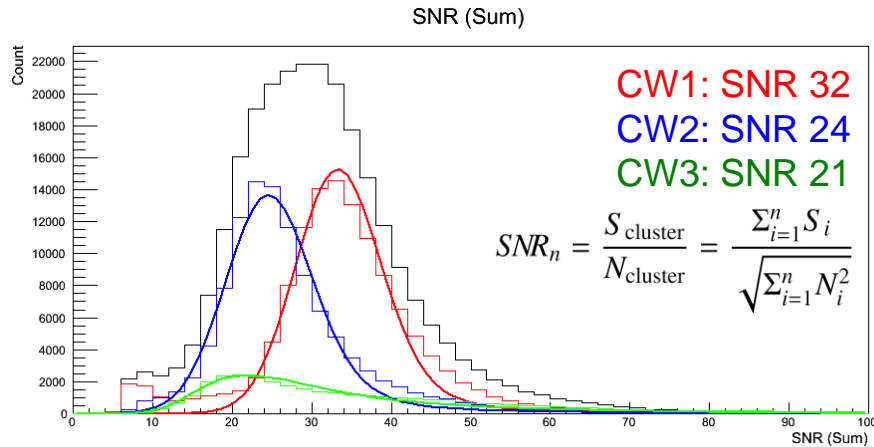
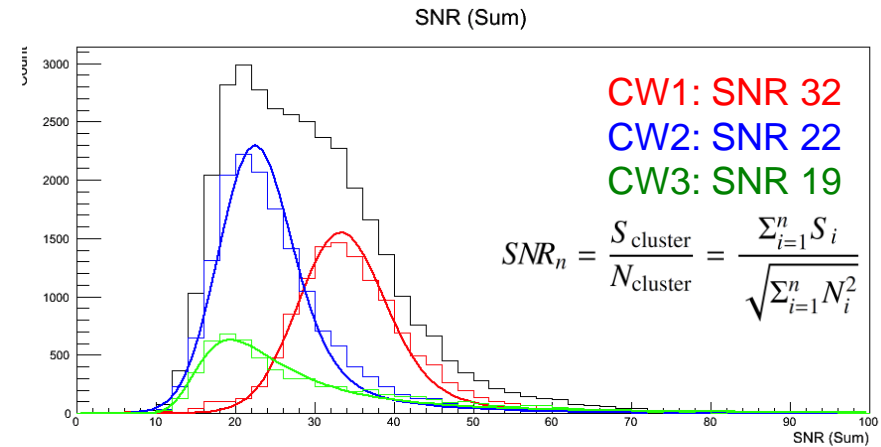
Signal-to-Noise

Results from „good“ strip area

Results from „bad“ strip area

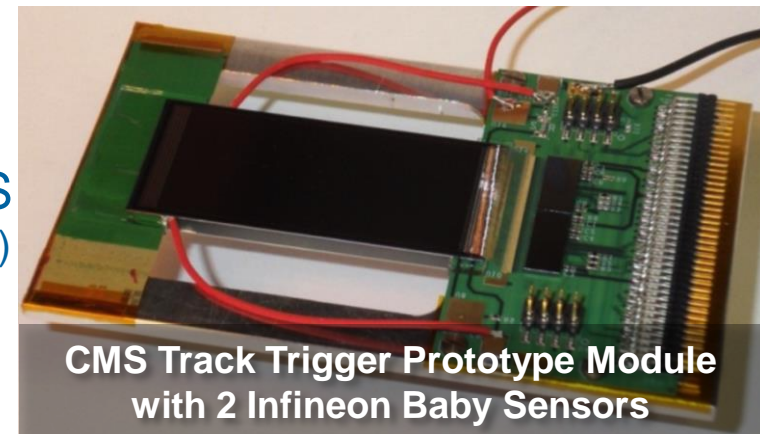
CMS Track Trigger Prototype Module
with 2 Infineon Baby Sensors

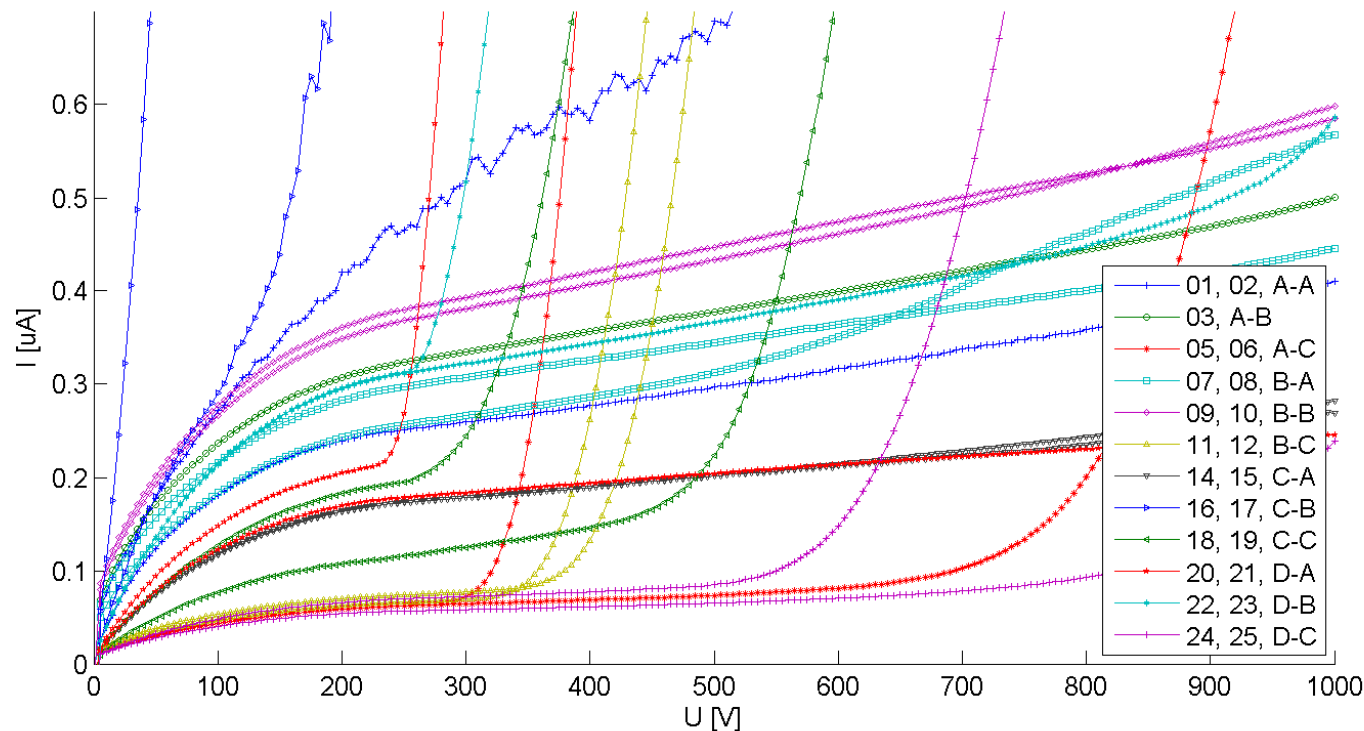
Baby Sensors – IV

Leakage Current of sensors

- Split group X-C shows very low leakage currents before breakdown
- Sensors 16 and 17 show ohmic behavior
