Cavity Treatment Summary

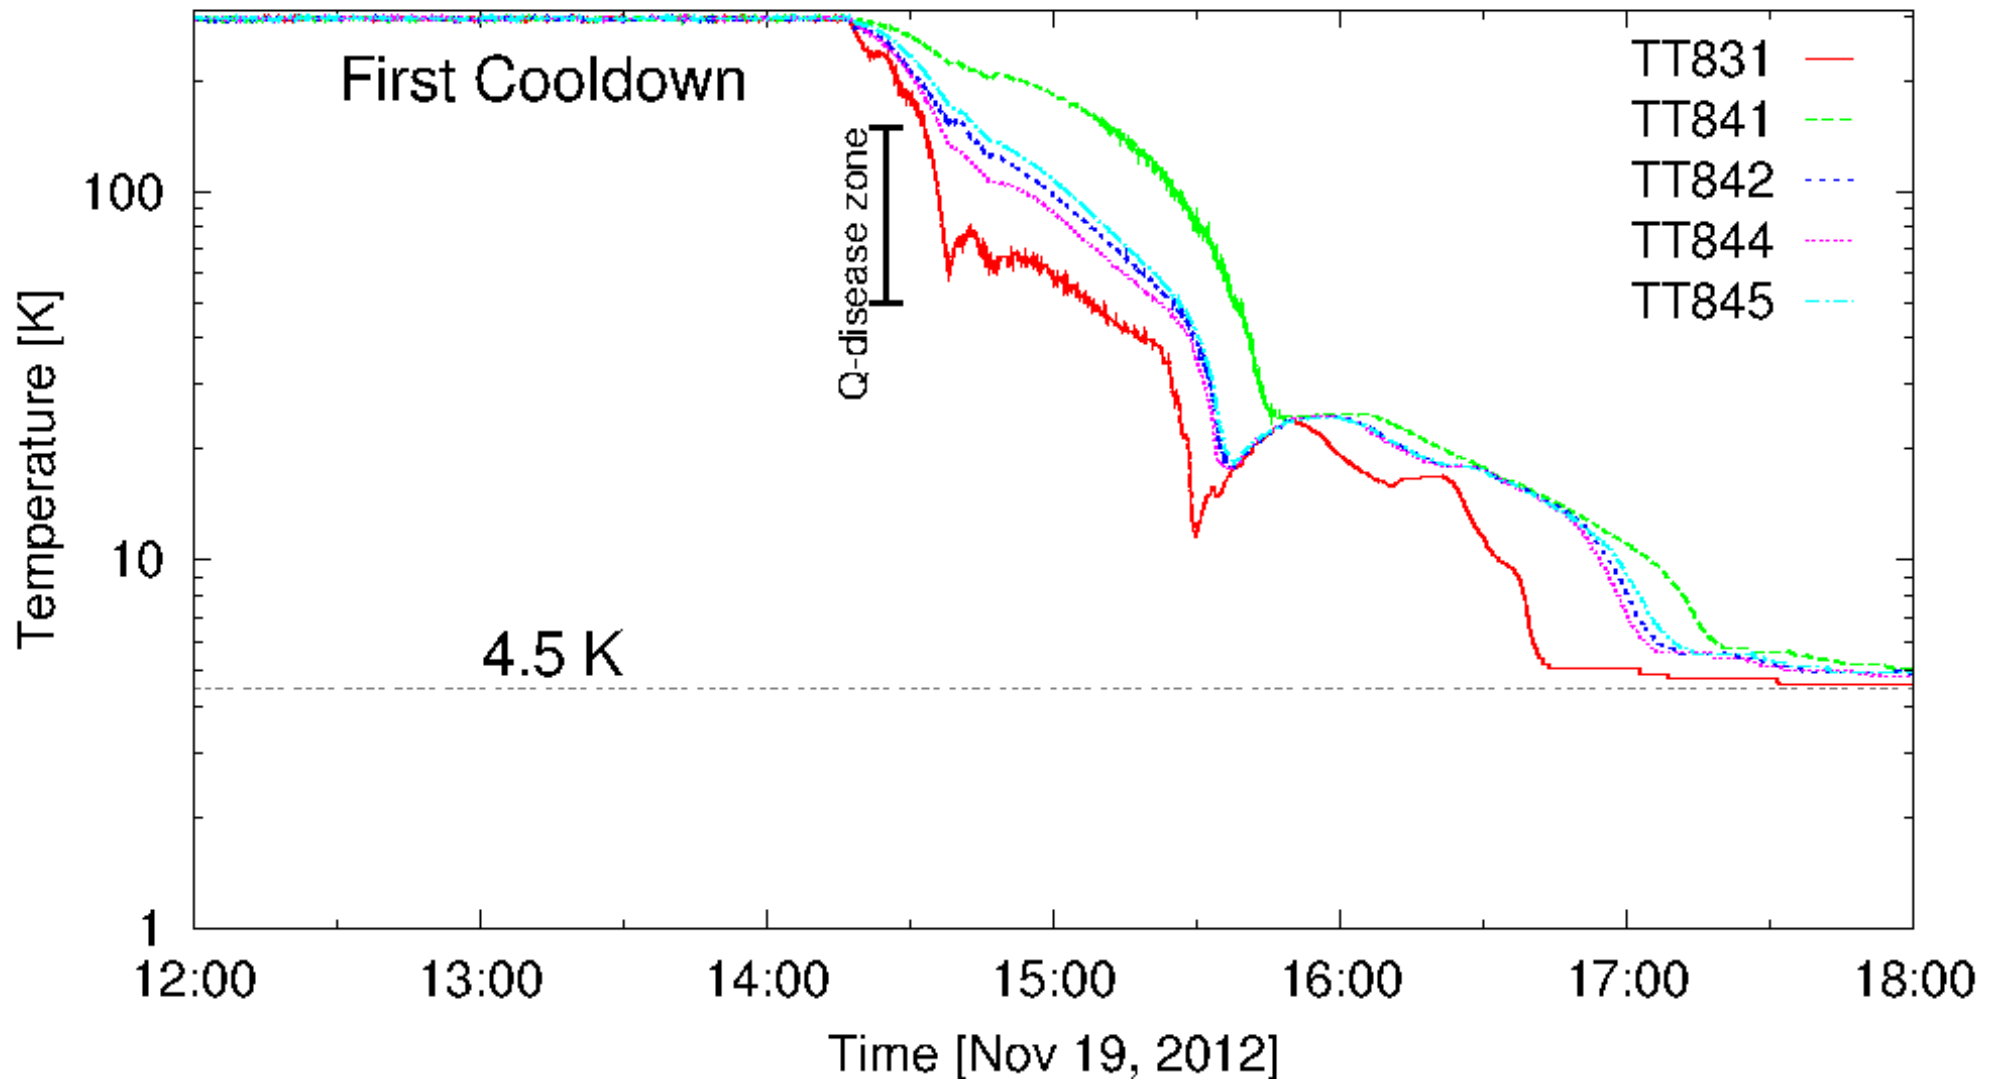
Q-disease zone (150-50K) \rightarrow Approx $\frac{1}{2}$ hr

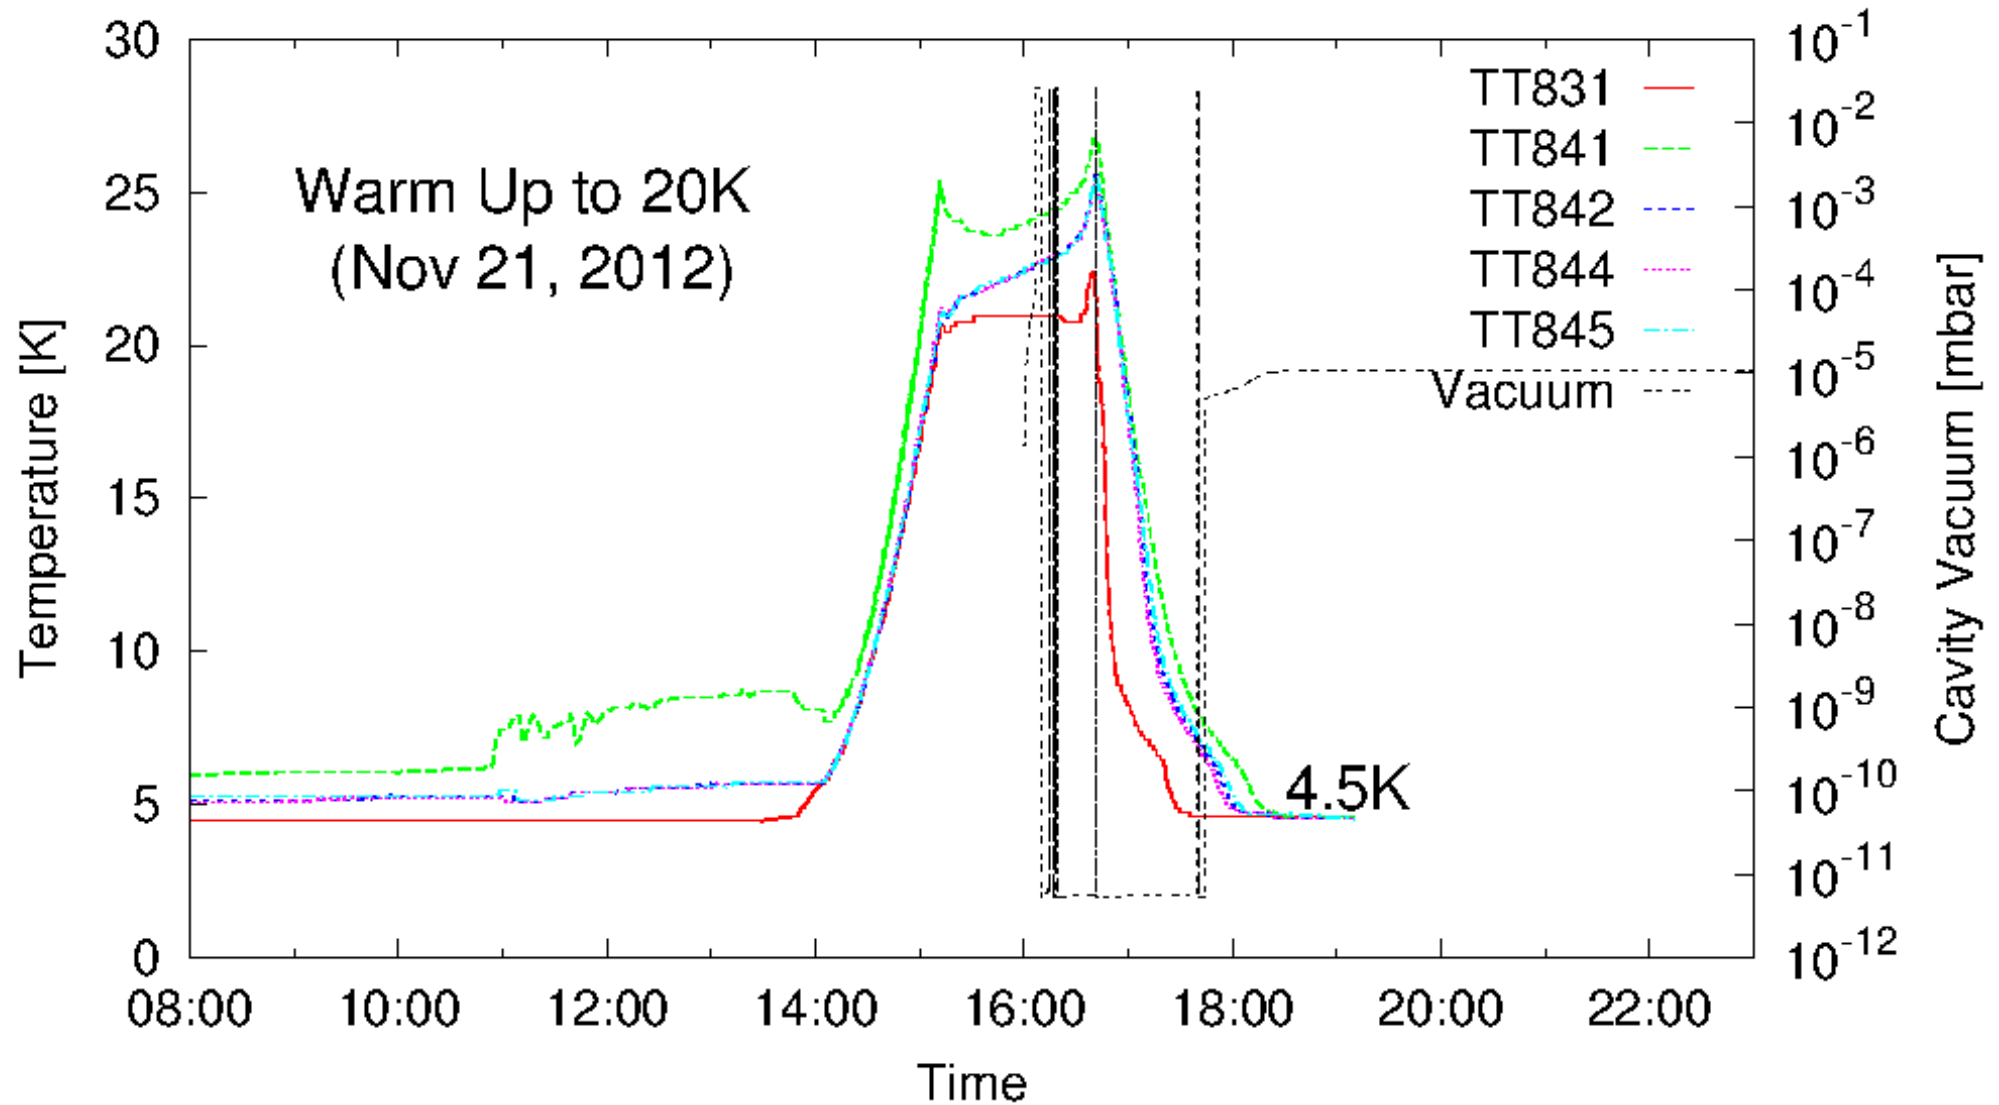
To initiate the external B-field compensation
(Turbo pump on)

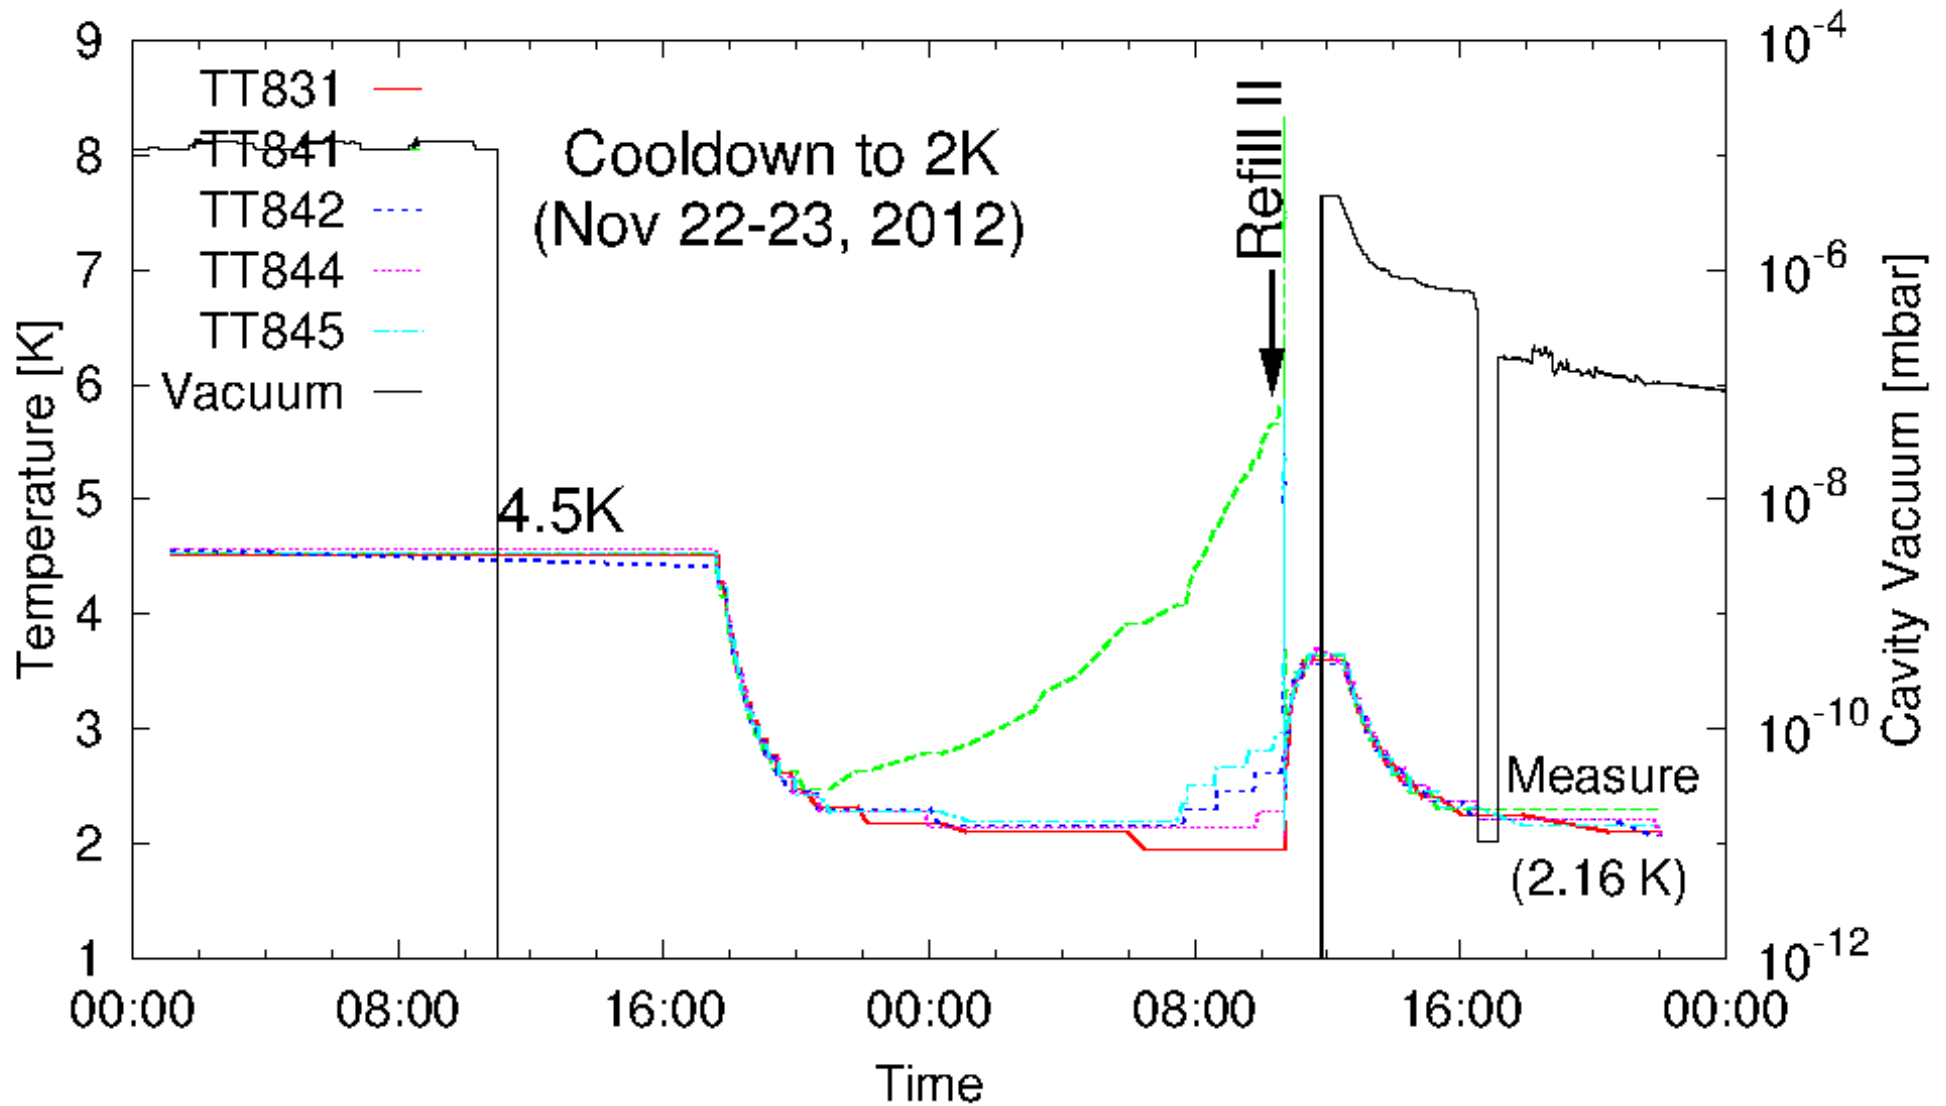
Cool down to 2K → Refill → Cool down to 2K
(Turbo pump on)

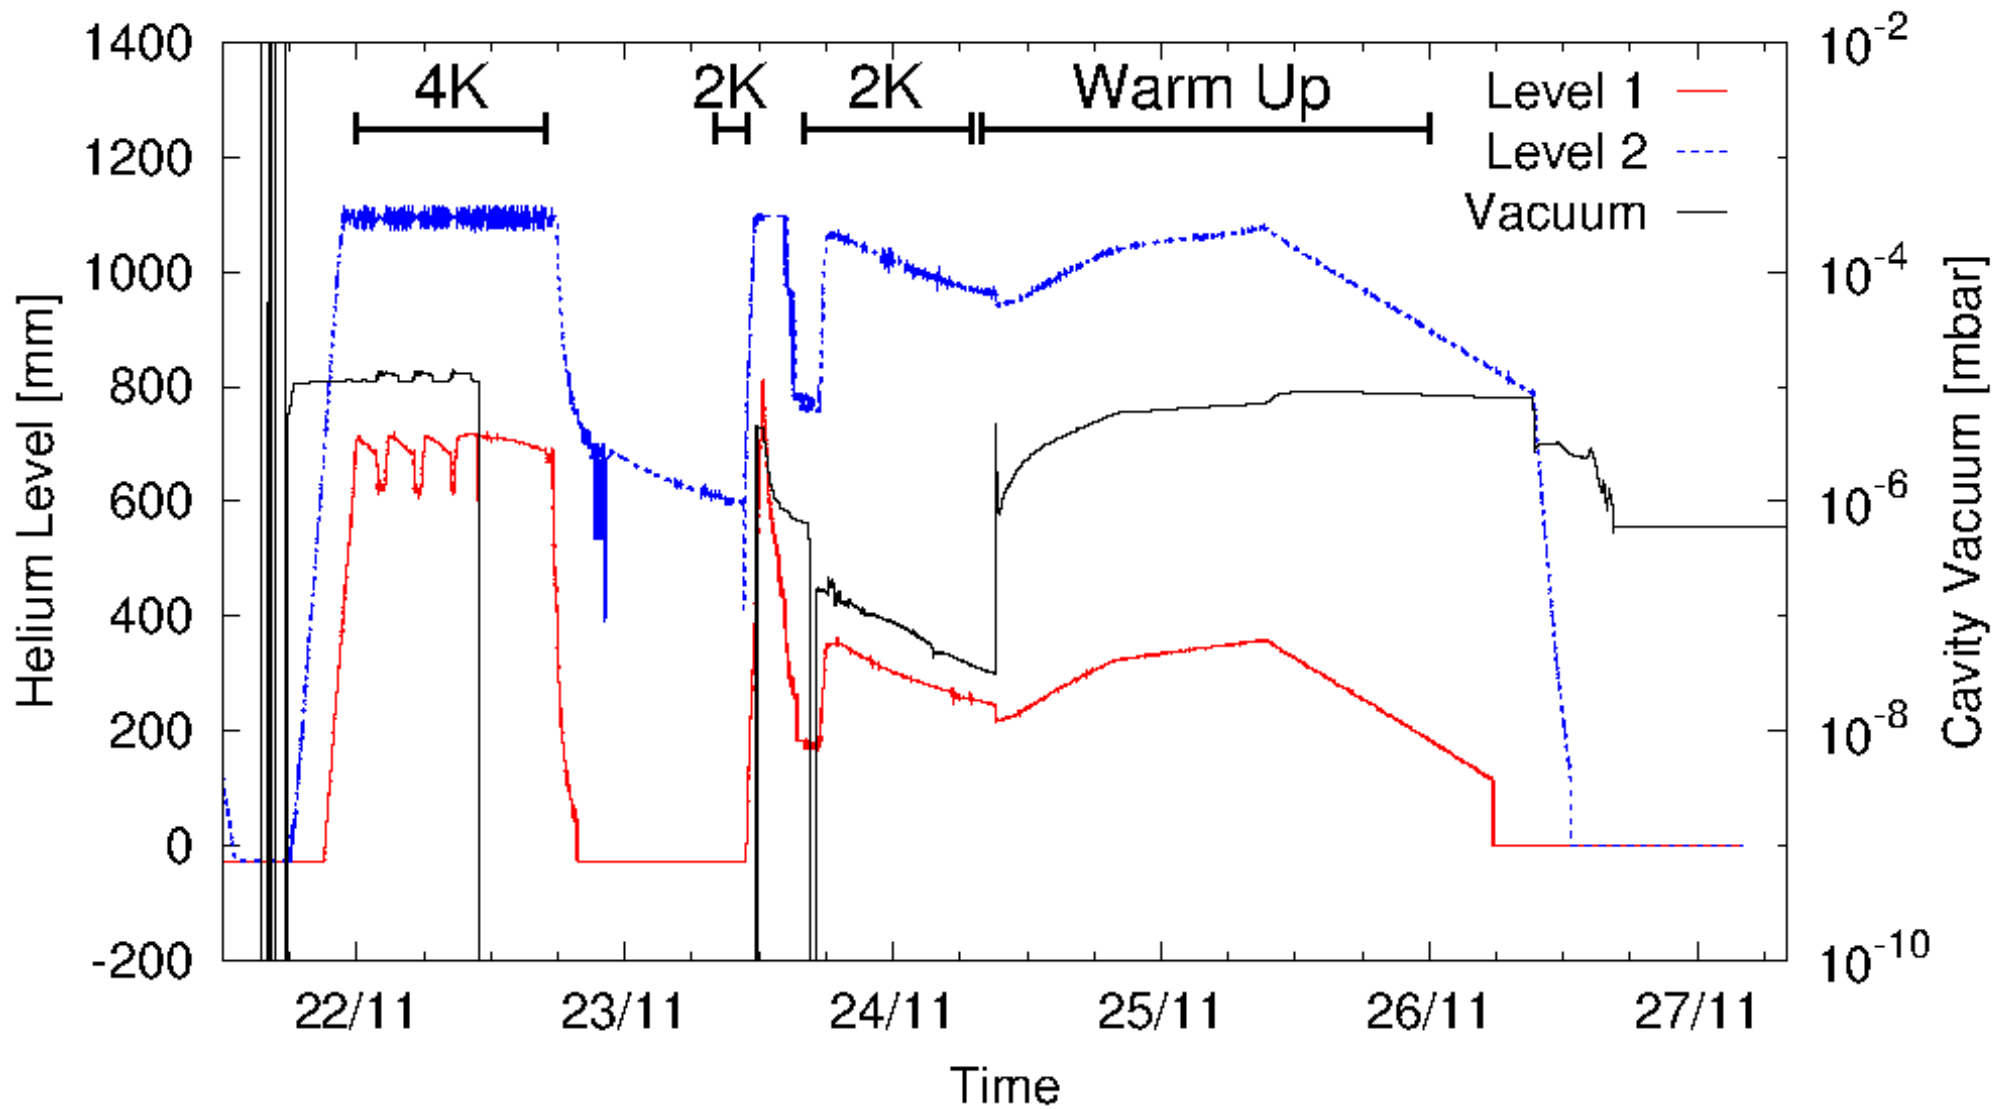
4K $\rightarrow 10^{-5}$ mbar

2K $\rightarrow 10^{-8}$ to 10^{-7} mbar (no evidence of leak from level)

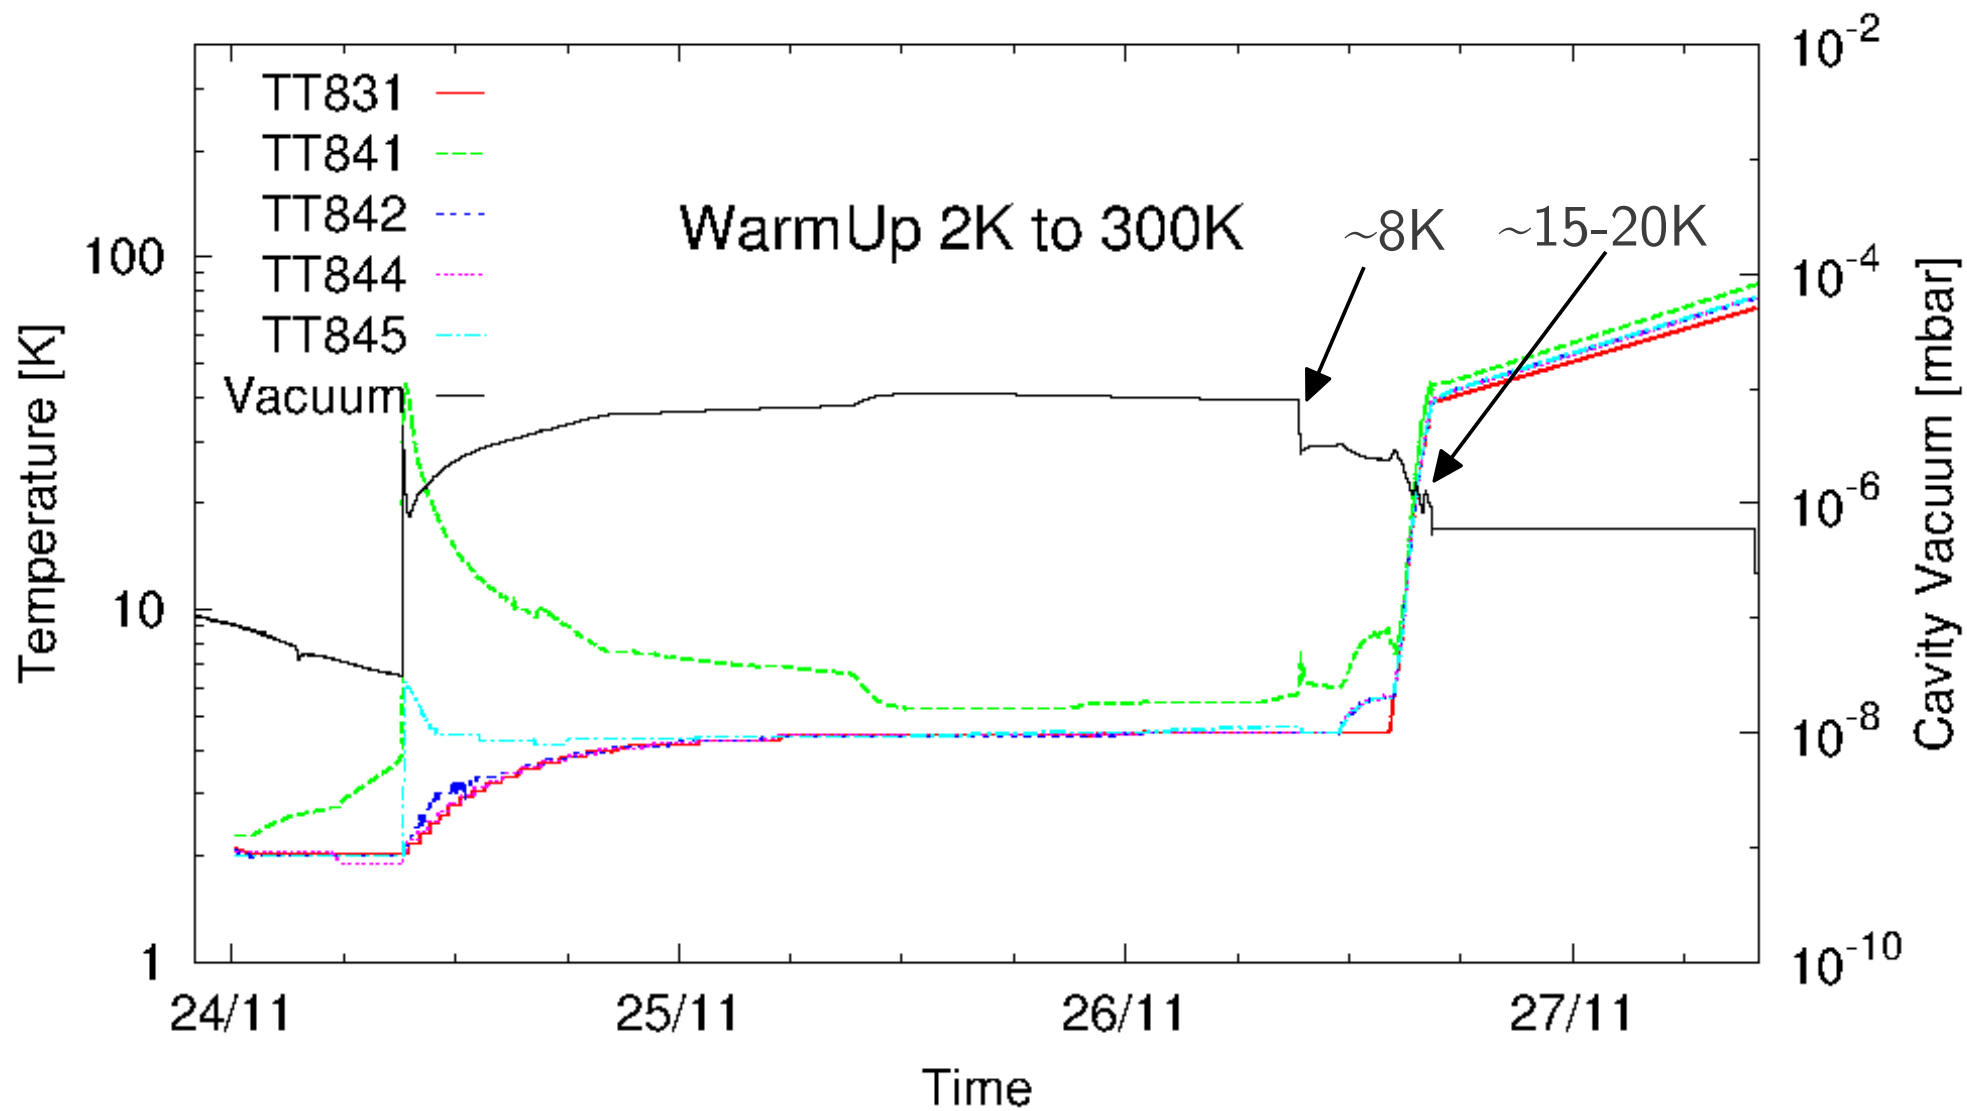
Vacuum steps visible around and above T_c
